**Roof Consulting
Services, Inc.**

Re: **In Progress Inspection – Single Ply Roof Recovery Project**
W.W. Grainger, Inc - 422 Laredo
610 Gale Street
Laredo, Texas 78093

In-Progress Inspection Photographs

Project Title: TPO Single Ply Roof Recovery

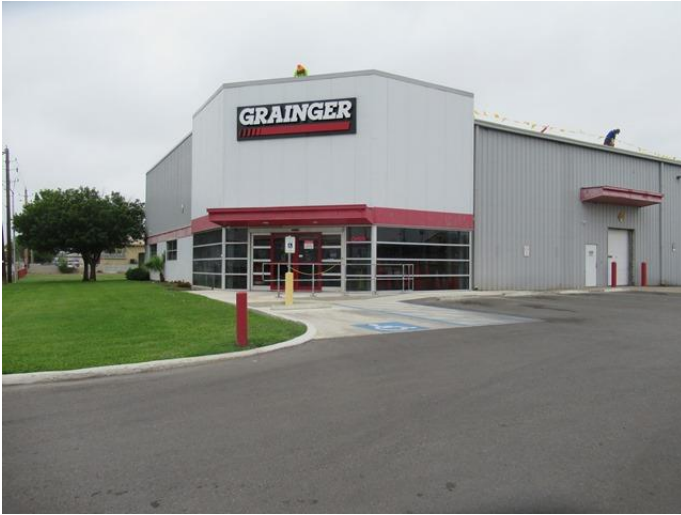
Exterior Elevation Overview

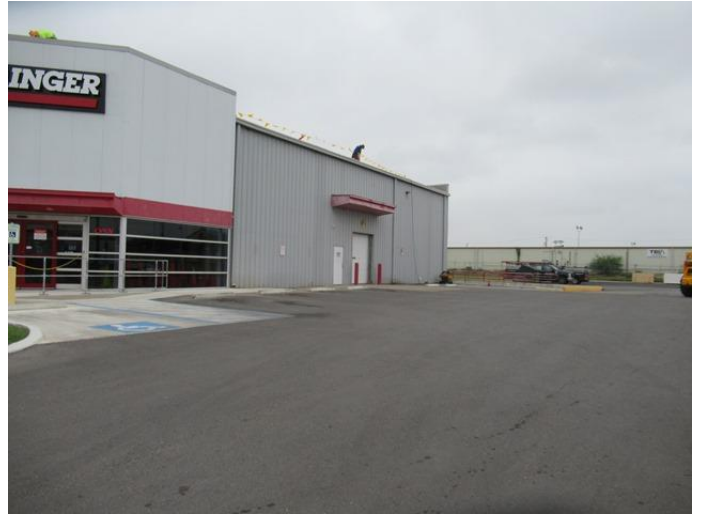
Exterior Elevation Overview

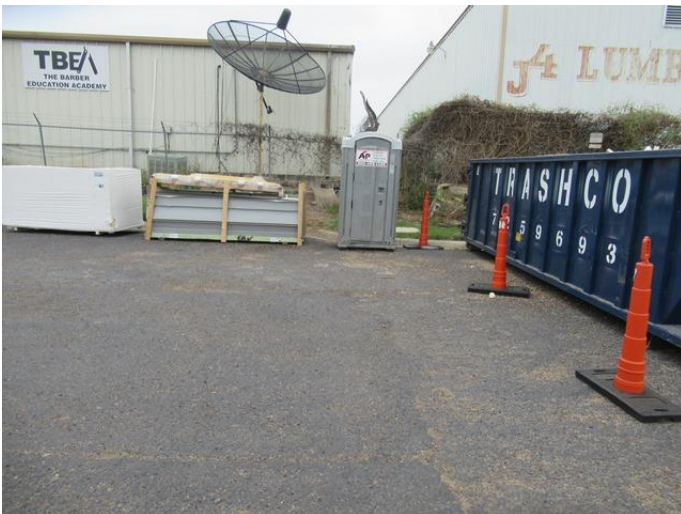
Staging Area Overview

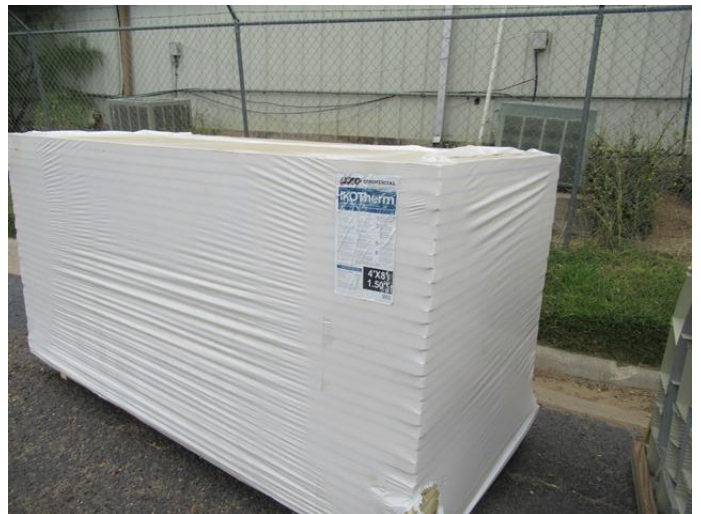
Materials Overview

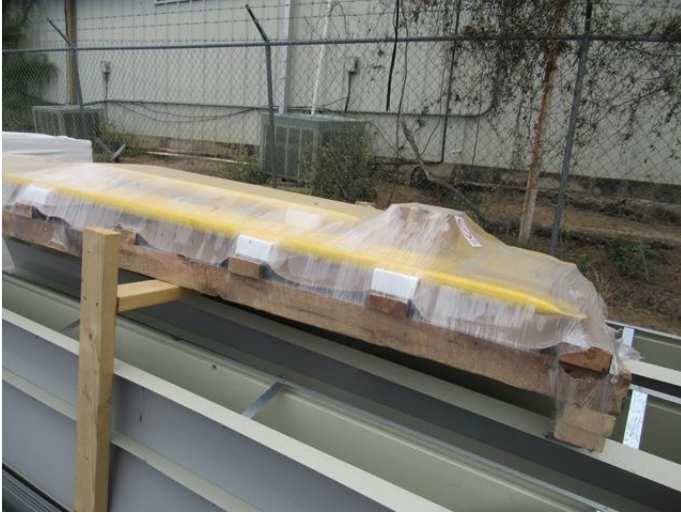
Materials Overview

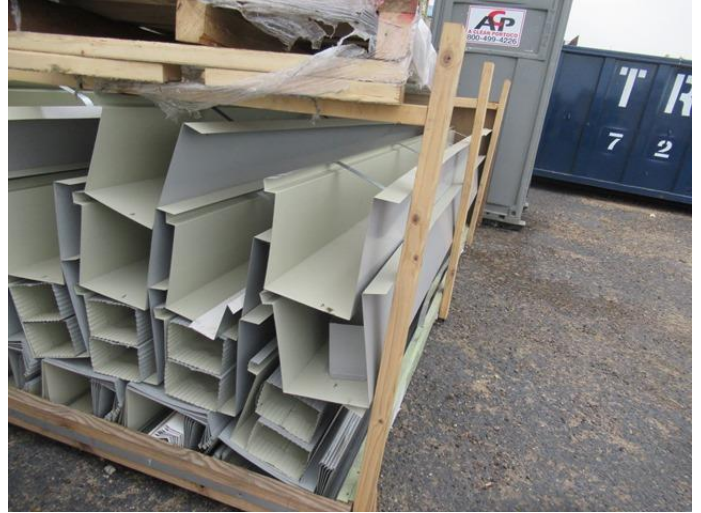
Materials Overview

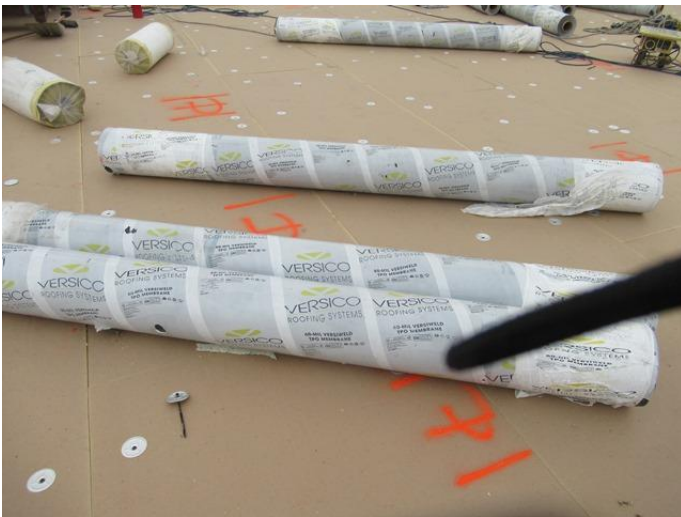
Materials Overview

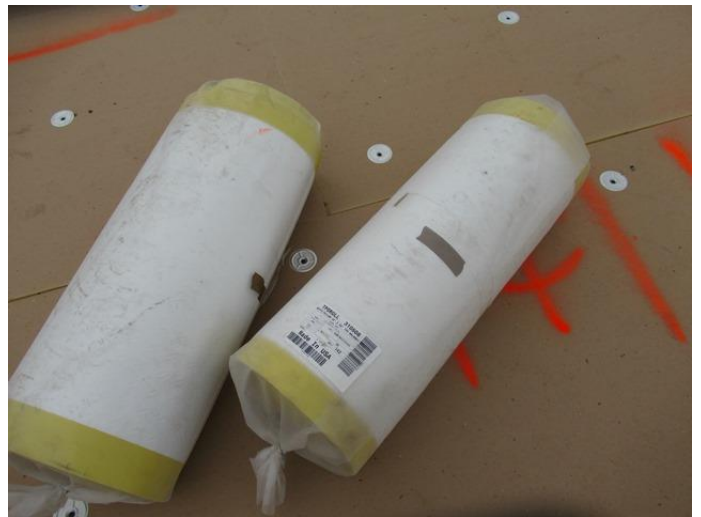
Materials Overview

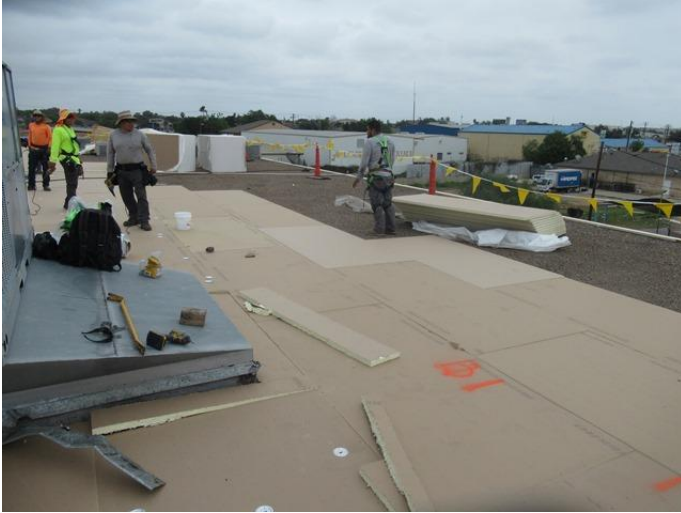
New TPO / Insulation Installation Overview

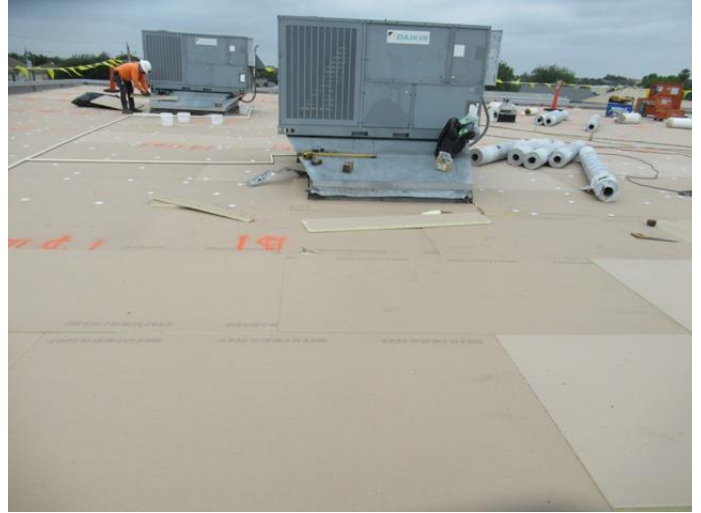
New TPO / Insulation Installation Overview

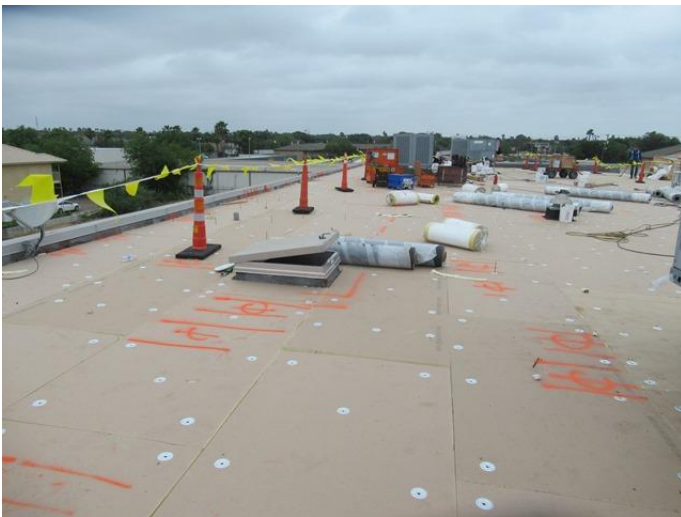
New TPO / Insulation Installation Overview

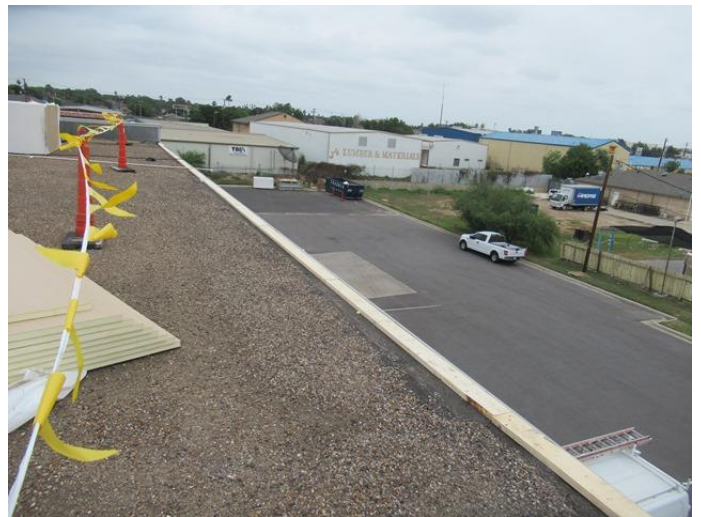
New TPO / Wood Nailers Installation Overview

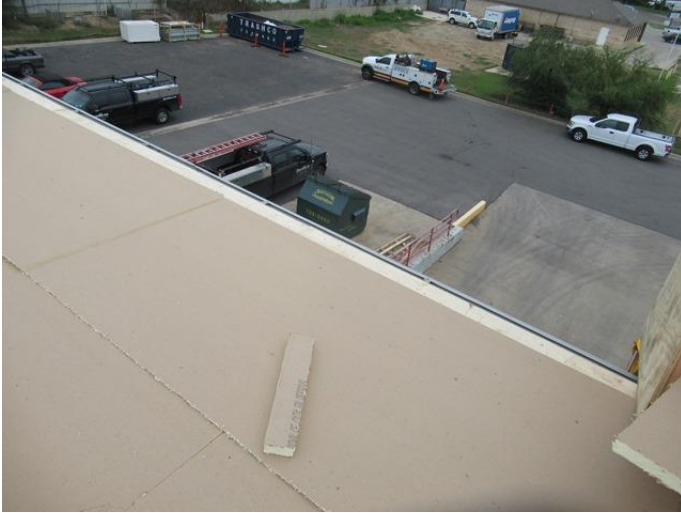
New TPO / Wood Nailers Installation Overview

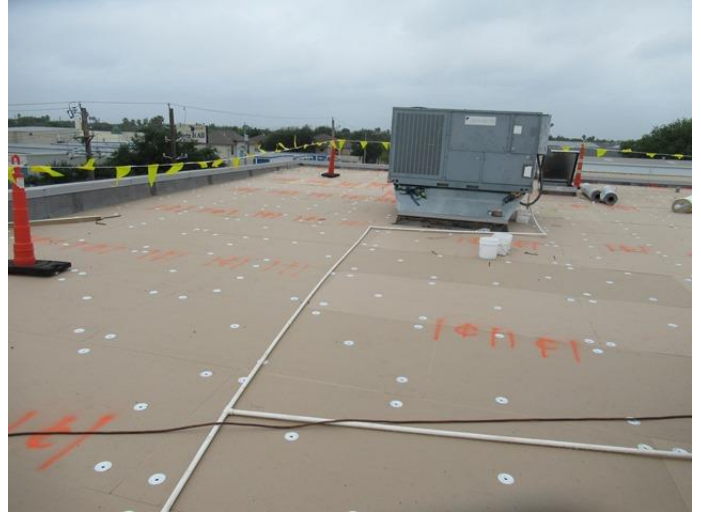
New TPO / Insulation Installation Overview

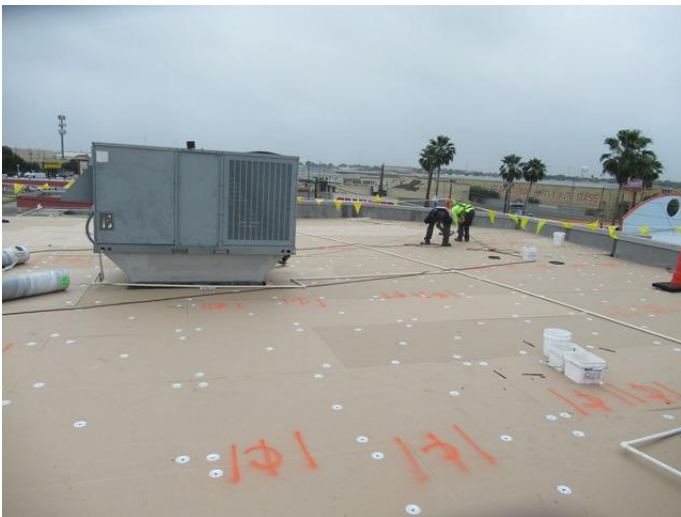
New TPO / Insulation Installation Overview

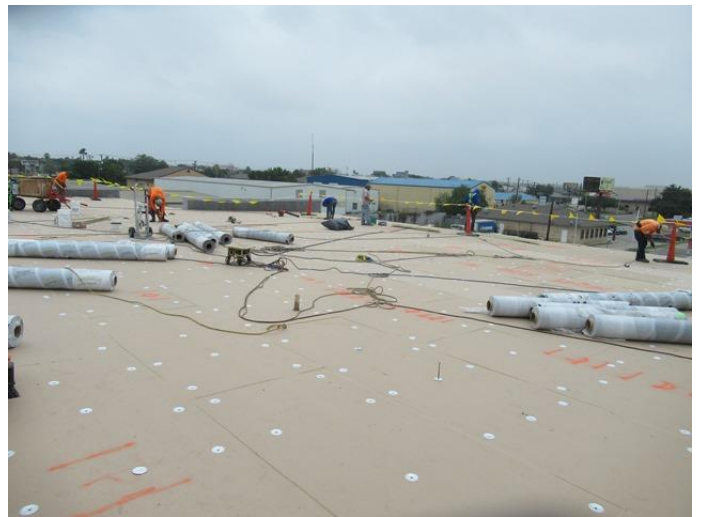
New TPO / Insulation Installation Overview

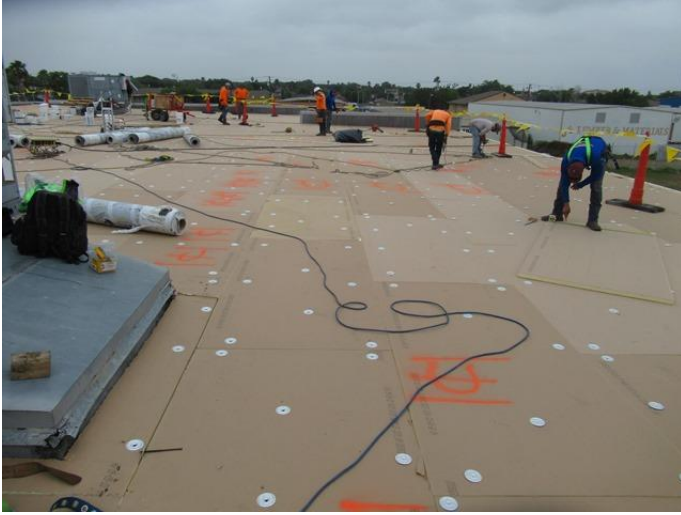
New TPO / Insulation Installation Overview

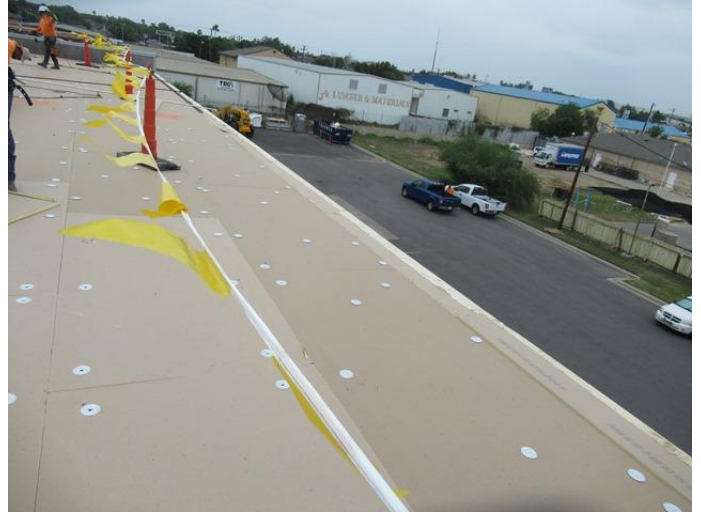
New TPO / Insulation Installation Overview

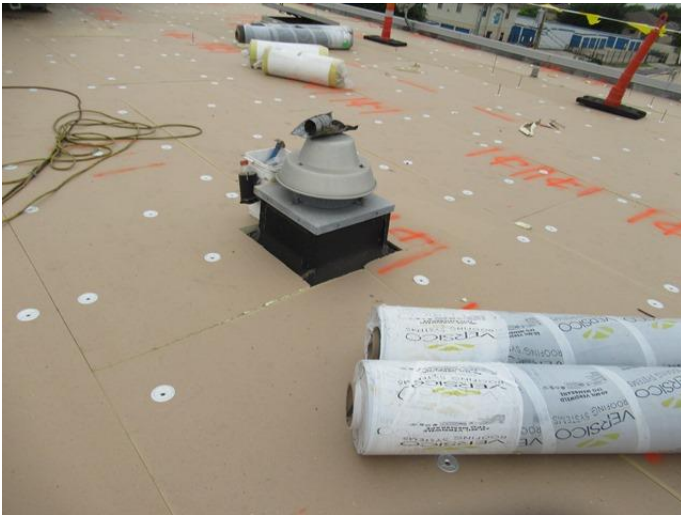
1. The base flashings at penetrations, curbs, and parapets have not been removed, no plywood was on site at the time of this inspection. I asked CentiMark foreman Elijah Garza to provide photo documentation to RCS of the process of base flashing installation.

Existing Flashings Not Removed

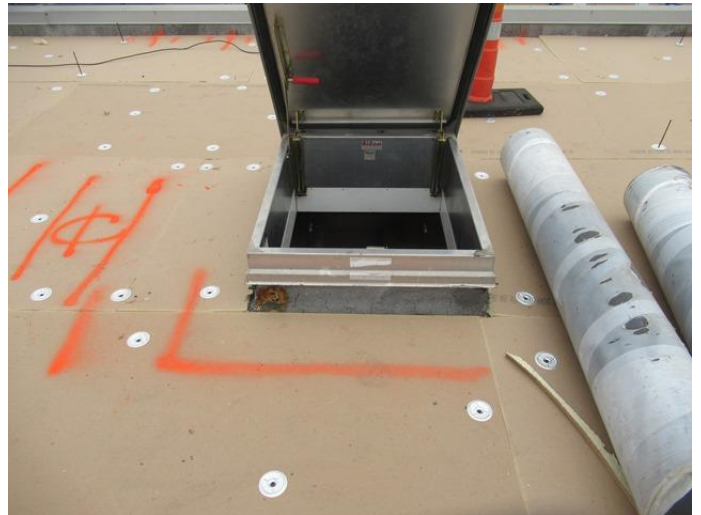
Existing Flashings Not Removed

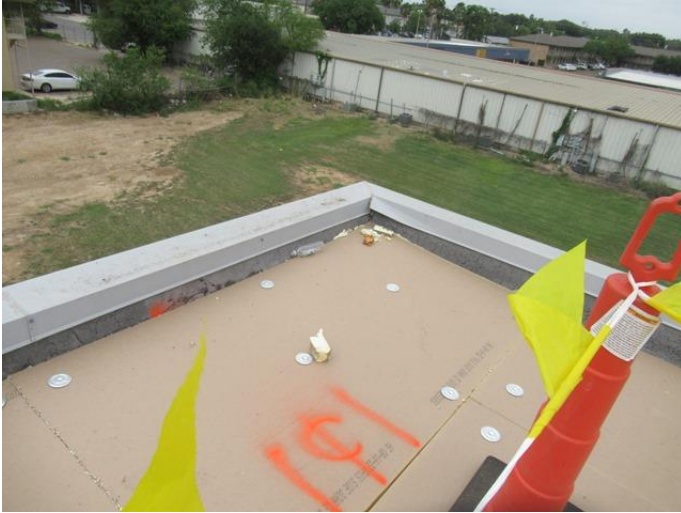
2. The metal coping, perimeter edge metal, gutters, downspouts, and 50% of counter flashings have not been removed at the time of this inspection.
3. The curbs without clearance for the required minimum 8 inch flashing heights have not been raised with installation of new wood nailers. CentiMark foreman Elijah Garza stated he plans raise the HVAC units with jacks that he had on the roof. And install the new flashing up over the top of curbs to provide the required flashing height. Note: Existing HVAC units have curb adaptors in place which reduced flashing height. I asked CentiMark foreman Elijah Garza to provide photo documentation to RCS of the process of raising and flashing these curbs.

Existing Flashing / Metal Coping Not Removed

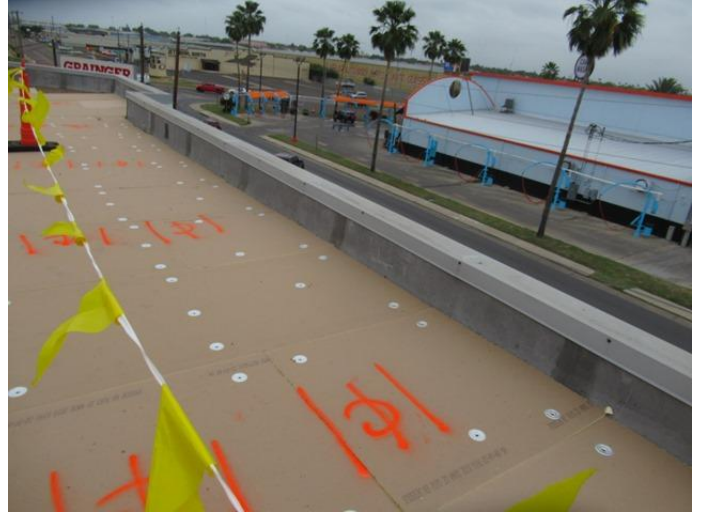
Existing Flashing / Metal Coping Not Removed

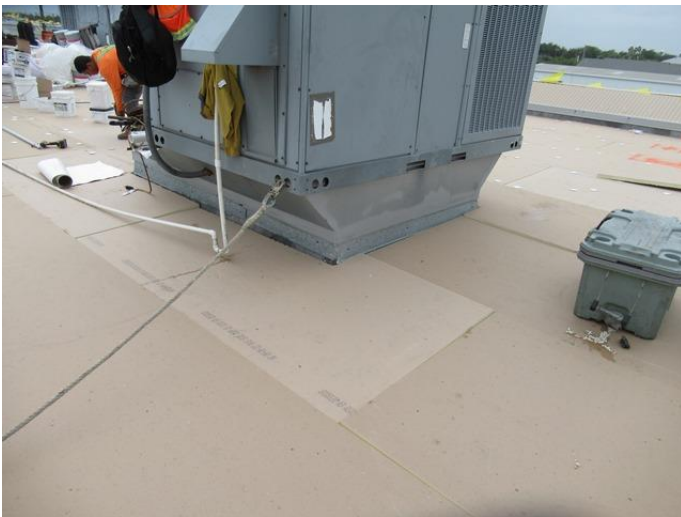
Existing Flashing / Counter Flashing Not Removed

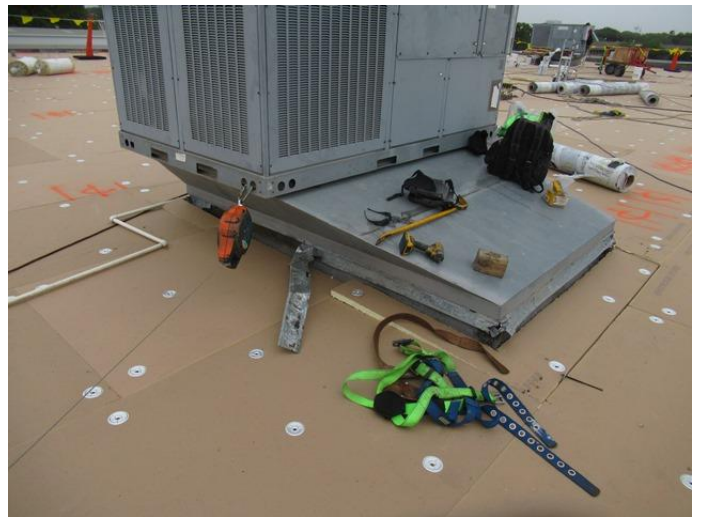
Existing Flashing / Counter Flashing Not Removed
Low Flashing Height also Depicted

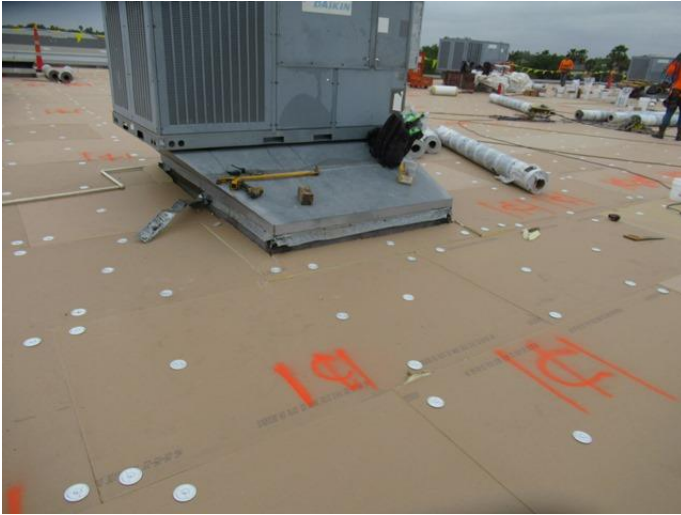
Existing Flashing / Counter Flashing Not Removed
Low Flashing Height also Depicted

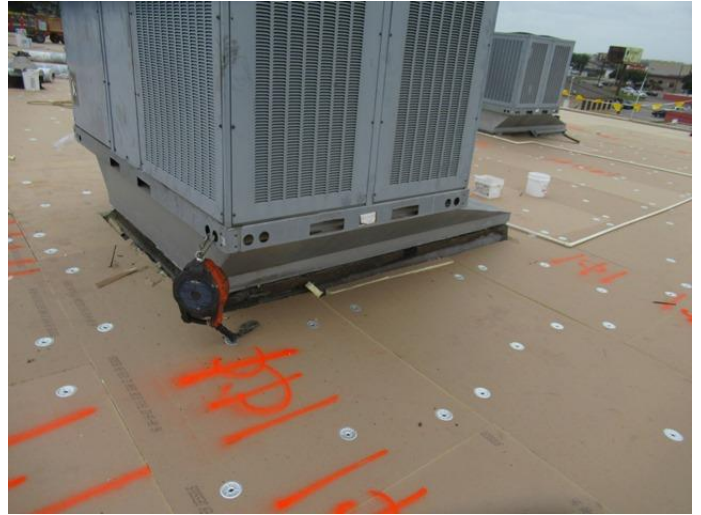
Existing Flashing Not Removed / Low Flashing Height

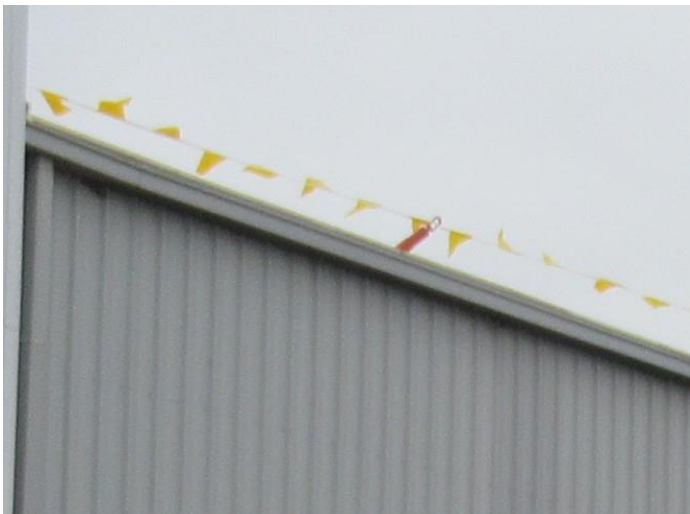
Existing Perimeter Edging / Gutter System Not
Removed

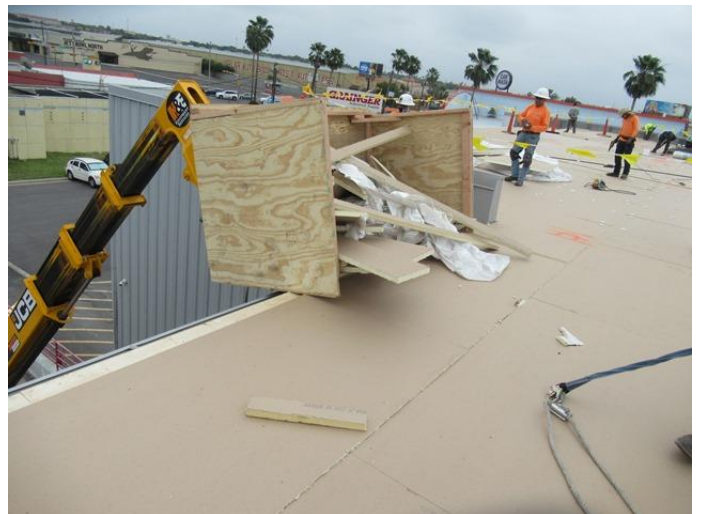
Debris Removal Process
