## **Domino Sugar Refinery**

# **Domino Sugar Facility**

**7412 N. Peters Street  
Arabi, LA**

**9/3/2022**

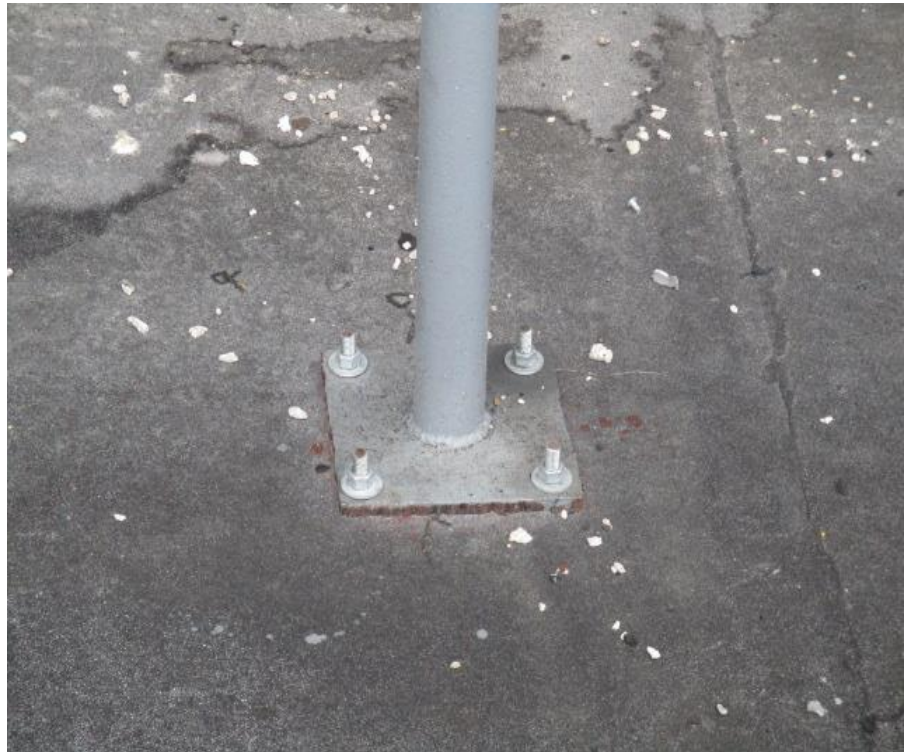
34. Deficiency #1 - Penetrations through roof surface have not been flashed

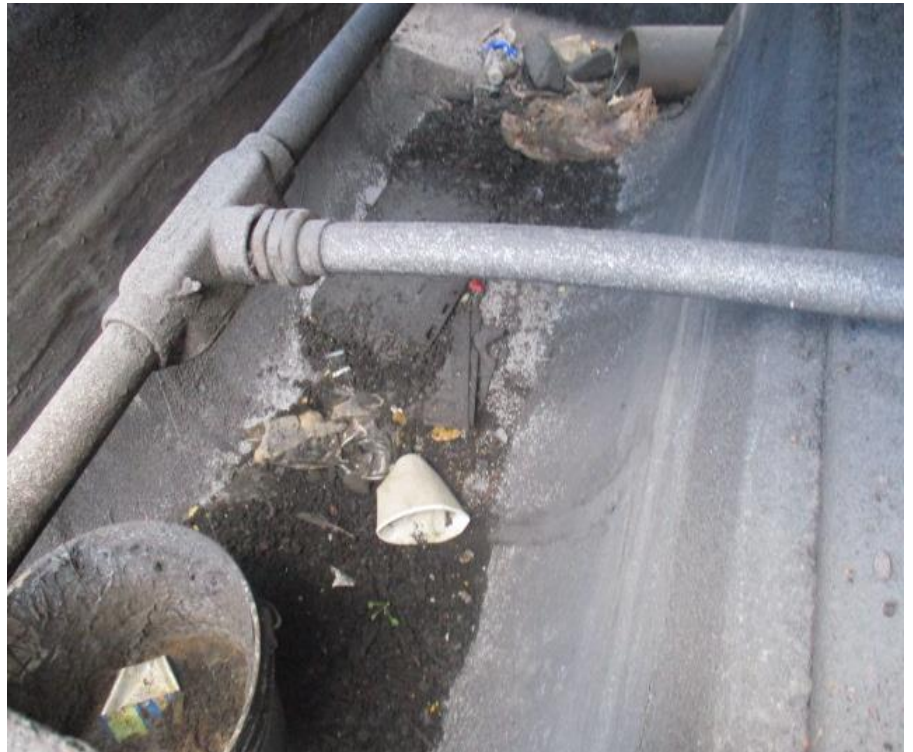
36. Deficiency #2 - Debris on roof surface

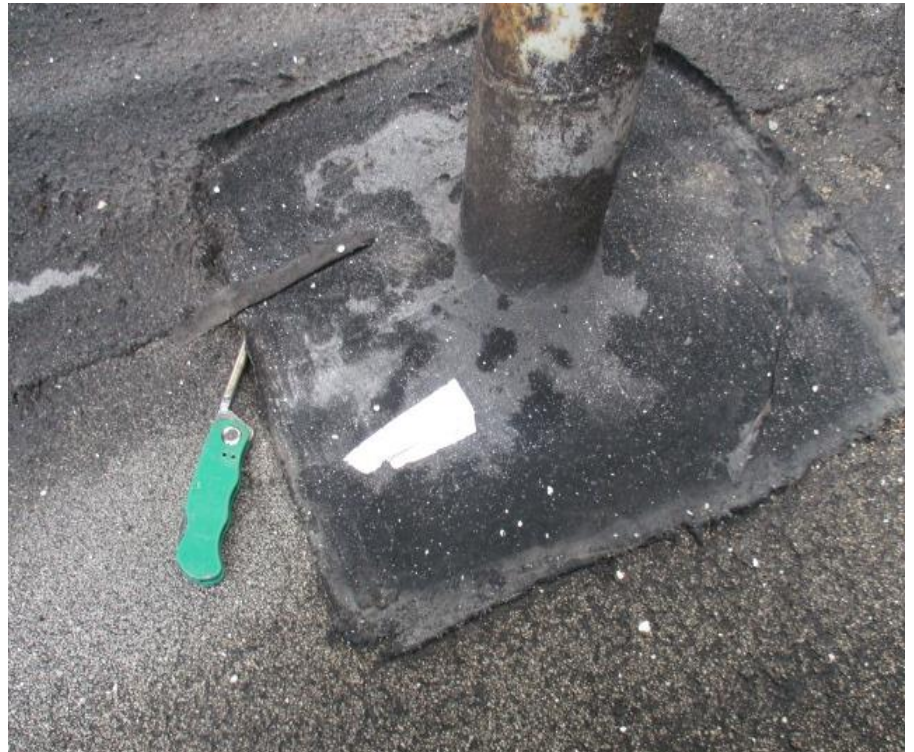
38. Deficiency #3 - Open flashing

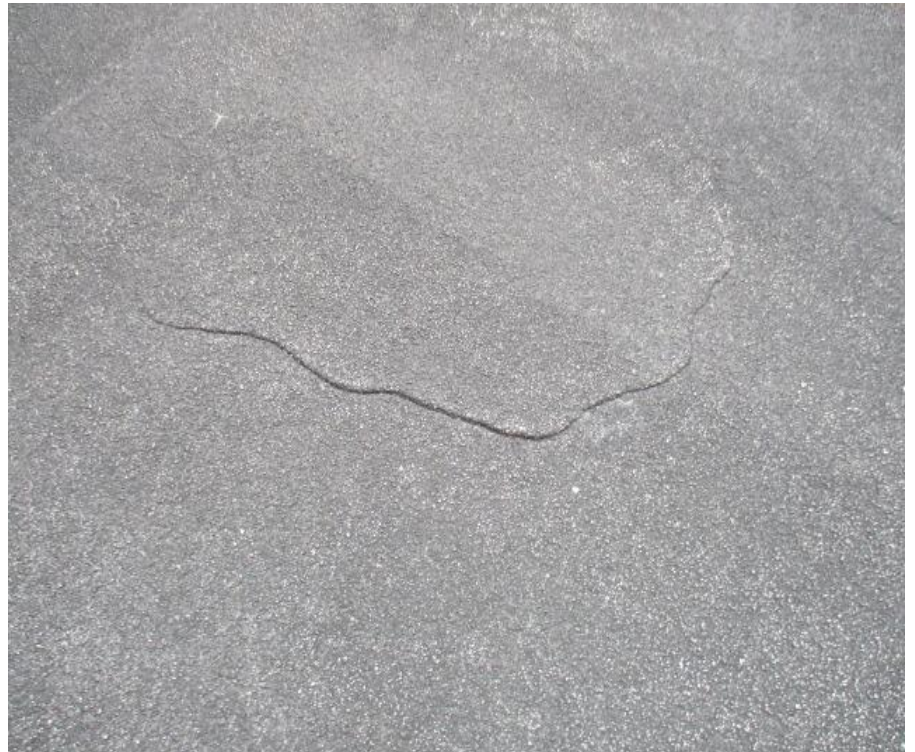
40. Deficiency #4 - Hole / puncture  
in membrane / felts

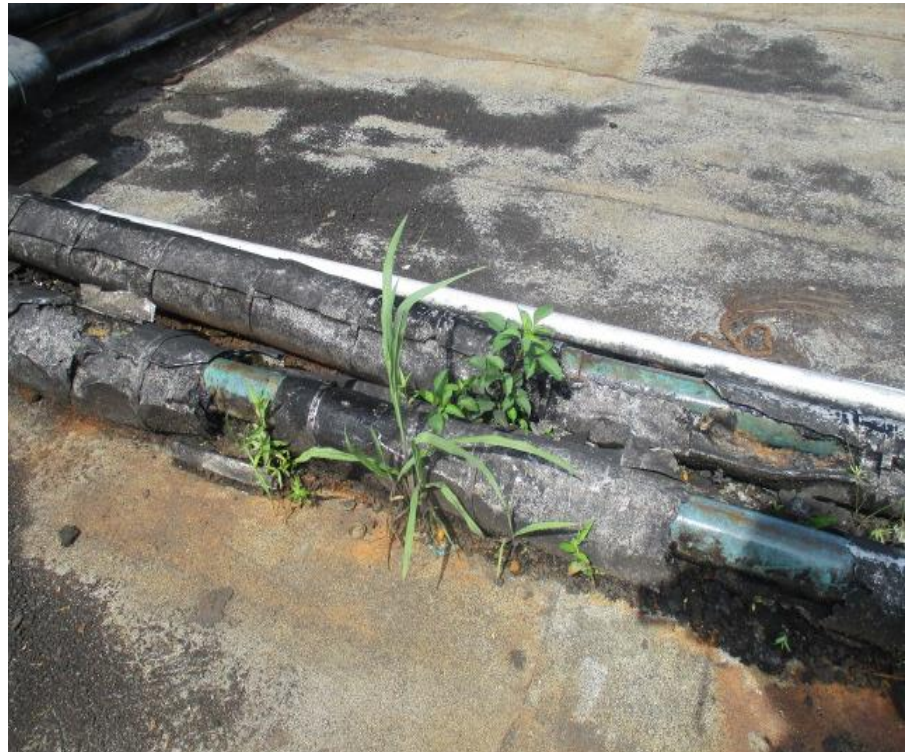
42. Deficiency #5 - Vegetative  
growth on roof surface

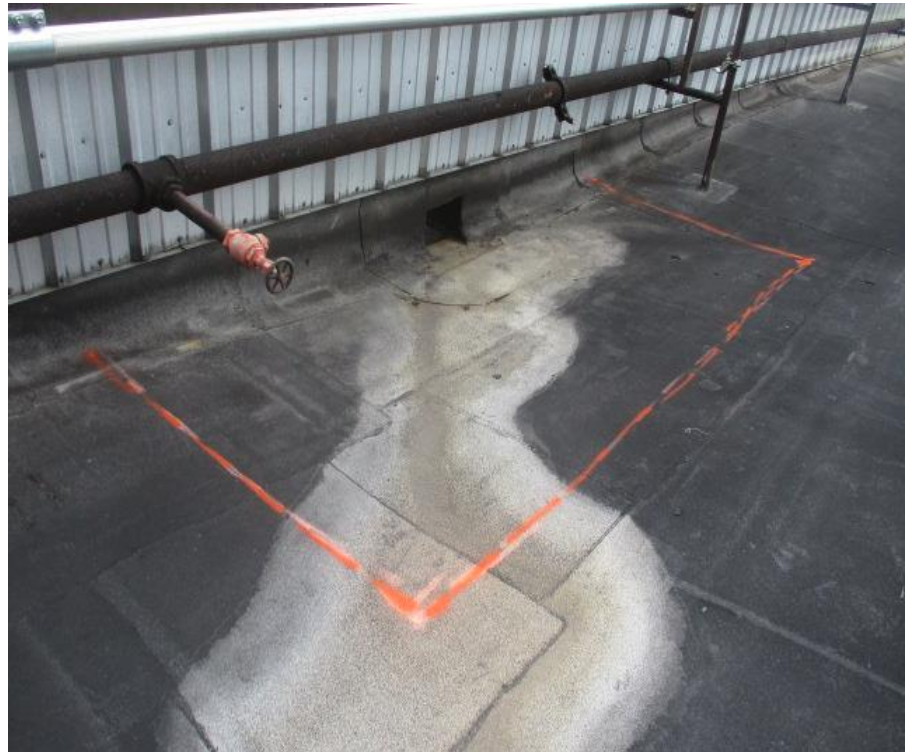
At time of roof system replacement, if the entire roof is not being torn off, all wet areas would require removal and replacement with new dry materials

44. Deficiency #22 - Wet insulation / moisture entrapment

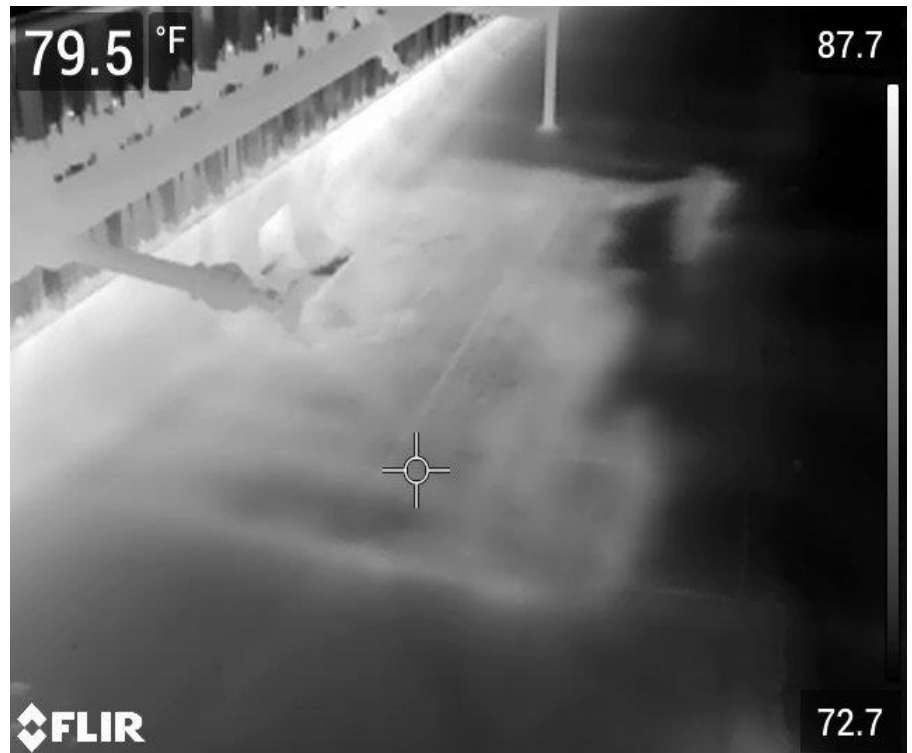
60. Infrared image on Bldg 8 - Area  
A with suspect wet areas observed

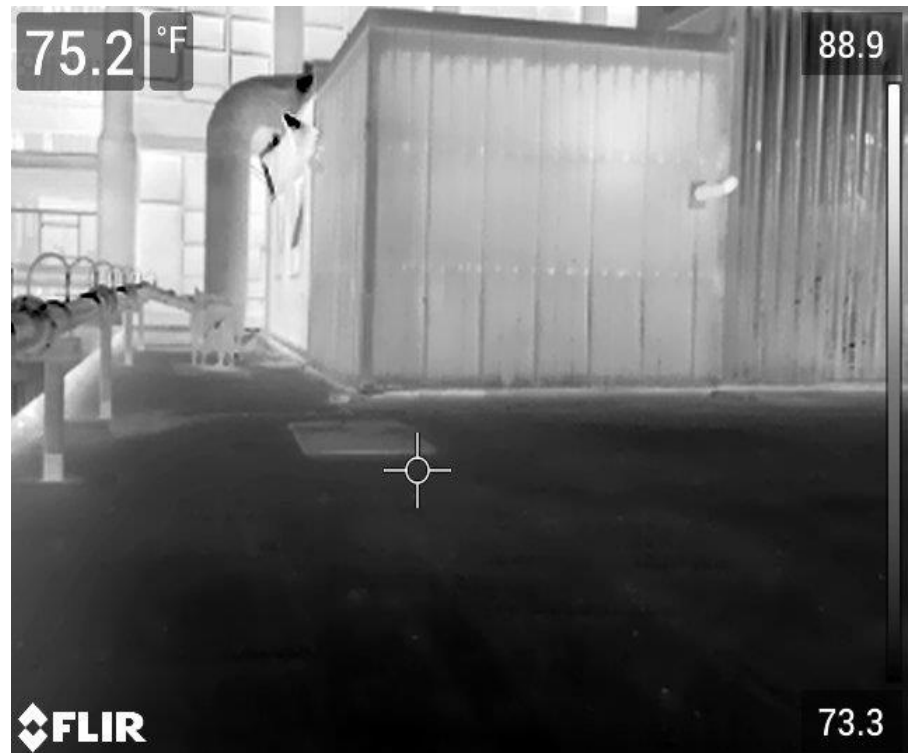
**62. Infrared image on Bldg 8 - Area A with no suspect wet areas observed**

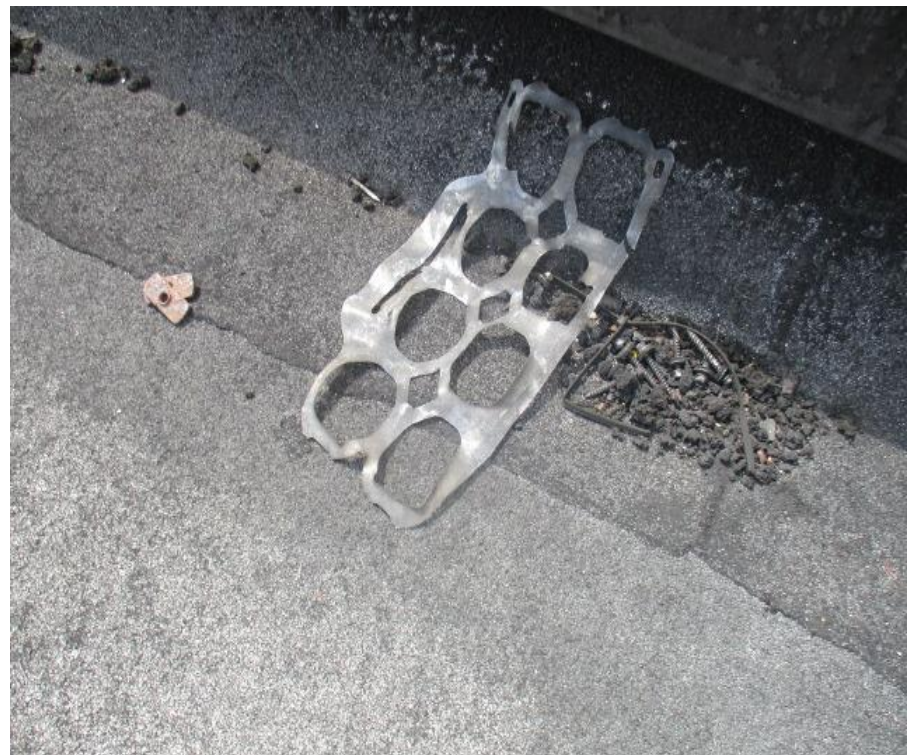
12. Deficiency #2 - Debris on roof surface

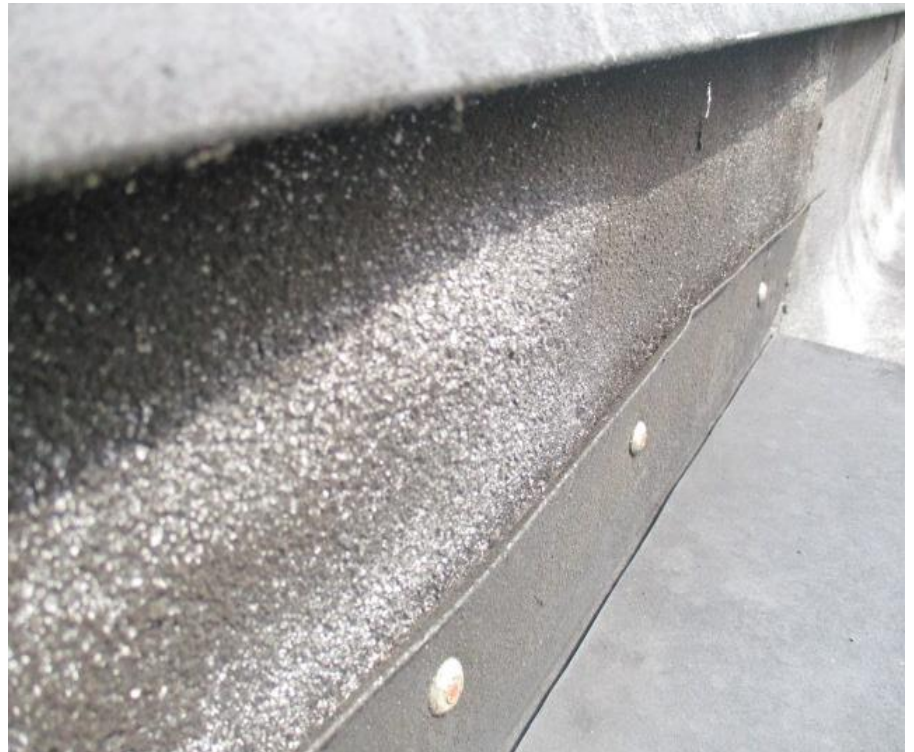
14. Deficiency #9 - Missing /  
deteriorated sealant at metal  
counter flashing

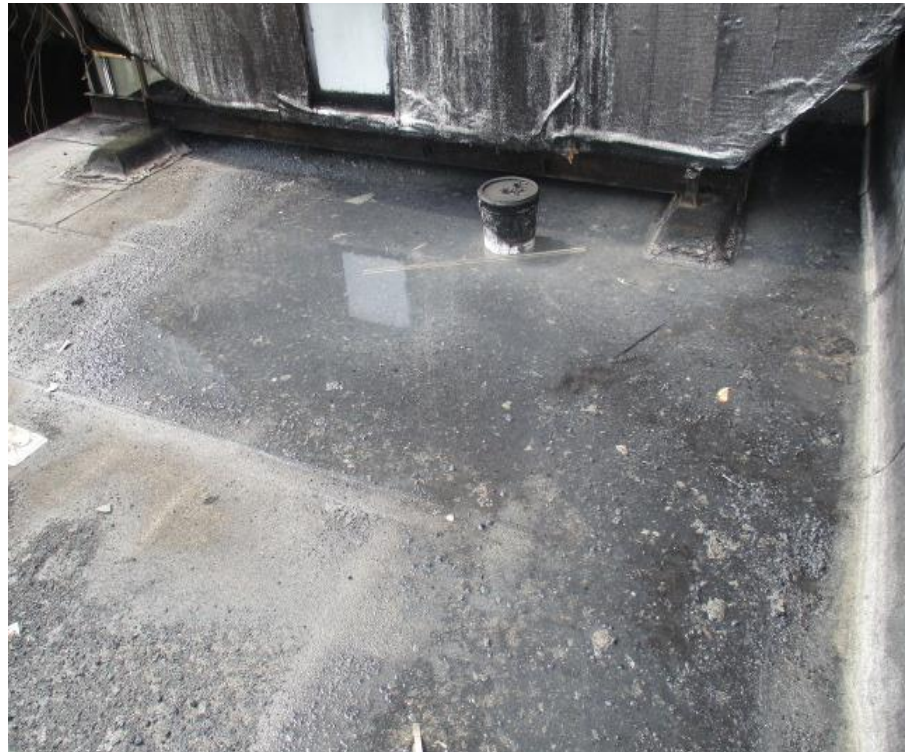
12. Deficiency #2 - Debris on roof surface

Deficiency #7 - Ponding water observed on roof surface

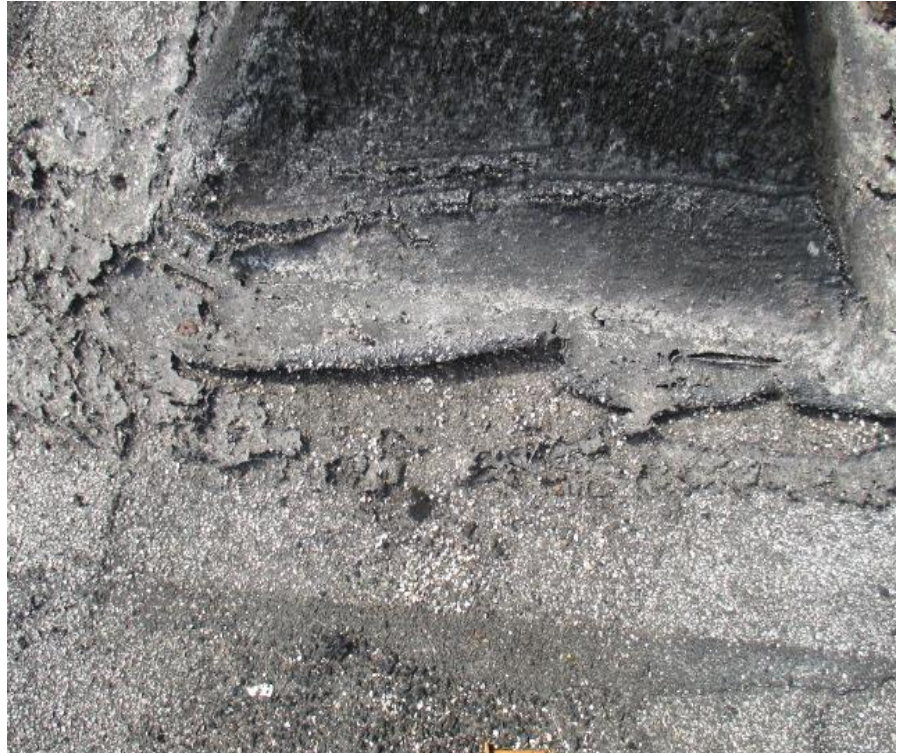
13. Deficiency #3 - Open flashing

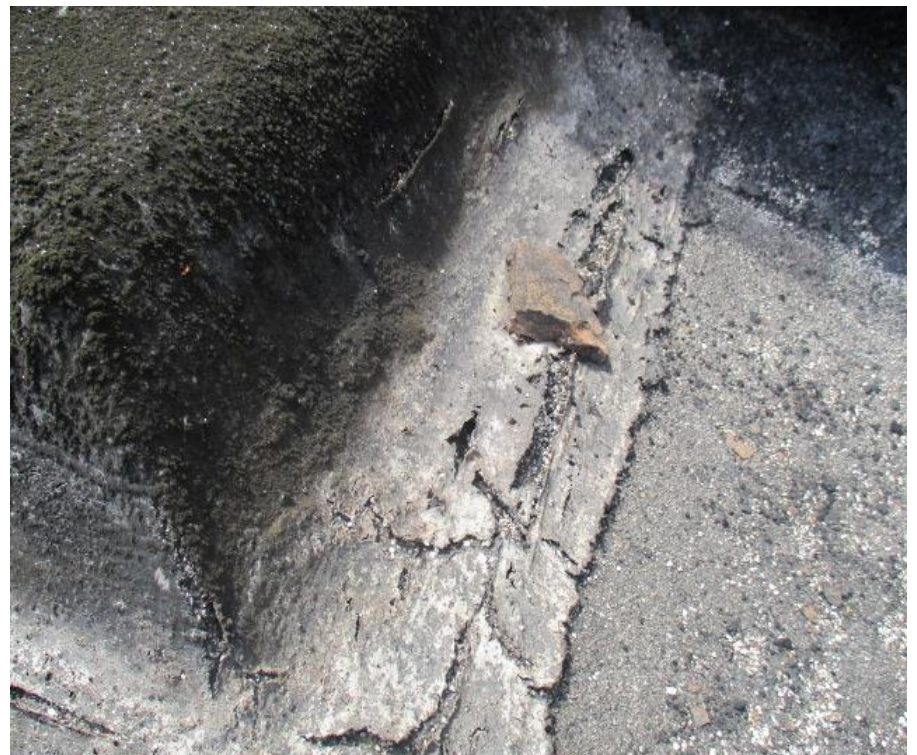
14. Deficiency #3 - Open flashing

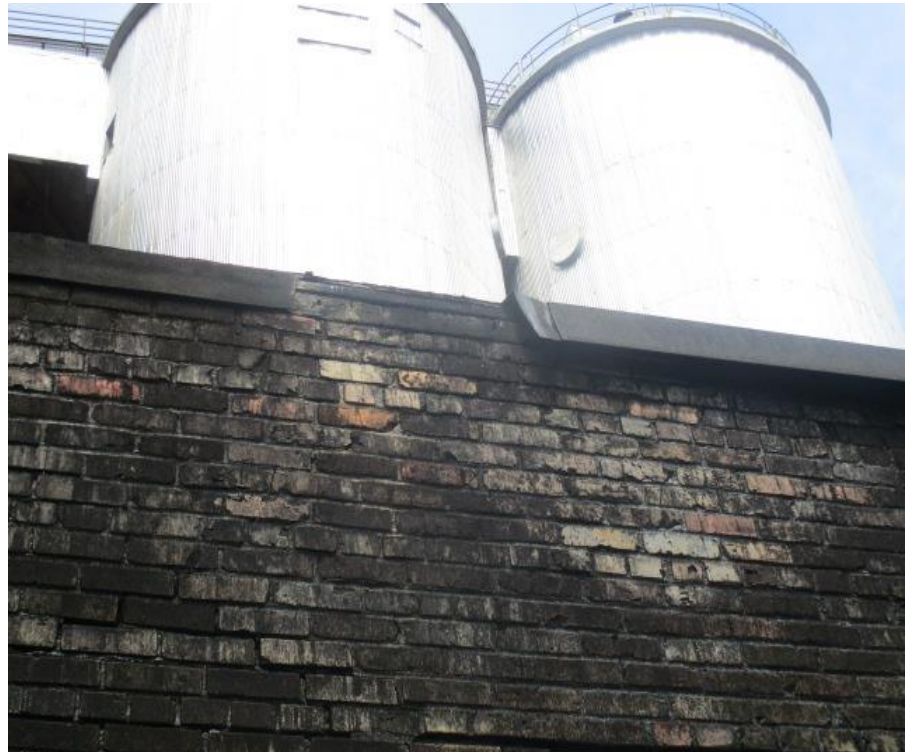
16. Deficiency #6 - Damaged metal edge

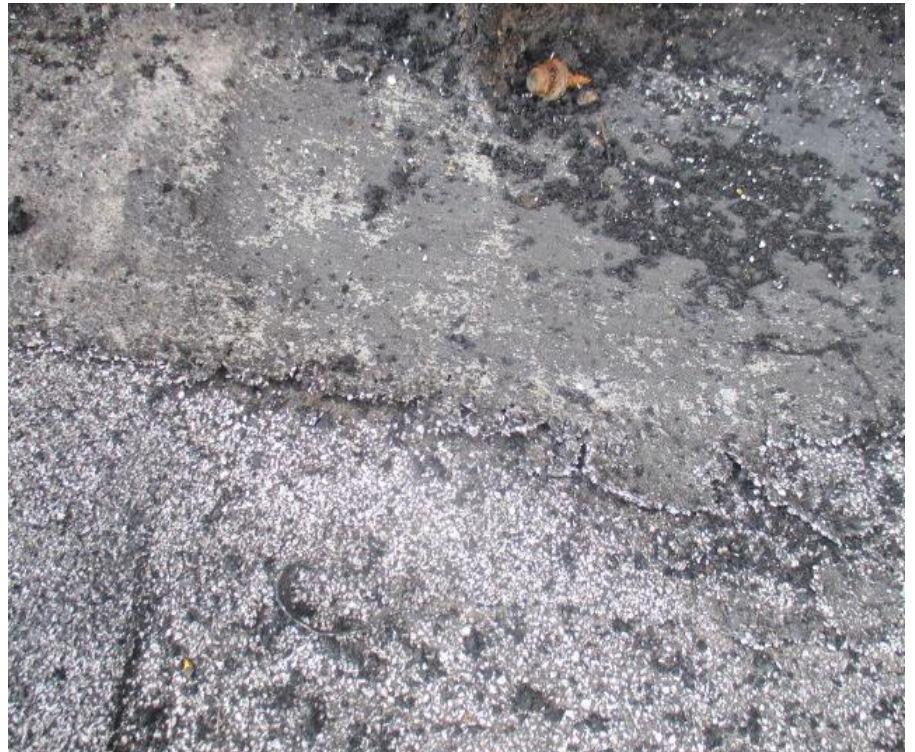
36. Deficiency #3 - Open flashing

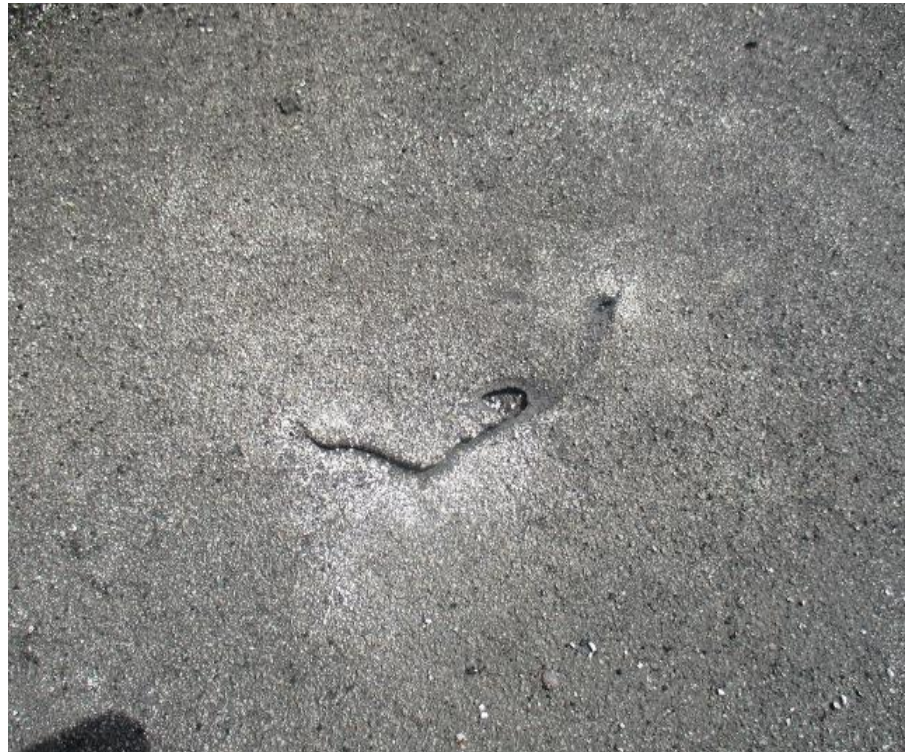
38. Deficiency #4 - Hole / puncture  
in membrane / felts

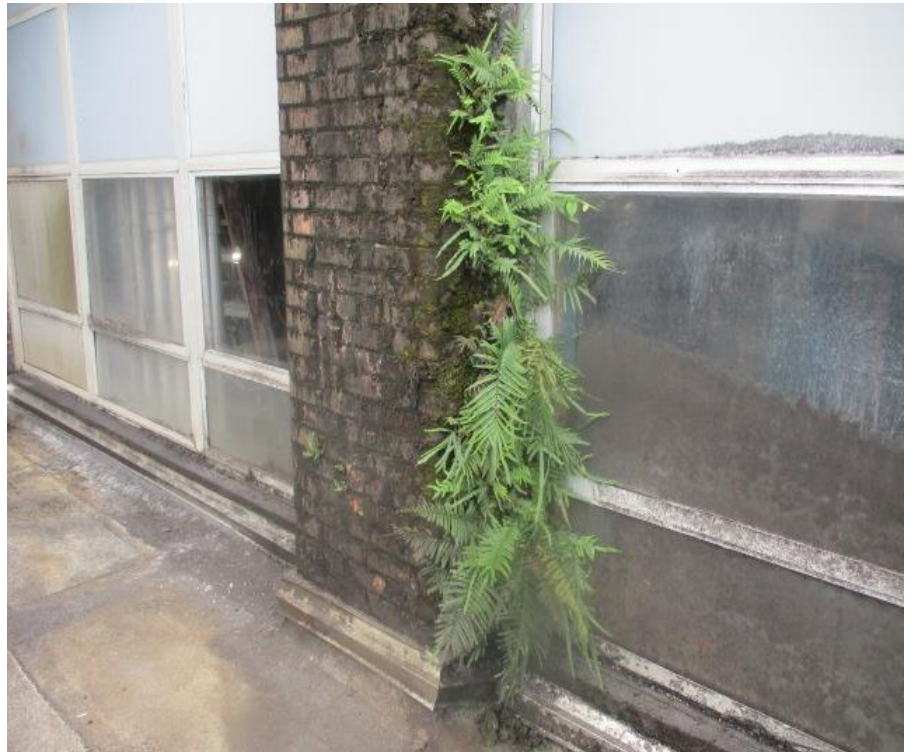
40. Deficiency #5 - Vegetative  
growth on roof surface

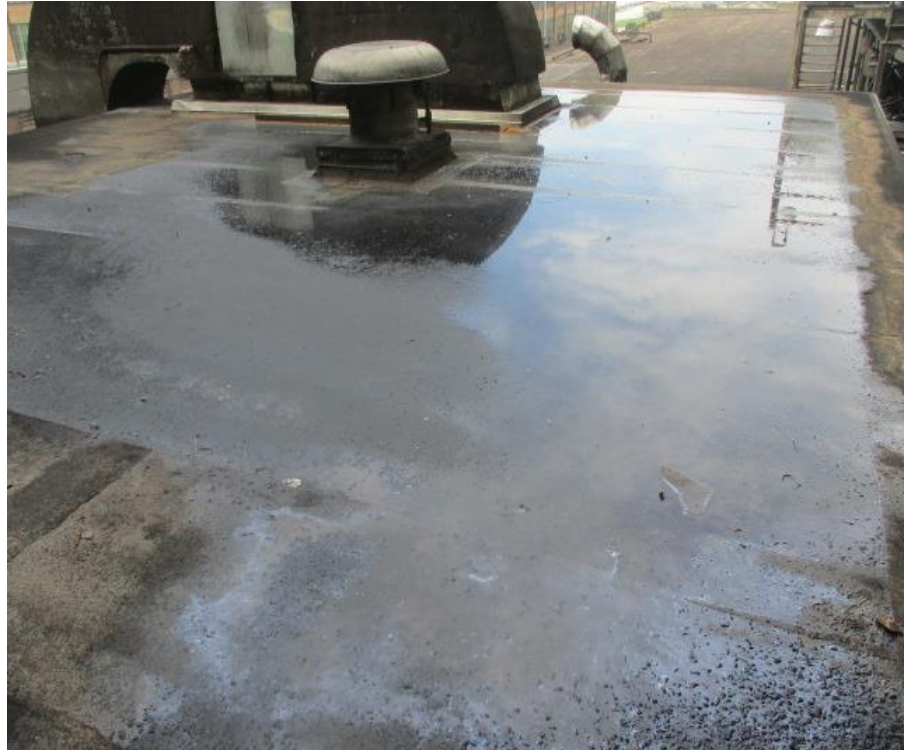
42. Deficiency #7 - Ponding water  
observed on roof surface

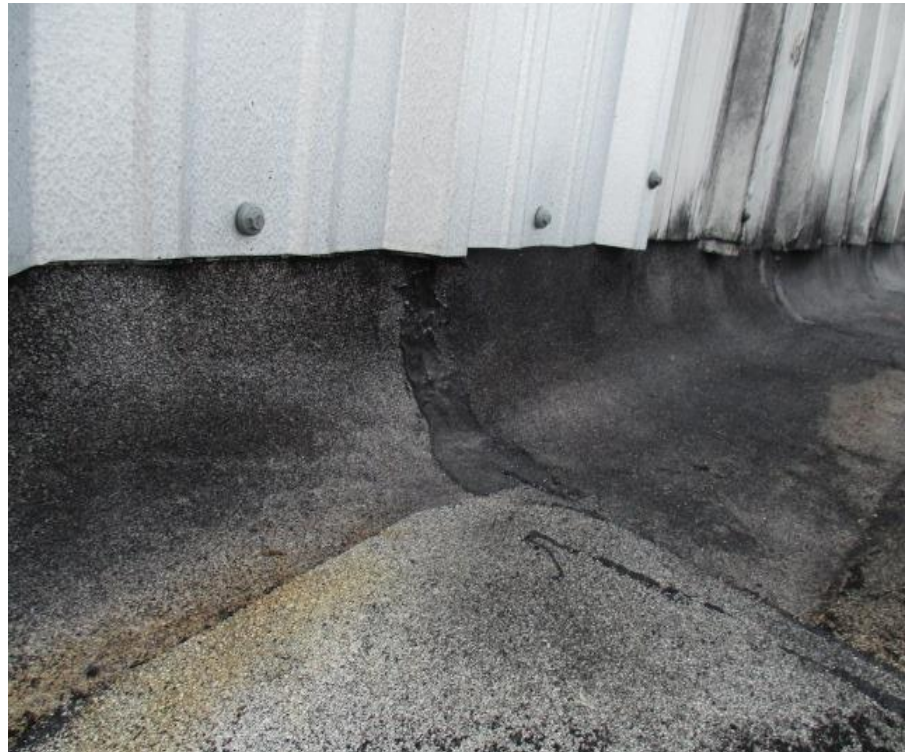
**44. Deficiency #11 - Improper wall flashing detail - flashing membrane not properly terminated and counter flashed by metal Z-metal panel closure**

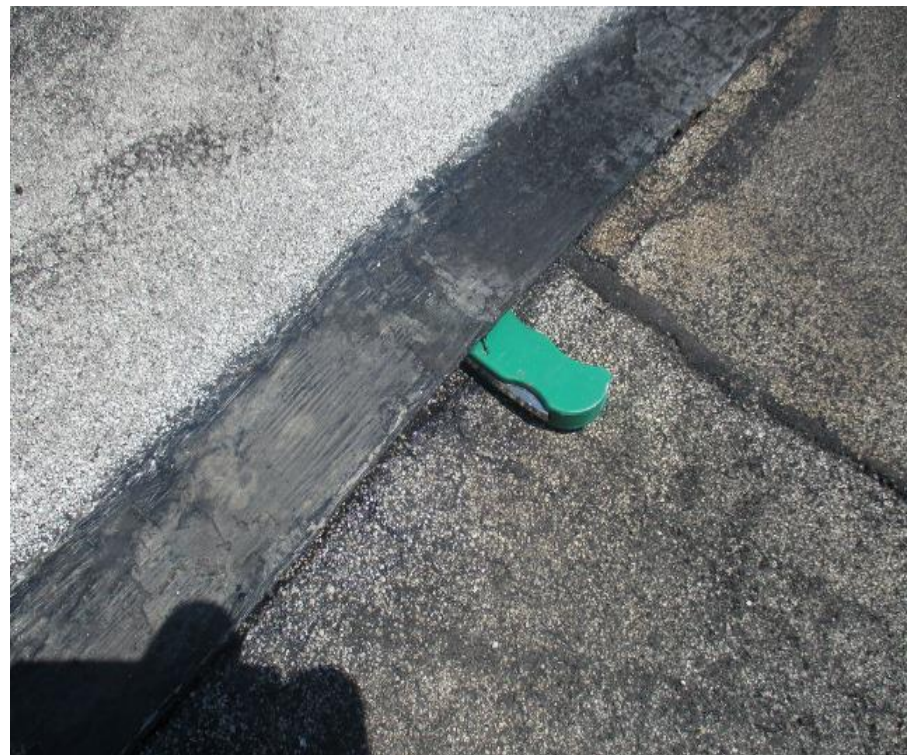
46. Deficiency #14 - Open lap in field membrane

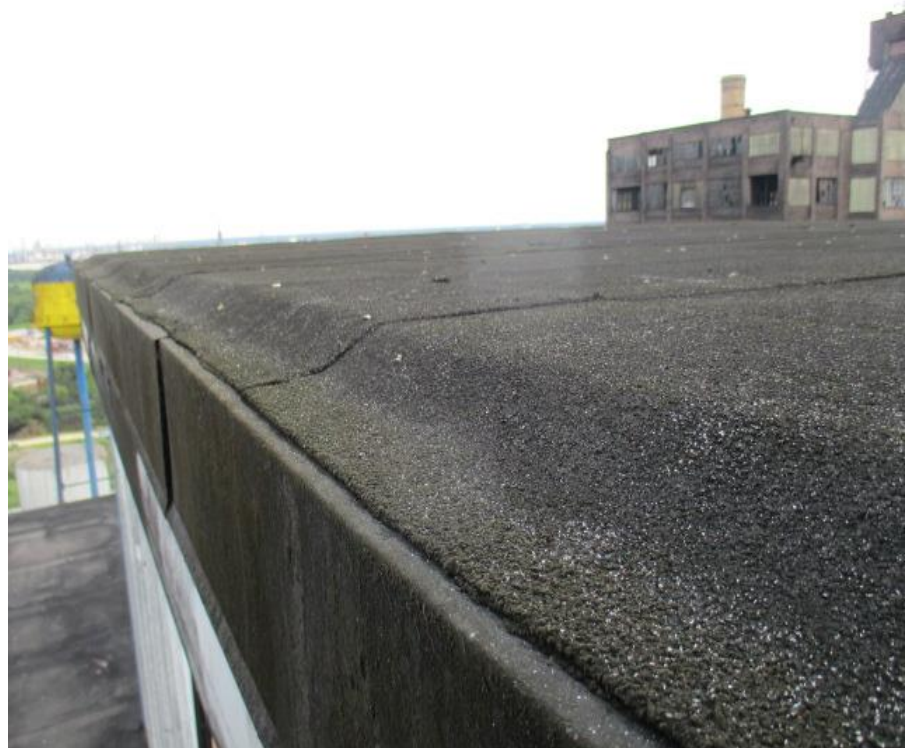
**48. Deficiency #16 - Improper roof edge detail - additional wood blocking to match insulation height required at roof area perimeter**

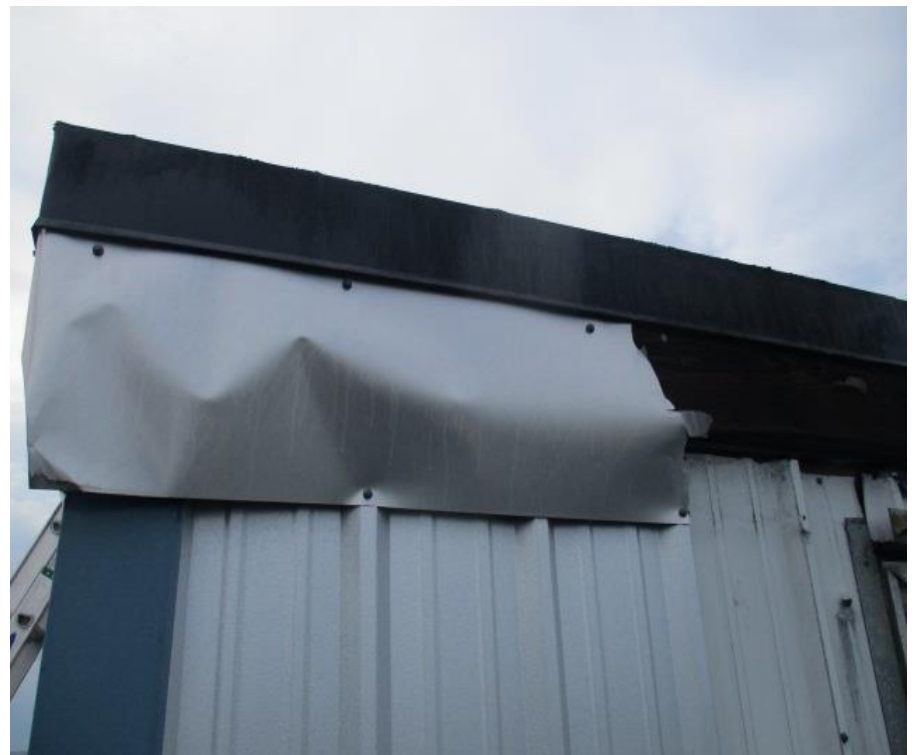
**50. Deficiency #17 - Improperly fabricated & installed fascia metal - as fabricated and installed perimeter edge does not meet ANSI/SPRI/FM4435 ES-1 wind design standard for edge systems used with low slope roofing systems**

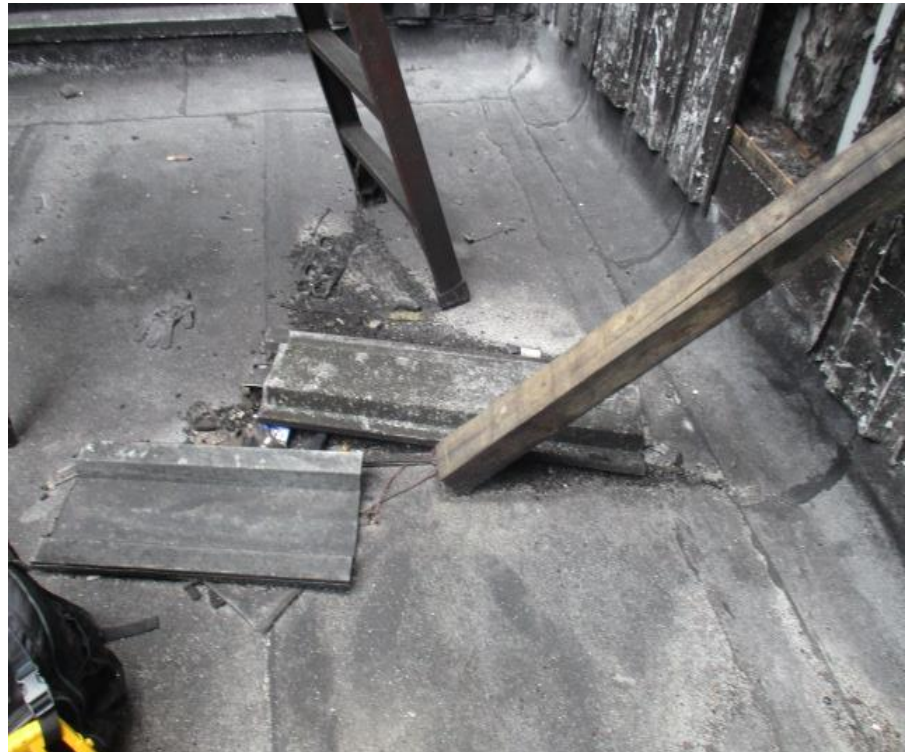
52. Deficiency #2 - Debris on roof surface

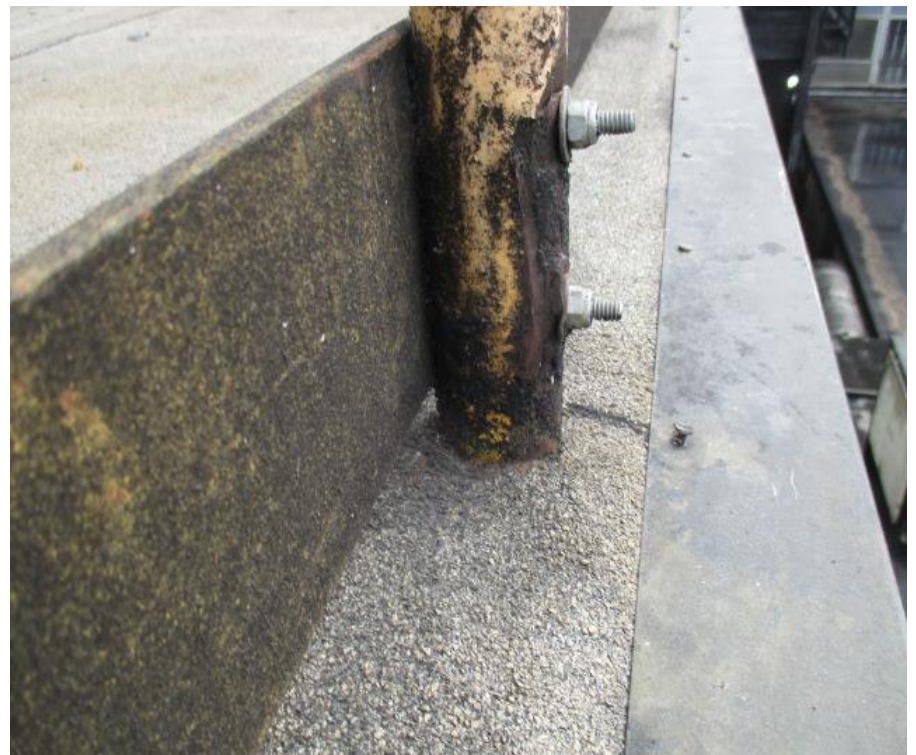
54. Deficiency #3 - Open flashing

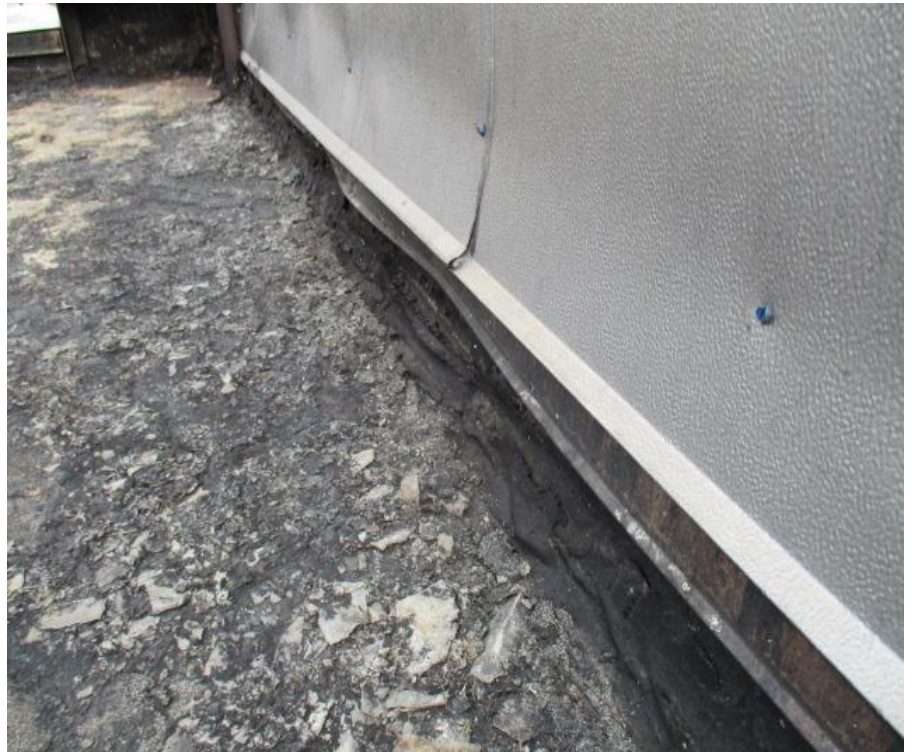
56. Deficiency #4 - Hole / puncture  
in membrane / felts

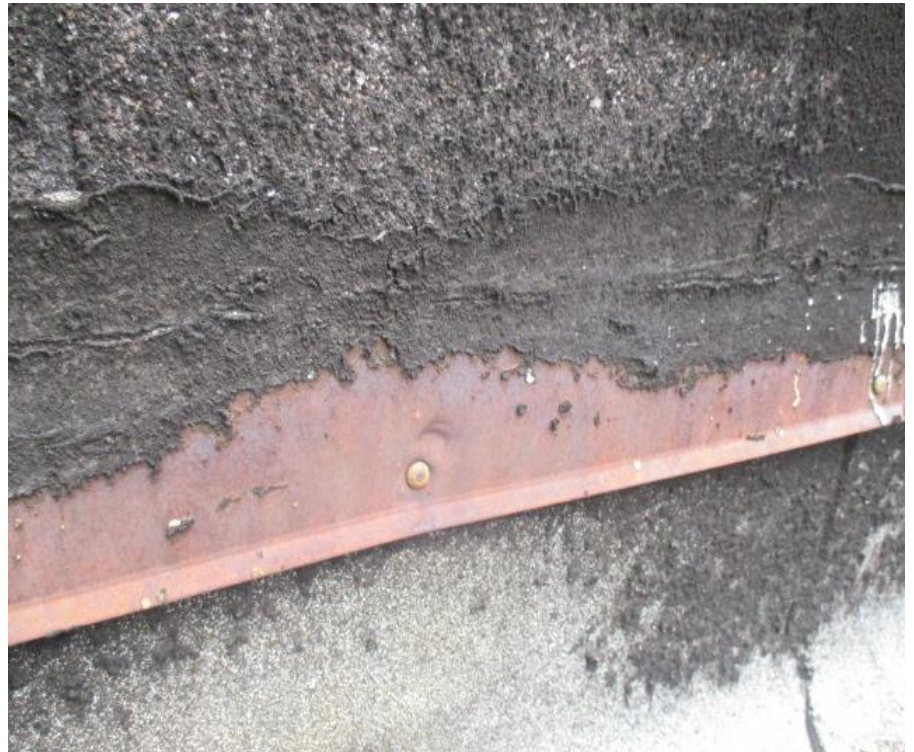
**58. Deficiency #9 - Missing /  
deteriorated sealant at metal  
counter flashing**

**Deficiency #10 - Rust developing on  
metal component**

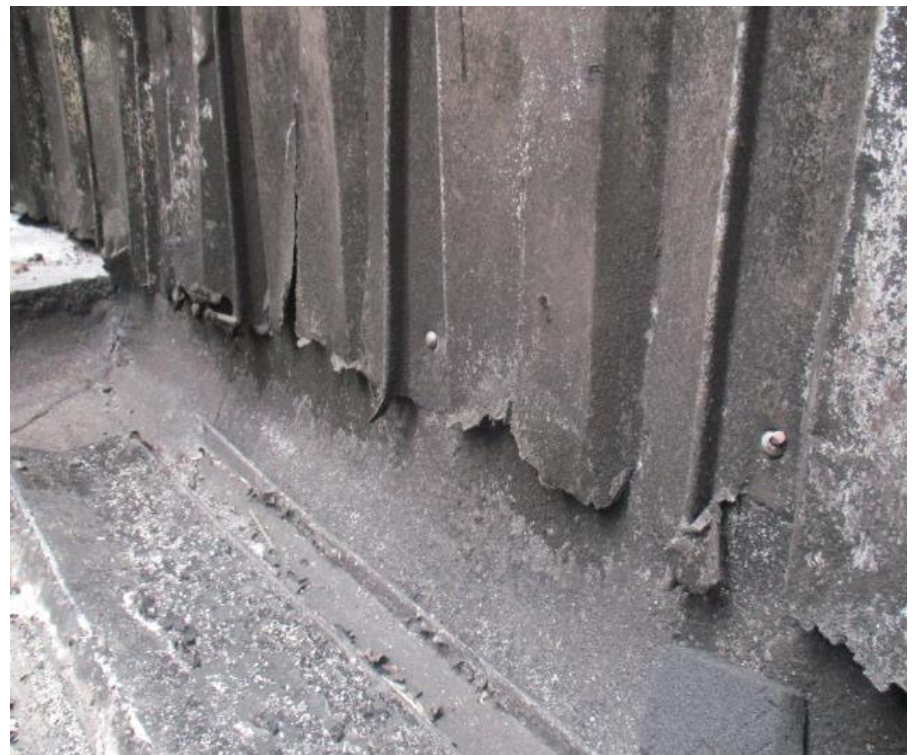
60. Deficiency #11 - Improper wall  
flashing detail - flashing membrane  
not properly terminated and counter  
flushed by metal Z-metal panel  
closure

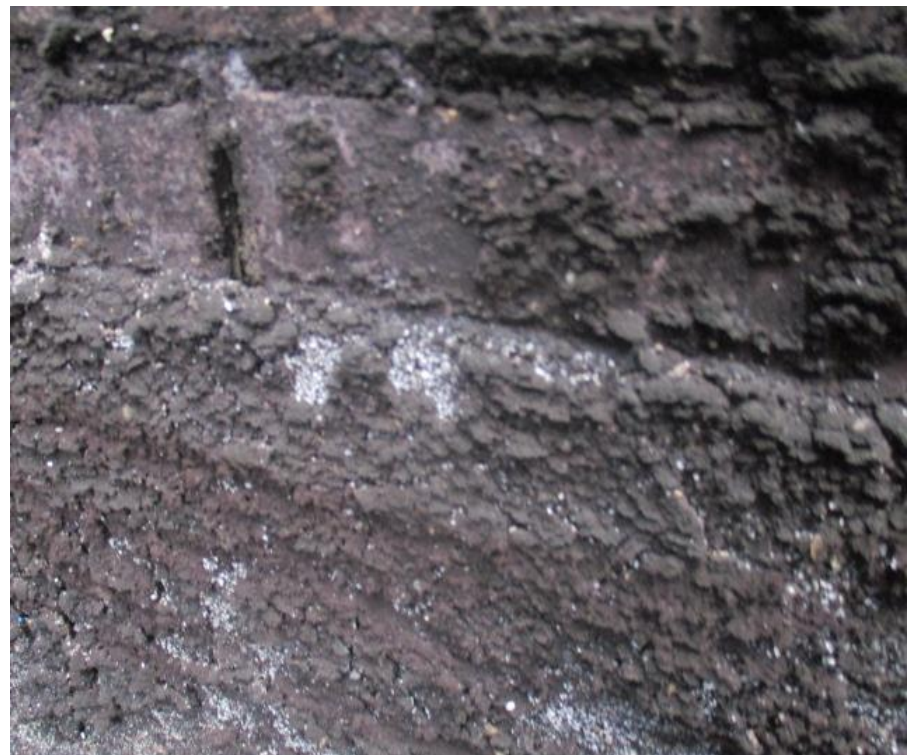
62. Deficiency #12 - Missing termination bar

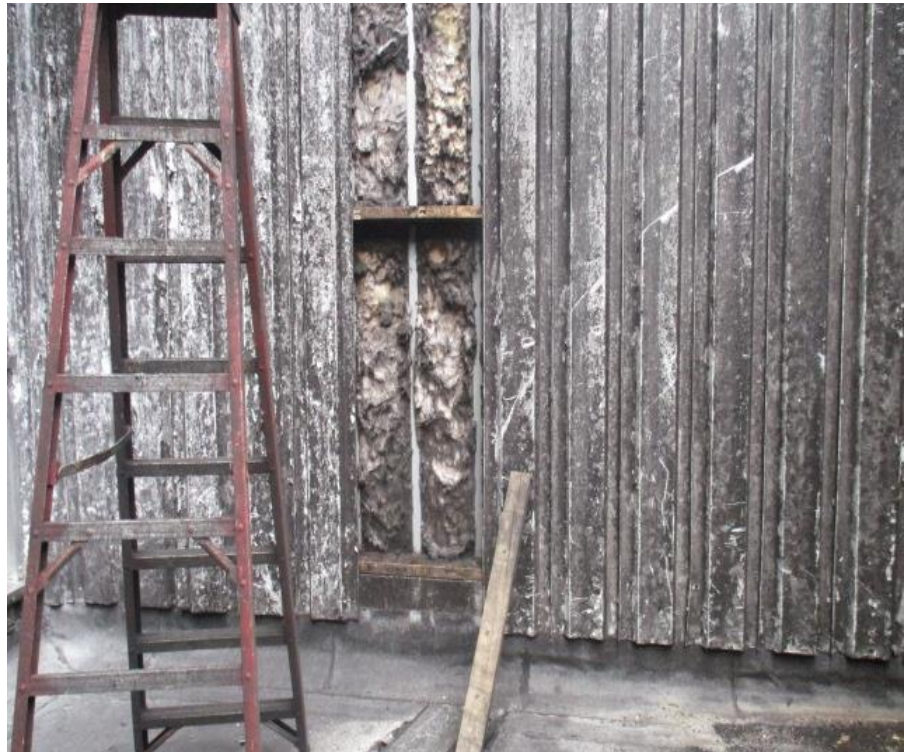
64. Deficiency #13 - Damaged / missing vertical metal panels

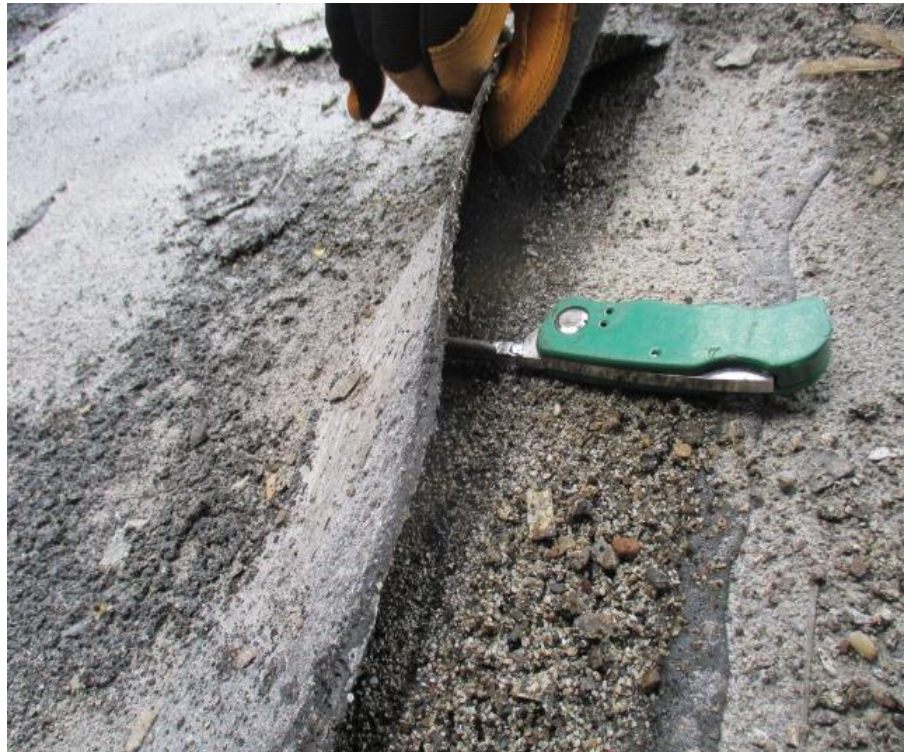
**66. Deficiency #14 - Open lap in field  
membrane**

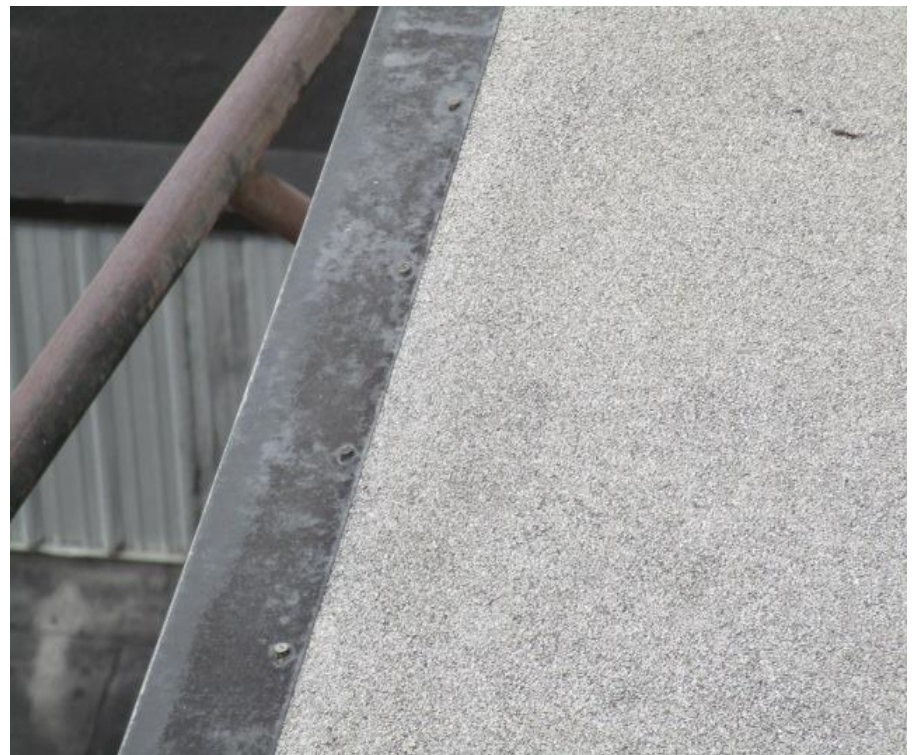
68. Deficiency #15 - Improper edge detail - insufficient fastening pattern & edge metal not properly stripped into roof system

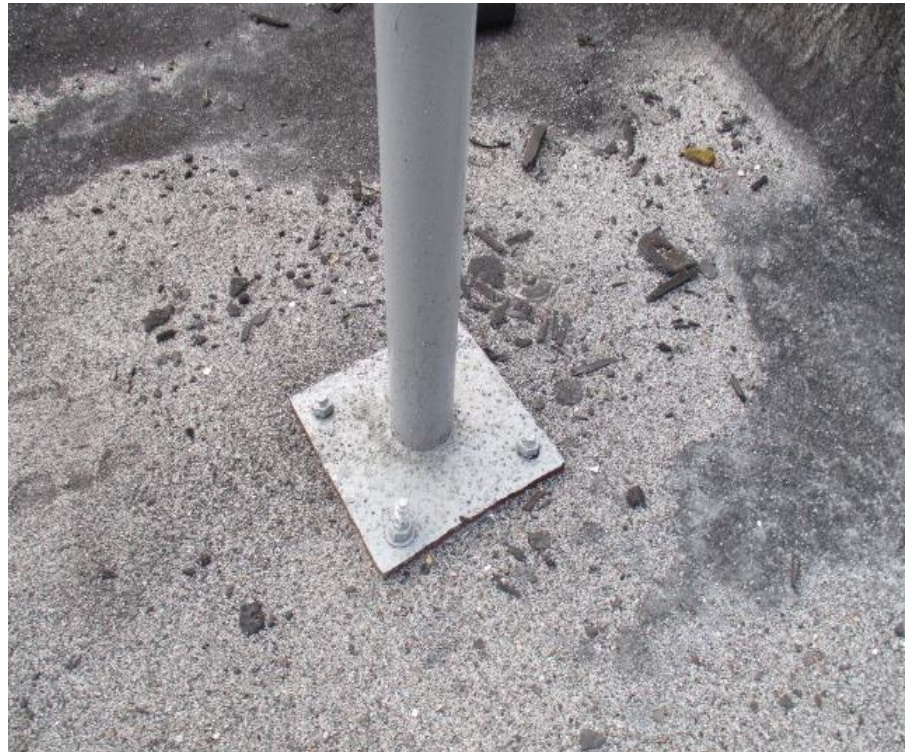
16. Deficiency #1 - Penetrations through roof surface have not been flashed
