## **Domino Sugar Refinery**

# **Domino Sugar Facility**

**7412 N. Peters Street  
Arabi, LA**

**9/3/2022**

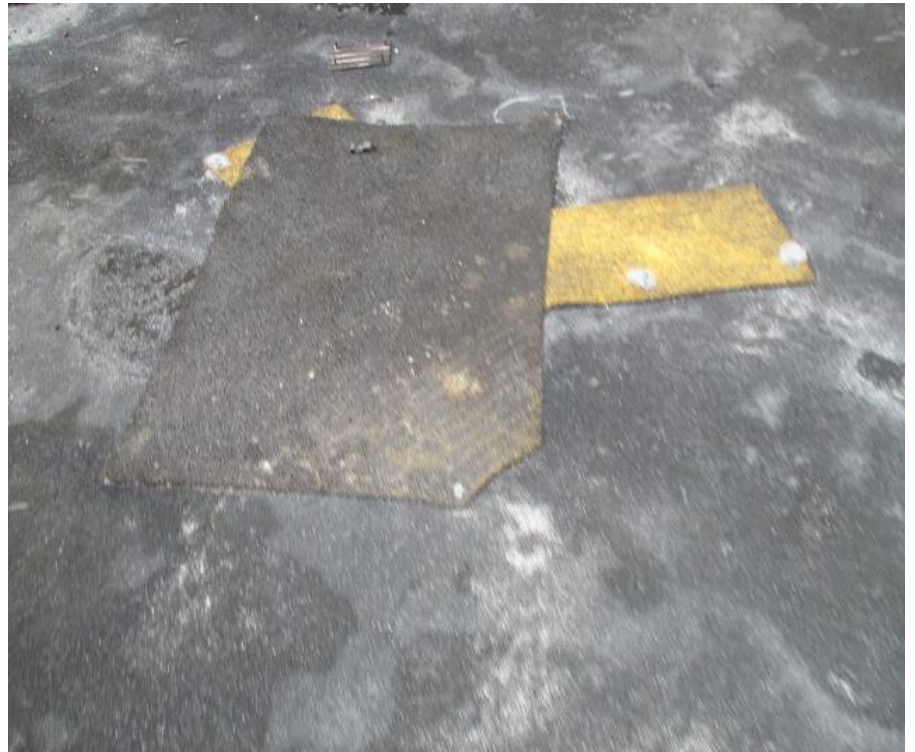
18. Deficiency #2 - Debris on roof surface

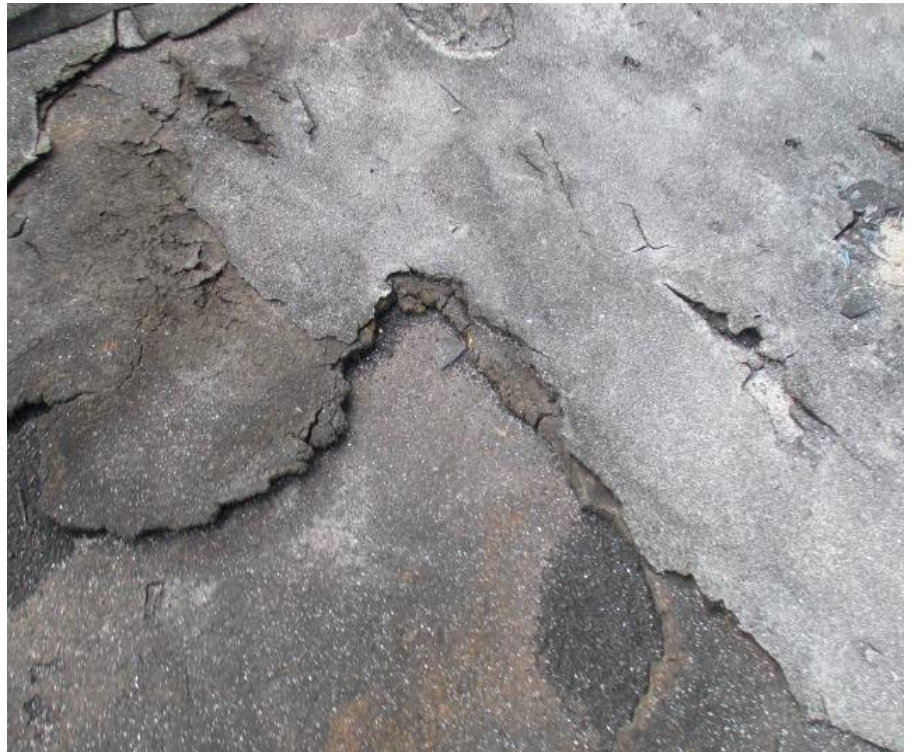
20. Deficiency #20 - Deteriorated  
roof coating on PUF

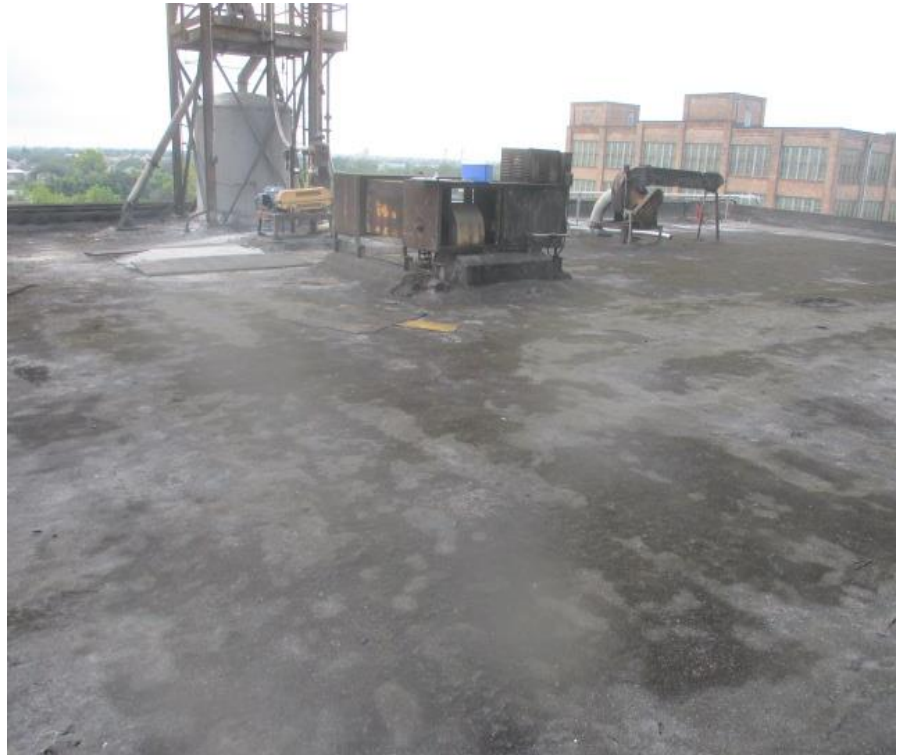
**21. Deficiency #22 - Wet insulation /  
moisture entrapment**

**Note: Image is overview of roof  
area; whole roof area is considered  
wet with entrapped moisture**

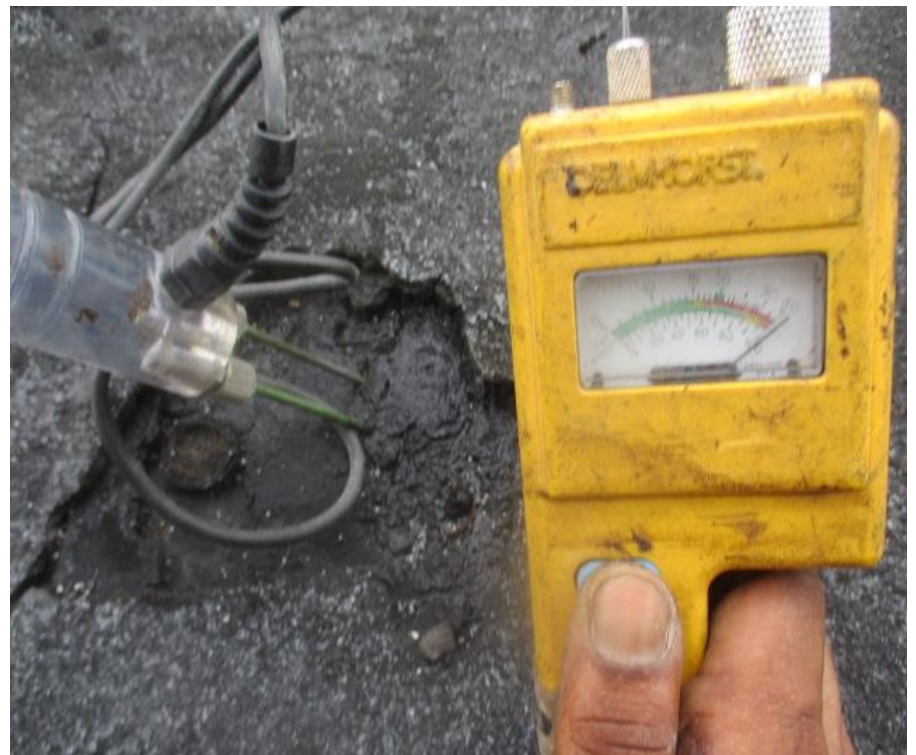
**22. Probe #15 (Area H) - Delmhorst  
moisture meter reading positive for  
moisture**

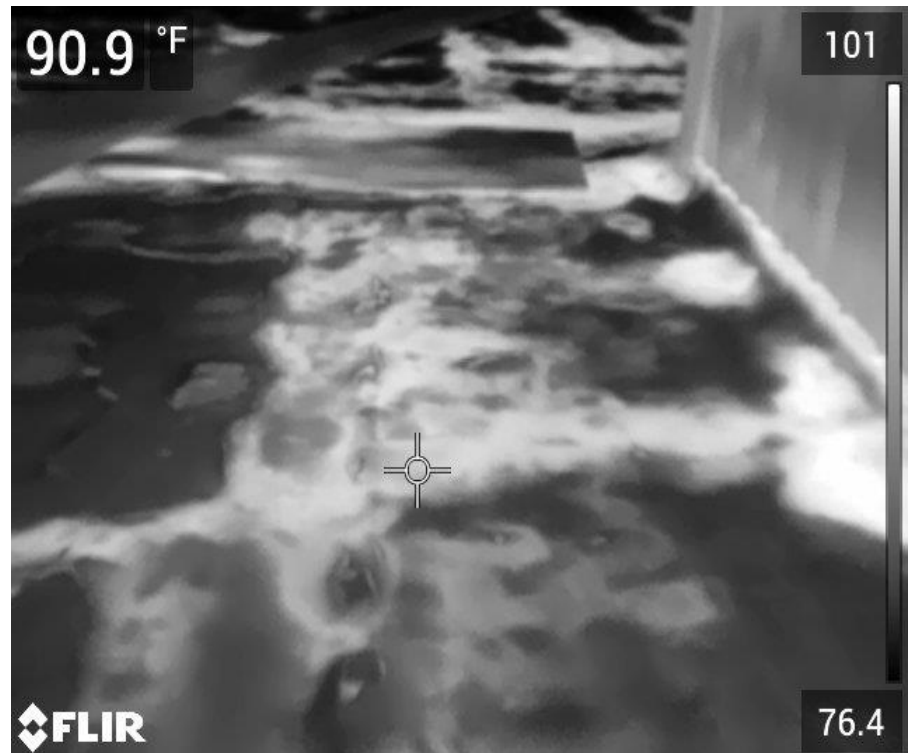
24. Infrared image on Bldg 8 - Area H with suspect wet areas observed

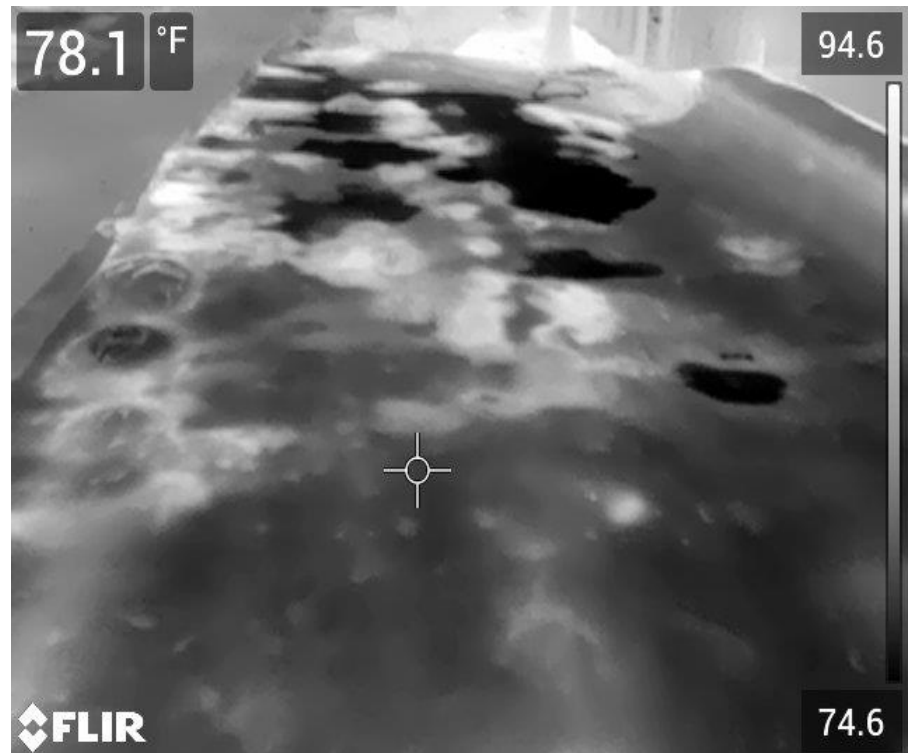
26. Infrared image on Bldg 8 - Area H with suspect wet areas observed

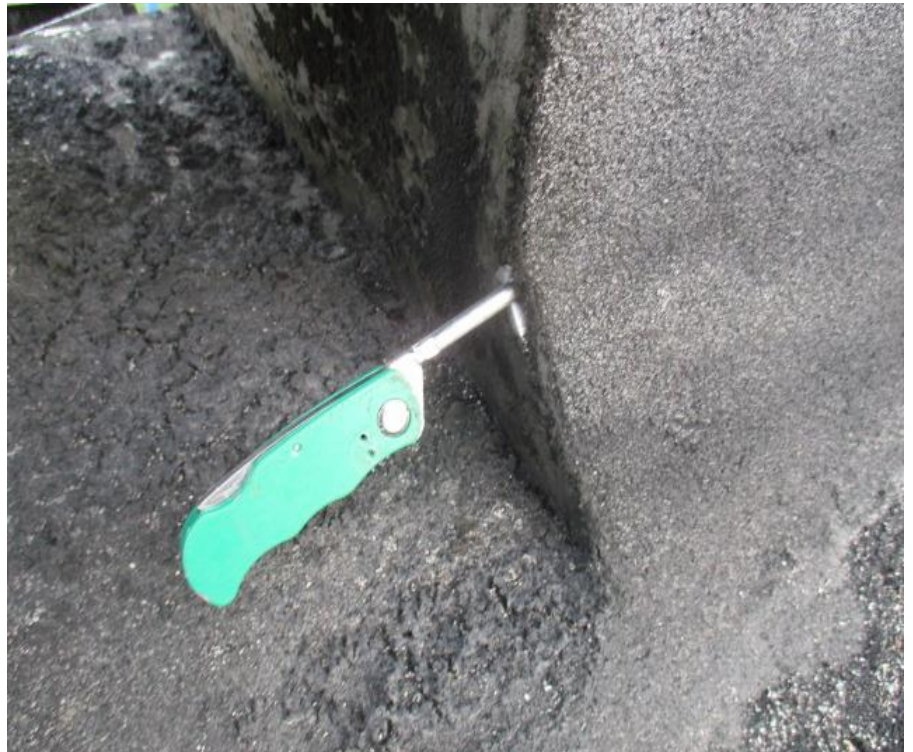
10. Deficiency #3 - Open flashing

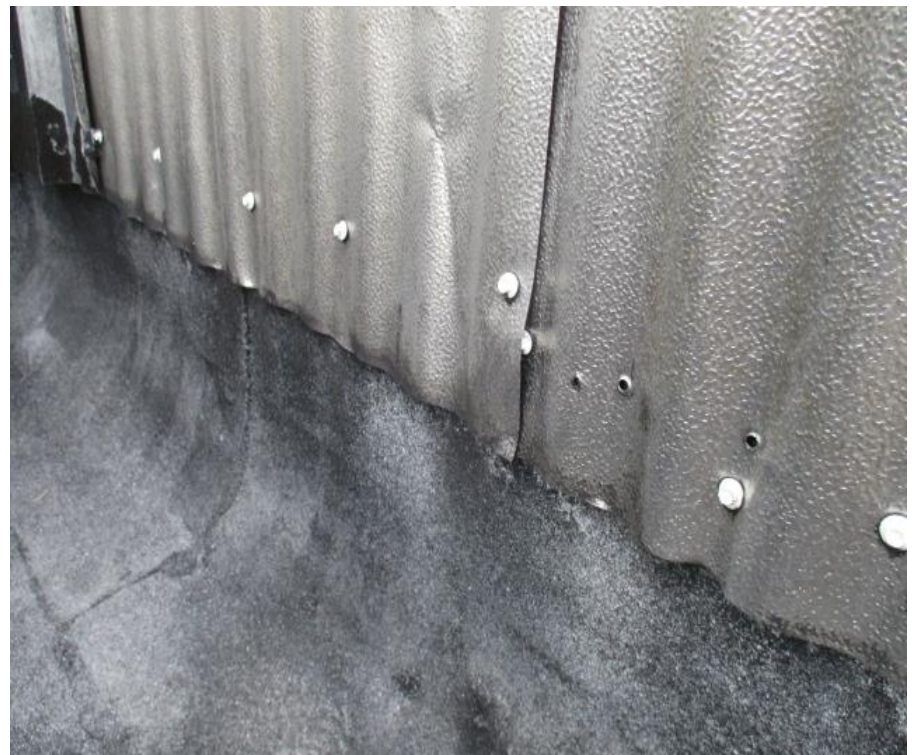
12. Deficiency #11 - Wall flashing  
membrane open - incomplete  
flashing detail

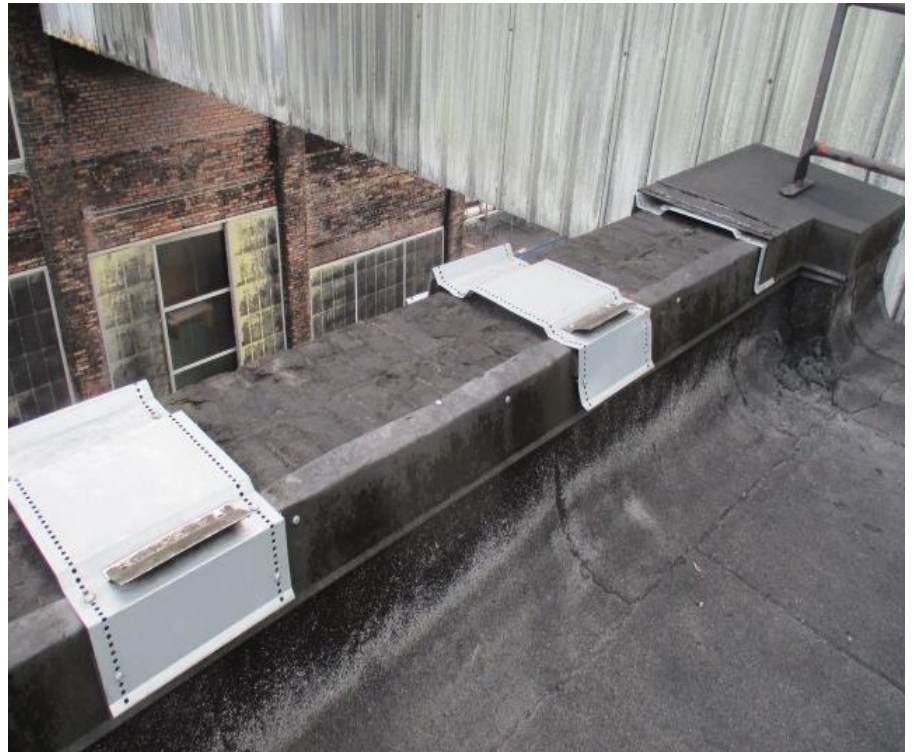
14. Deficiency #18 - Damaged / missing metal coping

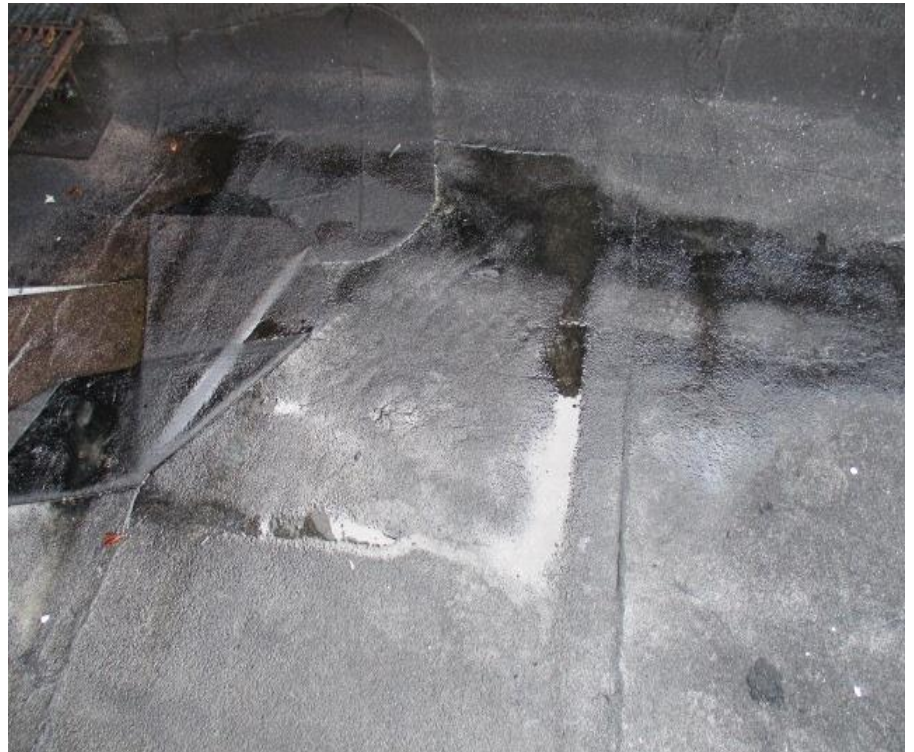
**16. Deficiency #19 - Chemical  
contamination on roof membrane**

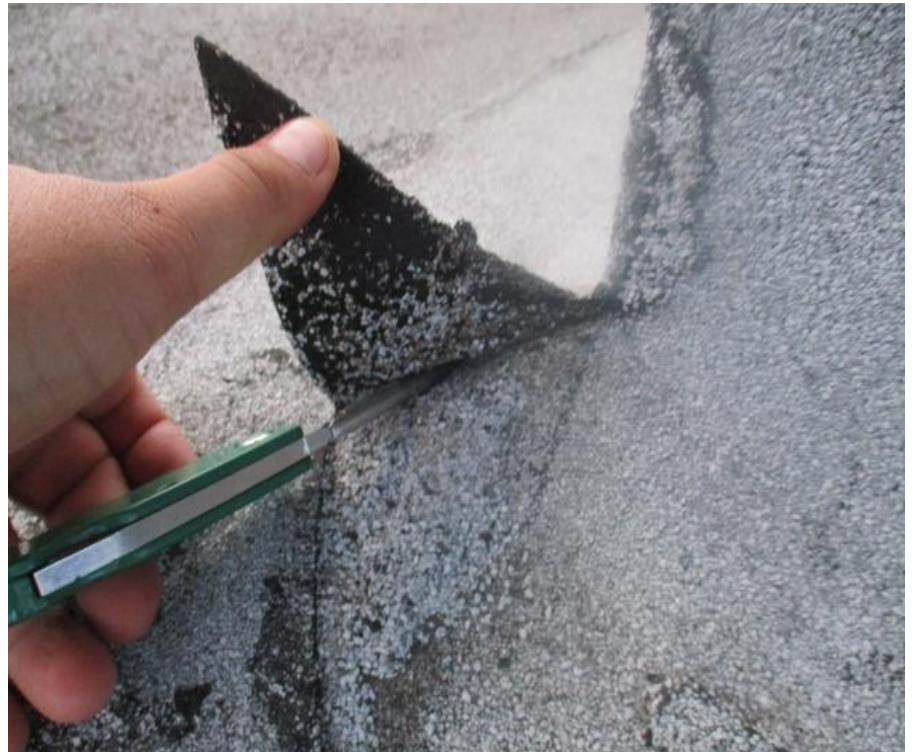
32. Deficiency #3 - Open flashing
