INFRARED MOISTURE SURVEY
 CLIENT: PENMARK MANAGEMENT
 PROJECT: CLEARFIELD SQUARE
 ADDRESS: 1800 DASY STREET
 CLEARFIELD, PA
 DRAWING: ROOF PLAN

INFRARED MOISTURE SURVEY

CLIENT: PENMARK MANAGEMENT
PROJECT: CLEARFIELD SQUARE
ADDRESS: 1800 DASY STREET
CLEARFIELD, PA

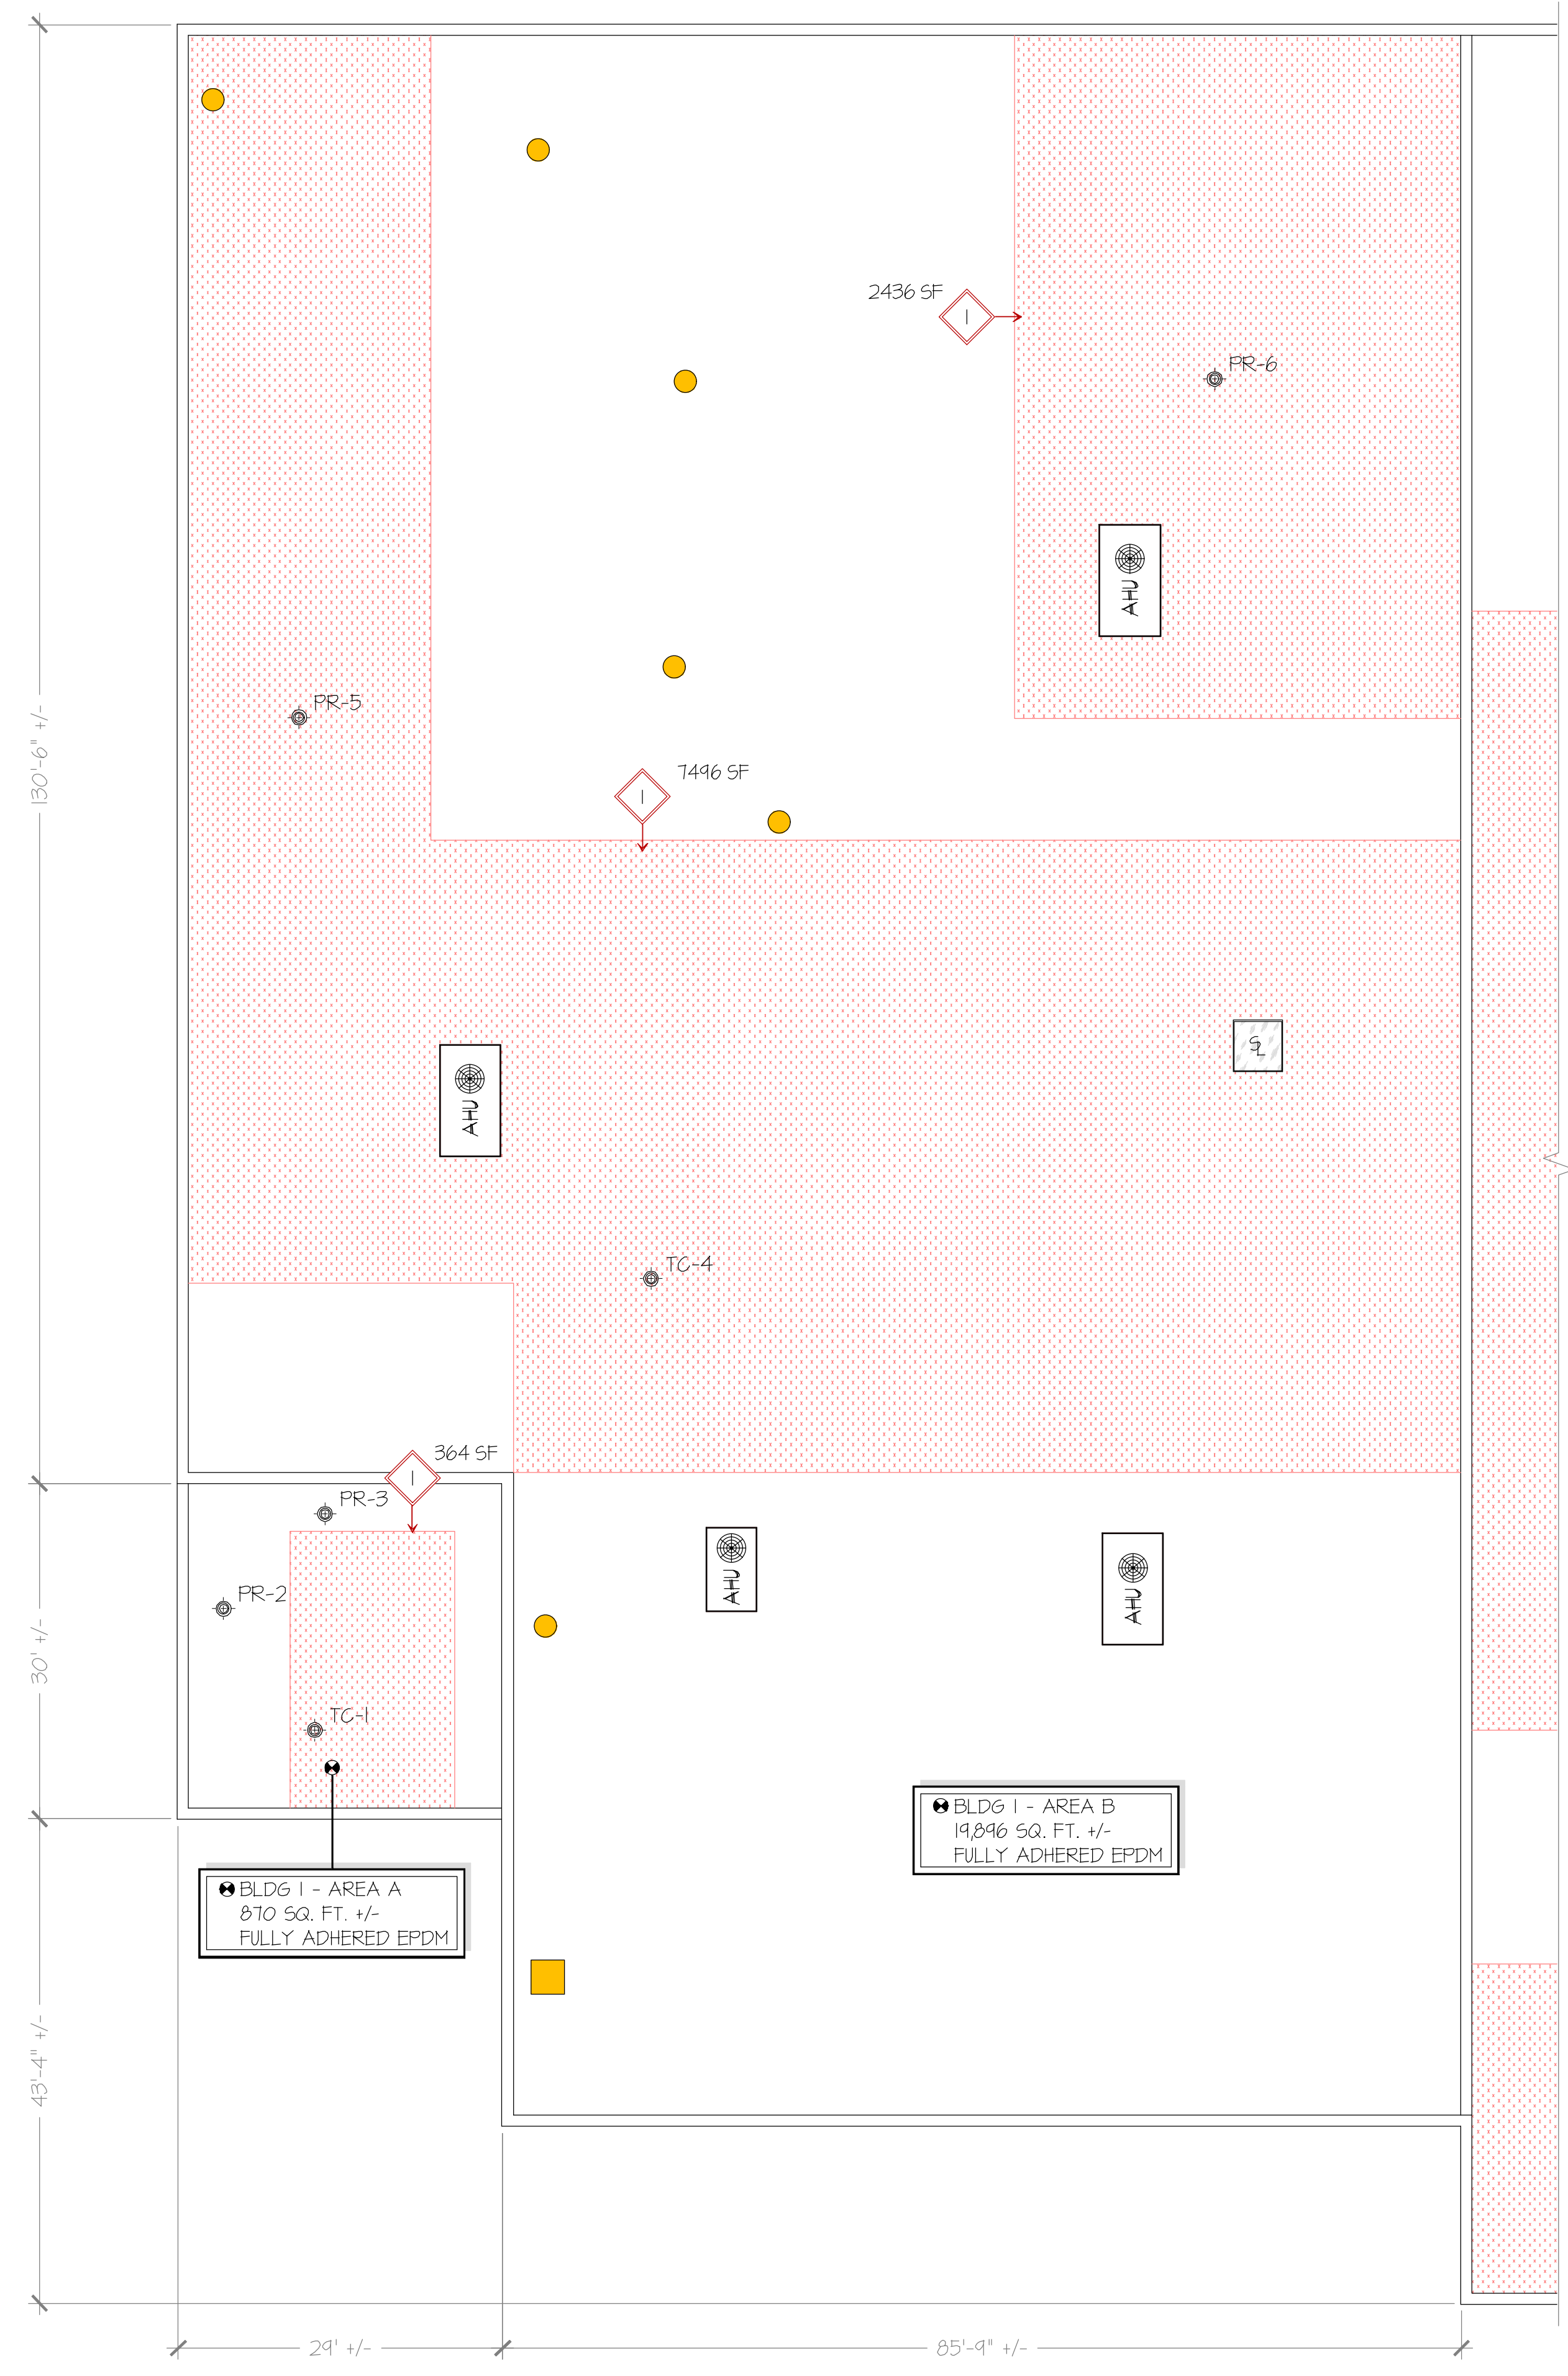
CONTOUR LEGEND			
BLDG 1 - AREAS A, B, C, D, E & F			
MOISTURE LEVEL	LEGEND	SQ. FT.	%
LEVEL I - DRY		69,145 SQ. FT. +/-	45.4%
LEVEL II - WET		83,426 SQ. FT. +/-	54.6%

TOTAL PROJECT ROOF AREA - 177,176 SQ. FT. +/-
 SCALE: 3/32"=1'-0"

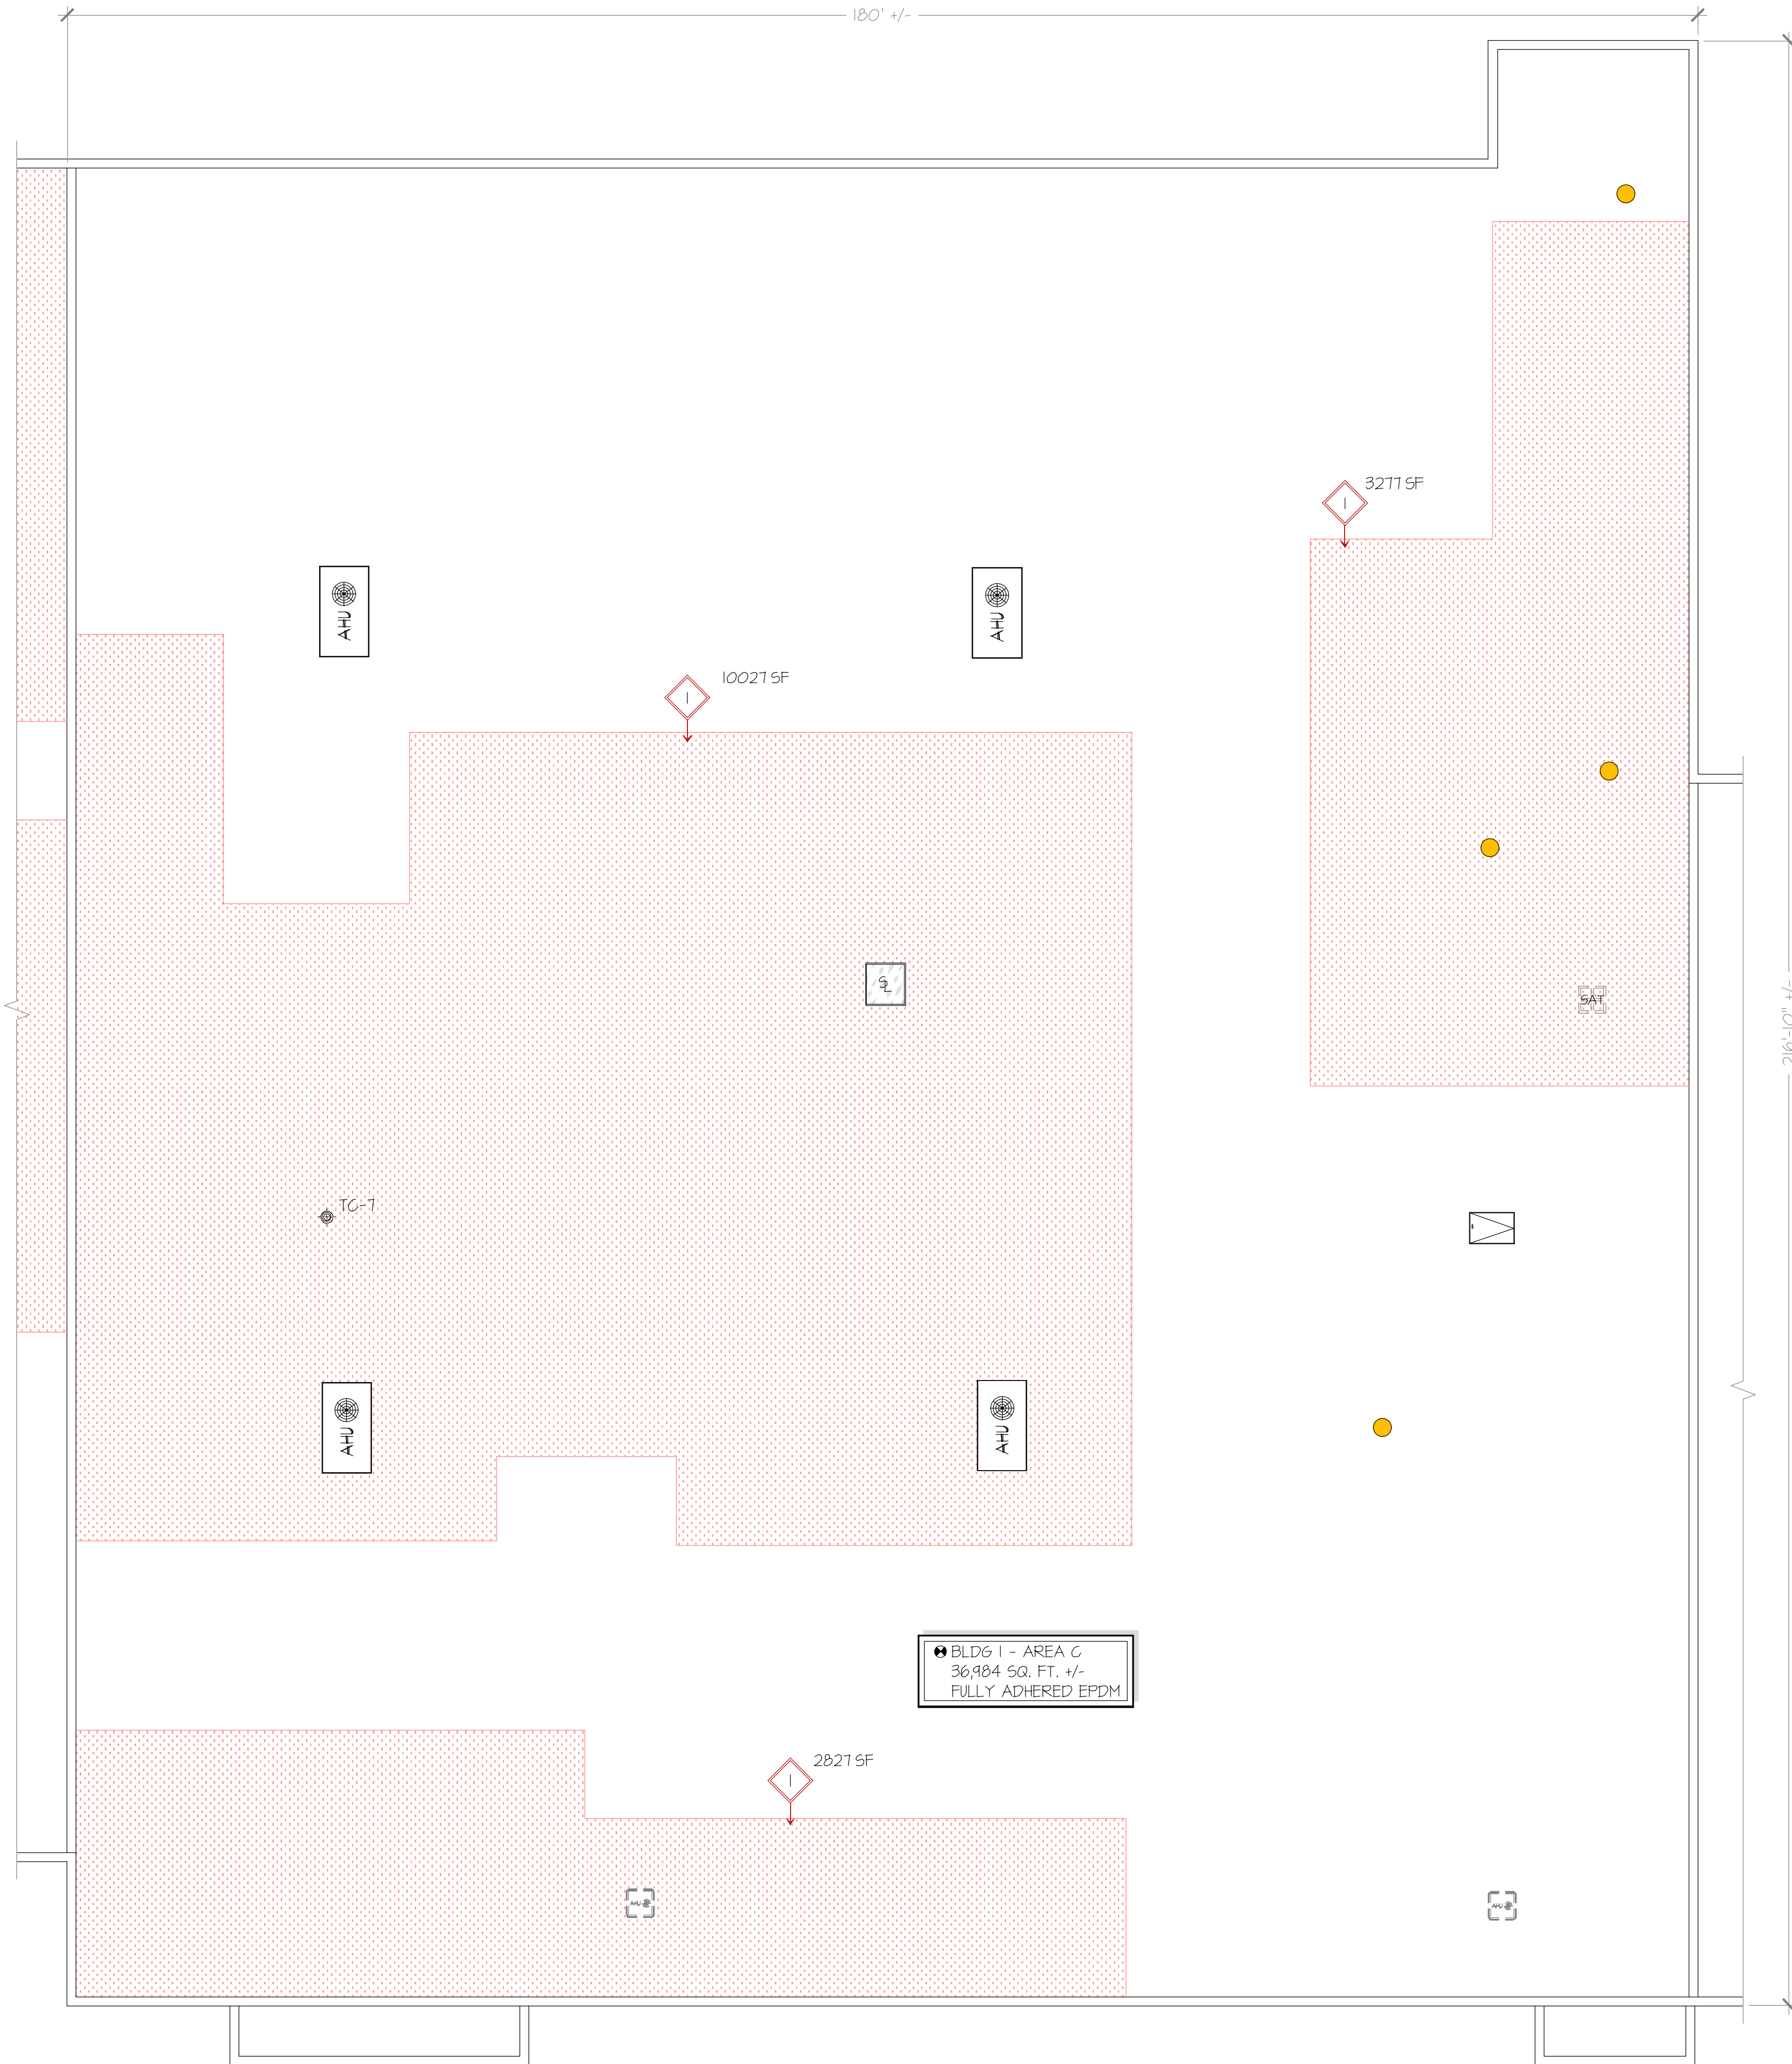
CONTOUR LEGEND			
BLDG I - AREAS A, B, C, D, E & F			
MOISTURE LEVEL	LEGEND	SQ. FT.	%
LEVEL I - DRY		69,145 SQ. FT. +/-	45.4%
LEVEL II - WET		83,426 SQ. FT. +/-	54.6%

1 TOTAL PROJECT ROOF AREA - 177,176 SQ. FT. +/-
A2 SCALE: 3/32"=1'-0"

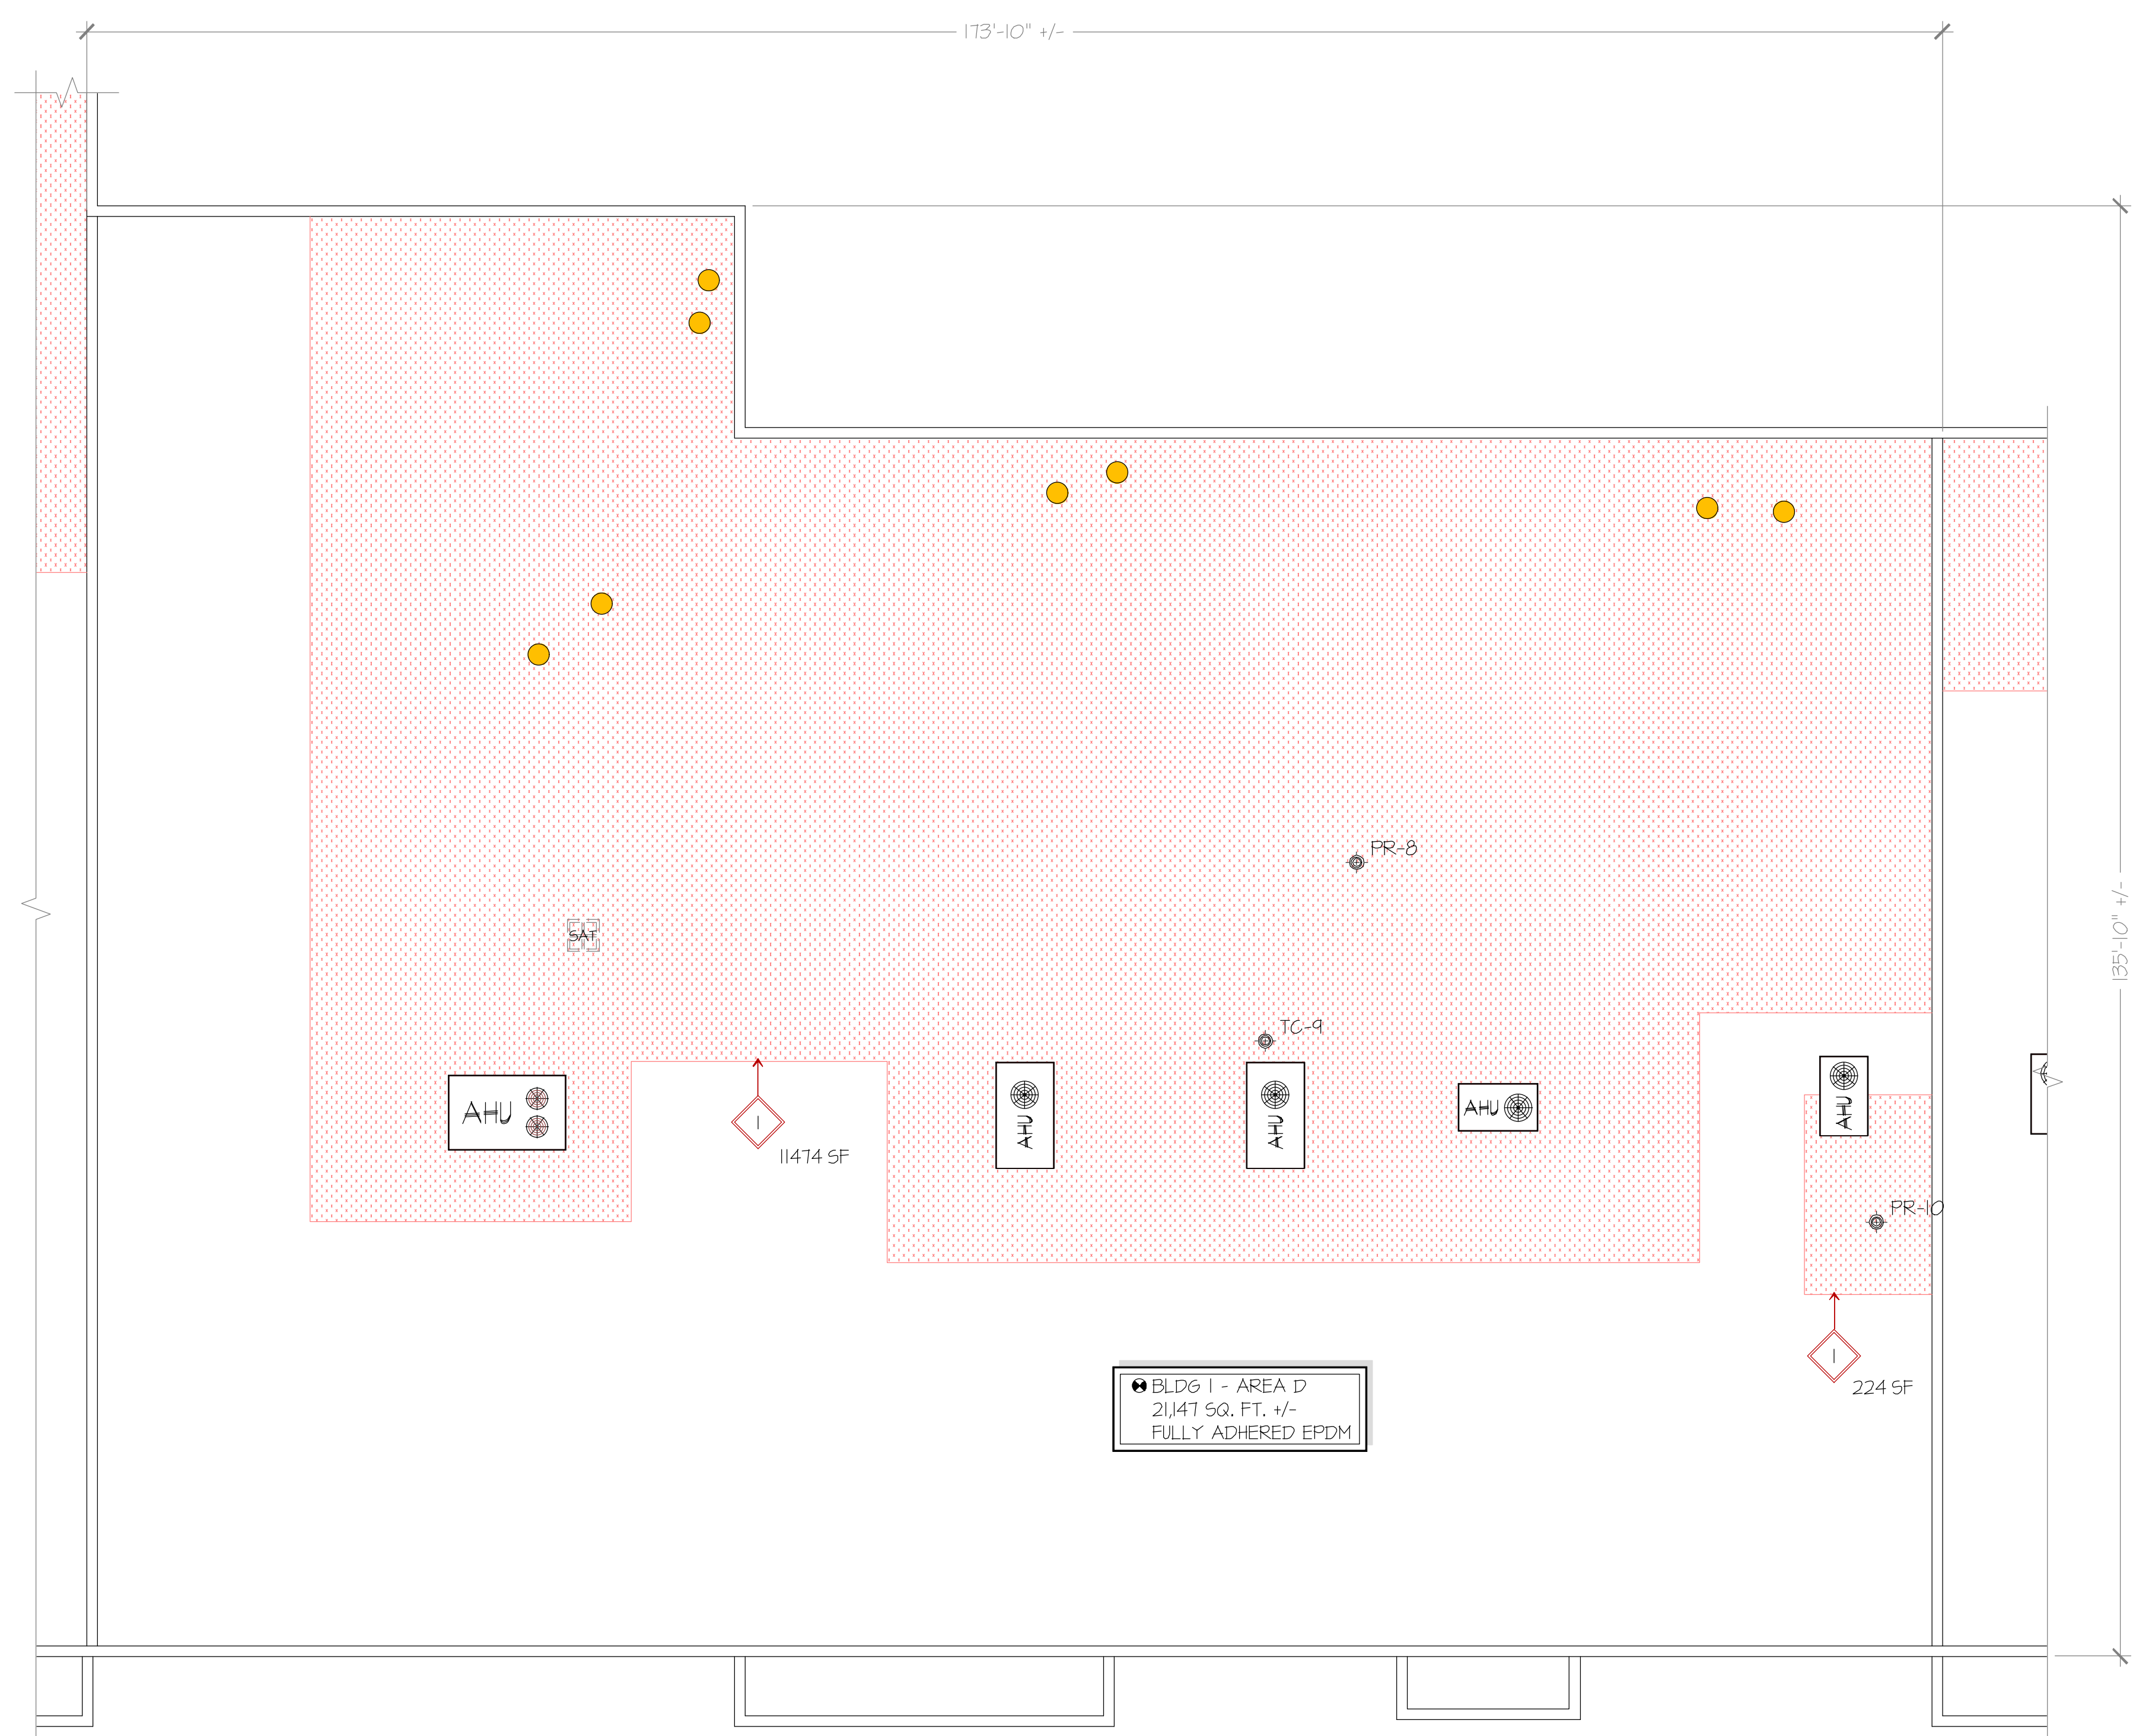
CONTOUR LEGEND			
BLDG 1 - AREAS A, B, C, D, E & F			
MOISTURE LEVEL	LEGEND	SQ. FT.	%
LEVEL I - DRY		69,145 SQ. FT. +/-	45.4%
LEVEL II - WET		83,426 SQ. FT. +/-	54.6%

1 TOTAL PROJECT ROOF AREA - 177,176 SQ. FT. +/-
A3 SCALE: 3/32"=1'-0"

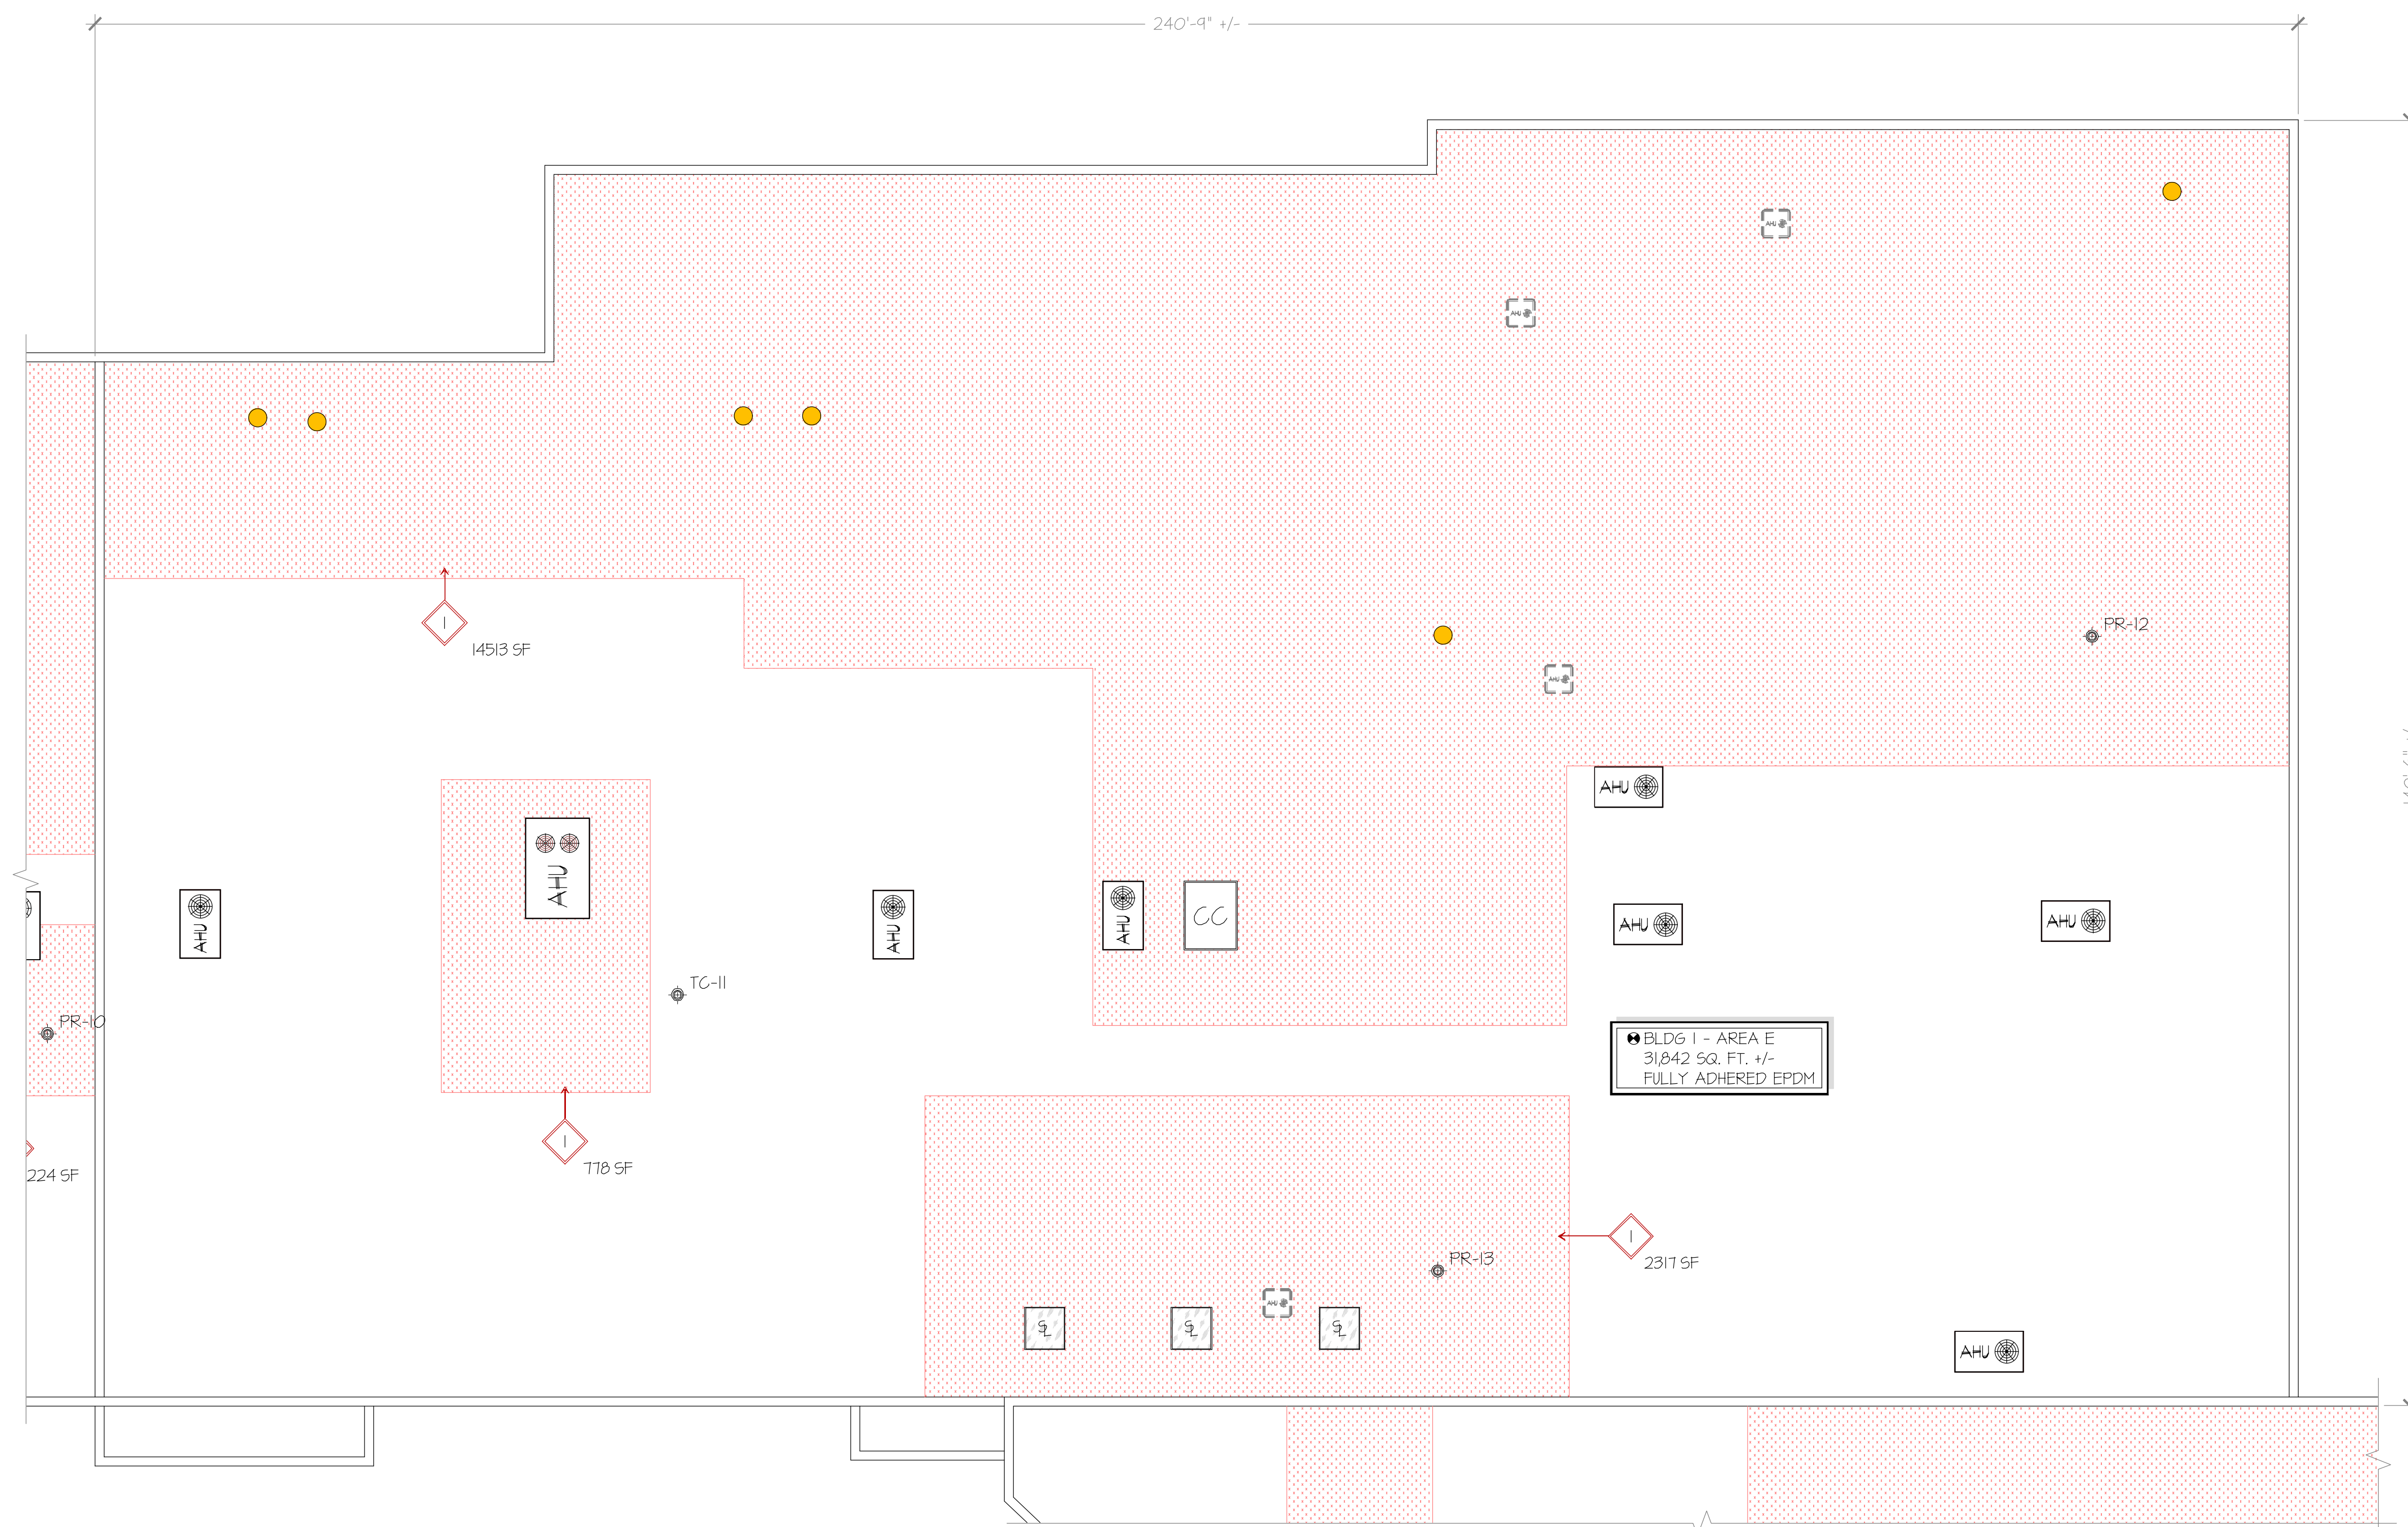
I TOTAL PROJECT ROOF AREA - 177,776 SQ. FT. +/-
A4 SCALE: 3/32"=1'-0"

CONTOUR LEGEND BLDG I - AREAS A, B, C, D, E & F

MOISTURE LEVEL	LEGEND	SQ. FT.	%
LEVEL I - DRY		69,145 SQ. FT. +/-	45.4%
LEVEL II - WET		83,426 SQ. FT. +/-	54.6%

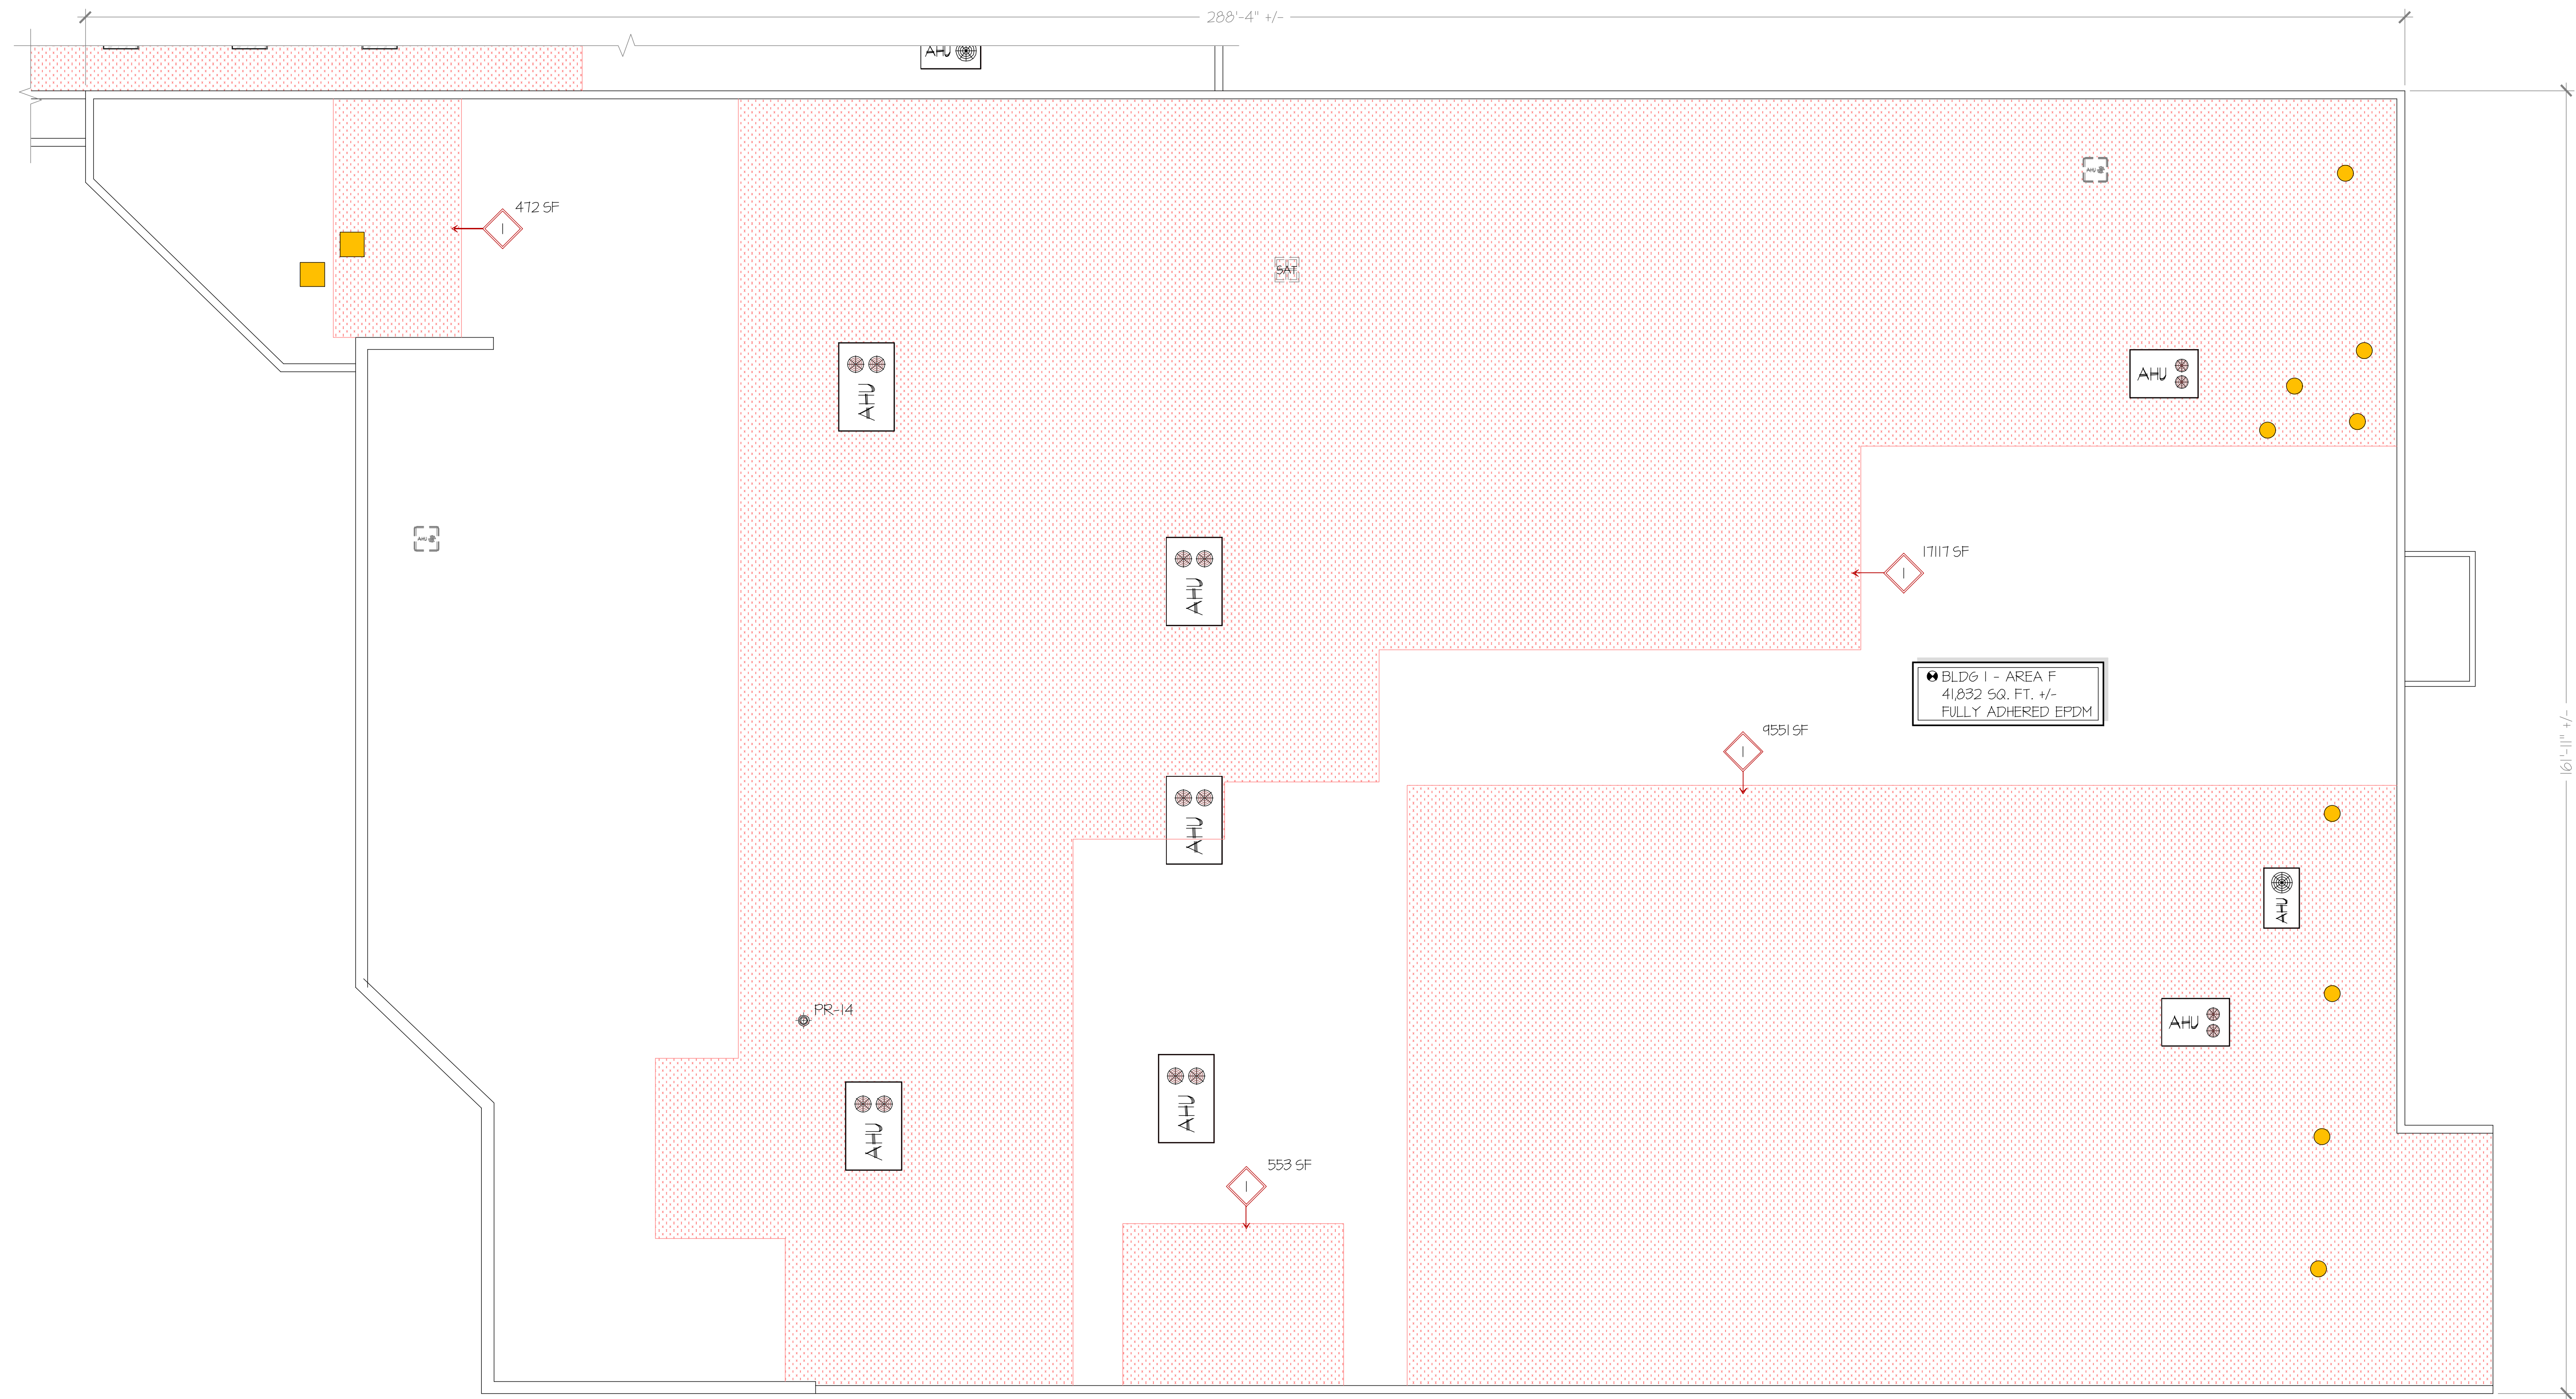
A5

TOTAL PROJECT ROOF AREA - 177,776 SQ. FT. +/-
SCALE: 3/32"=1'-0"

CONTOUR LEGEND BLDG I - AREAS A, B, C, D, E & F

MOISTURE LEVEL	LEGEND	SQ. FT.	%
LEVEL I - DRY		69,145 SQ. FT. +/-	45.4%
LEVEL II - WET		83,426 SQ. FT. +/-	54.6%

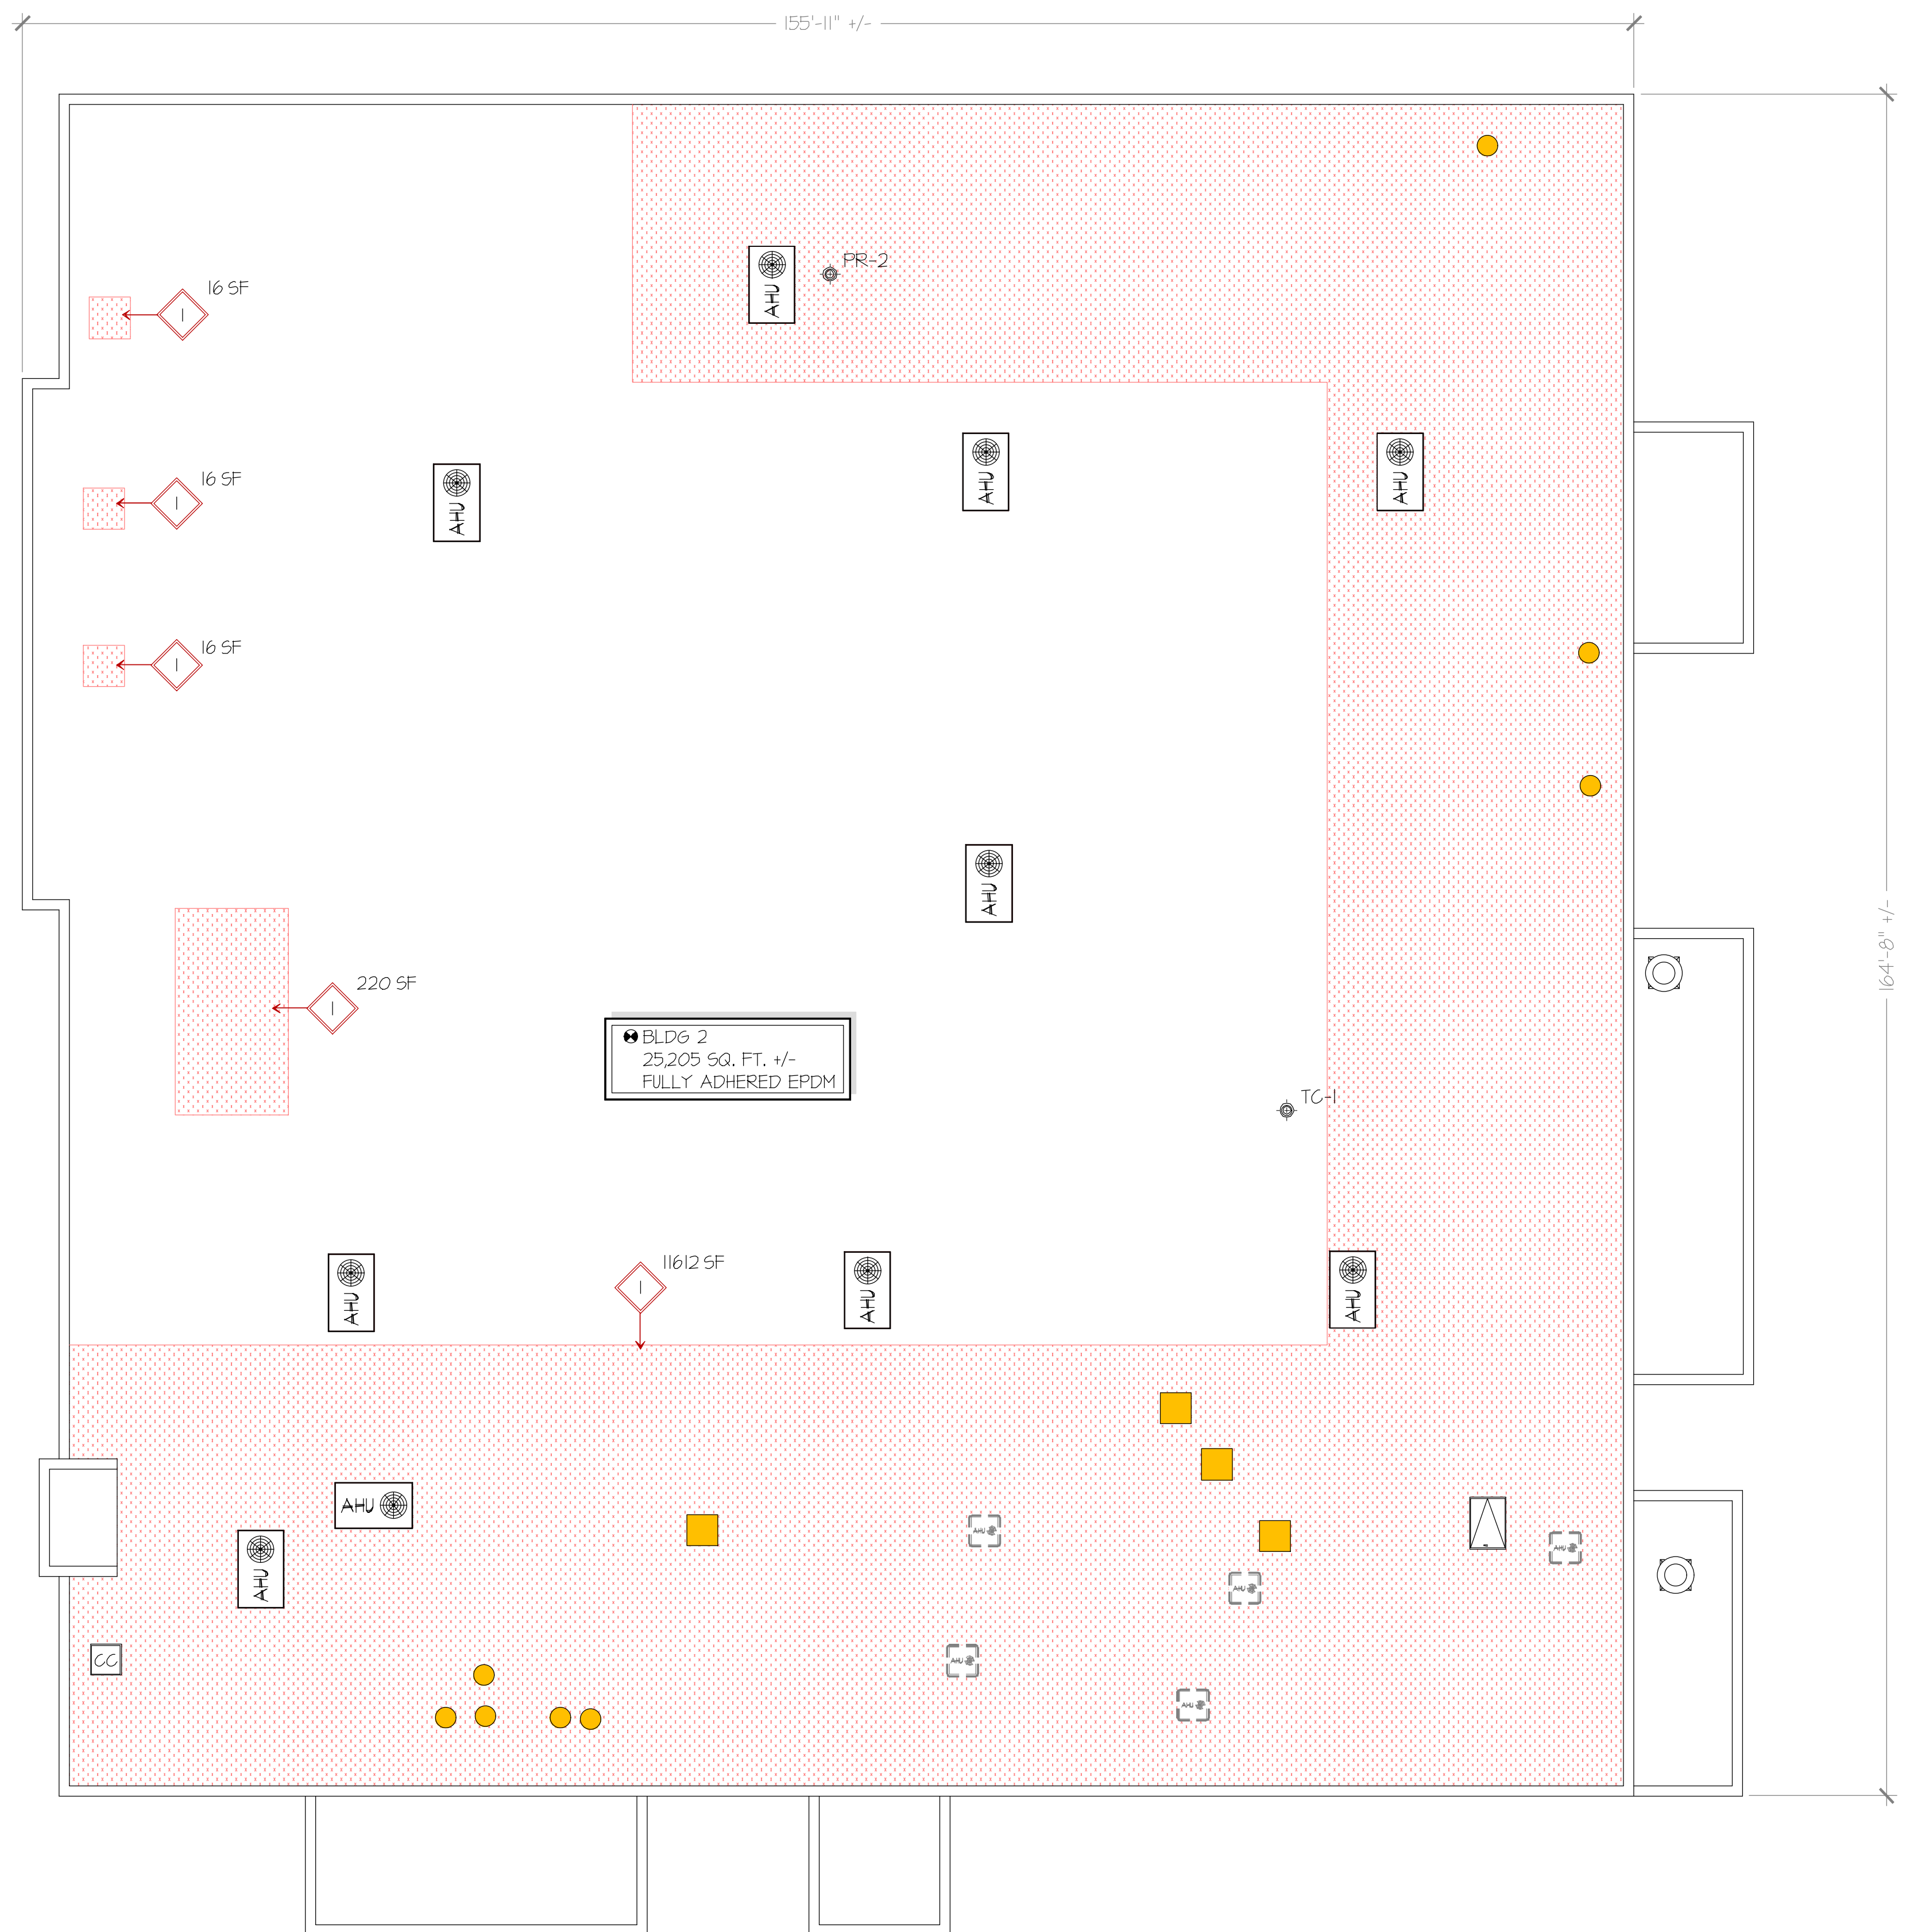
TOTAL PROJECT ROOF AREA - 177,776 SQ. FT. +/-
A6 SCALE: 3/32"=1'-0"

CONTOUR LEGEND BLDG 2			
MOISTURE LEVEL	LEGEND	SQ. FT.	%
LEVEL I - DRY		13,325 SQ. FT. +/-	52.4%
LEVEL II - WET		11,880 SQ. FT. +/-	47.1%
