**Roof Consulting  
Services, Inc.**

Re: Leak Investigation  
Chestnut Hill Shoppes  
8400 & 8625 Germantown Ave  
Philadelphia, Pennsylvania 19118

# LEAK INVESTIGATION PHOTOGRAPHS

**LEAK INVESTIGATION**  
CLIENT: ACADIA REALTY  
PROJECT: CHESTNUT HILL SHOPPES  
ADDRESS: 8400 & 8625 GERMAN TOWN AVE  
PHILADELPHIA, PENNSYLVANIA  
DRAWING: ROOF PLAN

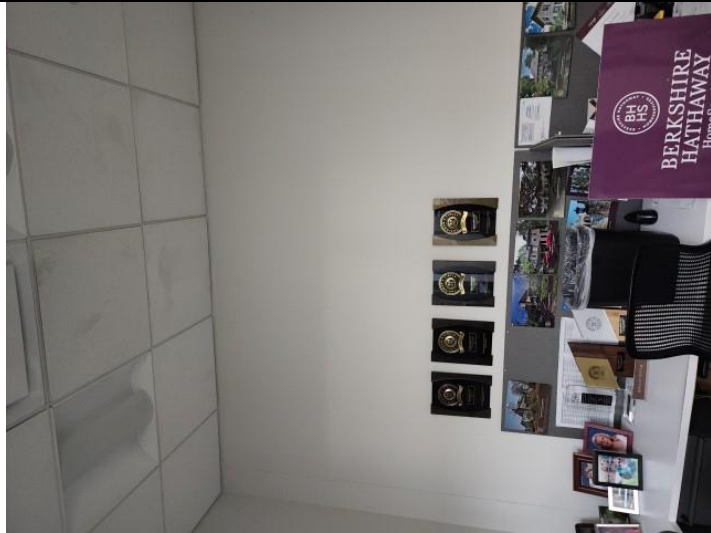
The two reported leak locations were found at the Berkshire Hathaway Realtor Office and at the Iron Hill Restaurant; the locations of the reported leaks can be found on our corresponding roof plan.

View of located interior leak at Realtor Office – Bldg 1

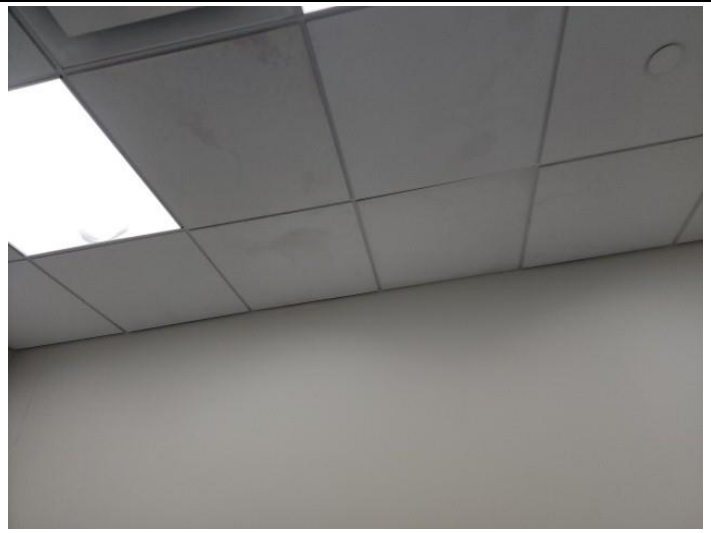
View of located interior leak at Realtor Office – Bldg 1

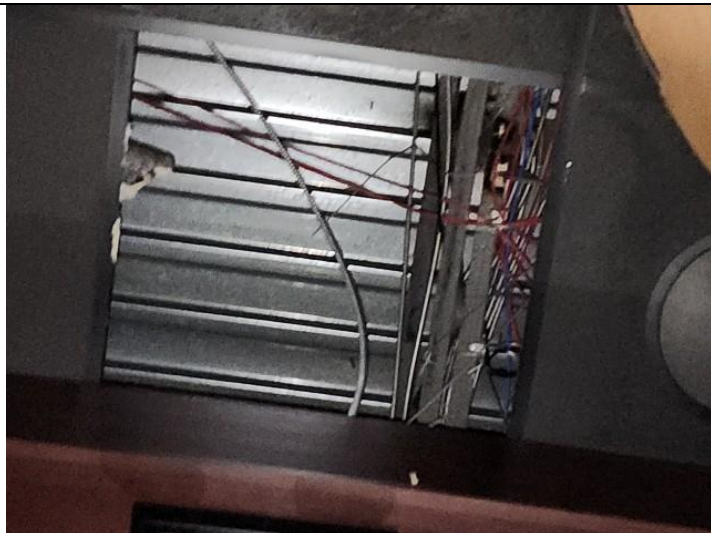
View of located interior leak at Restaurant – Bldg 1

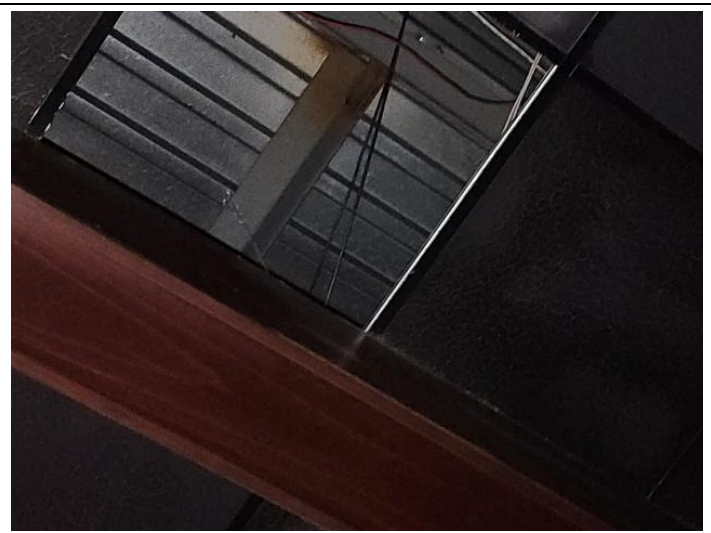
View of located interior leak at Restaurant – Bldg 1

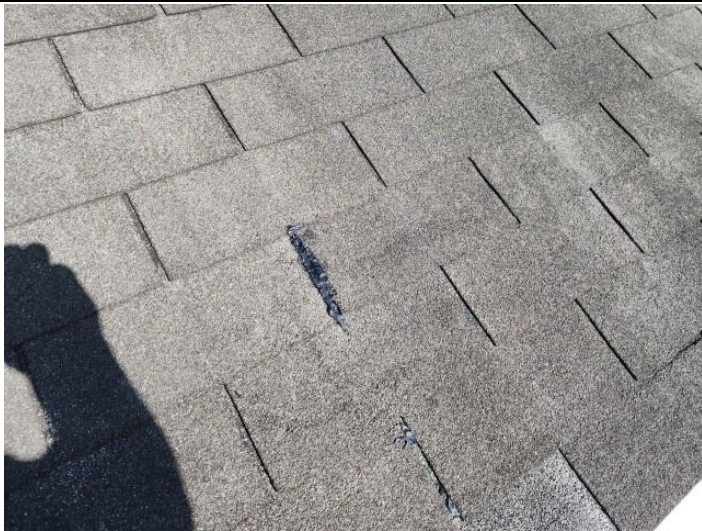
Water testing was performed for a total of five hours at varying locations concentrating water application to areas of suspected potential infiltration. During the testing no interior leak could be produced. Previous repairs have been implemented to adjacent shingle roof systems identified as being in "Poor" – "Failed" condition. The adjacent shingle roof systems were not part of the new roof installation scope.

Repaired Shingles on Bldg 1

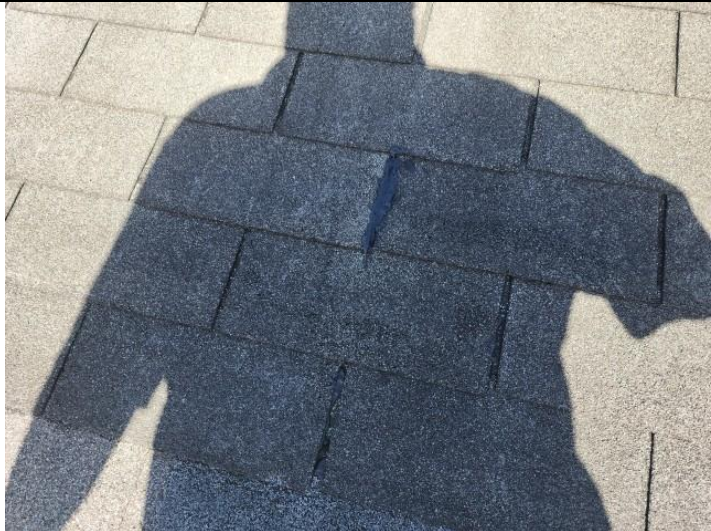
Repaired Shingles on Bldg 1

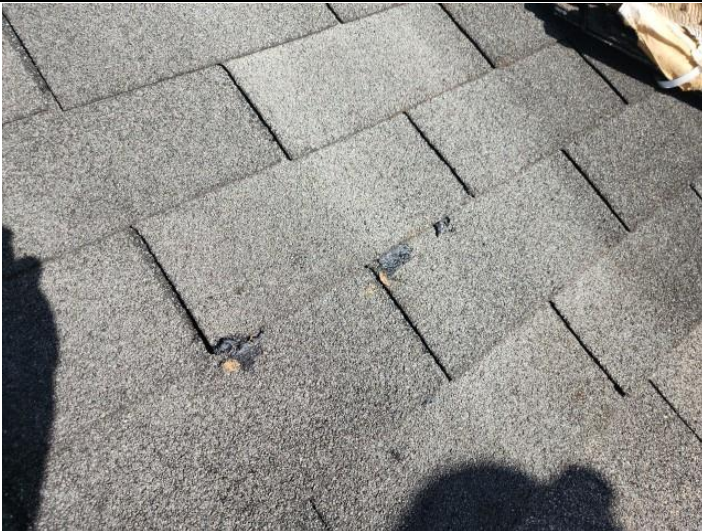
Repaired Shingles on Bldg 1

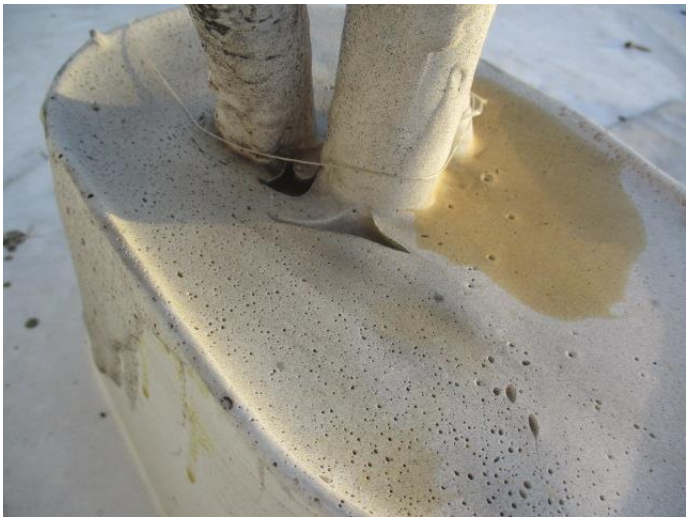
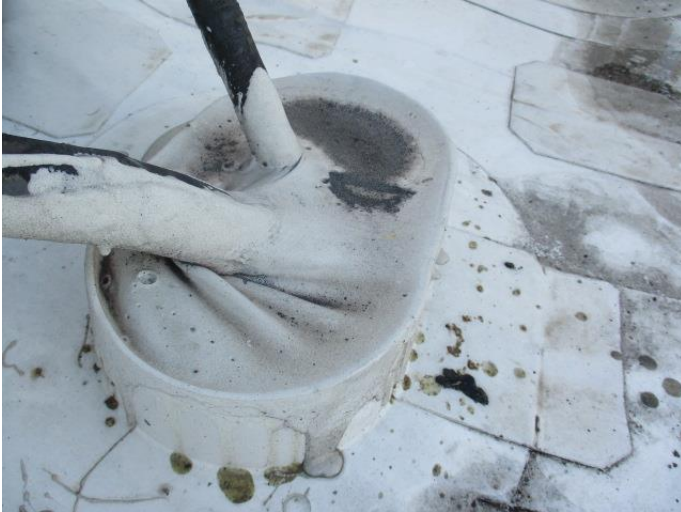
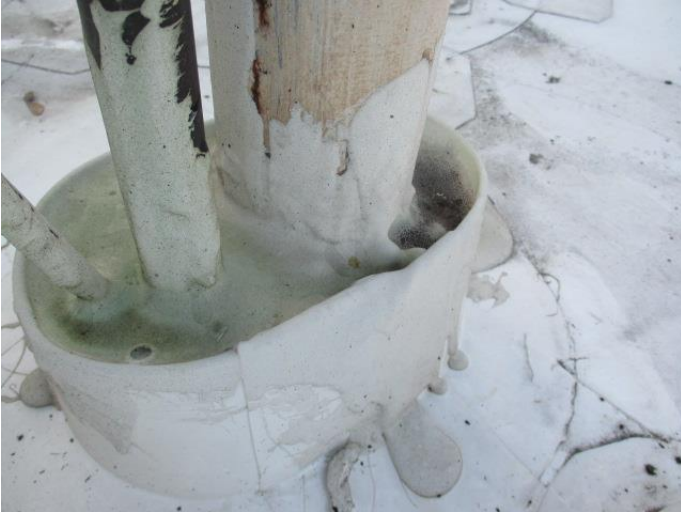
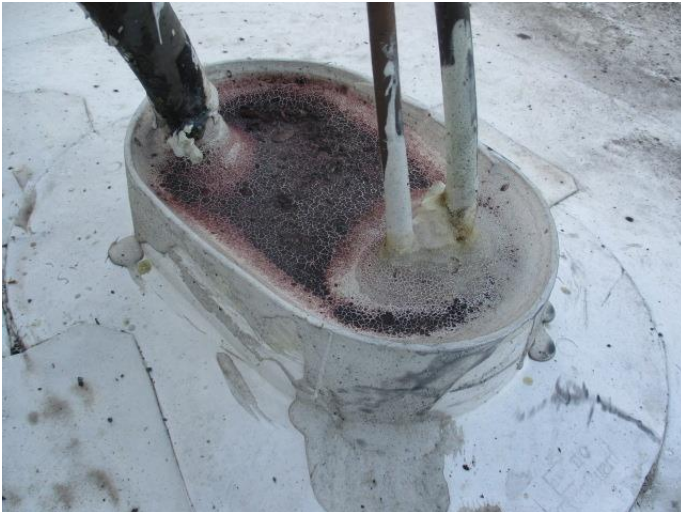
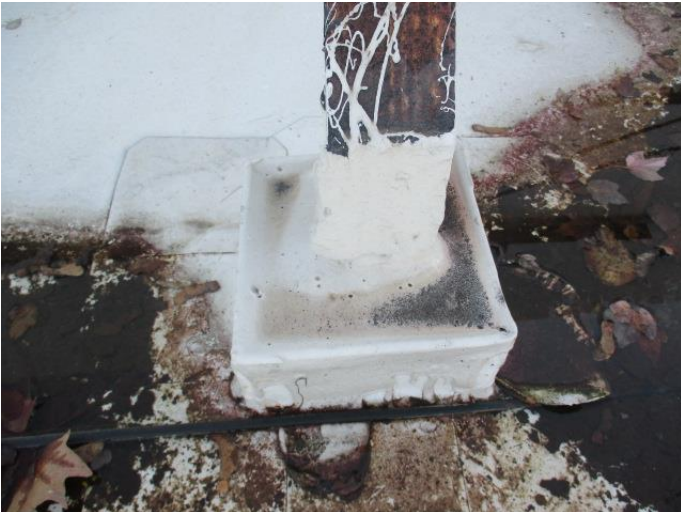
The locations of these deficient conditions can be found on our corresponding roof plan. Conditions #1 & #2 are **not** believed to be related to the active leak activity. Condition #1, insufficient filler material at pourable sealant pocket detail, is considered a maintenance related condition; however, because the roof system is still under the 2-year installers guarantee, it is recommended that the installing contractor be required to address this condition prior to expiration of the 2-year period. Condition #2, Open condition at conduit, was repaired by the installing contractor while onsite.

Insufficient filler material at pourable sealant pocket detail

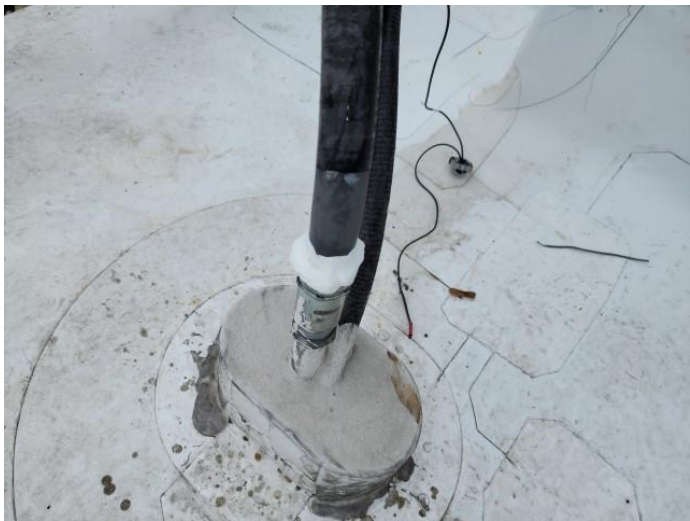
Open condition at conduit – Repair made with sealant

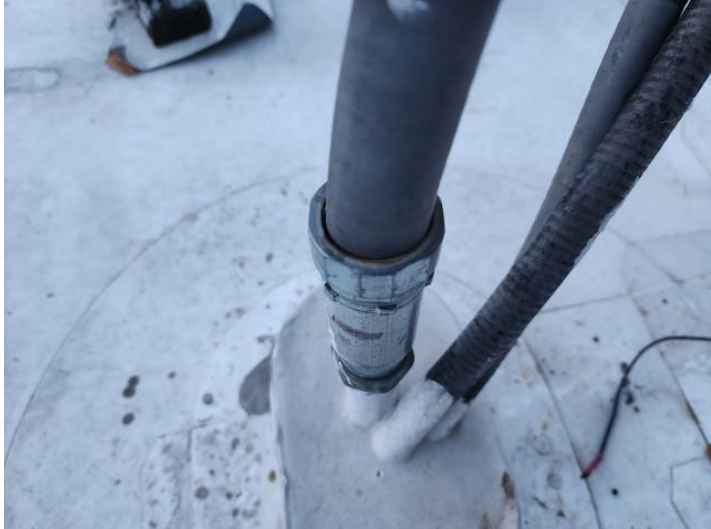
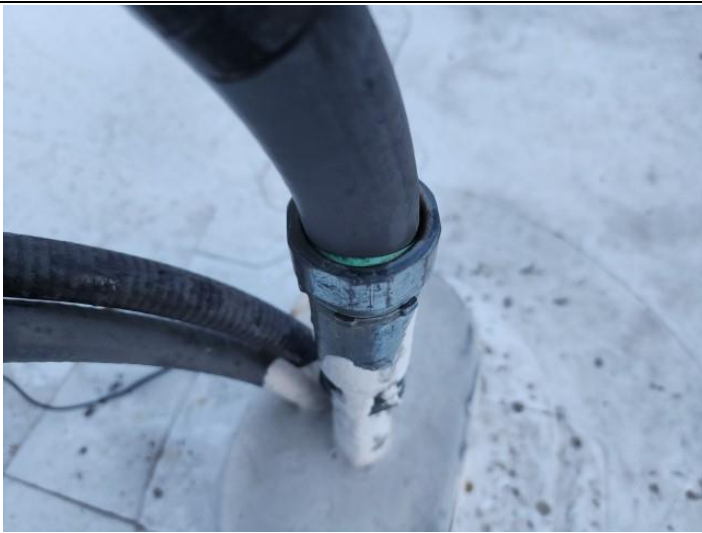
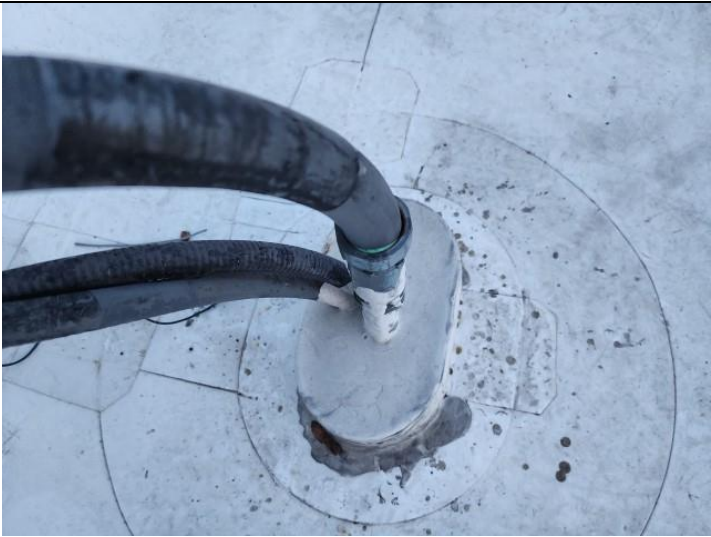
Open condition at conduit

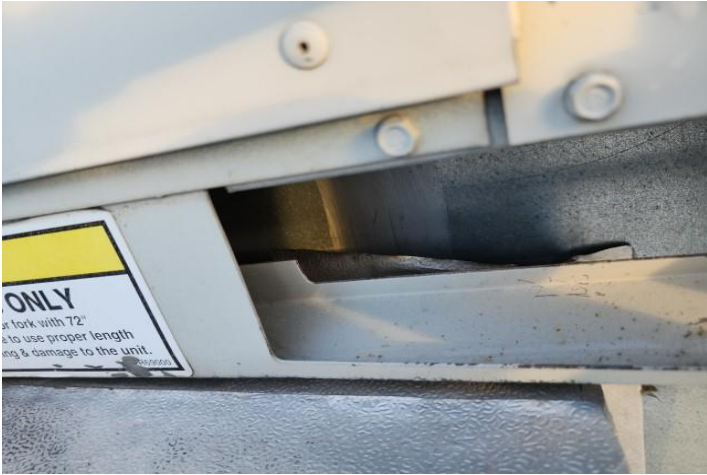
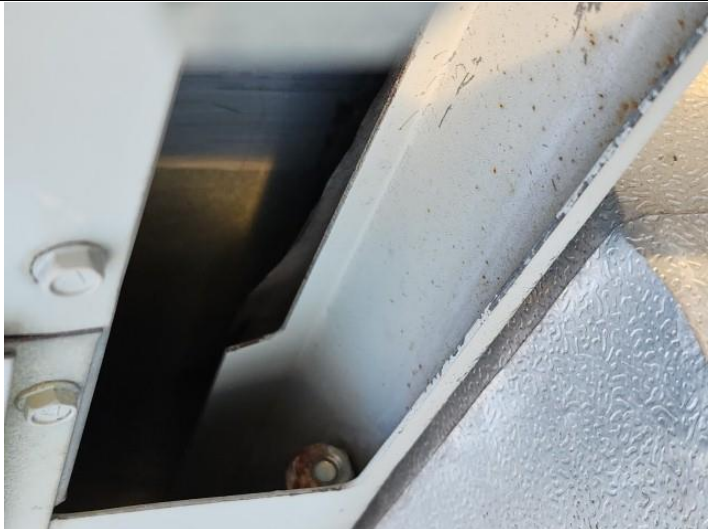
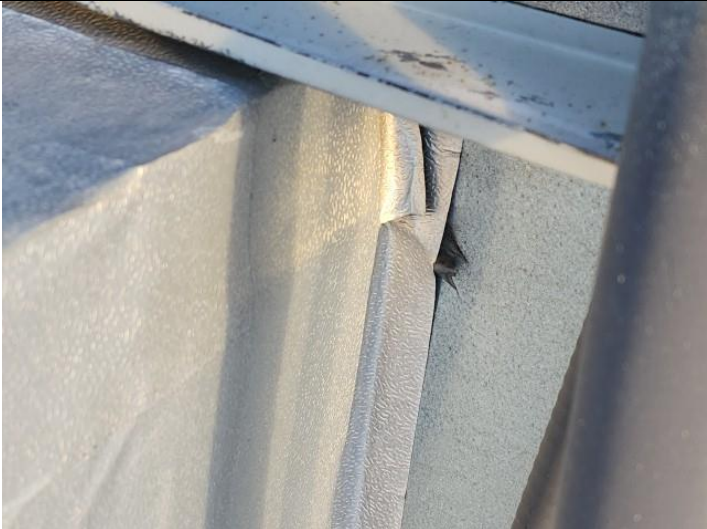
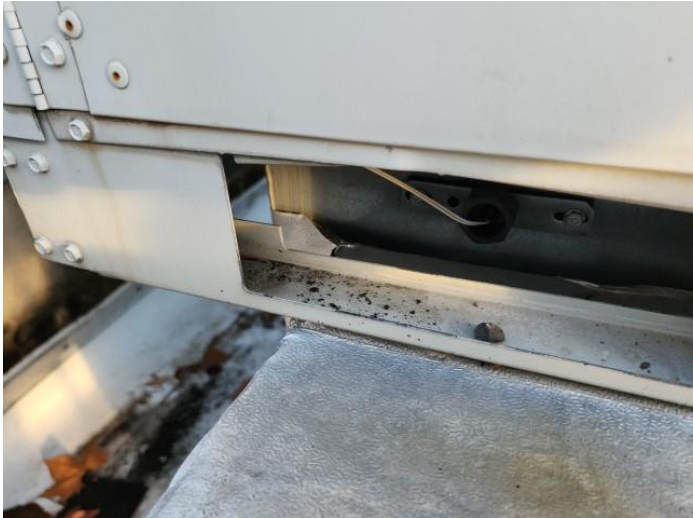
Condition #3, insulated duct wrap not properly terminated / sealed at unit is a mechanical related

Insulated duct wrap not properly terminated / sealed at unit

condition and was not included in the new roof installation scope. It is recommended that the Owner contact a local qualified mechanical contractor to assess the mechanical unit, duct, and insulated duct wrap installation for open conditions and provide recommended corrective action and estimated repair budget.

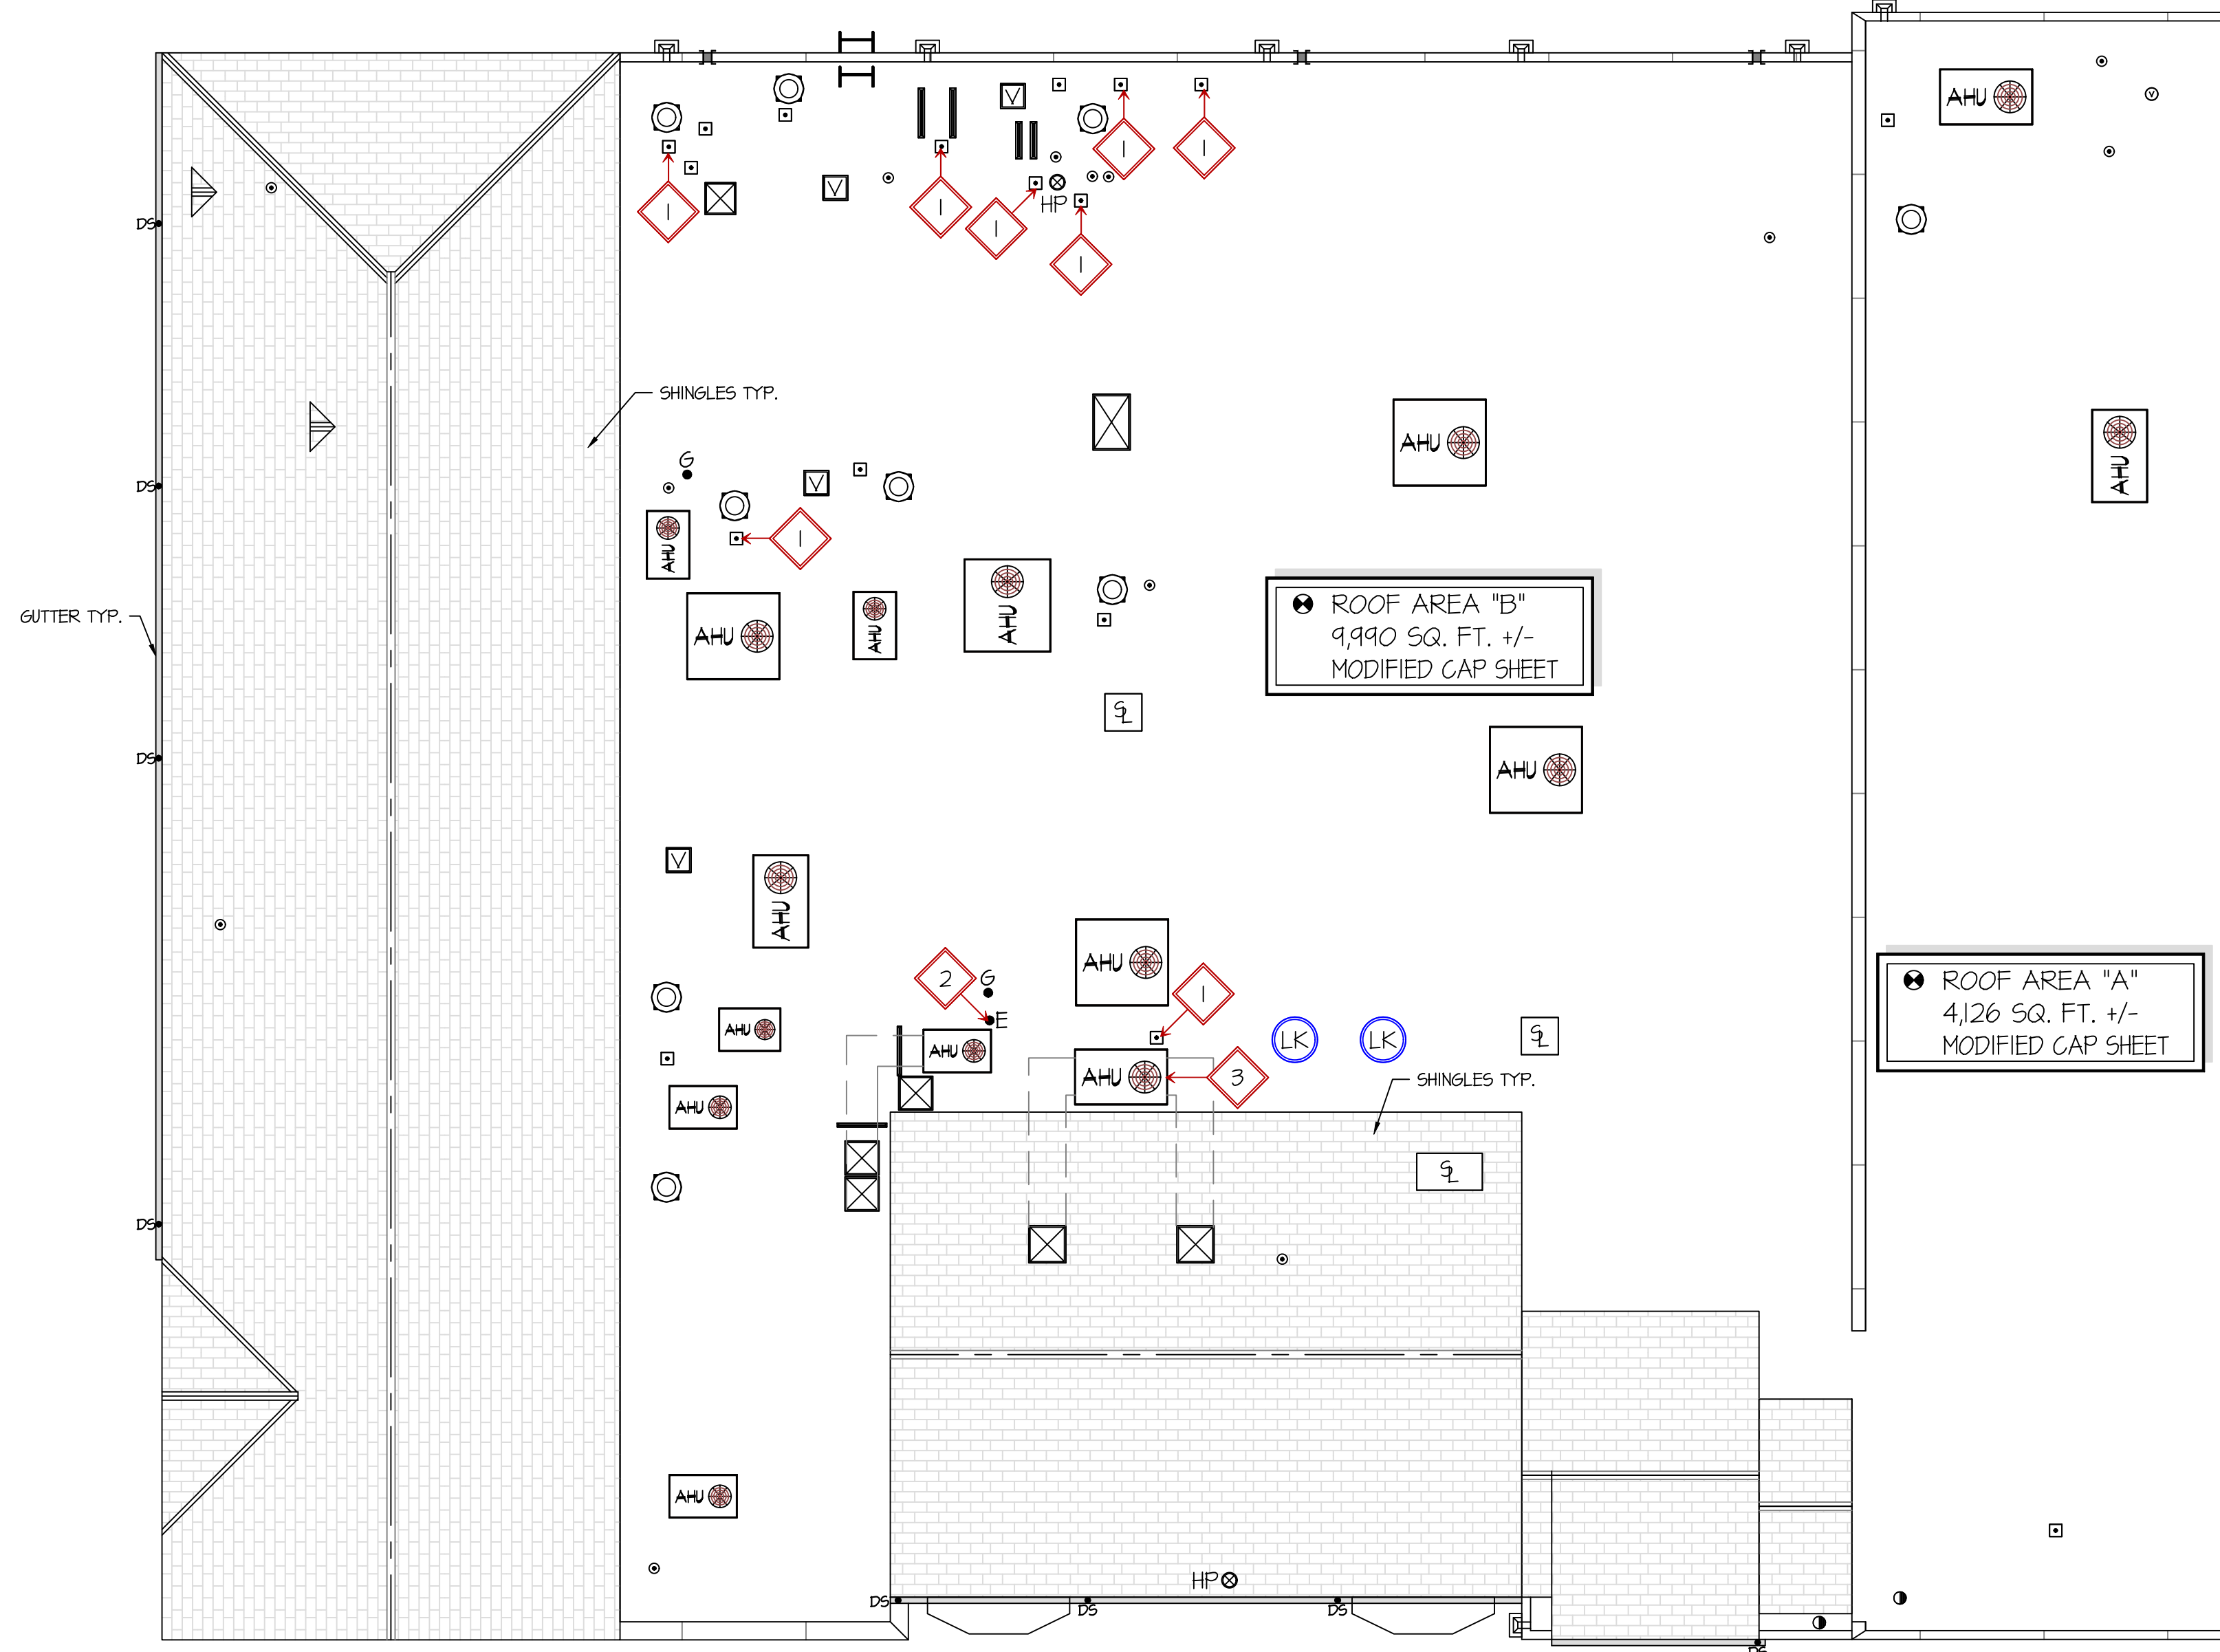
DEFICIENCY LIST	
1	INSUFFICIENT FILLER MATERIAL AT POURABLE SEALANT POCKET DETAIL
2	OPEN CONDITION AT CONDUIT
3	INSULATED DUCT WRAP NOT PROPERLY TERMINATED / SEALED AT UNIT
