Roof Systems Data Management

Dulles Technical Center

**22611 Markey Ct
Sterling, VA**

Roof System Condition Evaluation Report

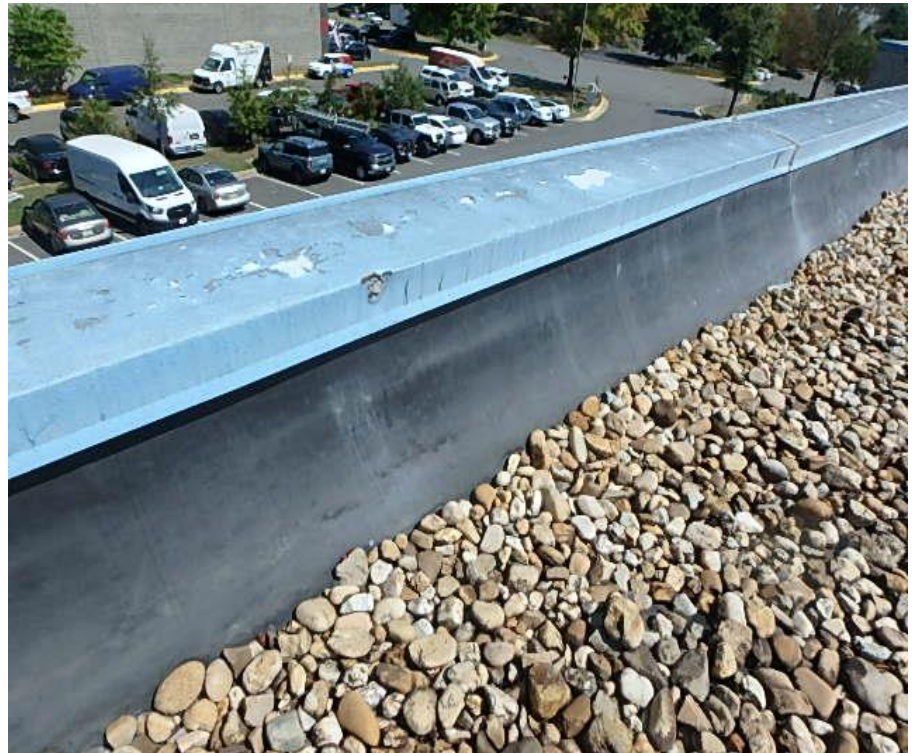
NUMBER	PRIORITY CODE	DEFICIENCY DESCRIPTION	QUANTITY	UNIT PRICE	REPAIR COST
		DEFICIENCY SOLUTION	UNITS		
1	MN	Bridging of base flashing	702		
		Monitor and address as needed to maintain a watertight condition until roof system replacement	LnFt		
2	M	Open membrane seam / flashing lap	20	\$150.00	\$3,000.00
		Properly clean, prime and overlay the affected seam with a EPDM cover strip with all cut edges sealed with EPDM lap sealant	Locations		
3	MN	Improper detailing - Pitch pocket or similar detailing needed for penetration flashing	2		
		Monitor and address at time of roof system replacement or as needed to maintain watertight integrity	Locations		
4	M	Improper repair detail - fastener through flashing membrane	3	\$150.00	\$450.00
		Remove fastener, cover with an EPDM patch centered over fastener head or hole to extend 2 inches past on all sides and caulk edges with lap sealant	Locations		
5	MN	Improper flashing detail at penetration	7

38. Deficiency #1 - Bridging of base flashing

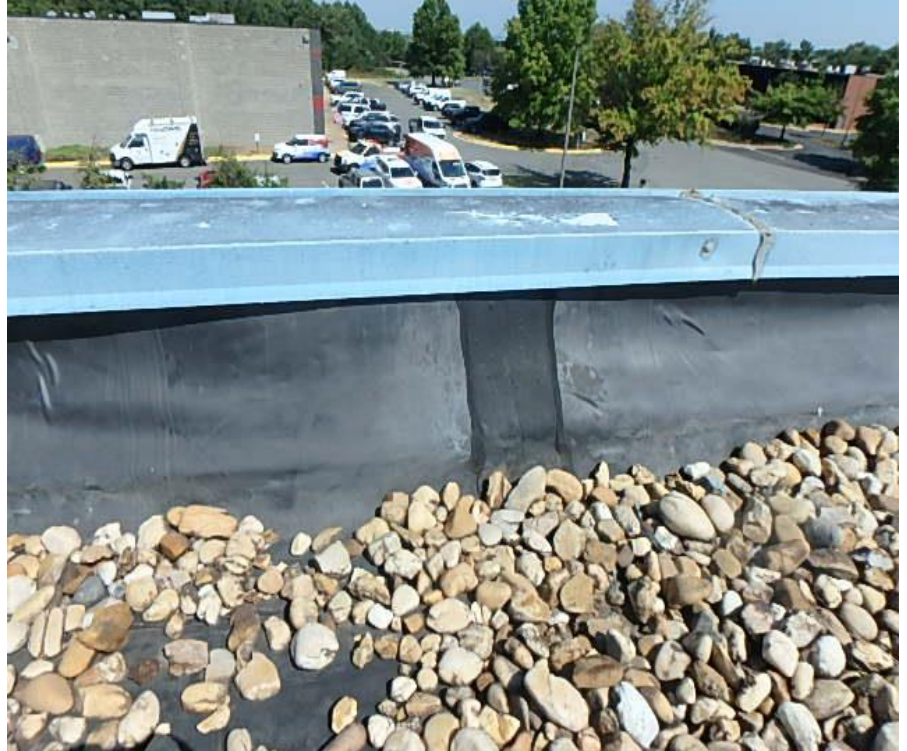
39. Deficiency #1 - Bridging of base flashing

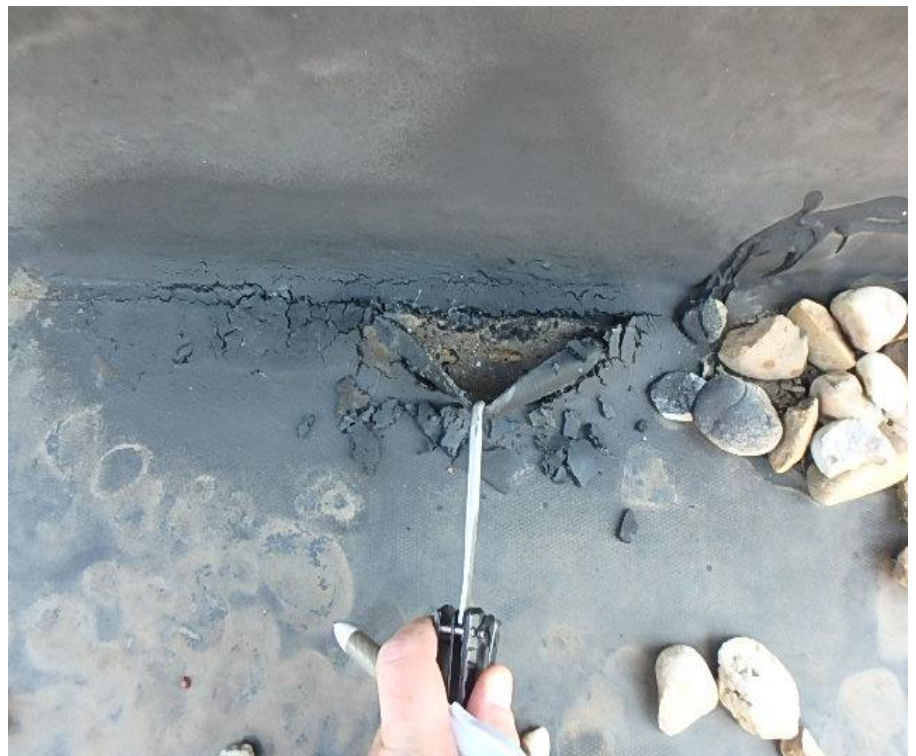
40. Deficiency #2 - Open membrane seam / flashing lap

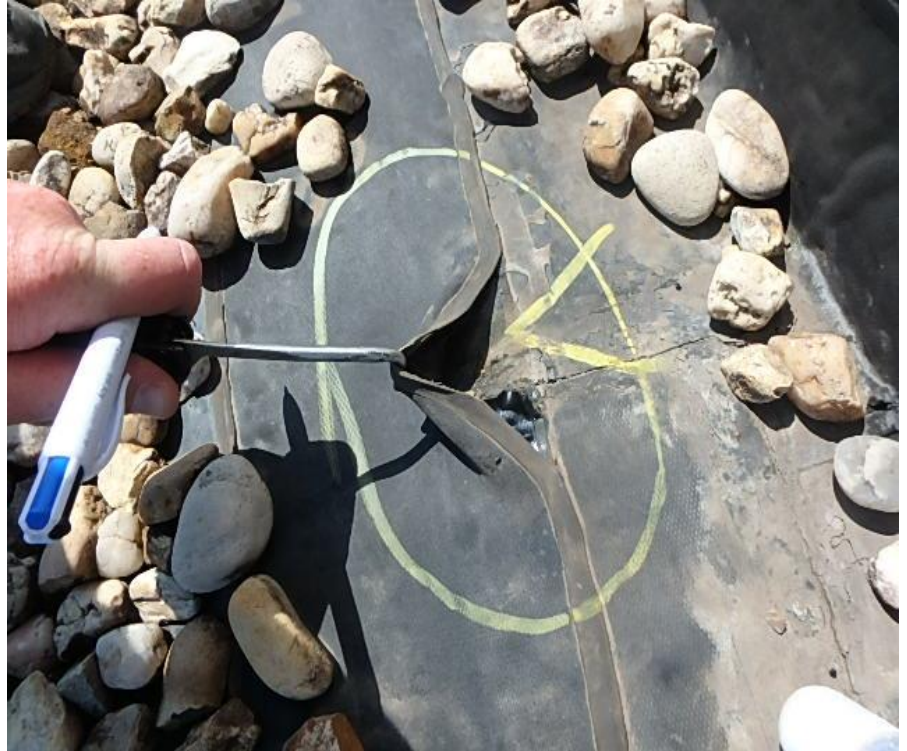
41. Deficiency #2 - Open membrane seam / flashing lap

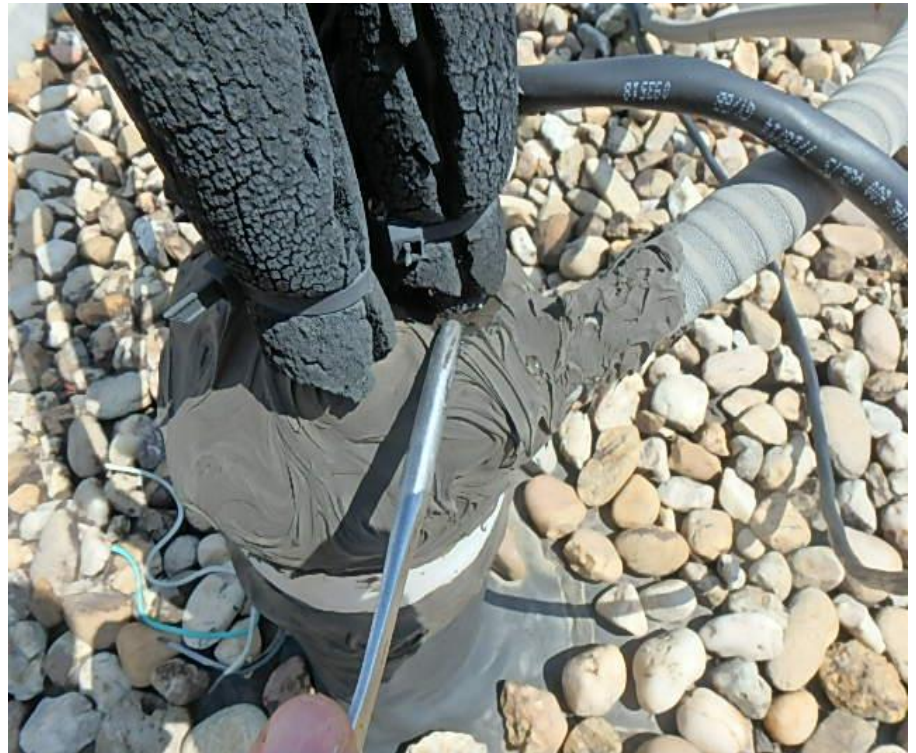
42. Deficiency #3 - Improper detailing - Pitch pocket or similar detailing needed for penetration flashing

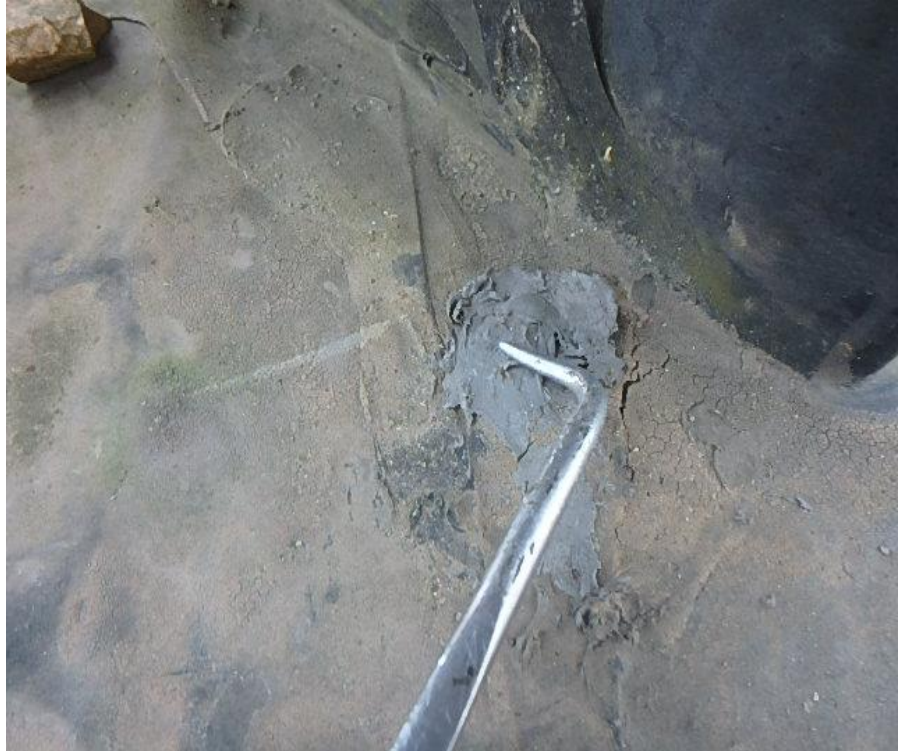
43. Deficiency #4 - Improper repair detail - fastener through flashing membrane

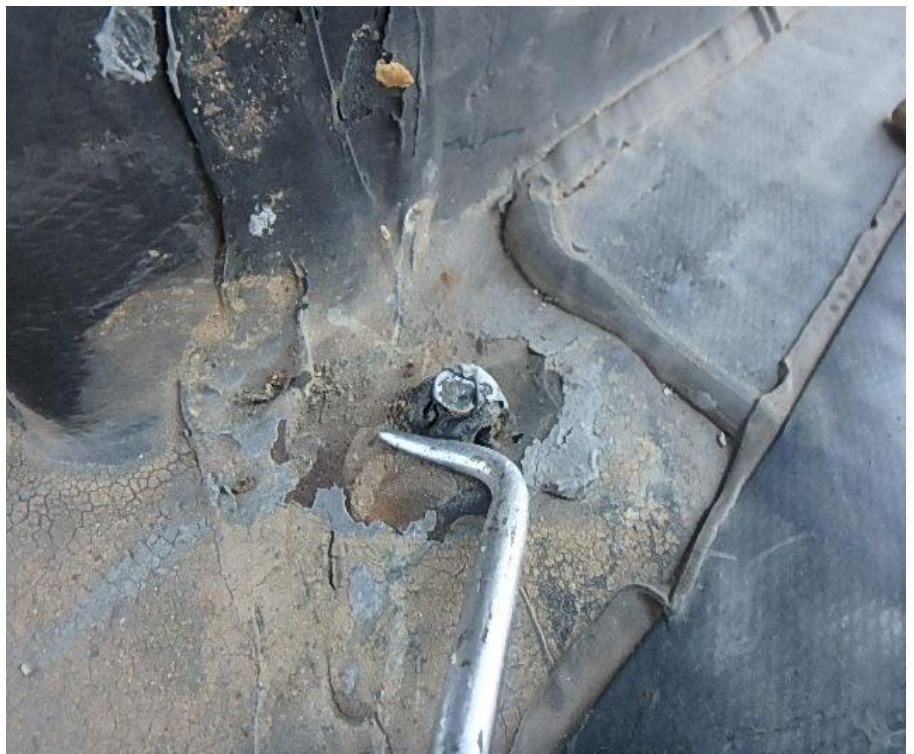
44. Deficiency #4 - Improper repair detail - fastener through flashing membrane

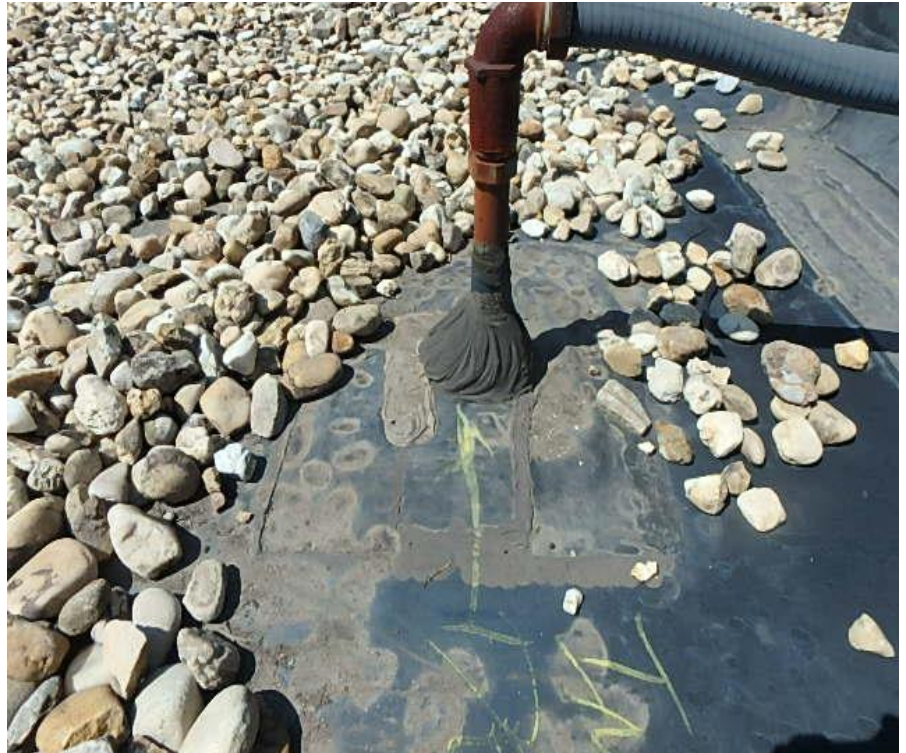
45. Deficiency #5 - Improper flashing detail at penetration

Monitor and address at time of roof system replacement or as needed to maintain watertight integrity	Locations		
6	MN	Rust developing on metal component	15		
		Monitor and address at time of roof system replacement or as needed to maintain watertight integrity	Locations		
7	M	Deteriorated pipe penetration flashing	7	\$175.00	\$1,225.00
		Flash pipe penetration with compatible materials to provide a watertight condition	Locations

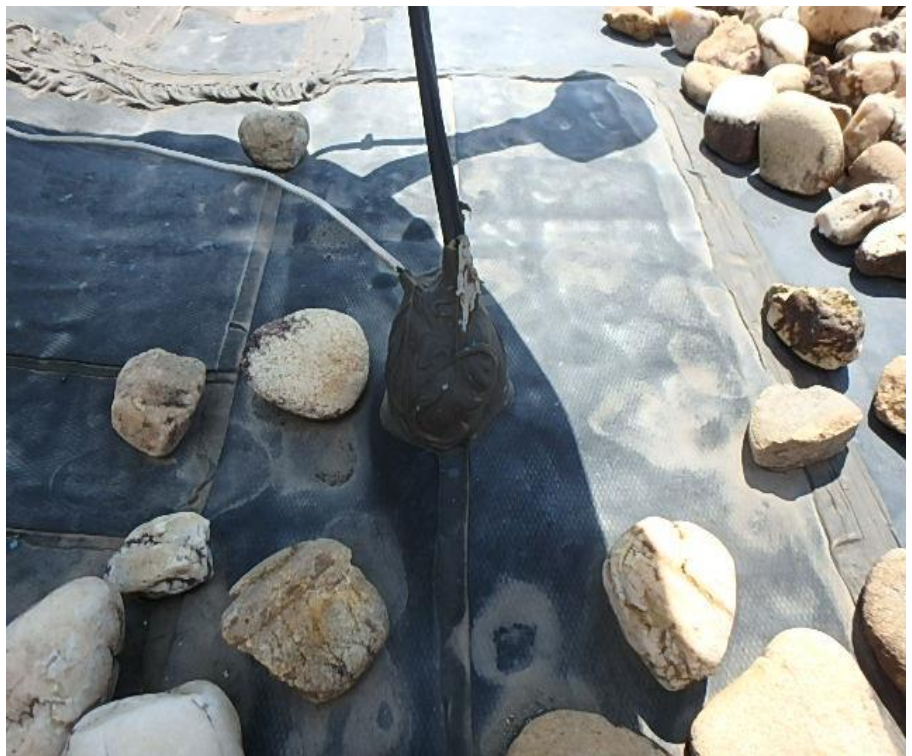
46. Deficiency #5 - Improper flashing detail at penetration

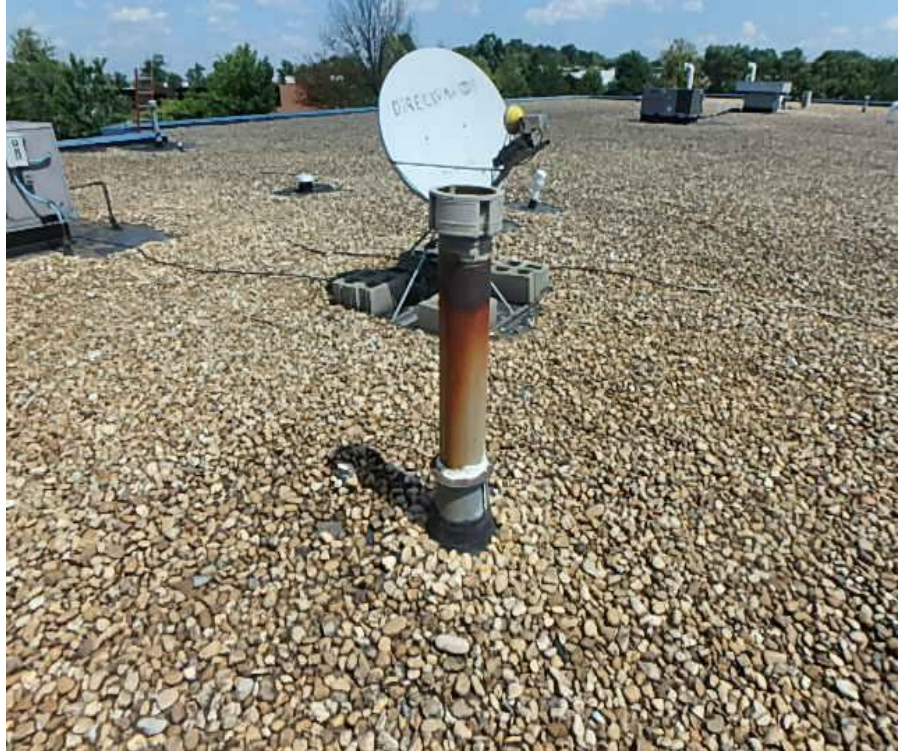
47. Deficiency #6 - Rust developing on metal component

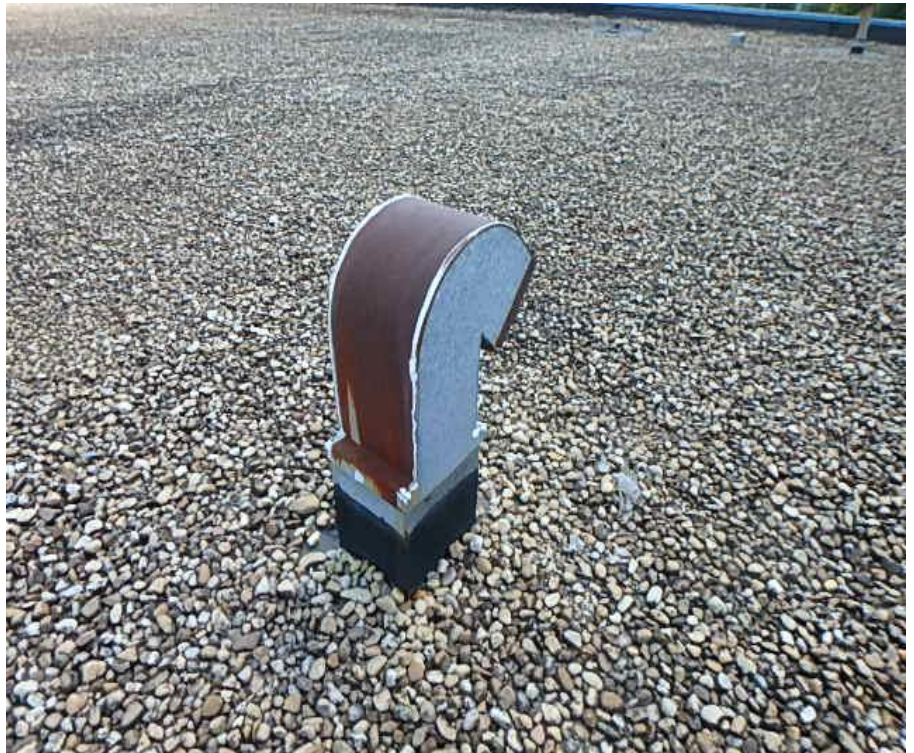
48. Deficiency #6 - Rust developing on metal component

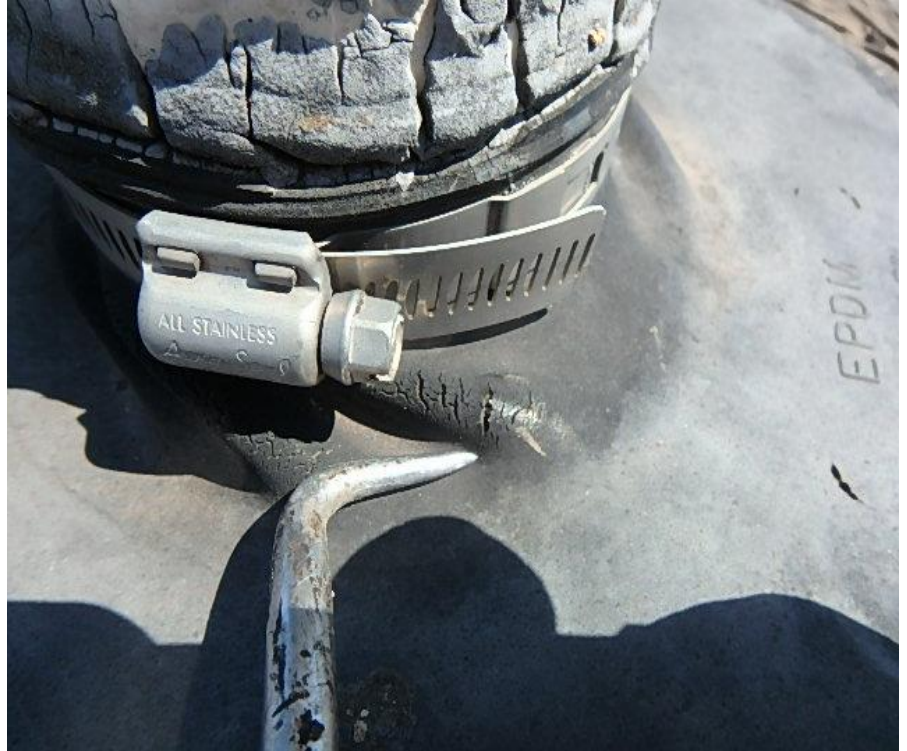
49. Deficiency #7 - Deteriorated pipe penetration flashing

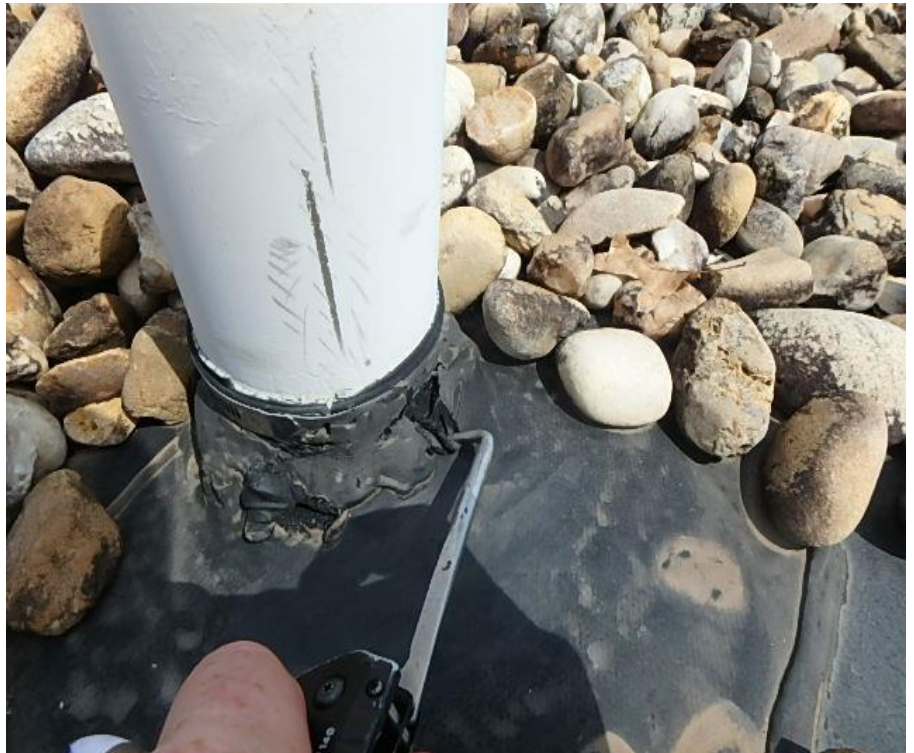
50. Deficiency #7 - Deteriorated pipe penetration flashing

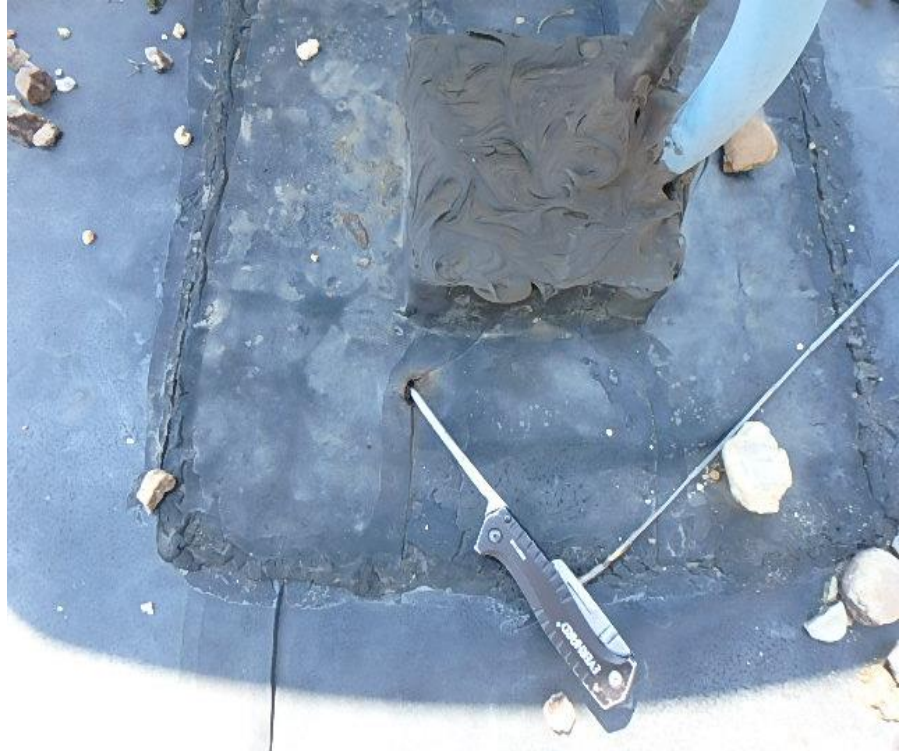
NUMBER	PRIORITY CODE	DEFICIENCY DESCRIPTION	QUANTITY	UNIT PRICE	REPAIR COST
		DEFICIENCY SOLUTION	UNITS		
8	M	Hole in flashing	2	\$125.00	\$250.00
		Properly clean and prime the affected area - apply pressure sensitive EPDM membrane centered over the hole to provide a watertight condition - seal the edge of repair membrane with EPDM lap sealant	Locations		
9	MN	Deteriorated conduit cover	1		
		Address at time of roof system replacement or as needed to maintain watertight integrity	Location		
10	M	Missing drain bowl clamping ring	2	\$250.00	\$500.00
		Install new drain clamping ring of appropriate size and material for existing drain bowl with fasteners installed at all provided locations	Locations		
11	MN	Membrane exhibiting various signs of deterioration - cracking & splitting	1		
		Monitor and address at time of roof system replacement or as needed to maintain watertight integrity	Typical		
12	M	Open masonry control joint	11	\$25.00	\$275.00

51. Deficiency #8 - Hole in flashing

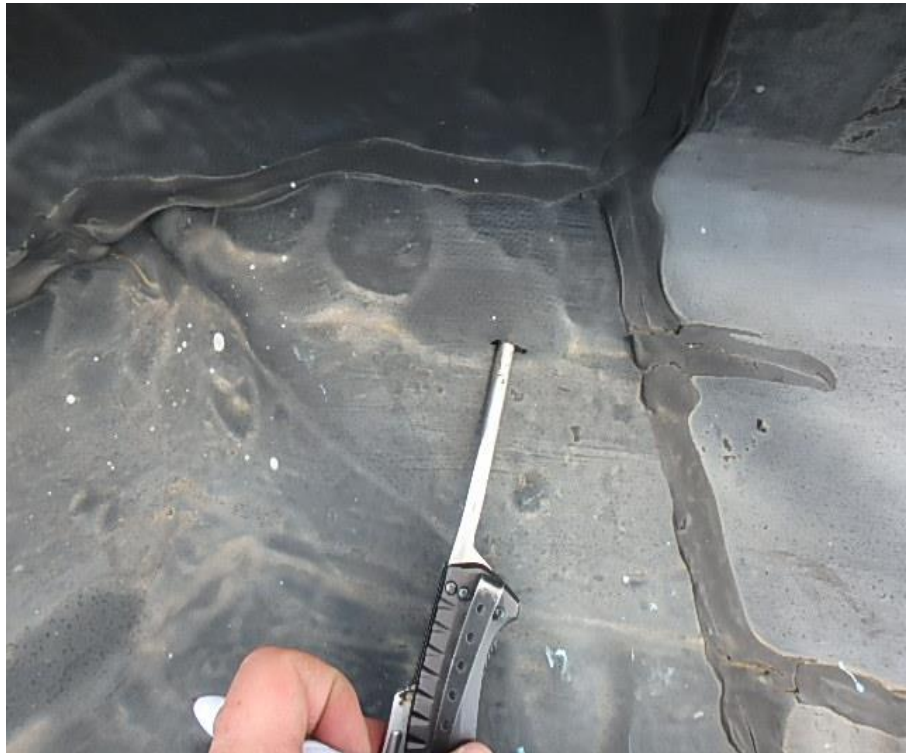
52. Deficiency #8 - Hole in flashing

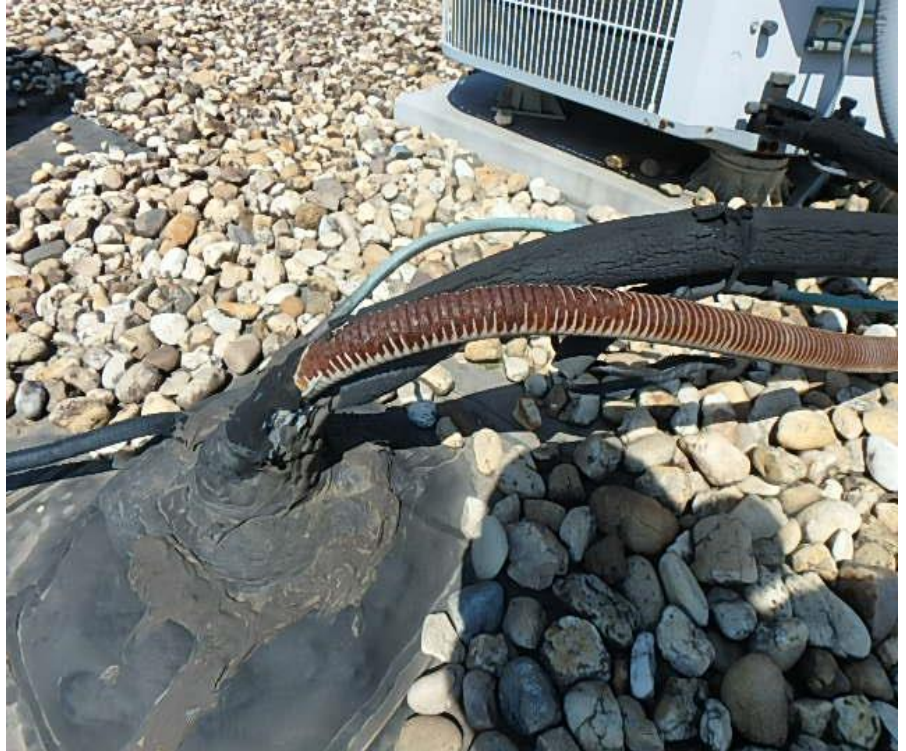
53. Deficiency #9 - Deteriorated
conduit cover

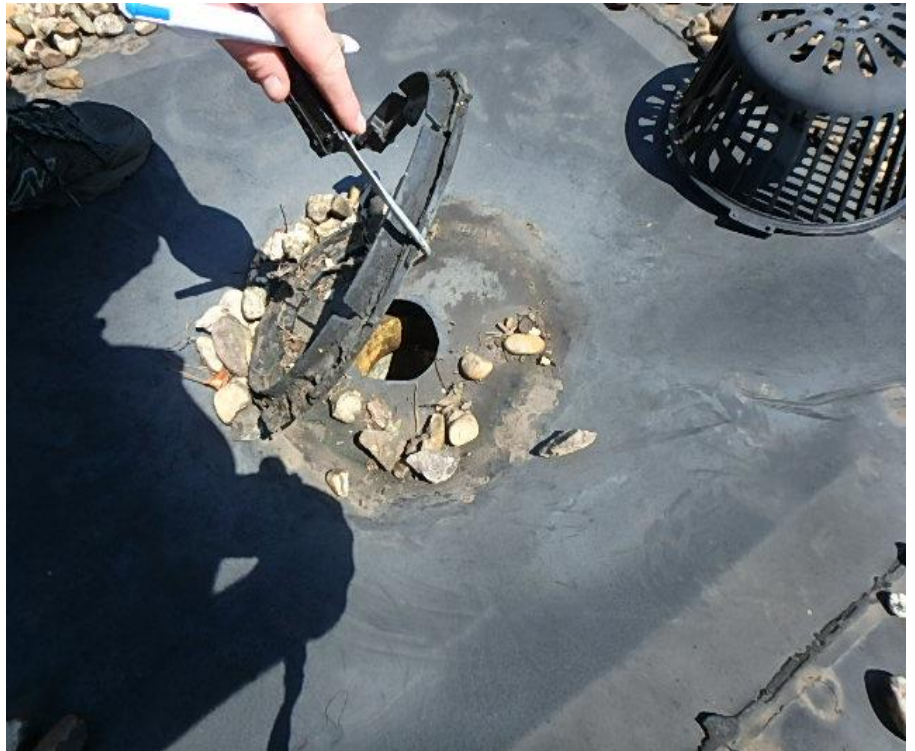
54. Deficiency #10 - Missing drain
bowl clamping ring

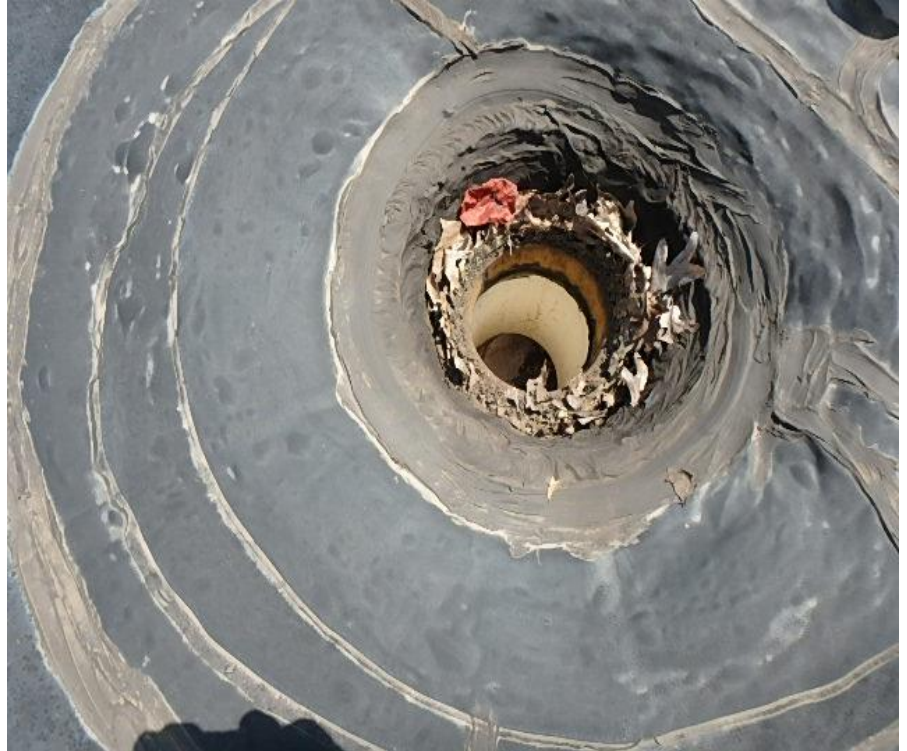
55. Deficiency #10 - Missing drain bowl clamping ring

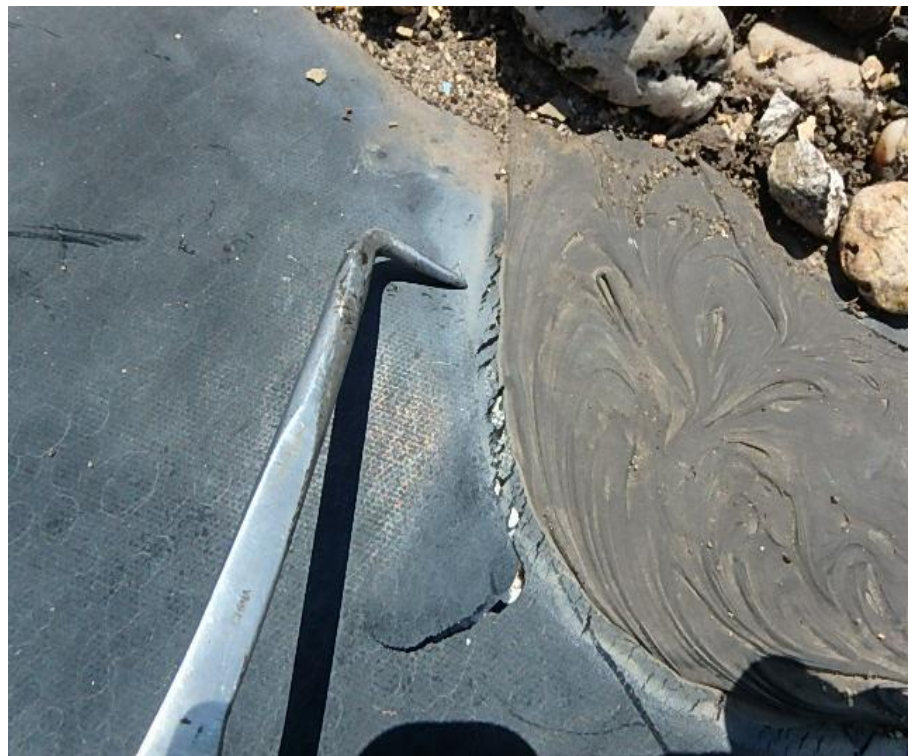
56. Deficiency #11 - Membrane exhibiting various signs of deterioration - cracking & splitting

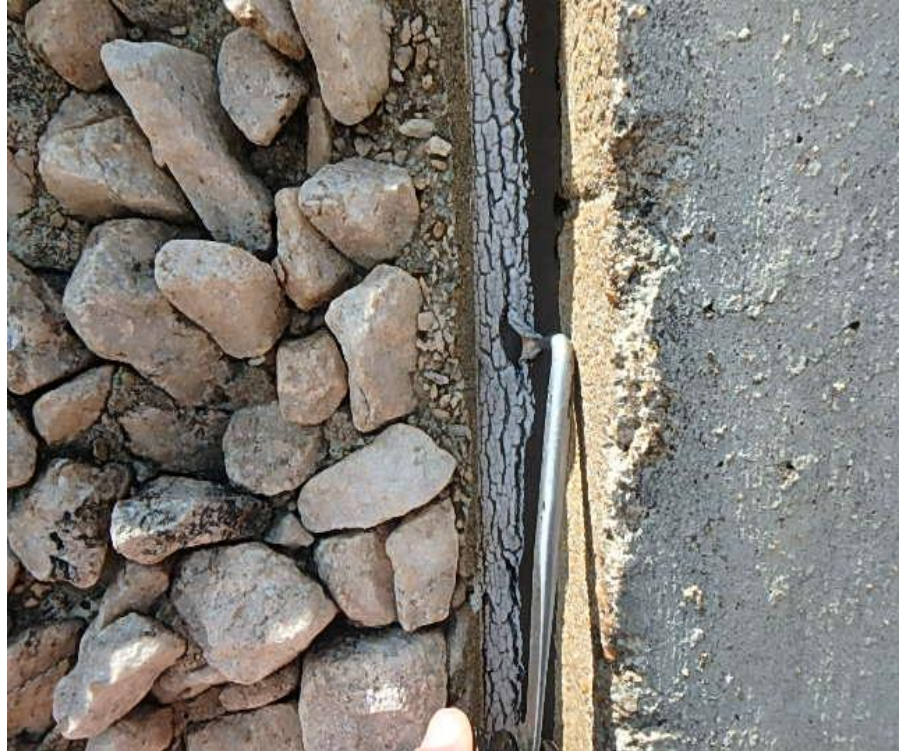
57. Deficiency #12 - Open masonry control joint

Rake joint clean and install new foam backer rod as needed and then reseal joint with industrial grade polyurethane sealant	LnFt		
13	M	Loose termination bar	1	\$50.00	\$50.00
		Remove loose fasteners as required and re-secure with fasteners of sufficient length and diameter to secure termination bar- seal top of bar with industrial grade polyurethane sealant	Location		
14	MN	Dissimilar materials used for repair to EPDM membrane	10		
		Monitor and address at time of roof system replacement or as needed to maintain watertight integrity	Locations

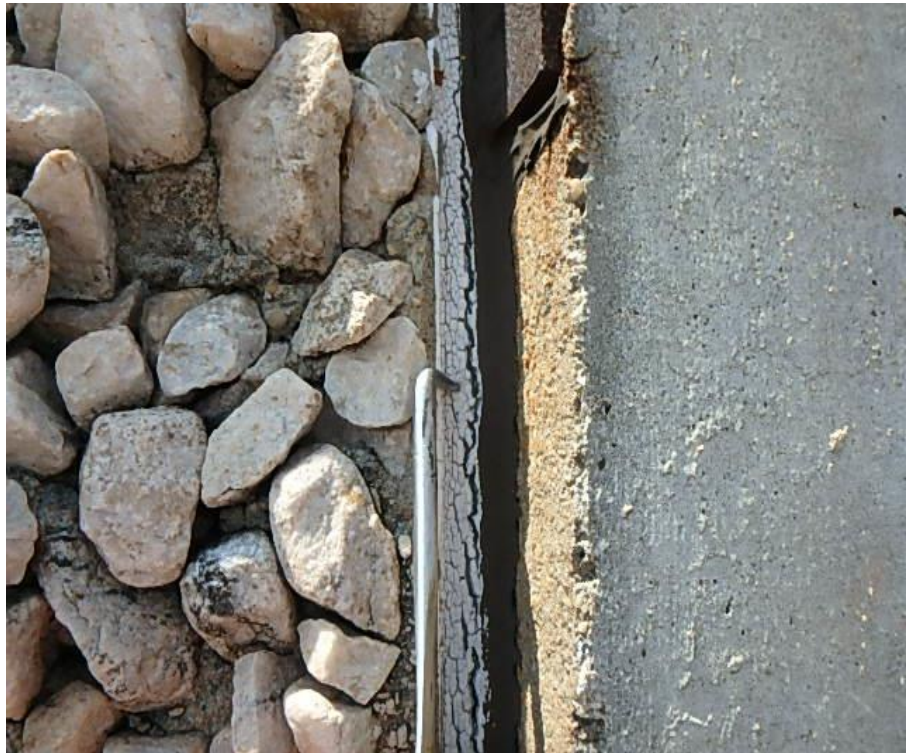
58. Deficiency #12 - Open masonry control joint

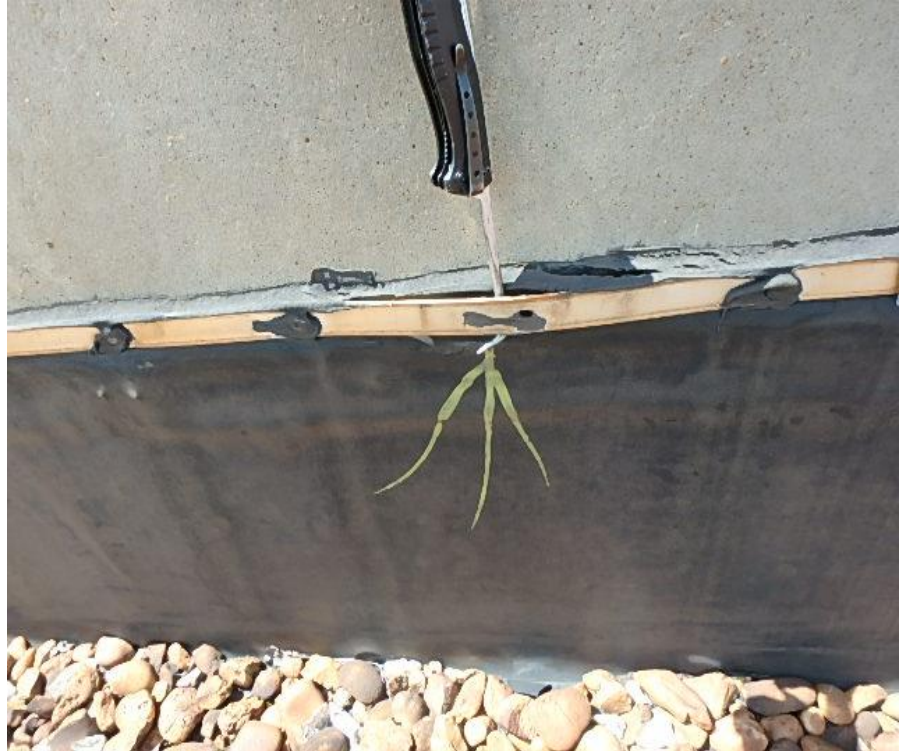
59. Deficiency #13 - Loose termination bar

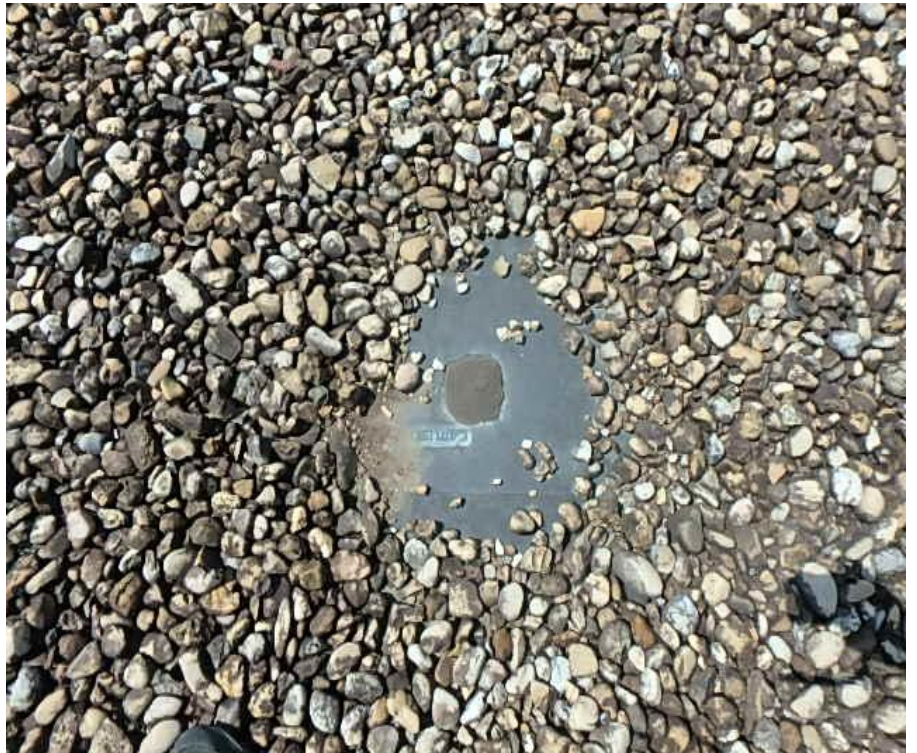
60. Deficiency #14 - Dissimilar materials used for repair to EPDM membrane

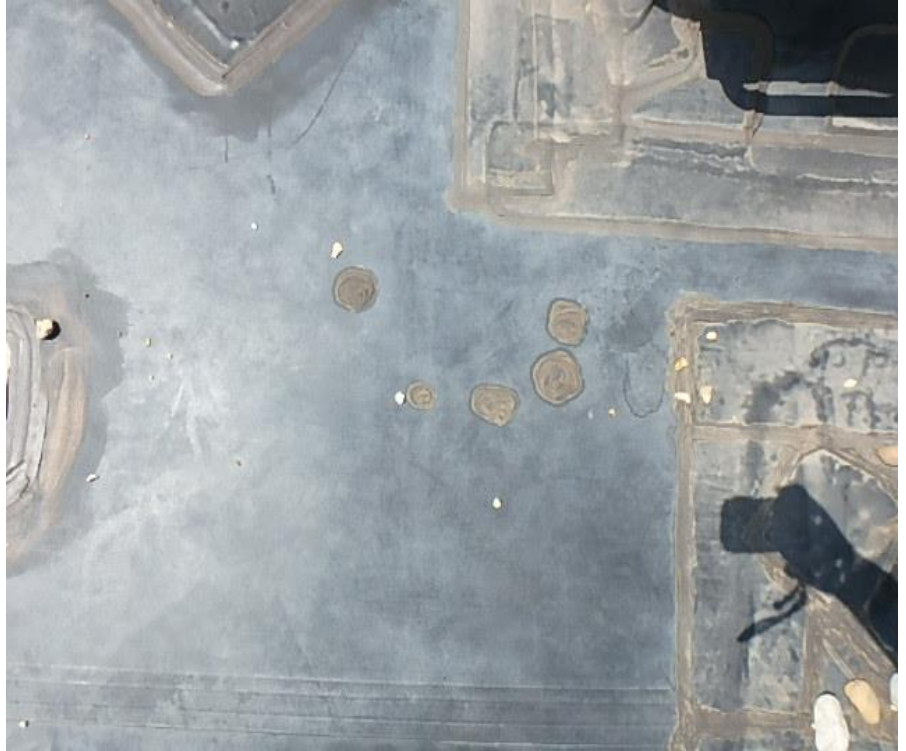
61. Deficiency #14 - Dissimilar materials used for repair to EPDM membrane

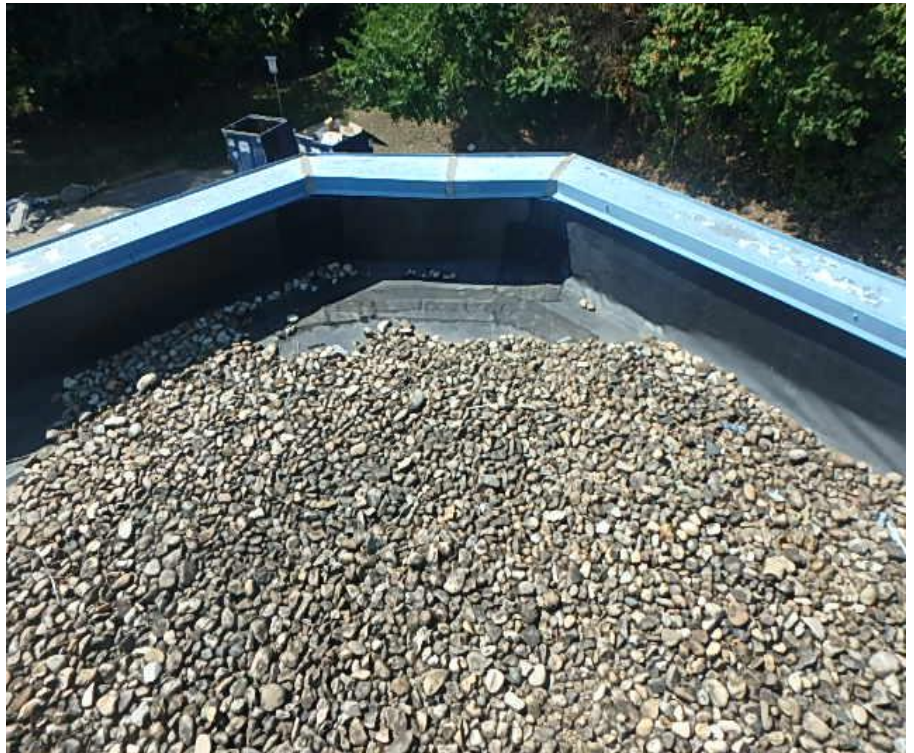
NUMBER	PRIORITY CODE	DEFICIENCY DESCRIPTION	QUANTITY	UNIT PRICE	REPAIR COST
		DEFICIENCY SOLUTION	UNITS		
15	MN	Deteriorating / peeling paint on metal coping	1,549		
		Monitor and address at time of roof system replacement or as needed to maintain watertight integrity	LnFt		
16	M	Missing termination bar	100	\$25.00	\$2,500.00
		At missing location, install termination bar at edge of flashing and fasten 6" o.c. with fasteners appropriate for substrate - seal top edge of termination bar and fastener heads with industrial grade polyurethane sealant	LnFt

62. Deficiency #15 - Deteriorating / peeling paint on metal coping

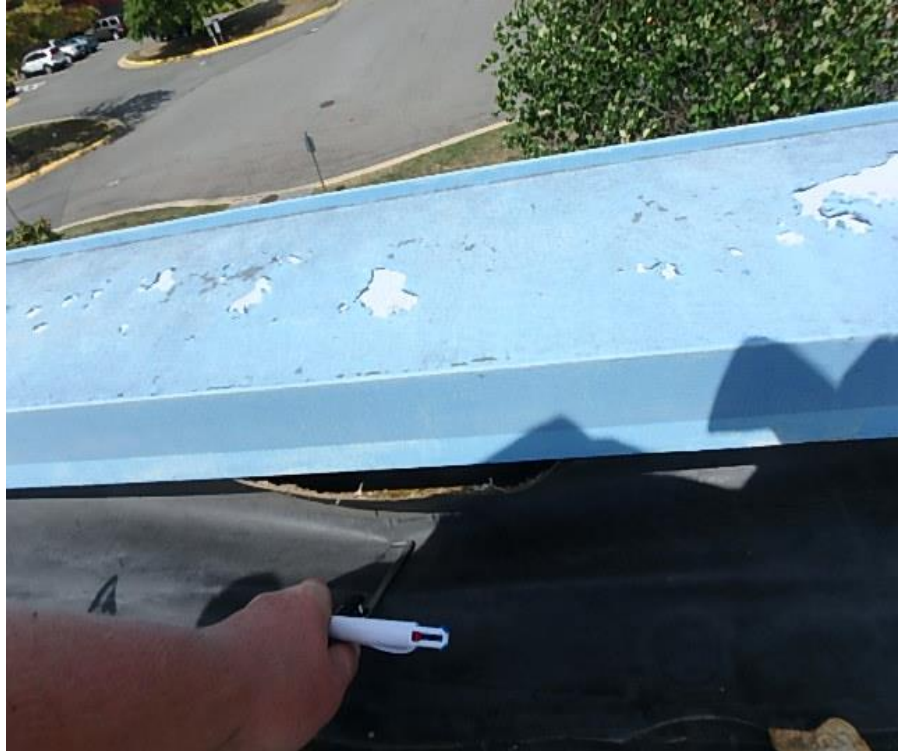
63. Deficiency #15 - Deteriorating / peeling paint on metal coping

Deficiency #16 - Missing termination bar

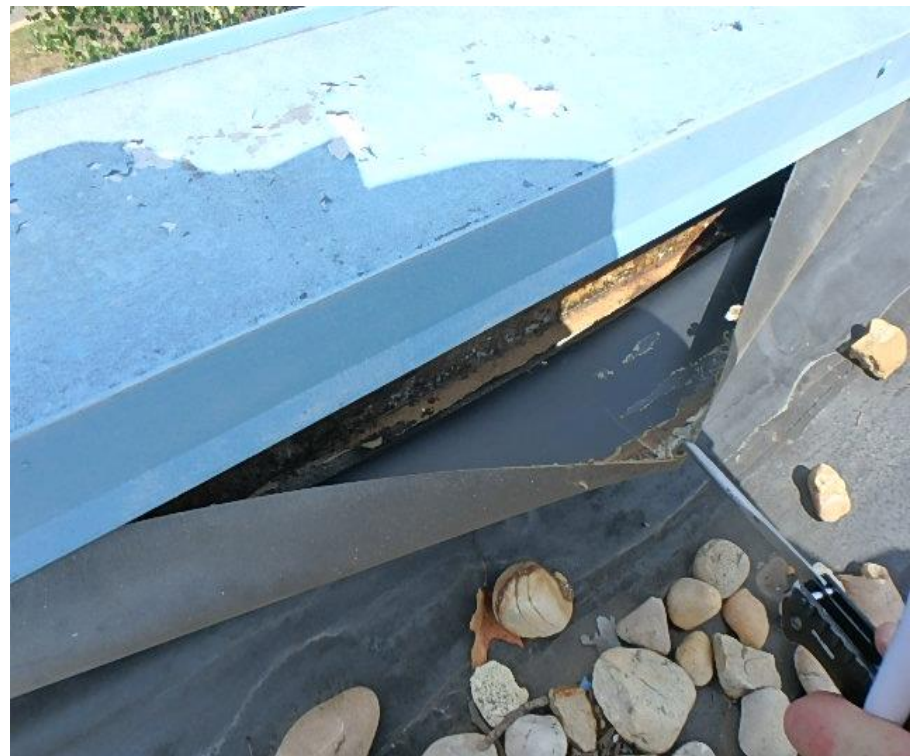
64. Deficiency #16 - Missing termination bar

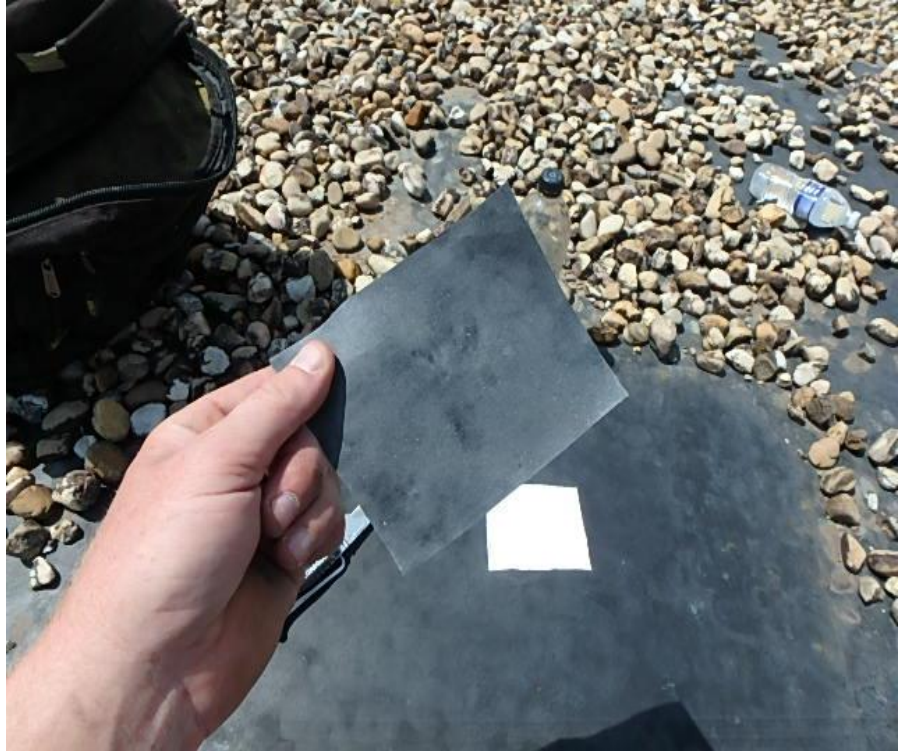
<i>TEST CUT / PROBE NUMBER</i>	1
<i>Test Cut Size</i>	4" x 4"
<i>Troxler Reading</i>	N/A
<i>Infra-red Reading</i>	N/A
<i>Delmhorst Reading</i>	Dry
<i>Deck Condition</i>	Good
<i>Vapor Retarder Condition</i>	N/A
<i>Insulation Condition</i>	Fair
<i>Membrane Condition</i>	Failed

65. View of roof core on Bldg 1 - Area C with roof membrane removed exposing insulation

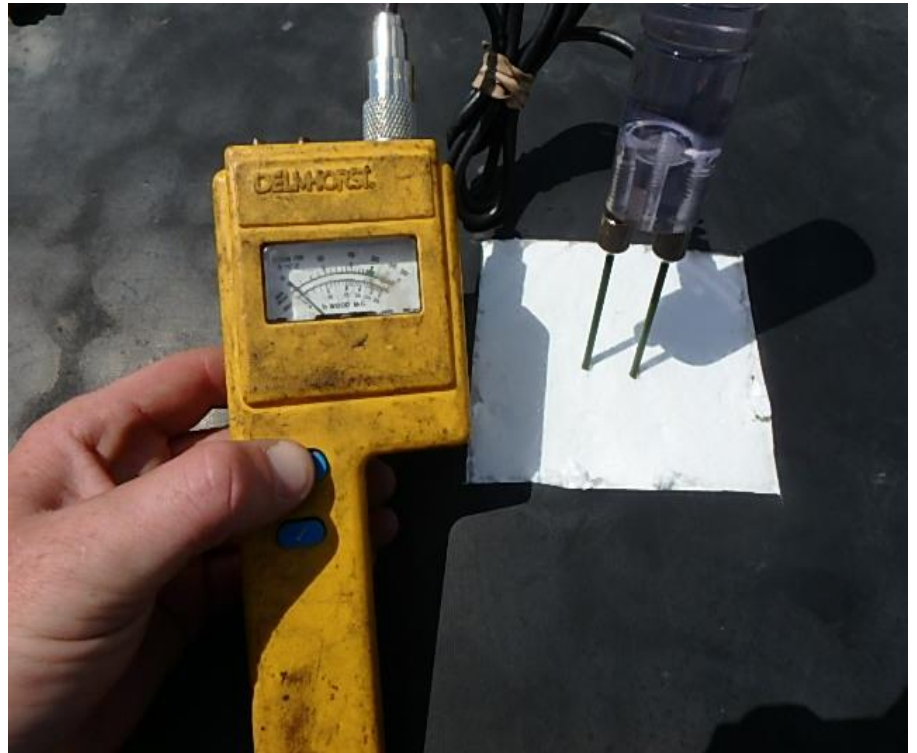
66. Probe #1 - Delmhorst moisture meter reading negative for insulation moisture on Bldg 1 - Area C

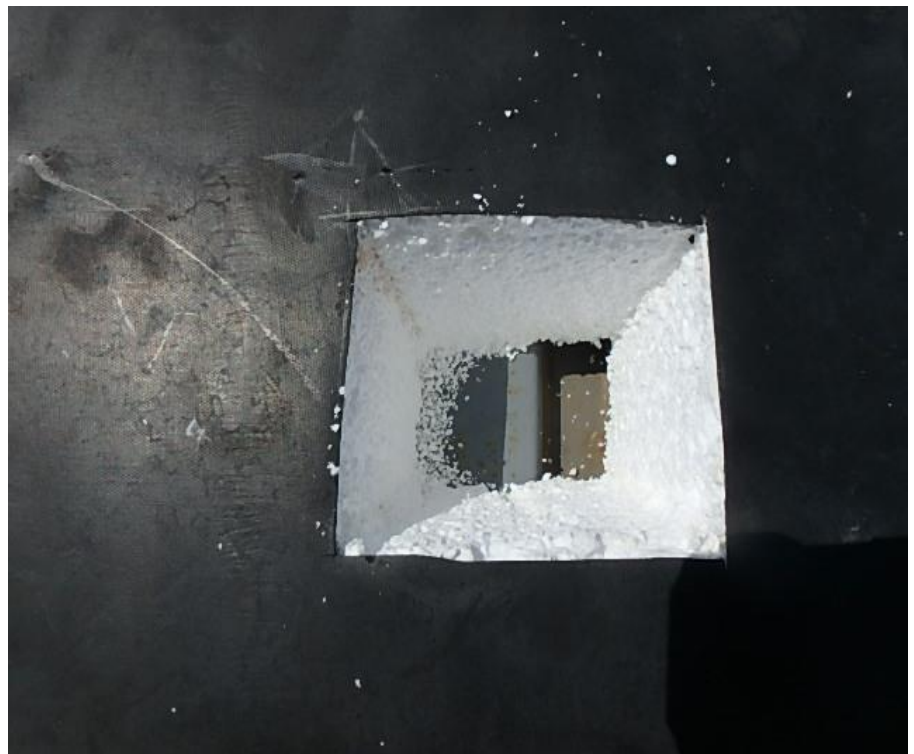
68. View of roof composition removed on Bldg 1 - Area C exposing a painted metal deck
