**Roof Consulting  
Services, Inc.**

Re: Leak Investigation  
Short Pump Middle School  
4701 Pouncey Tract Road  
Glen Allen, VA

# LEAK INVESTIGATION PHOTOGRAPHS

**Project Name: HCPS– Short Pump Middle School – Leak Investigation**

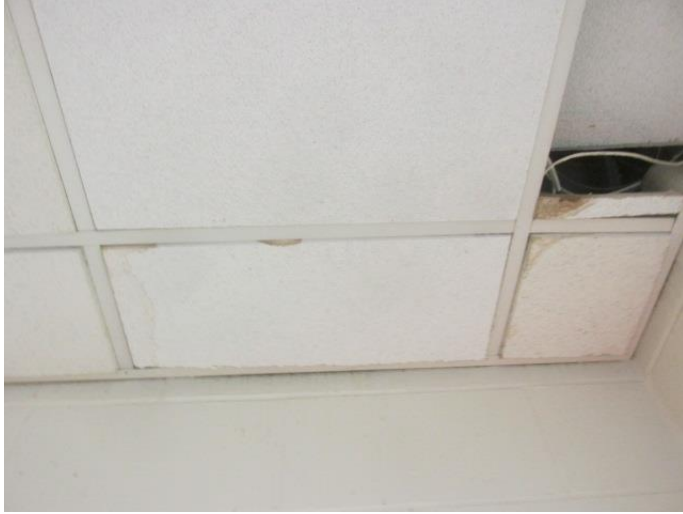
RCS contact, Susan Moore, reported one on-going individual leak near the South entrance at Roof Area "F". While viewing the interior space, water damage was observed on interior walls and interior ceiling.

**Interior view of reported leak area. Water staining visible on interior ceiling**

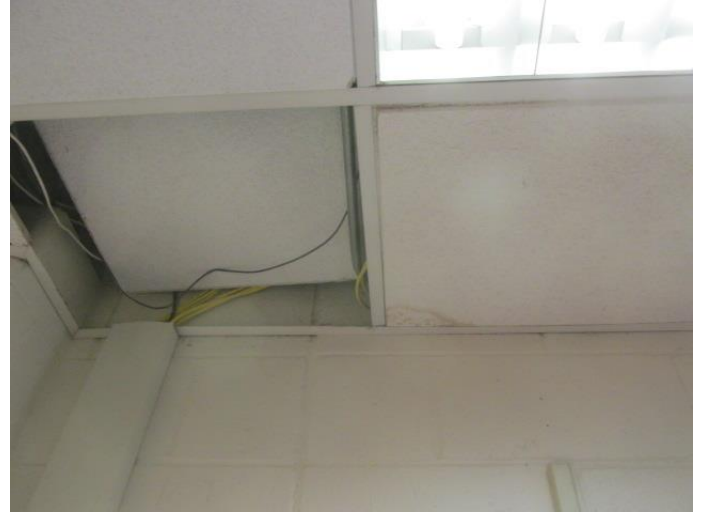
**Interior view of reported leak area. Water staining visible on interior ceiling**

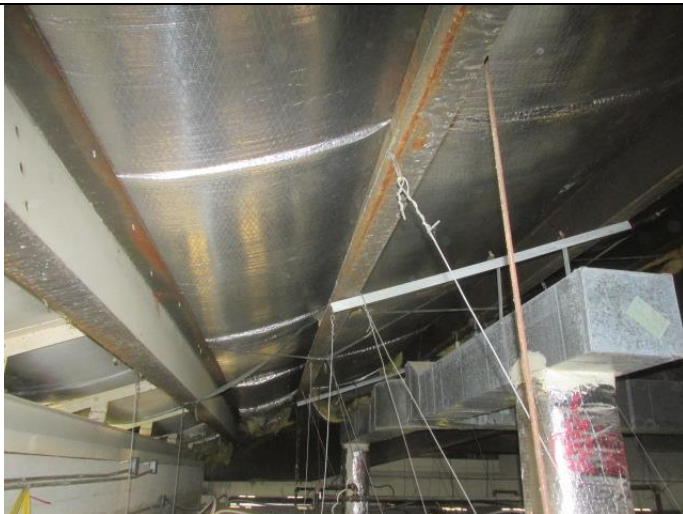
**Interior view of reported leak area**

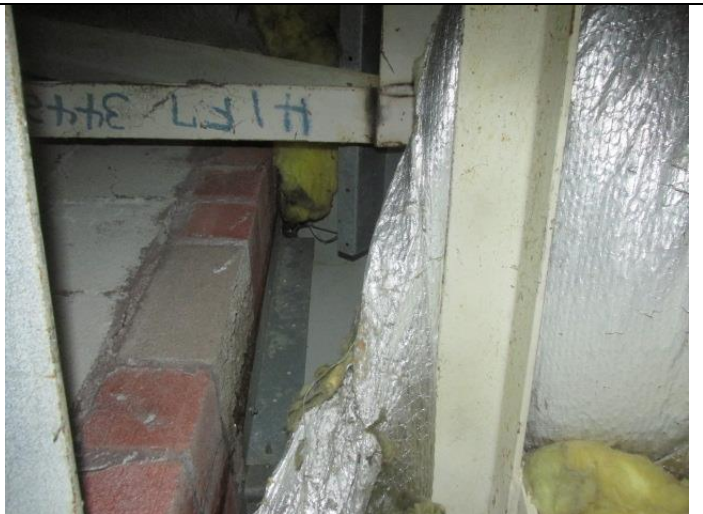
**Interior view of reported leak area**

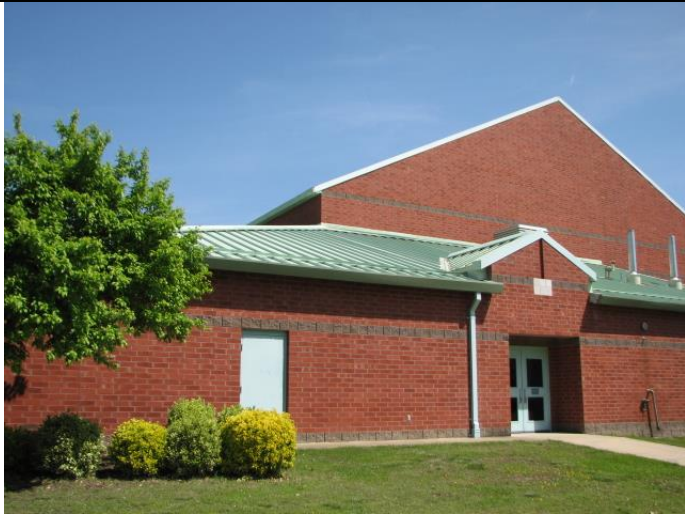
**Overview of the leak area at Roof Area "F".**

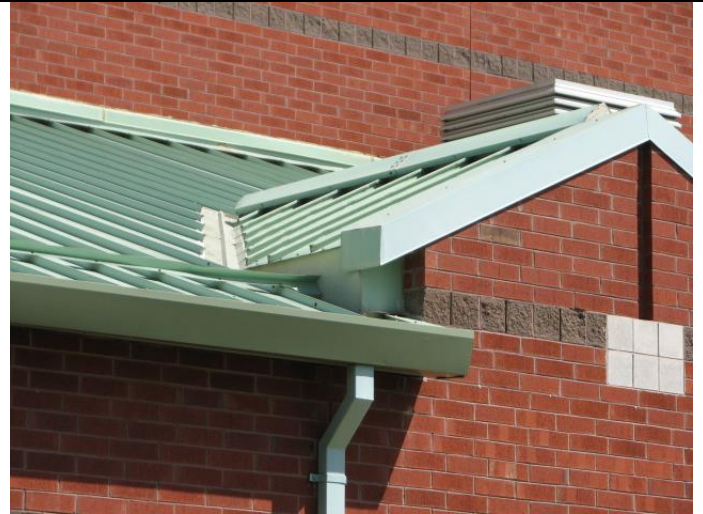
**Overview of the leak area at Roof Area "F"**

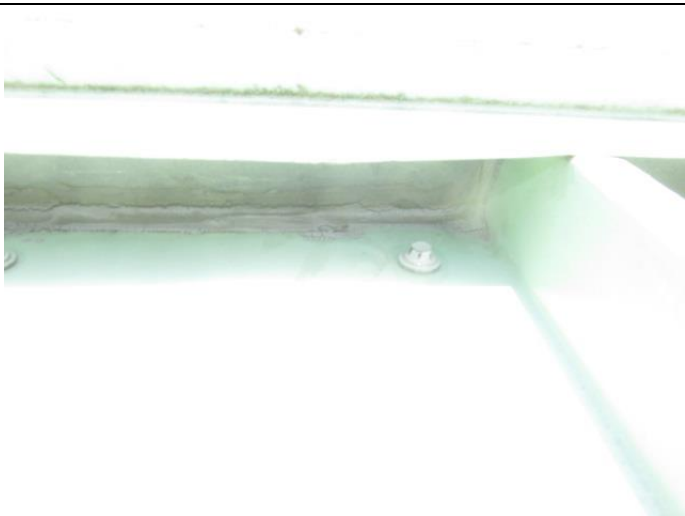
During the water test our inspector identified the source of the leak at the ridge / rake intersection, directly upslope from the interior damage. The leak was then allowed to subside and produced a second time for verification purposes. After close inspection of the ridge / rake intersection it was determined the metal panel along the rake edge was installed, apparently during original construction, short of the ridge resulting in an open condition.

**Close up view of the identified leak source**

Remove ridge cap, rake edge, Z-closures and all related deteriorated or loose sealants.

Fabricate and install a panel extension to counter flash the existing panel. Fabricate and install new Z-closures for the ridge cap / rake edge intersection to properly seal the roof assembly detailing. Re-install the rake edge and ridge cap. Fabricate and install an end closure to terminate the ridge cap to the rake edge providing a water tight seal.

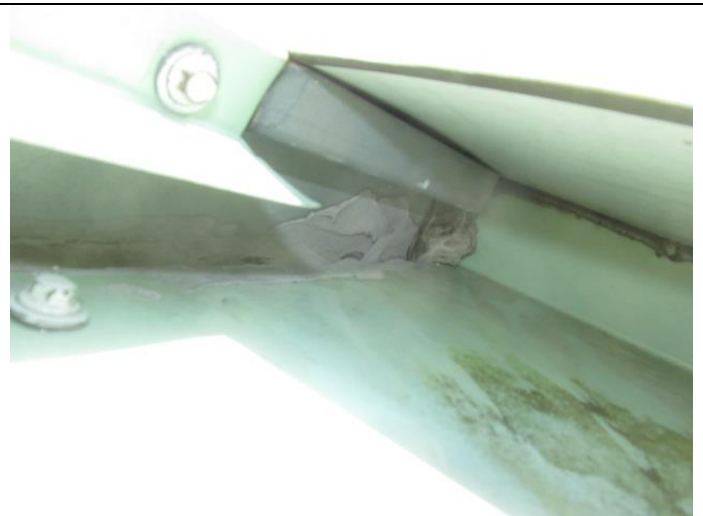
1. Open Condition at ridge
2. Open Condition at rake edge

**Close up view identifying the poor detailing at the roof panel / ridge cap / rake edge**
