Bon Air Fire Department Company #4

**2600 Polo Parkway
Midlothian, VA**

11/7/2017

Roof System Condition Evaluation Report

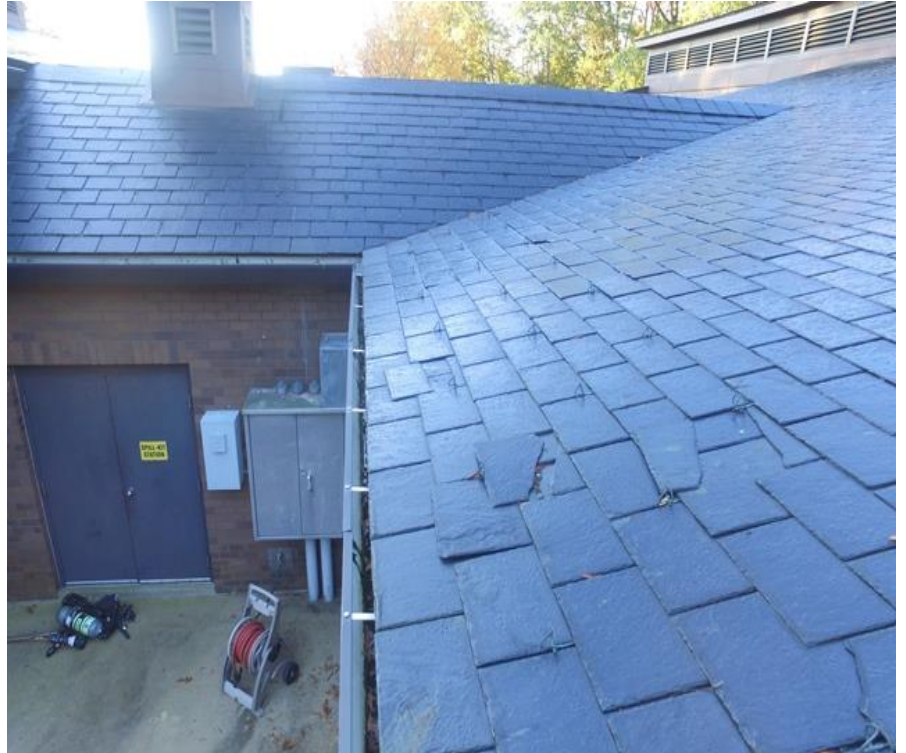
NUMBER	PRIORITY CODE	DEFICIENCY DESCRIPTION	QUANTITY	UNIT PRICE	REPAIR COST
		DEFICIENCY SOLUTION	UNITS		
1	M	Missing / damaged slate tiles	23	\$100.00	\$2,300.00
		Remove damaged slate tiles and install new slates to match existing type, size, thickness and length, secured to substrate with copper slate bibs	Each		
2	M	Debris on roof surface	1	\$25.00	\$25.00
		Remove and properly dispose of all debris	Location		
3	M	Debris in gutter	5	\$50.00	\$250.00
		Remove and properly dispose of all debris to provide positive drainage from gutter to downspouts	Locations		
4	M	Vegetative growth (mold) on roof surface	1	\$100.00	\$100.00
		Staining on the roof surface is directly related to the Northern exposure of the installed roofing. Remove and properly dispose of all vegetative growth with commercial grade soap and bristle brush. Rinse clean.	Location		
5	M	Tree limbs / branches overhanging roof surface	3	\$100.00	\$300.00

27. Deficiency #1 - Missing /
damaged slate tiles

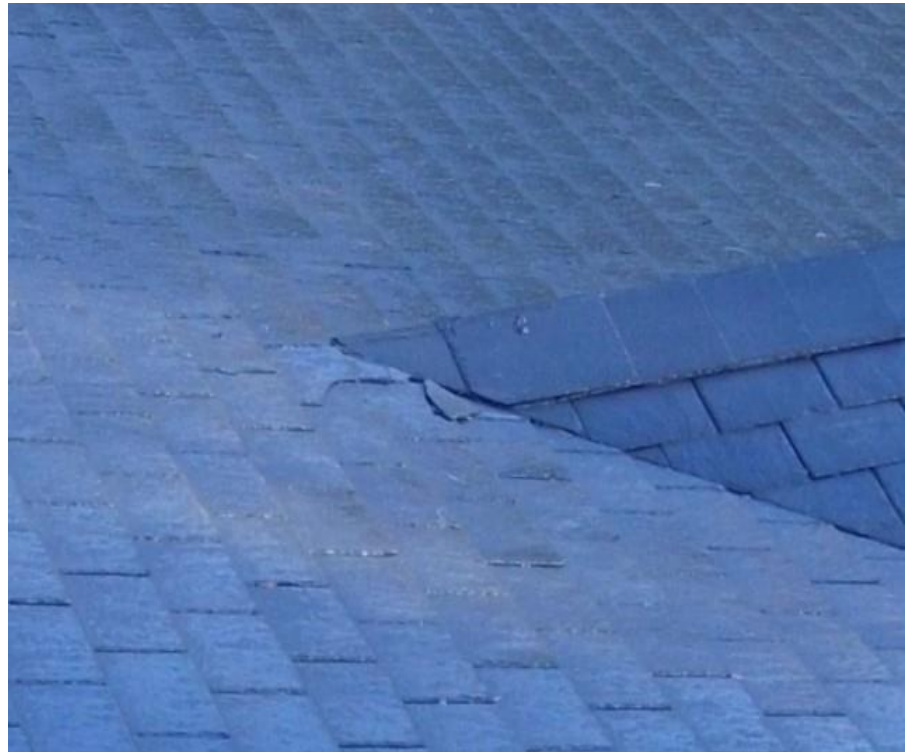
28. Deficiency #1 - Missing /
damaged slate tiles

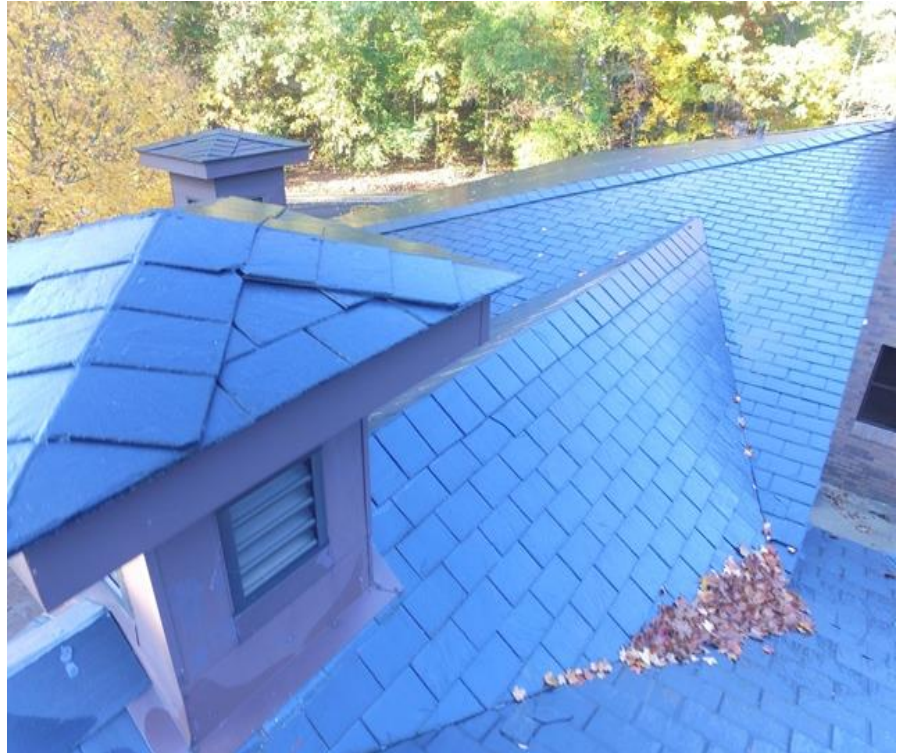
29. Deficiency #2 - Debris on roof surface

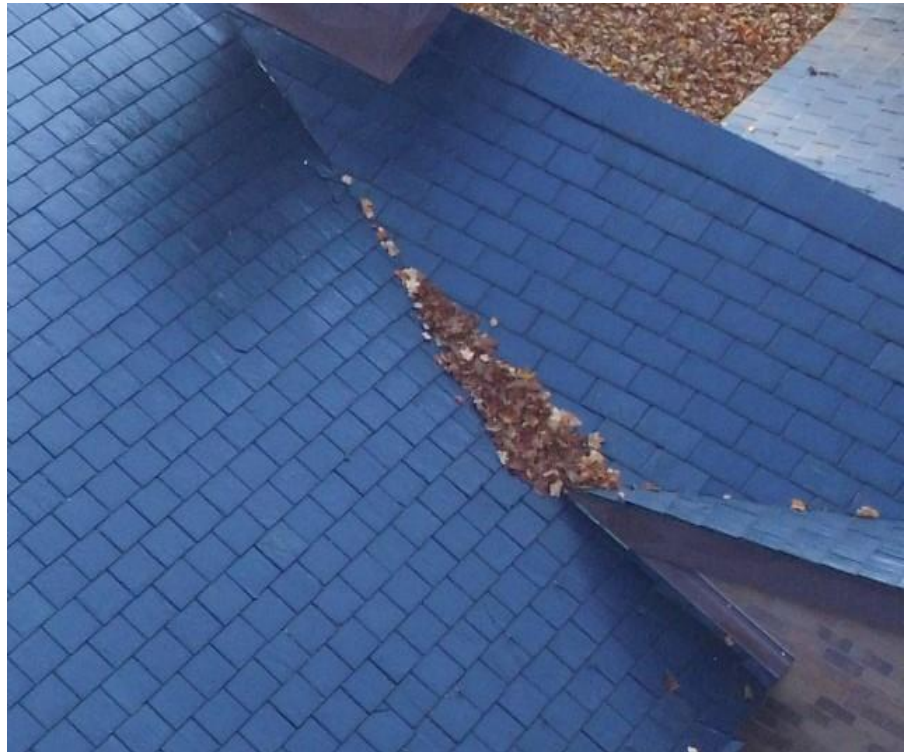
30. Deficiency #2 - Debris on roof surface

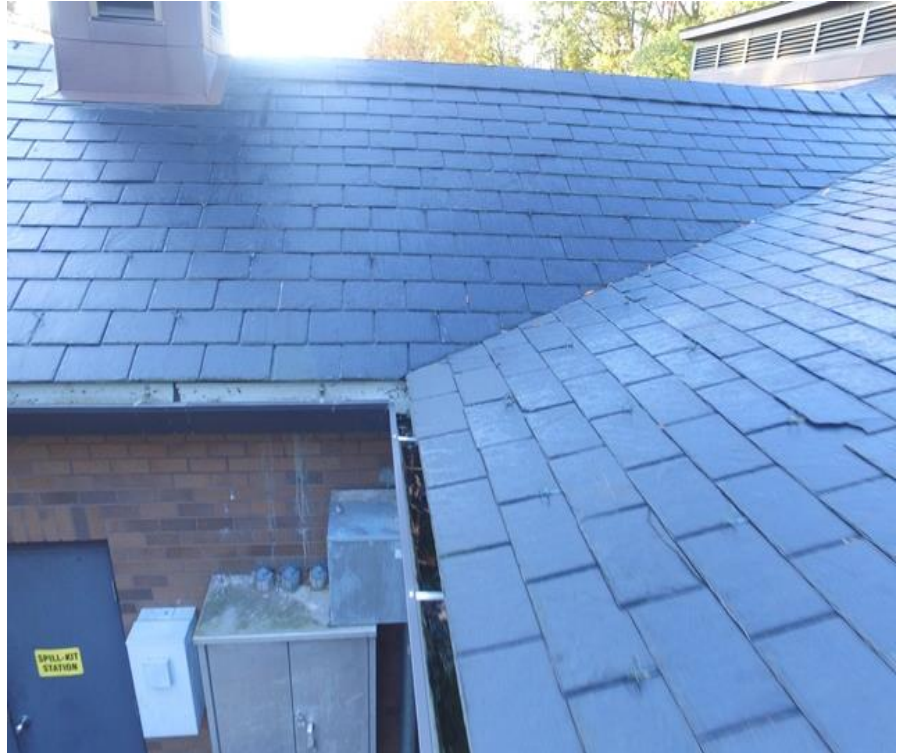
31. Deficiency #3 - Debris in gutter

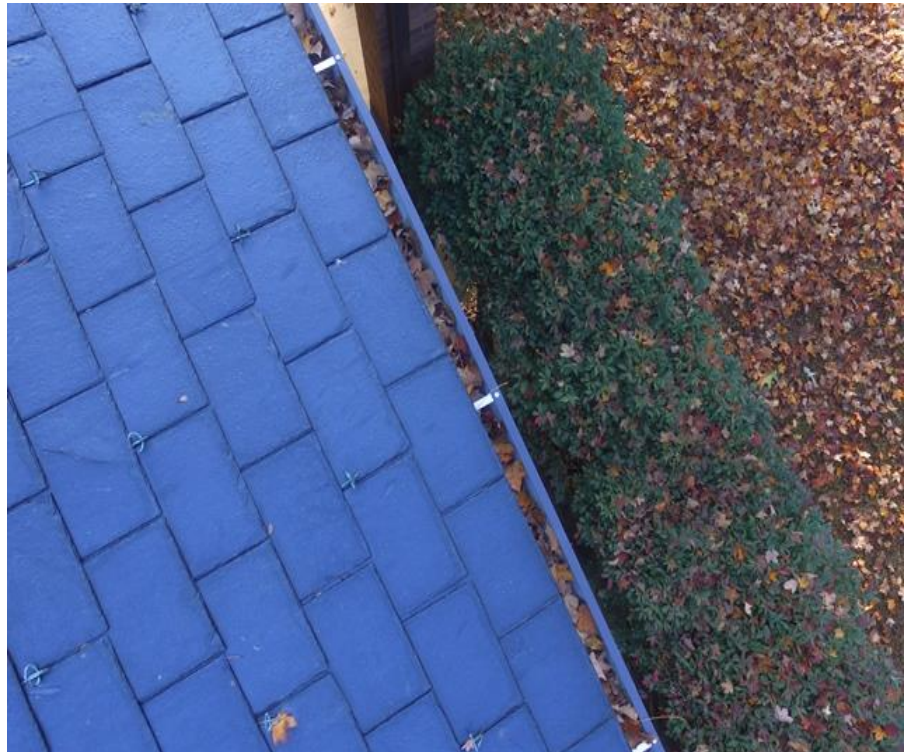
32. Deficiency #3 - Debris in gutter

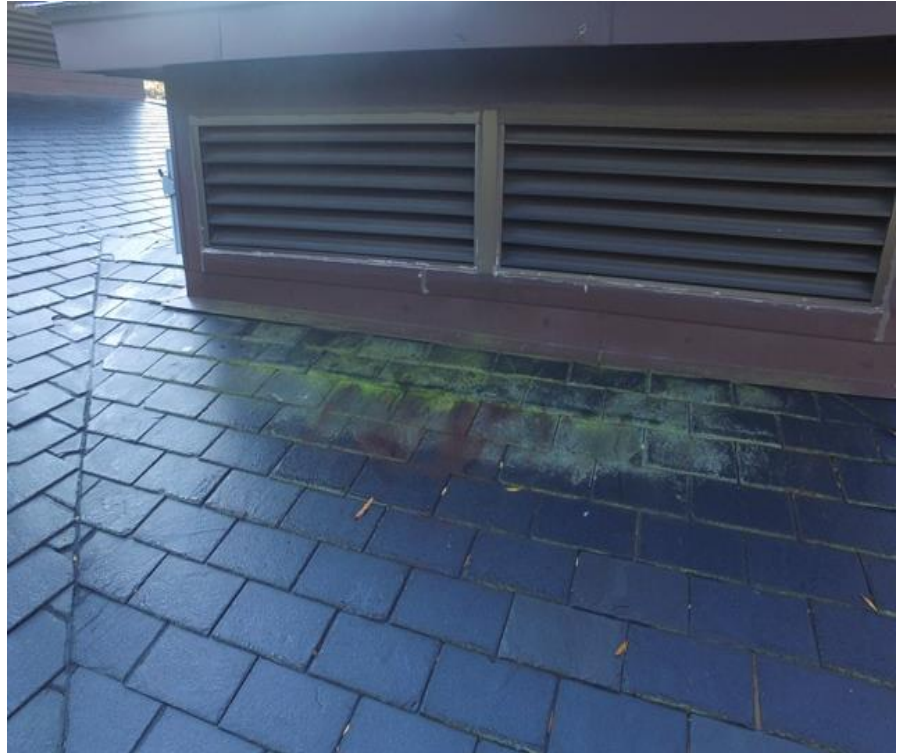
33. Deficiency #4 - Vegetative growth (mold) on roof surface

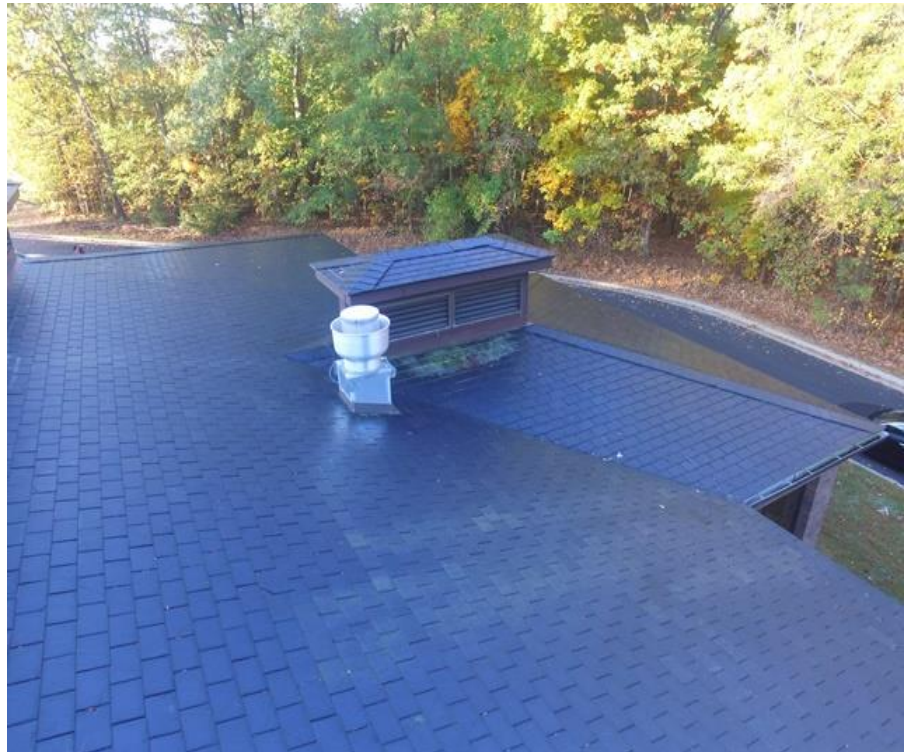
34. Deficiency #4 - Vegetative growth (mold) on roof surface

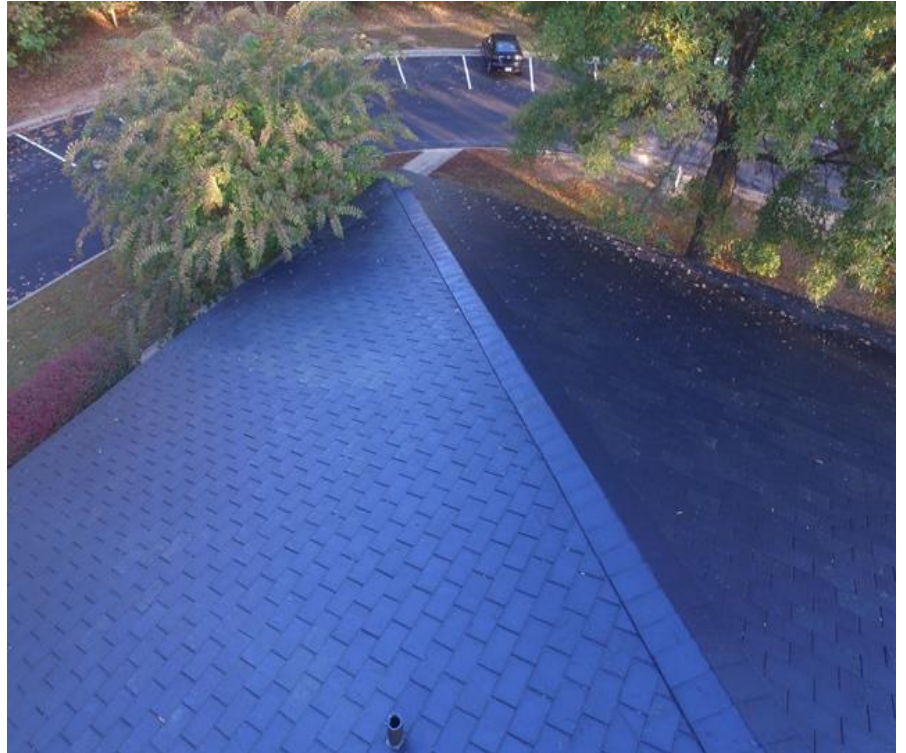
**35. Deficiency #5 - Tree limbs /
branches overhanging roof surface**

Contact a local tree service to have the overhanging limbs to prevent prevent damage to roof surface and reduce organic debris accumulation	Locations		
6	M	Loose slate tiles	2	\$100.00	\$200.00
		Re-install tiles to prevent them from sliding off roof and to provide a watertight condition	Locations

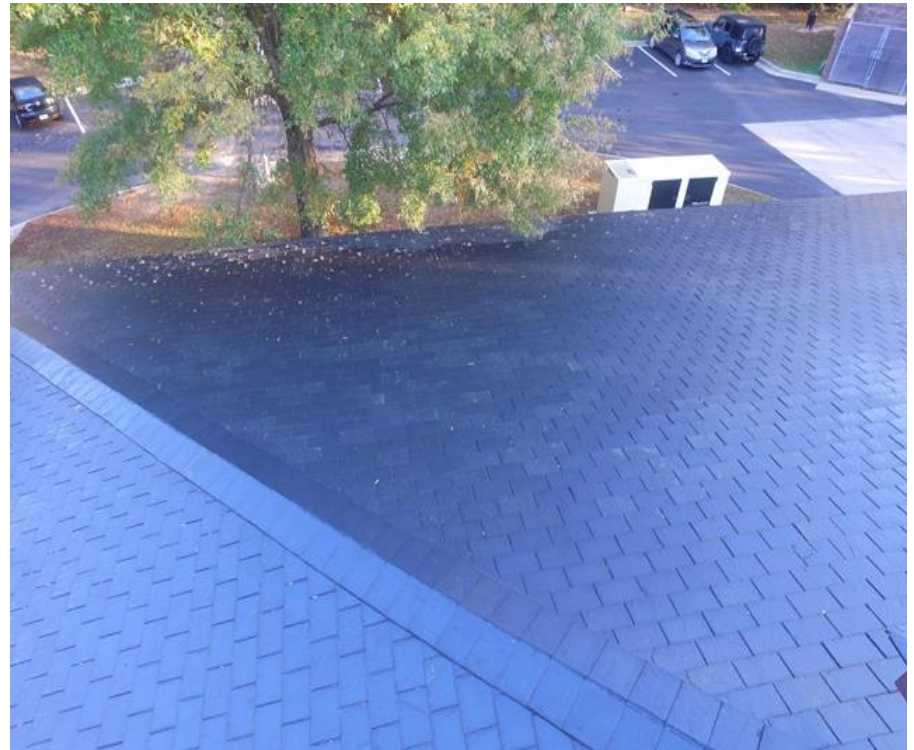
**36. Deficiency #5 - Tree limbs /
branches overhanging roof surface**

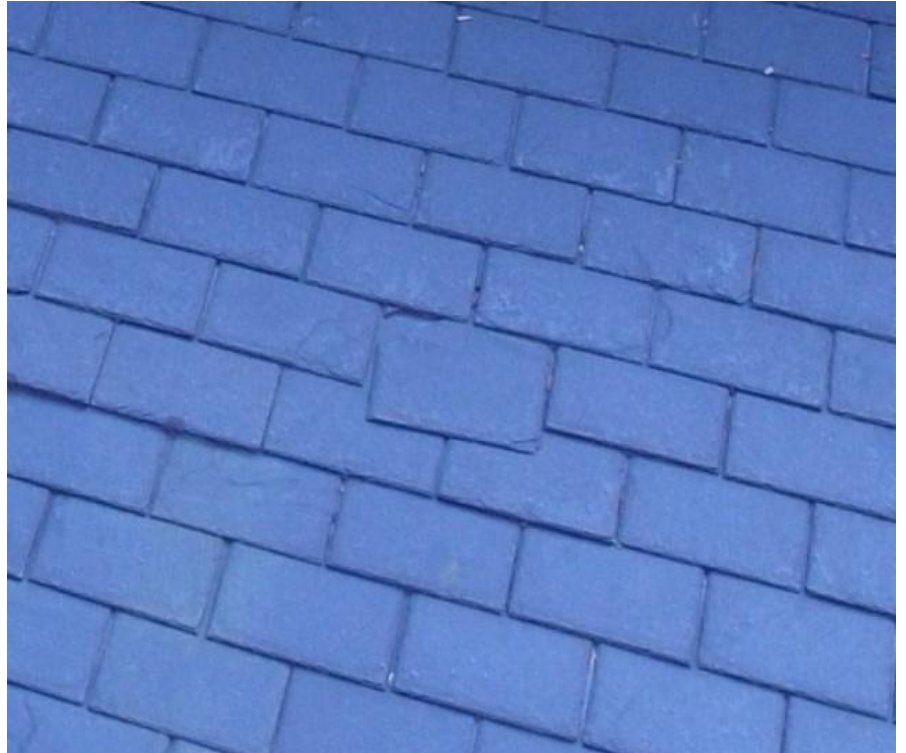
37. Deficiency #6 - Loose slate tiles

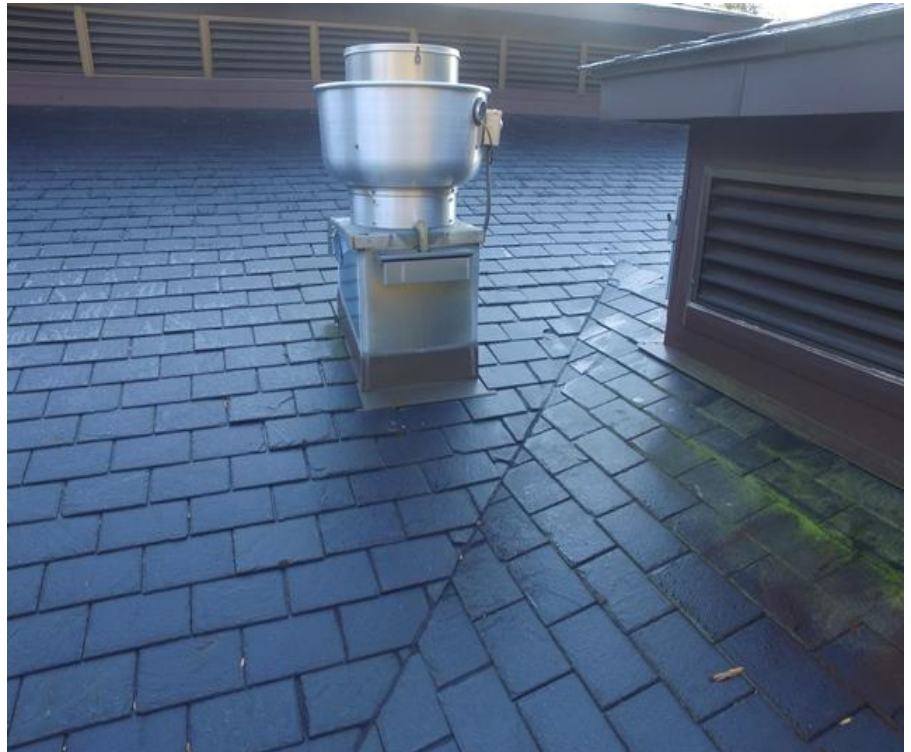
NUMBER	PRIORITY CODE	DEFICIENCY DESCRIPTION	QUANTITY	UNIT PRICE	REPAIR COST
		DEFICIENCY SOLUTION	UNITS		
7	M	Improper flashing detail at exhaust unit	1	\$250.00	\$250.00
		Due to the unit being flashed with metal flashing, the expanding and contracting of the metals has caused the sealants to deteriorate and open. It is our recommendation that an adhered membrane be installed as though this was a low slope detail penetrating the primary membrane. Flashing over the existing base metal and terminate at the top of the exhaust unit. The top can be terminated using over sized backer-rod to prevent the need for fasteners (similar to a typical roof hatch detail).	Location

38. Deficiency #7 - Improper flashing detail at exhaust unit

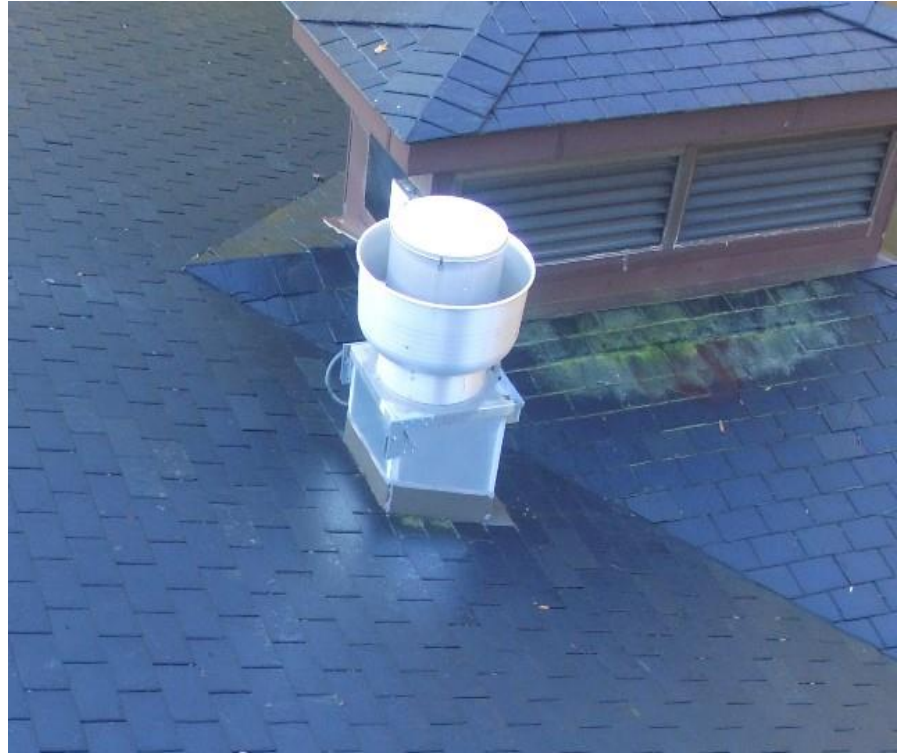
39. Deficiency #7 - Improper flashing detail at exhaust unit
