## **Domino Sugar Refinery**

# **Domino Sugar Facility**

**7412 N. Peters Street  
Arabi, LA**

**9/3/2022**

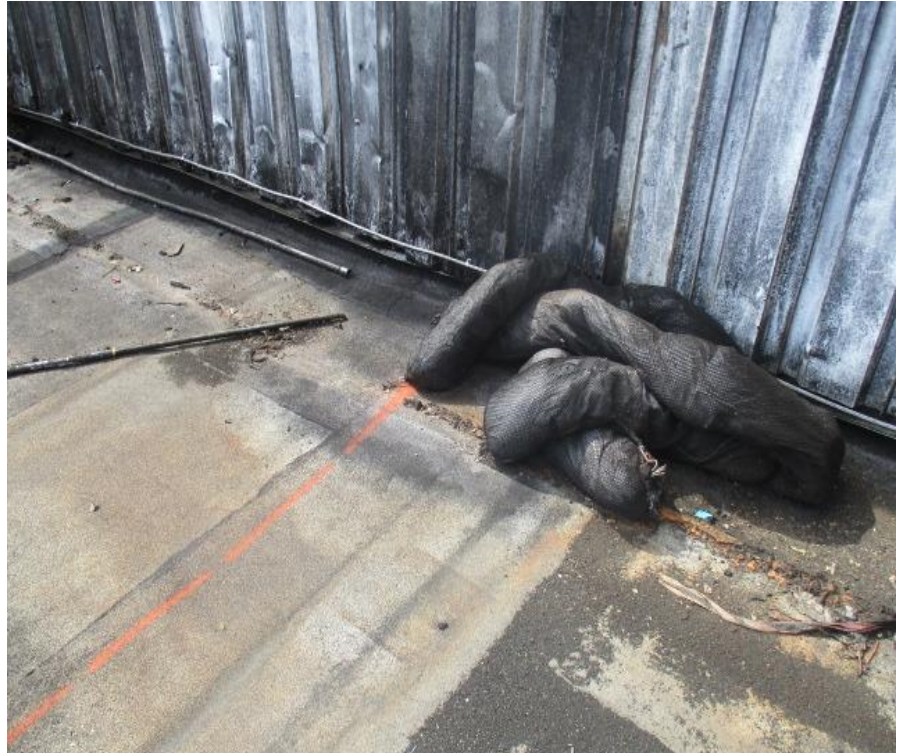
Roof Area - Bldg 8 - Area A

37. Deficiency #2 - Debris on roof surface

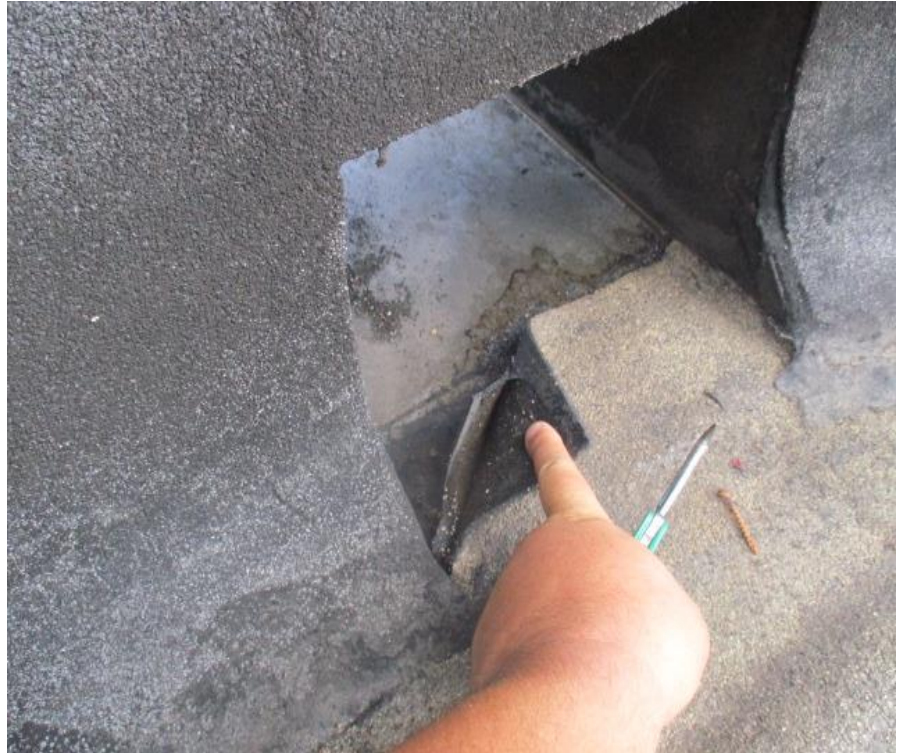
Roof Area - Bldg 8 - Area A

39. Deficiency #3 - Open flashing

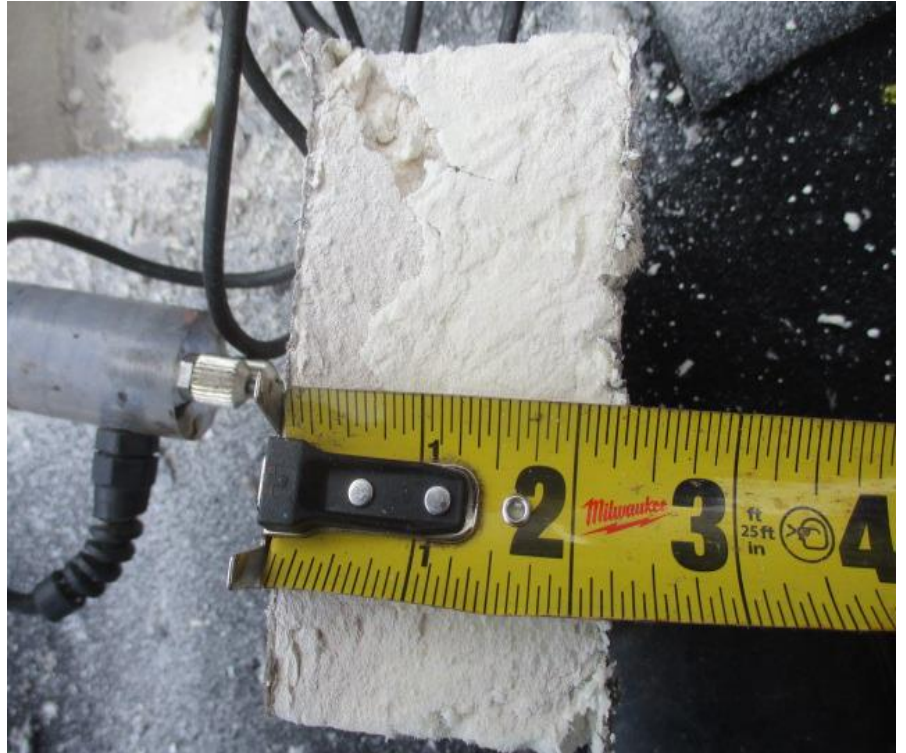
49. Test Cut #1 (Area A): View of roof insulation measurement

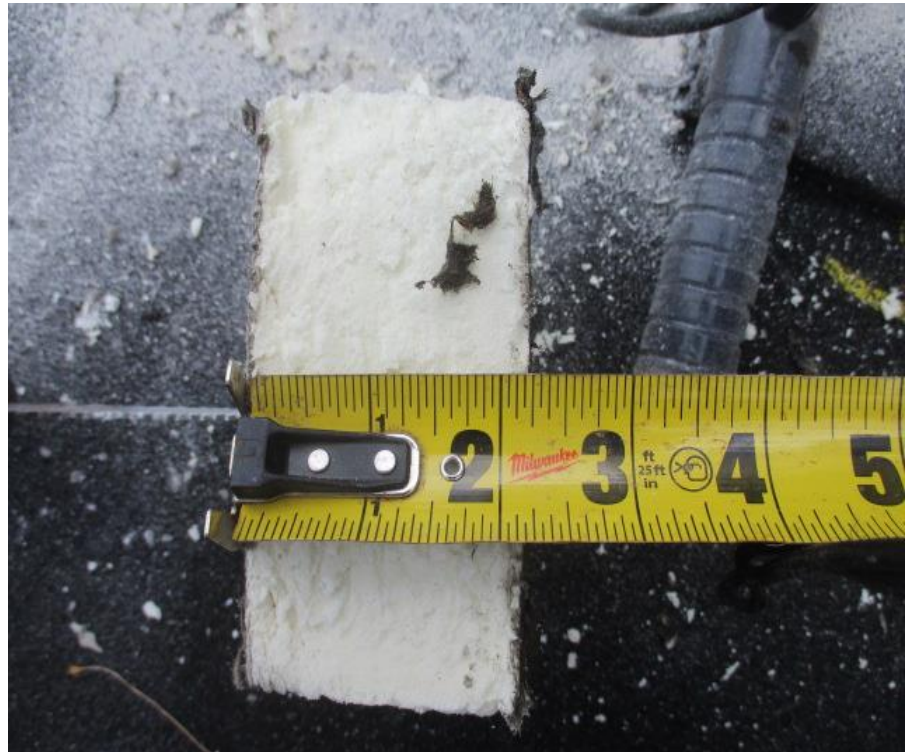
50. Test Cut #1 (Area A): View of roof insulation measurement

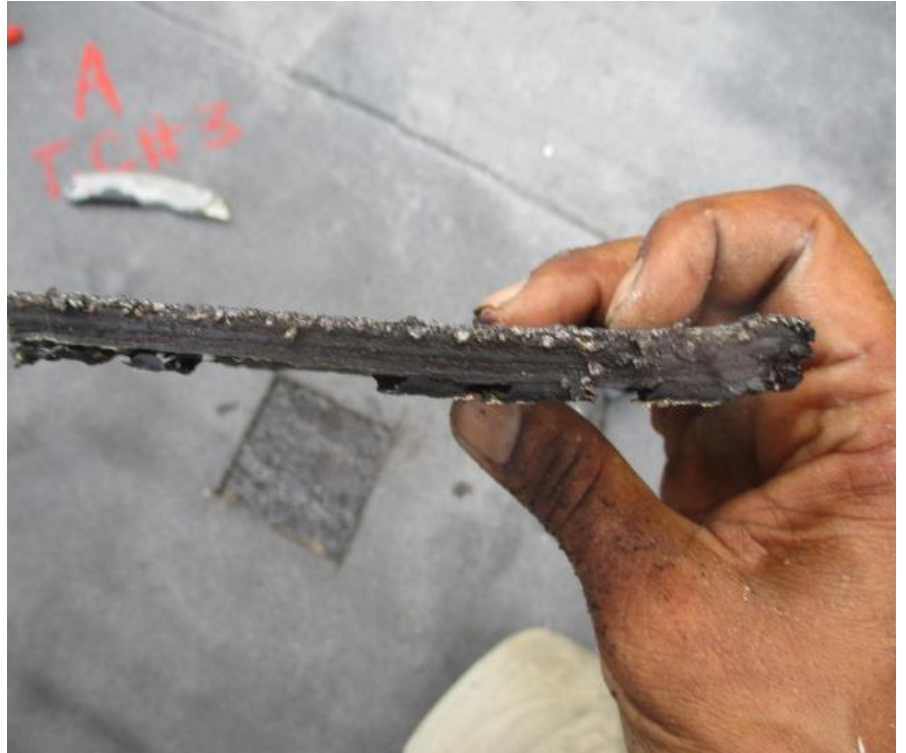
57. Test Cut #3 (Area A): View of modified bitumen plies

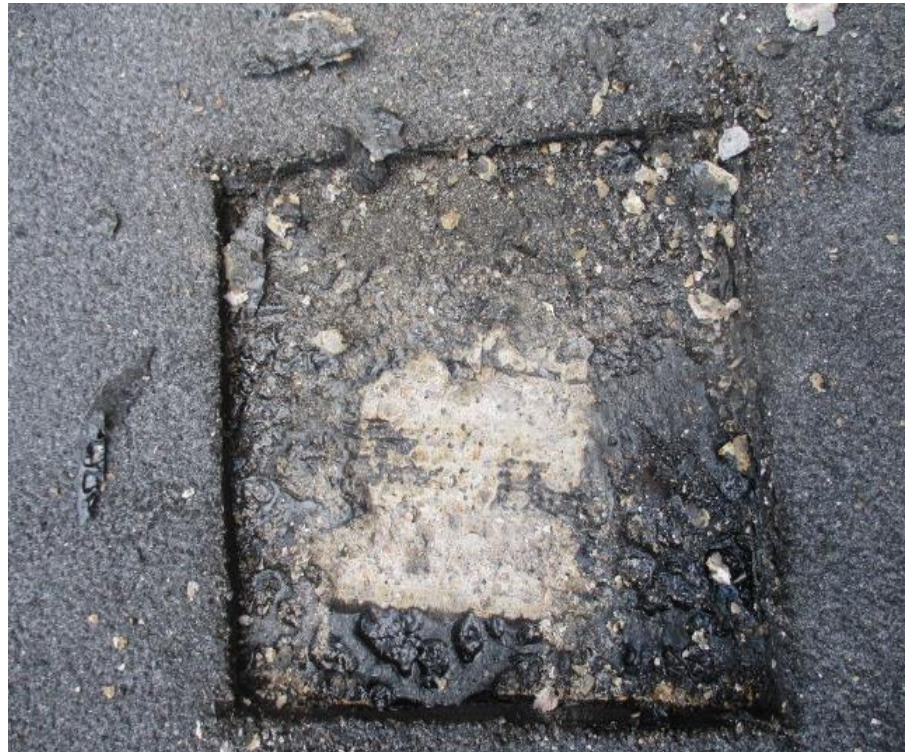
58. Test Cut #3 (Area A): View of roof composition removed exposing a pre-cast concrete tee roof deck

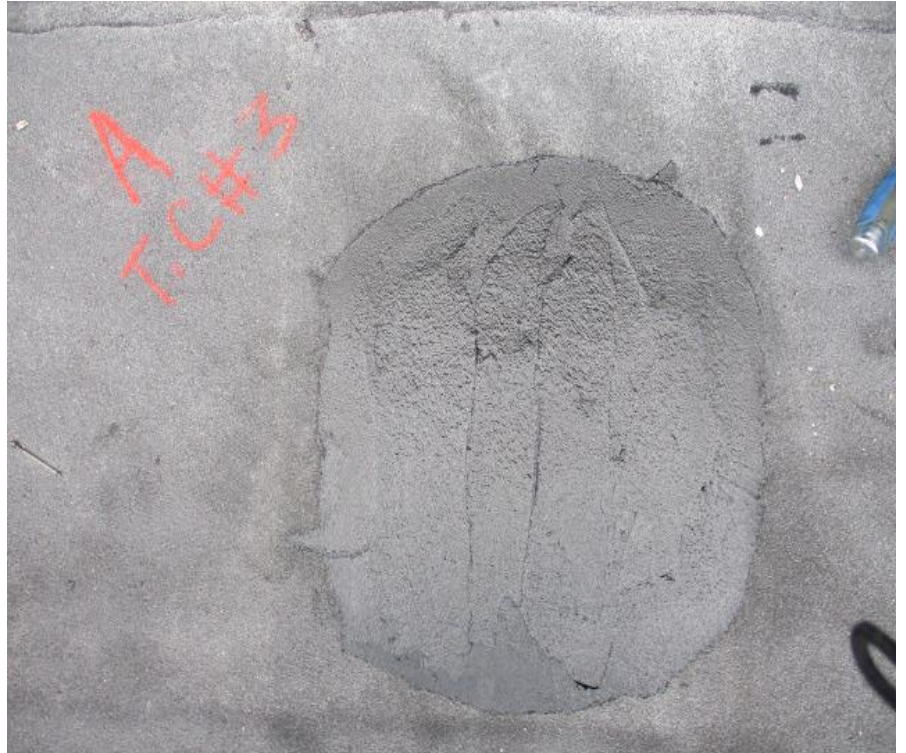
59. Test Cut #3 (Area A): View of  
RCS repair

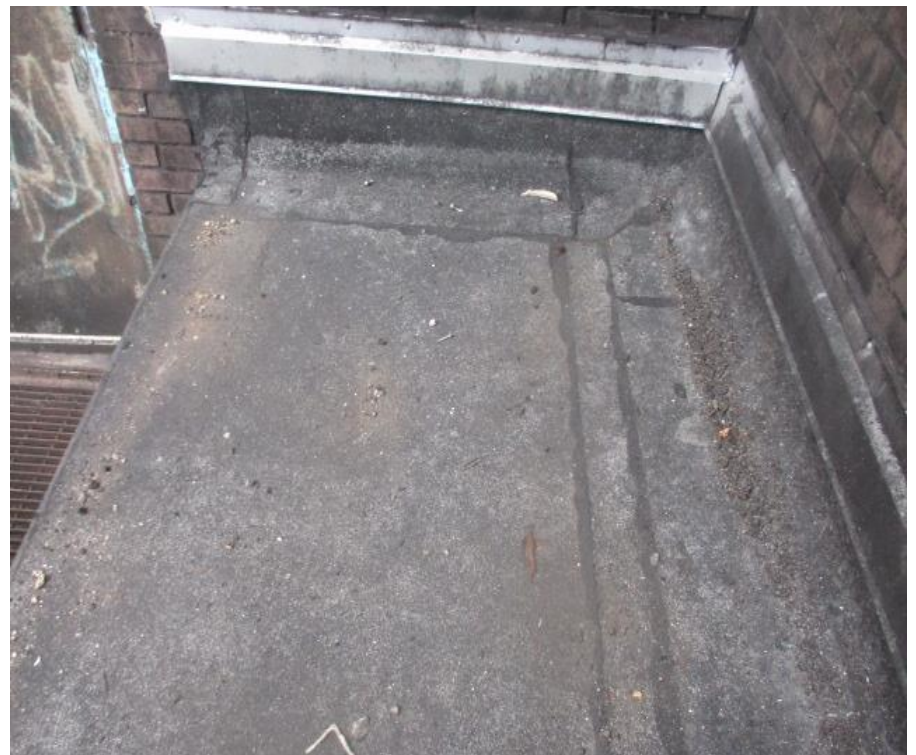
10. Bldg 8 - Area E1 roof system overview

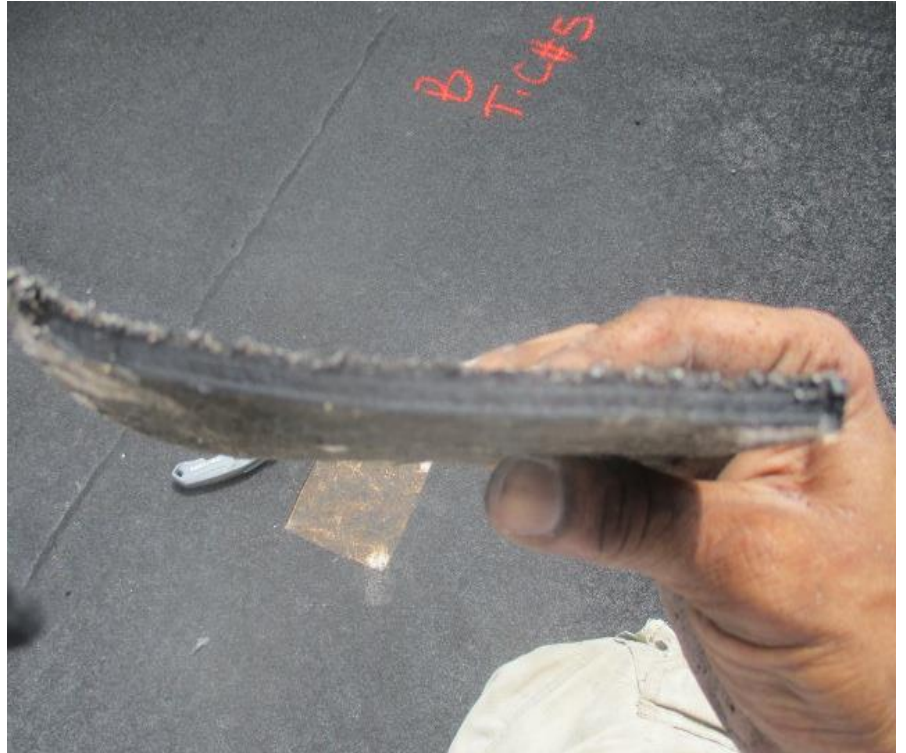
15. Test Cut #5 (Area B): View of modified bitumen plies

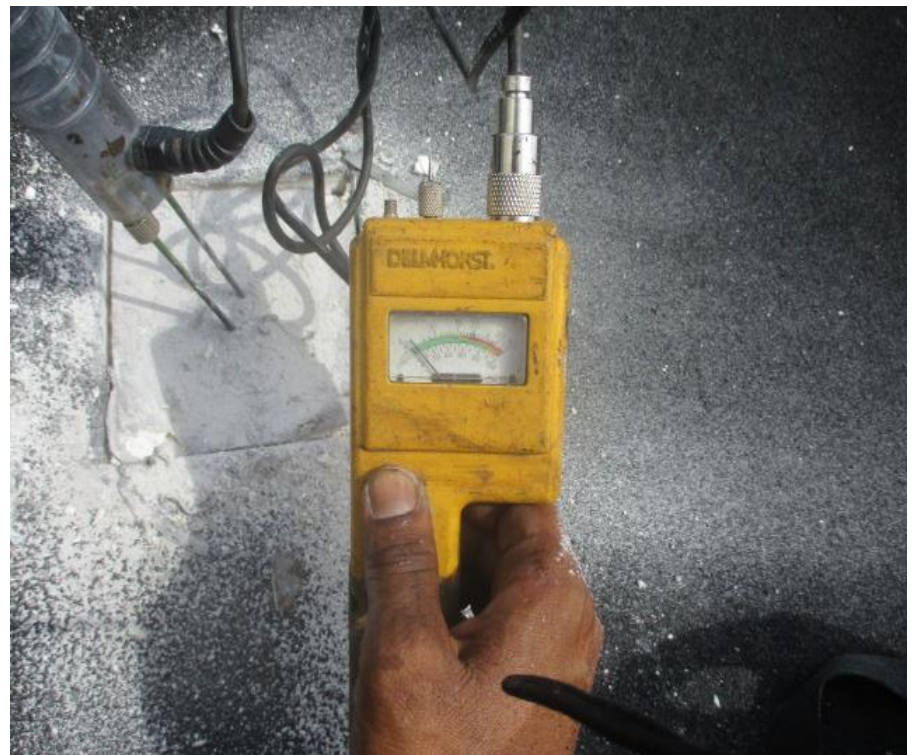
16. Test Cut #5 (Area B): Delmhorst moisture meter reading negative for moisture within the DensDeck sheathing layer

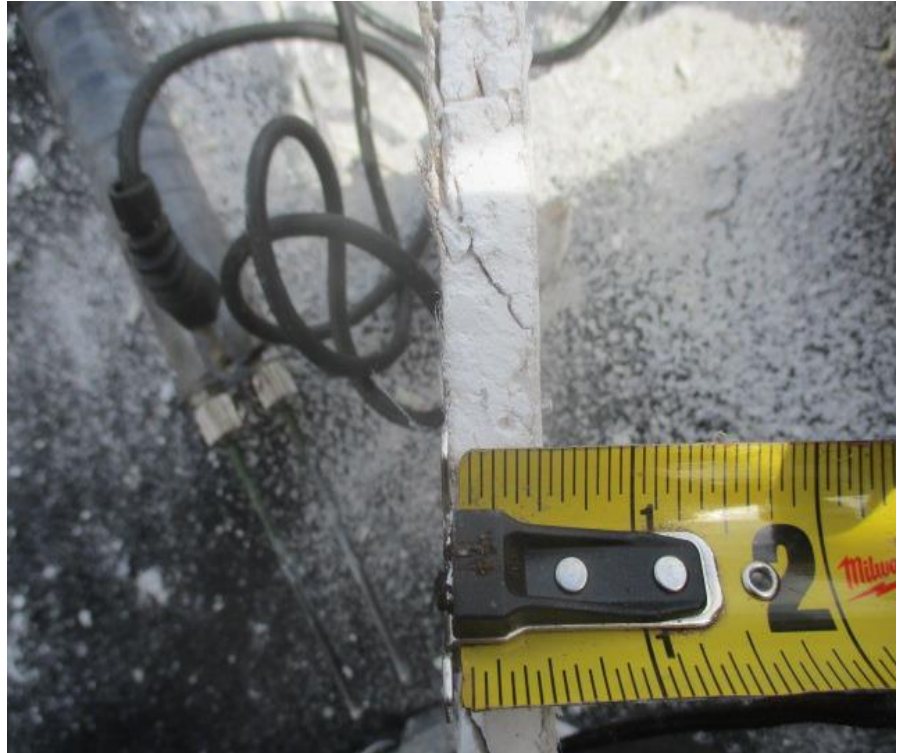
17. Test Cut #5 (Area B): View of DensDeck measurement

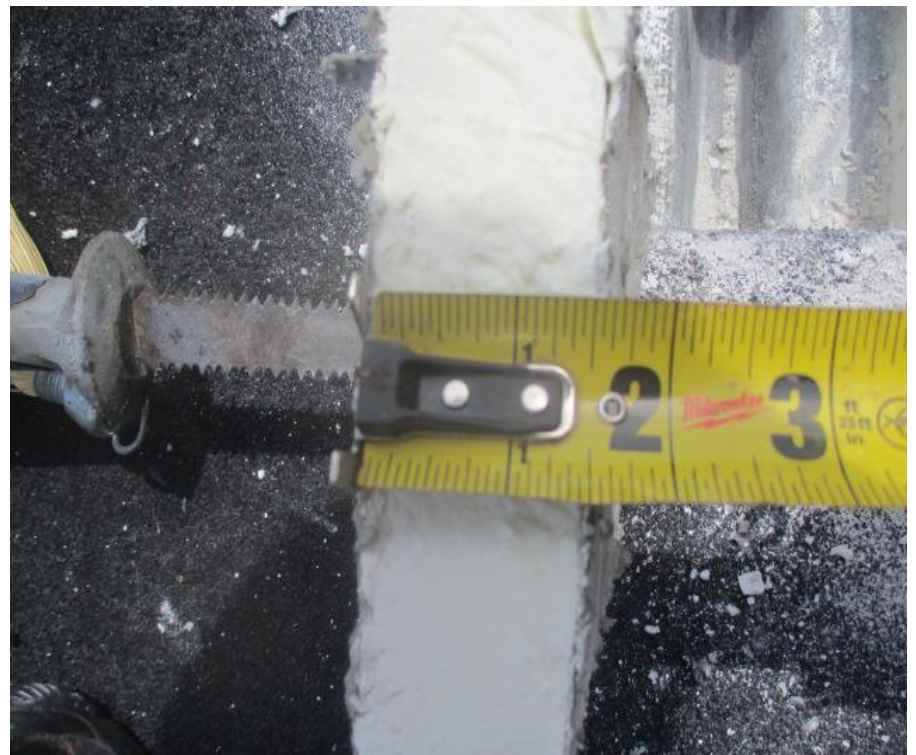
18. Test Cut #5 (Area B): View of roof insulation measurement

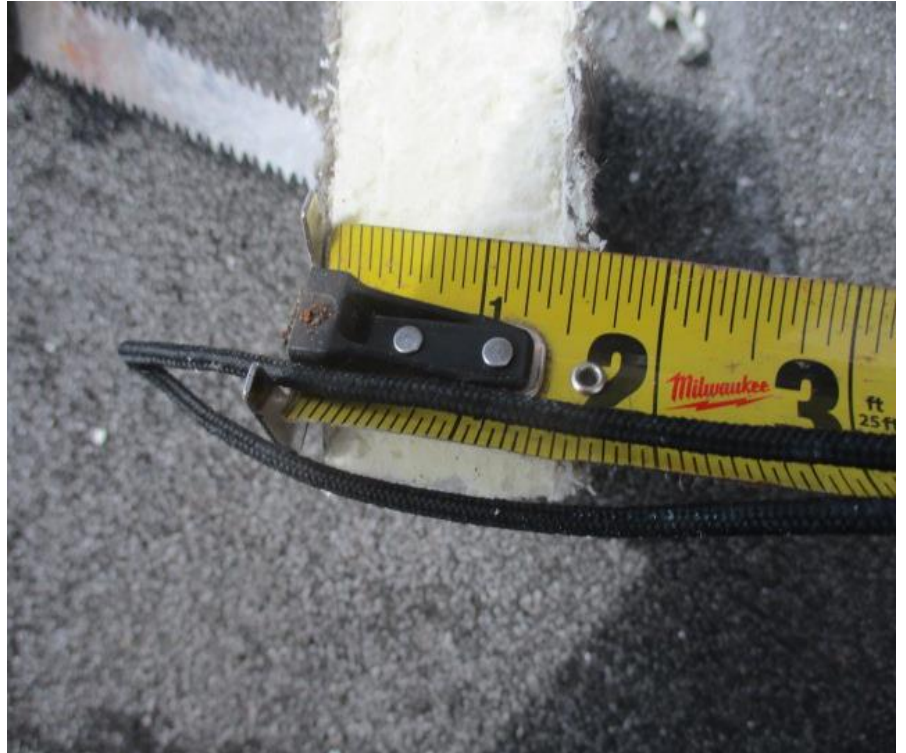
21. Test Cut #4 (Area B1): View of roof insulation measurement

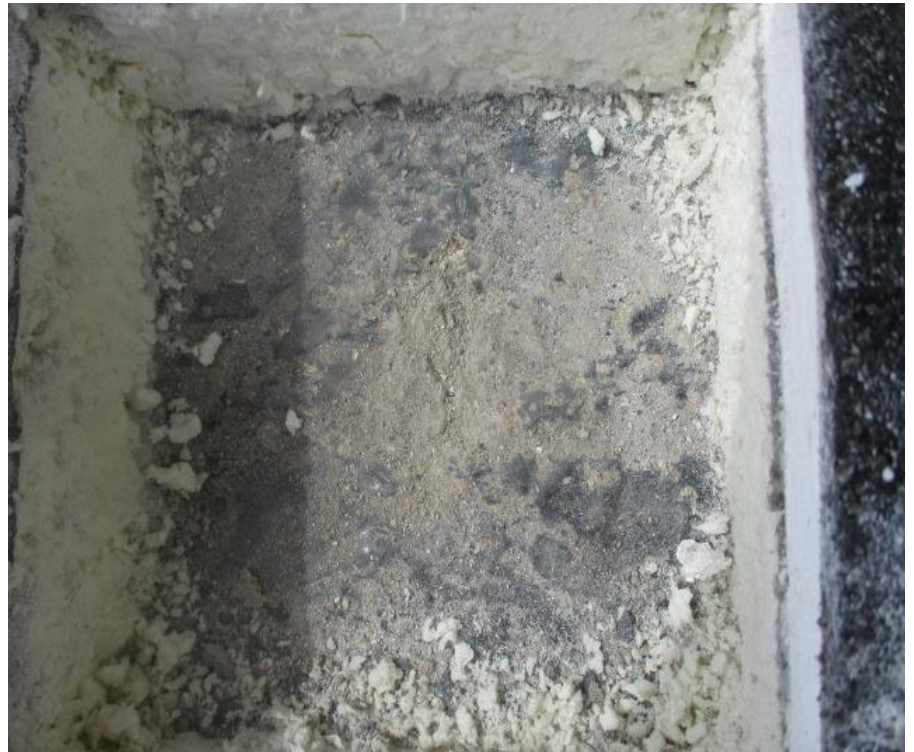
22. Test Cut #4 (Area B1): View of roof composition removed exposing a lightweight concrete in metal form roof deck

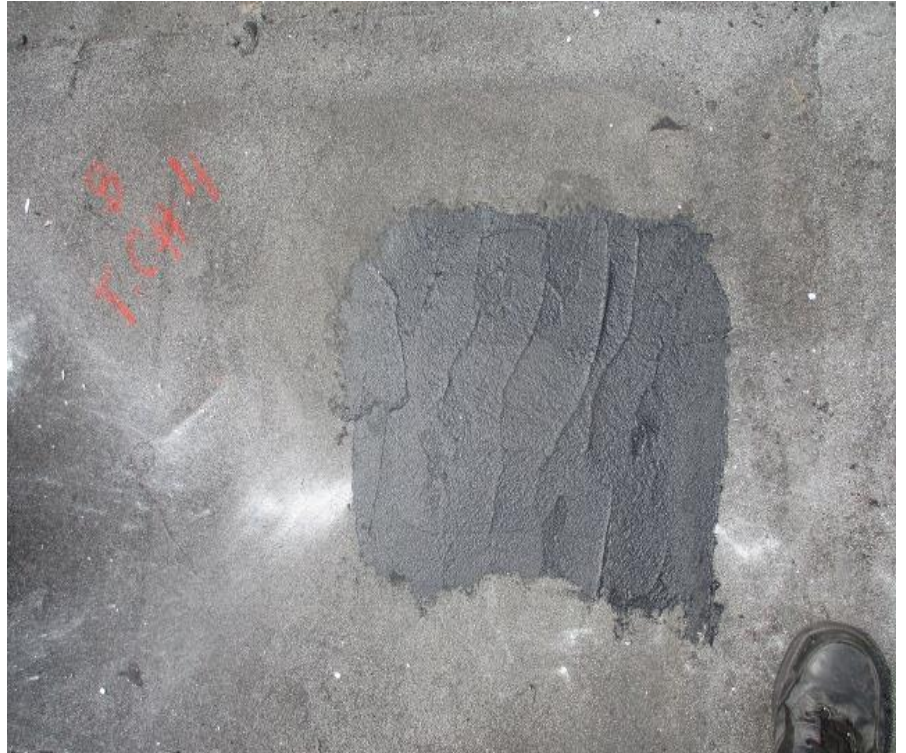
23. Test Cut #4 (Area B1): View of  
RCS repair

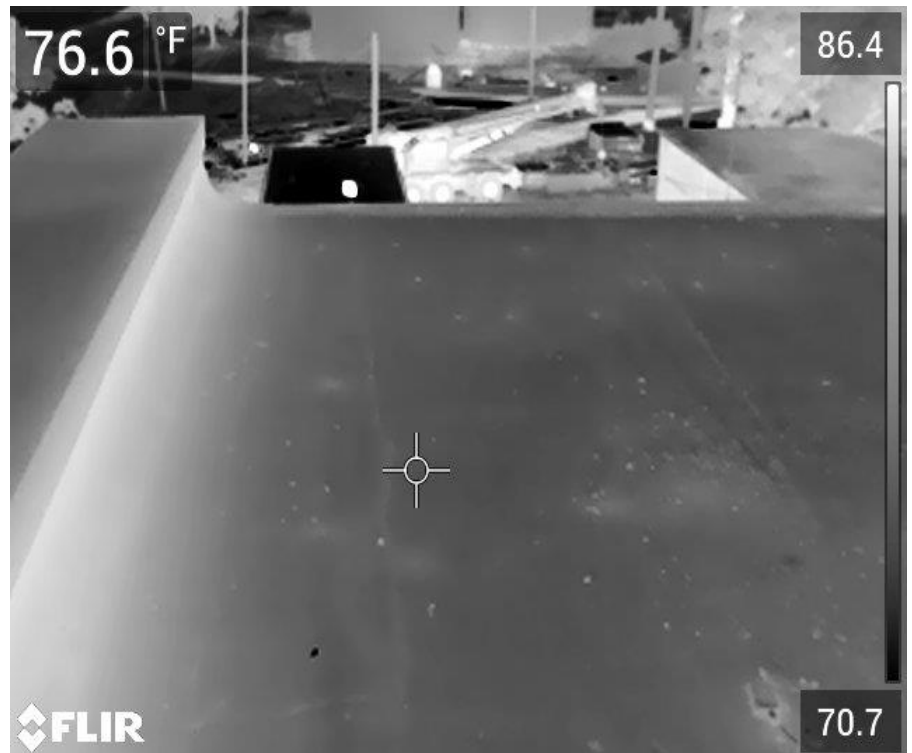
24. Infrared image on Bldg 8 - Area  
B1 with no suspect wet areas  
observed

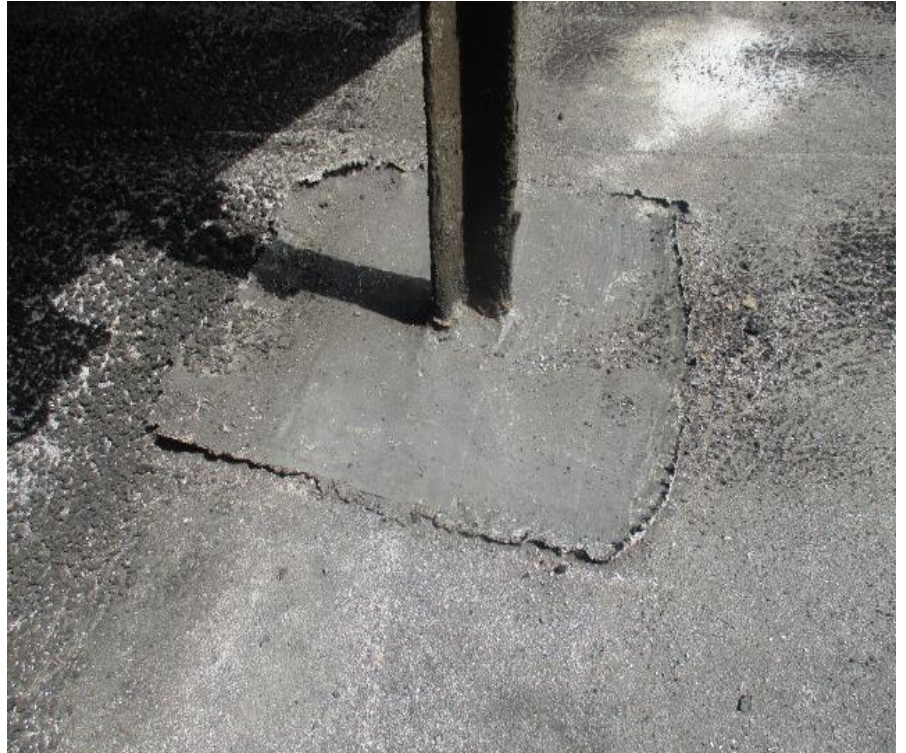
37. Deficiency #3 - Open flashing

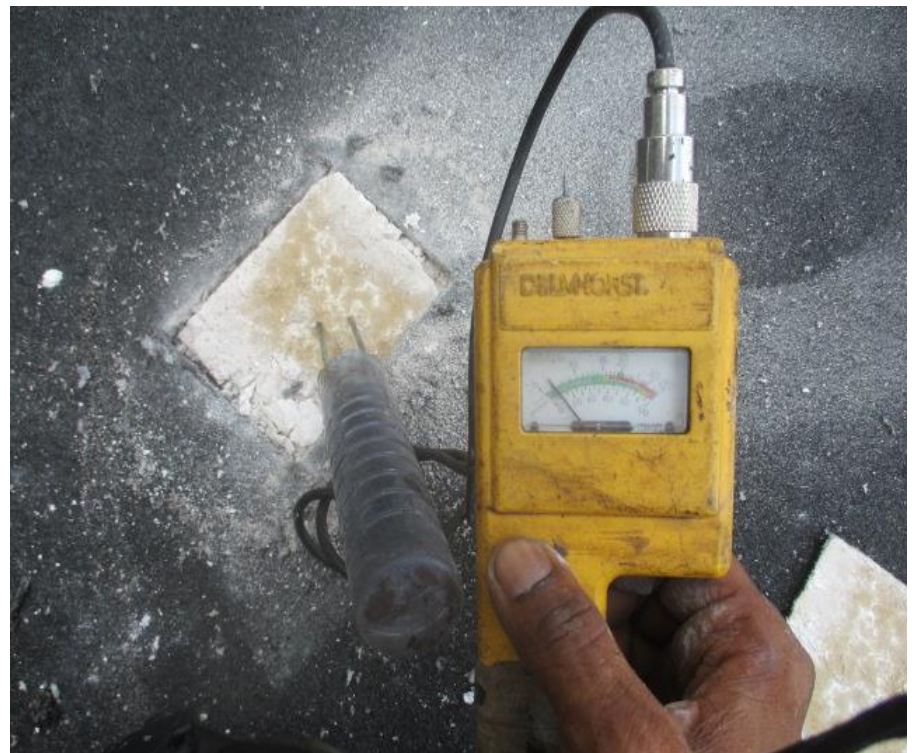
52. Test Cut #6 (Area C): Delmhorst moisture meter reading negative for moisture within DensDeck sheathing

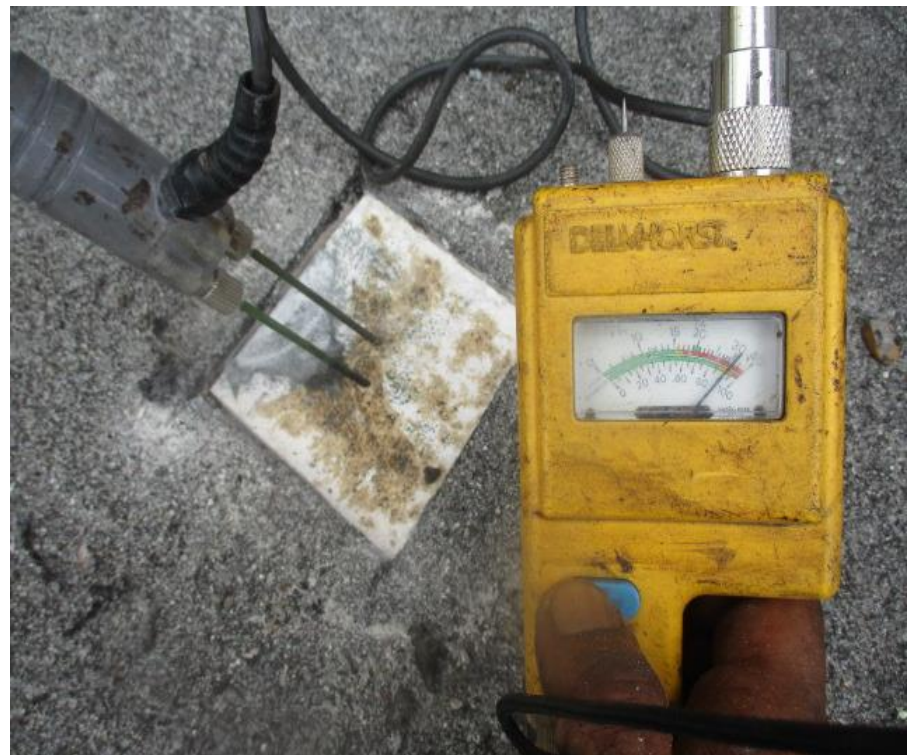
58. Test Cut #9 (Area F): Delmhorst reading negative for moisture within DensDeck sheathing

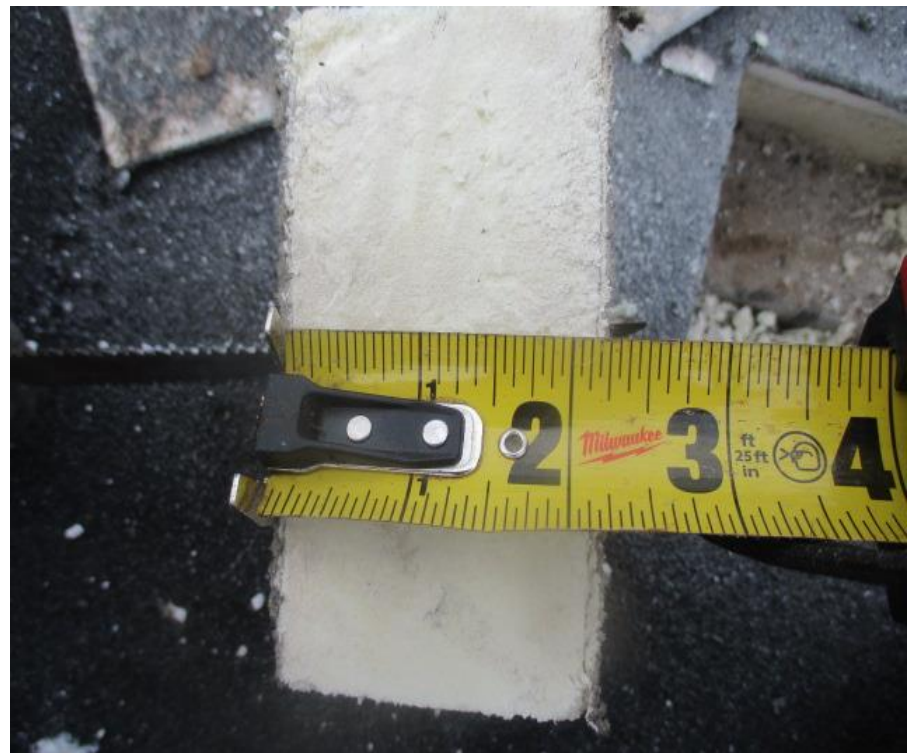
66. Test Cut #11 (Area G): View of roof insulation measurement

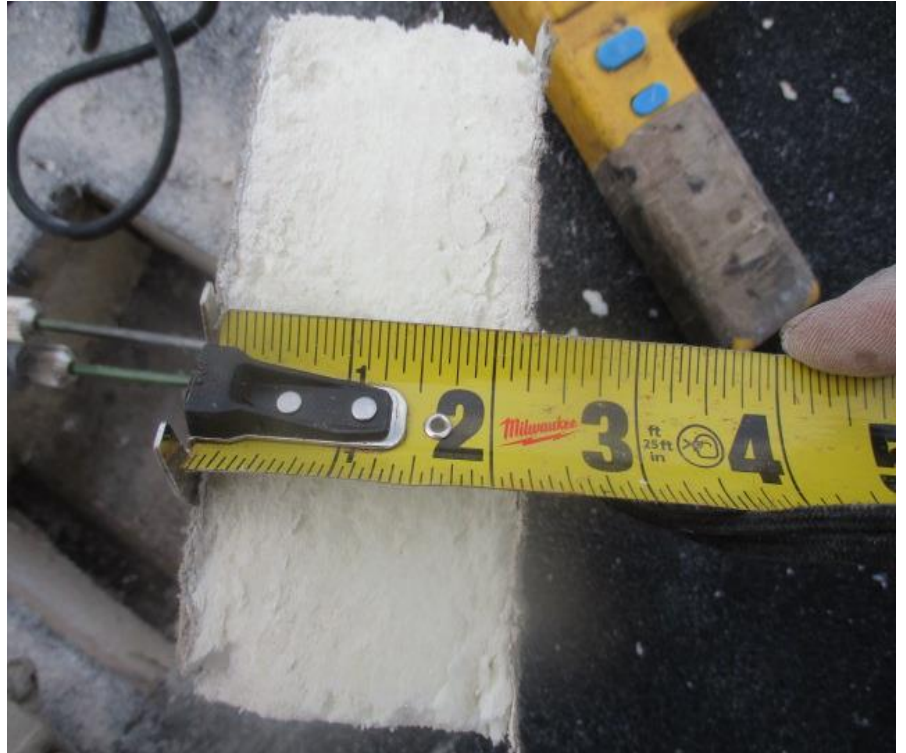
71. Test Cut #12 (Area G): View of roof insulation measurement

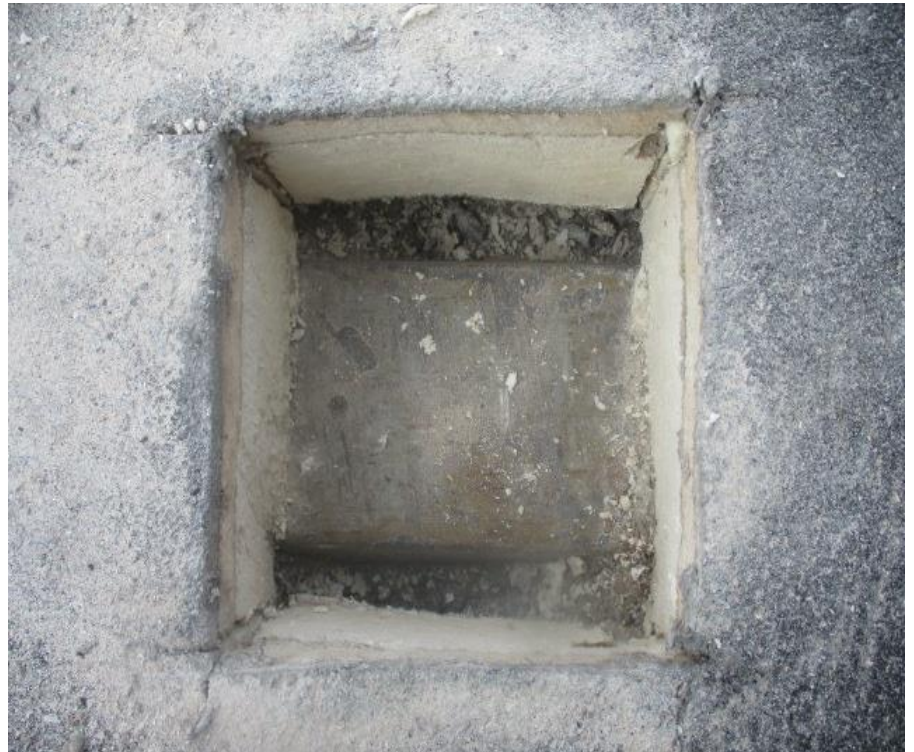
72. Test Cut #12 (Area G): View of roof composition removed exposing a galvanized metal deck

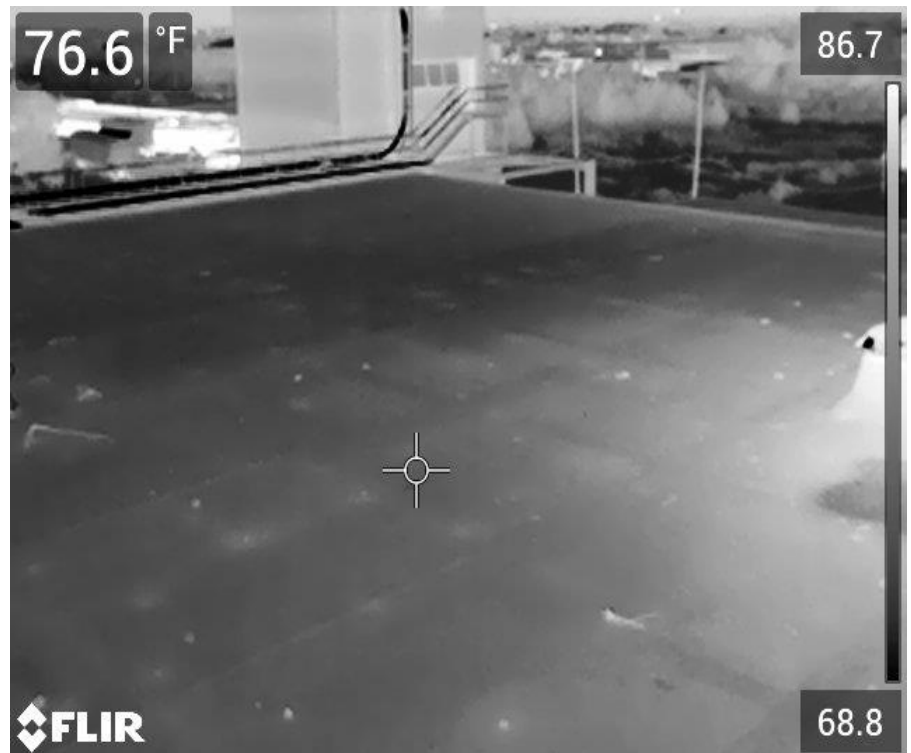
74. Infrared image on Bldg 8 - Area C  
with no suspect wet areas  
observed

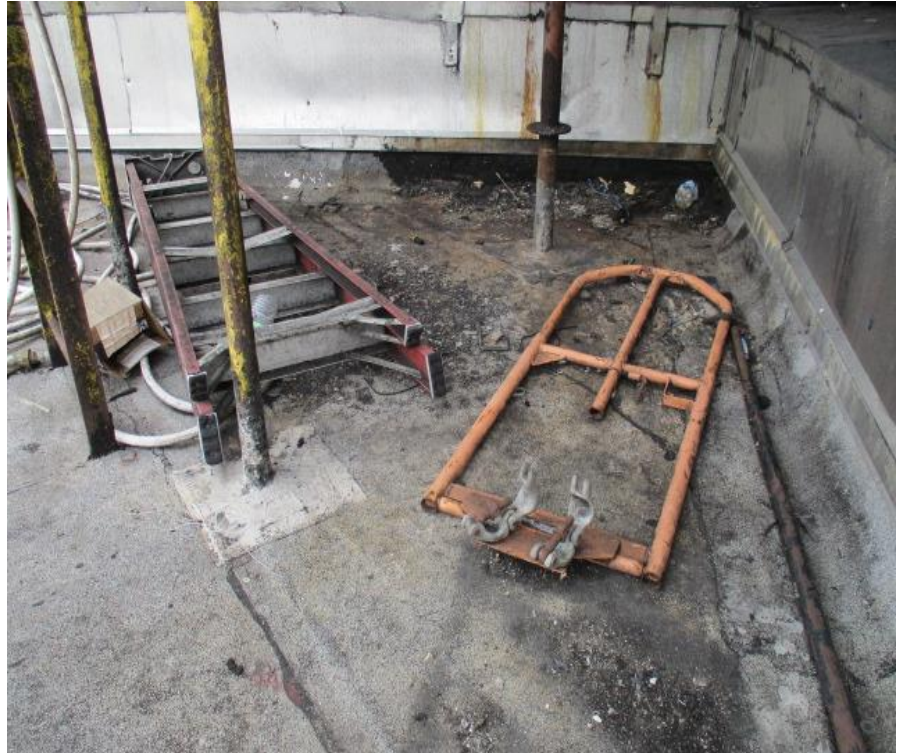
NUMBER	PRIORITY CODE	DEFICIENCY DESCRIPTION	QUANTITY	UNIT PRICE	REPAIR COST
		DEFICIENCY SOLUTION	UNITS		
2	M	Debris on roof surface	6	\$25.00	\$150.00
		Remove and properly dispose of all debris	Locations		
3	M	Open flashing	27	\$225.00	\$6,075.00
		Repair with a (3) three course application of flashing grade roof cement and reinforcing fabric	Locations		
4	M	Hole / puncture in membrane / felts	2	\$275.00	\$550.00
		Repair with a (5) five course application of flashing grade roof cement and reinforcing fabric	Locations		
7	MN	Ponding water observed on roof surface	1		
		Monitor and address at time of roof system replacement or as needed to maintain watertight integrity of the roof system	Area		
9	MN	Missing / deteriorated sealant at metal counter flashing	83		
		Monitor at this time and address only as required to maintain a watertight condition until time of the eventual roof system replacement	LnFt

51. Deficiency #2 - Debris on roof surface

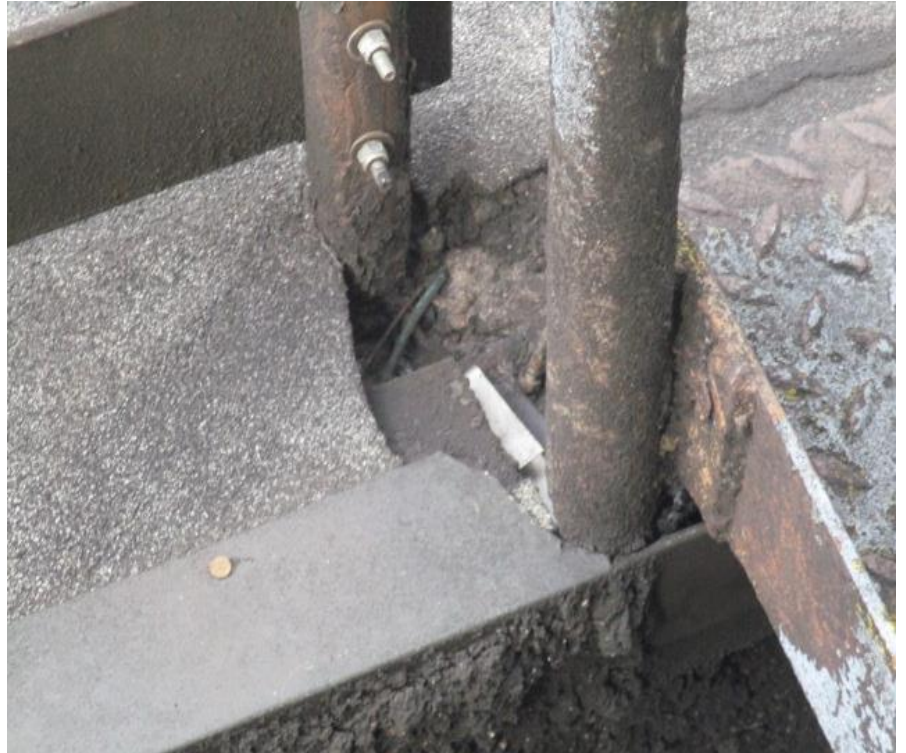
53. Deficiency #3 - Open flashing

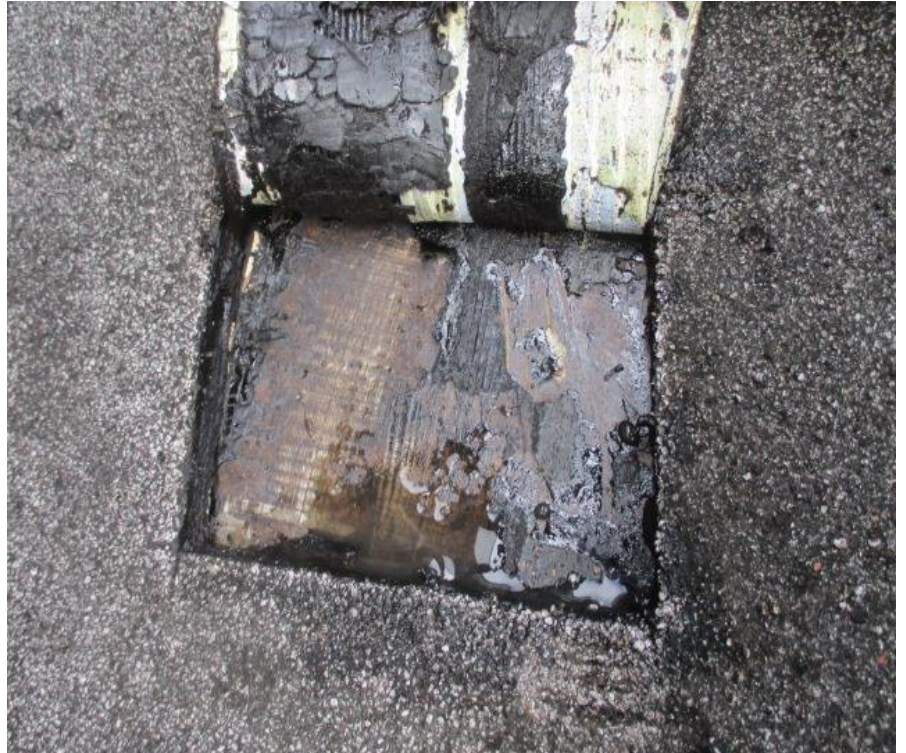
71. Test Cut #7 (Area D): View of roof membrane removed exposing a concrete deck

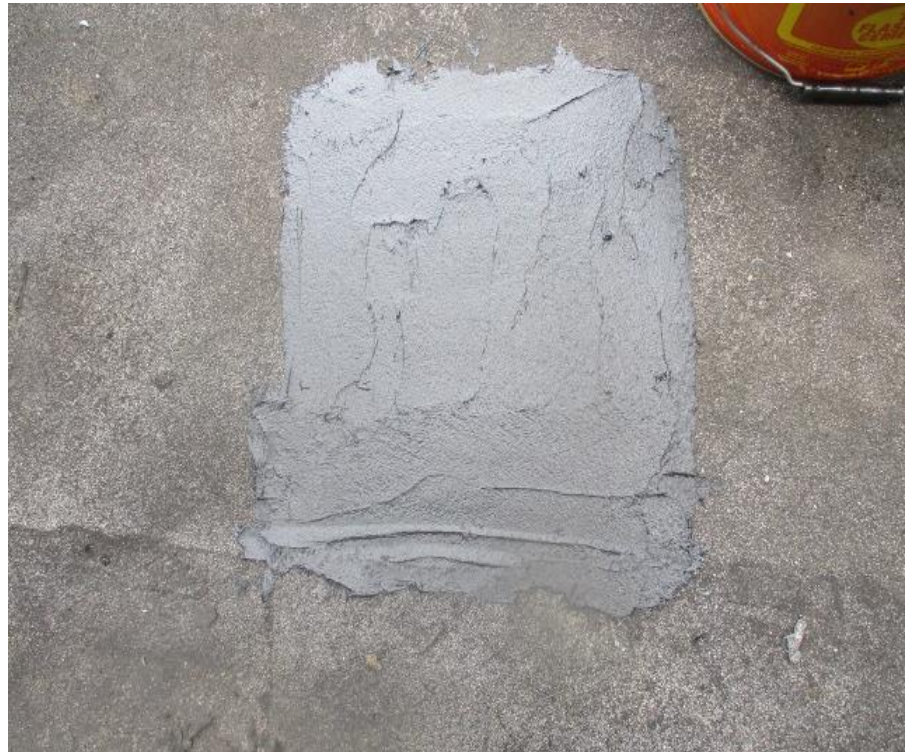
72. Test Cut #7 (Area D): View of RCS repair

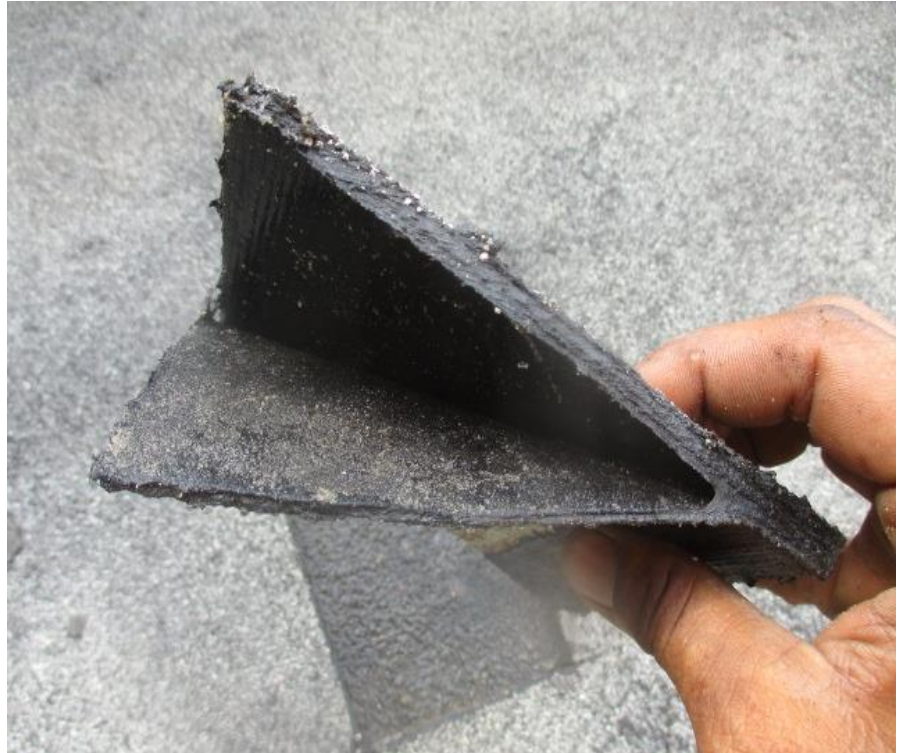
<b><i>TEST CUT / PROBE NUMBER</i></b>	<b>7</b>	<b>10</b>
<b><i>Test Cut Size</i></b>	6" x 6"	6" x 6"
<b><i>Troxler Reading</i></b>	N/A	N/A
<b><i>Infra-red Reading</i></b>	N/A	N/A
<b><i>Delmhorst Reading</i></b>	Dry	Wet
<b><i>Deck Condition</i></b>	Good	Good
<b><i>Vapor Retarder Condition</i></b>	N/A	N/A
<b><i>Insulation Condition</i></b>	N/A	N/A
<b><i>Membrane Condition</i></b>	Poor	Poor

73. Test Cut #10 (Area E2): View of modified bitumen plies

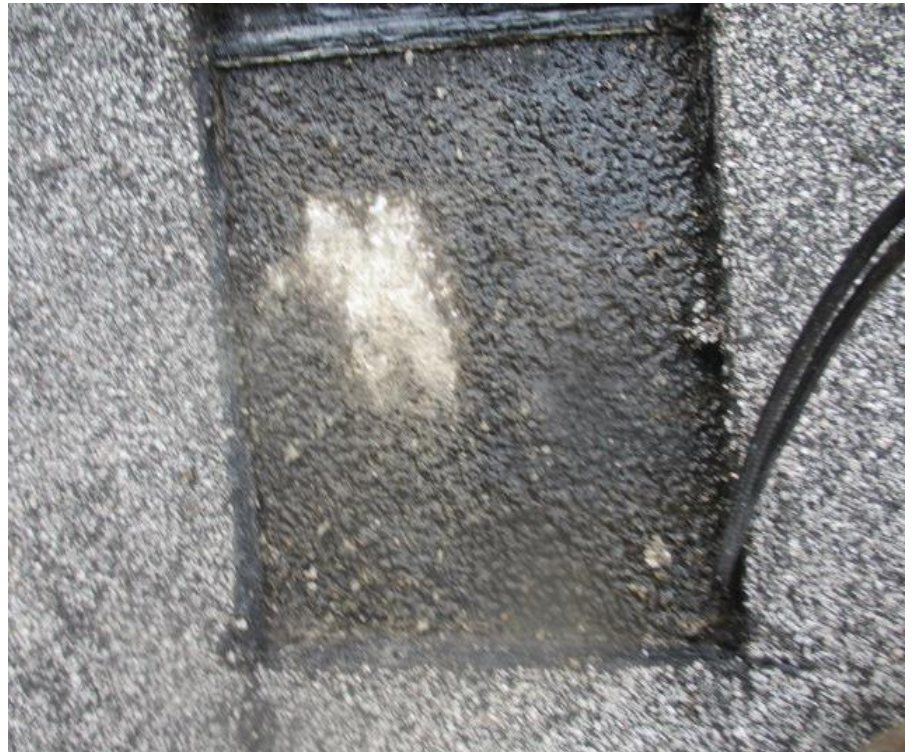
74. Test Cut #10 (Area E2): View of roof membrane removed exposing a concrete deck

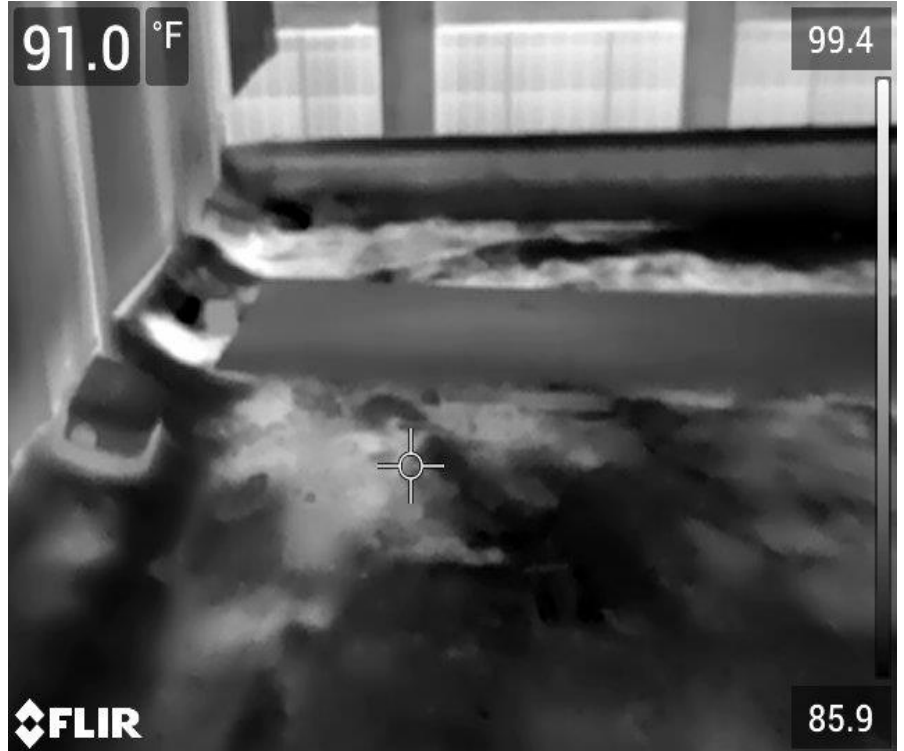
An infrared moisture survey was performed and the results of the survey were positive. One hundred (100) percent of the roof area was determined to be affected by moisture infiltration. No active interior roof leak locations were identified by RCS project contact.

23. Infrared image on Bldg 8 - Area H with suspect wet areas observed

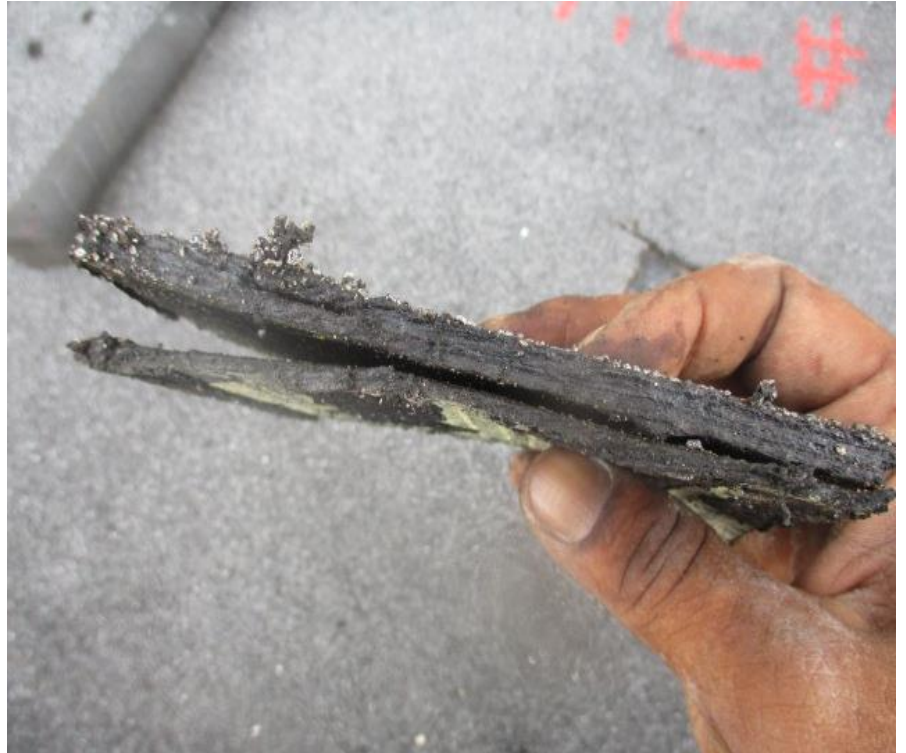
21. Test Cut #14 (Area I): View of modified bitumen plies

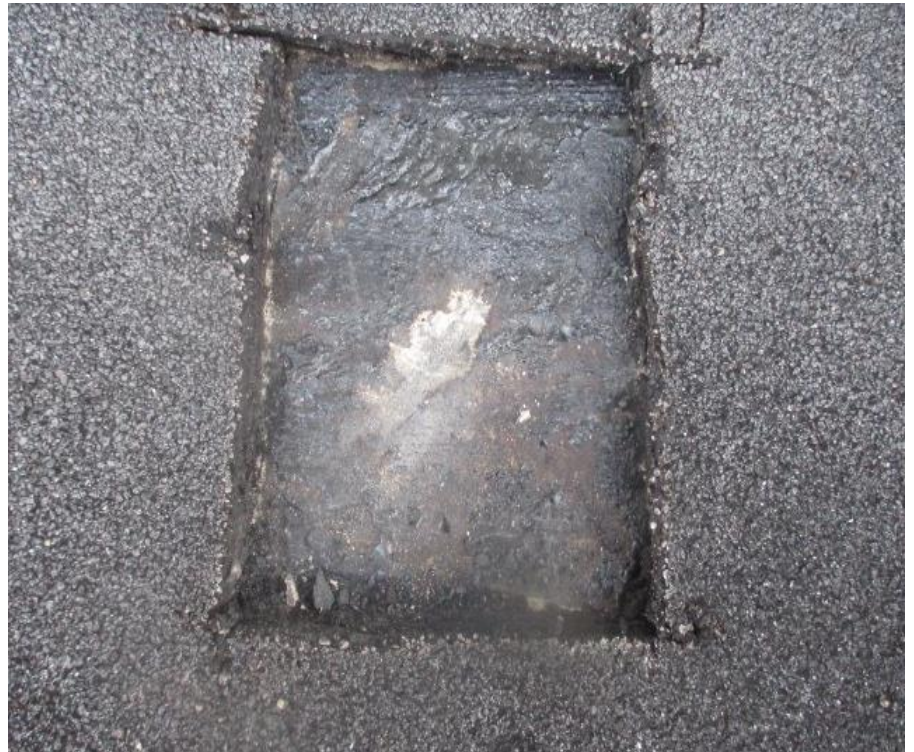
22. Test Cut #14 (Area I): View of roof membrane removed exposing a structural concrete roof deck
