## **Domino Sugar Refinery**

# **Domino Sugar Facility**

**7412 N. Peters Street  
Arabi, LA**

**9/3/2022**

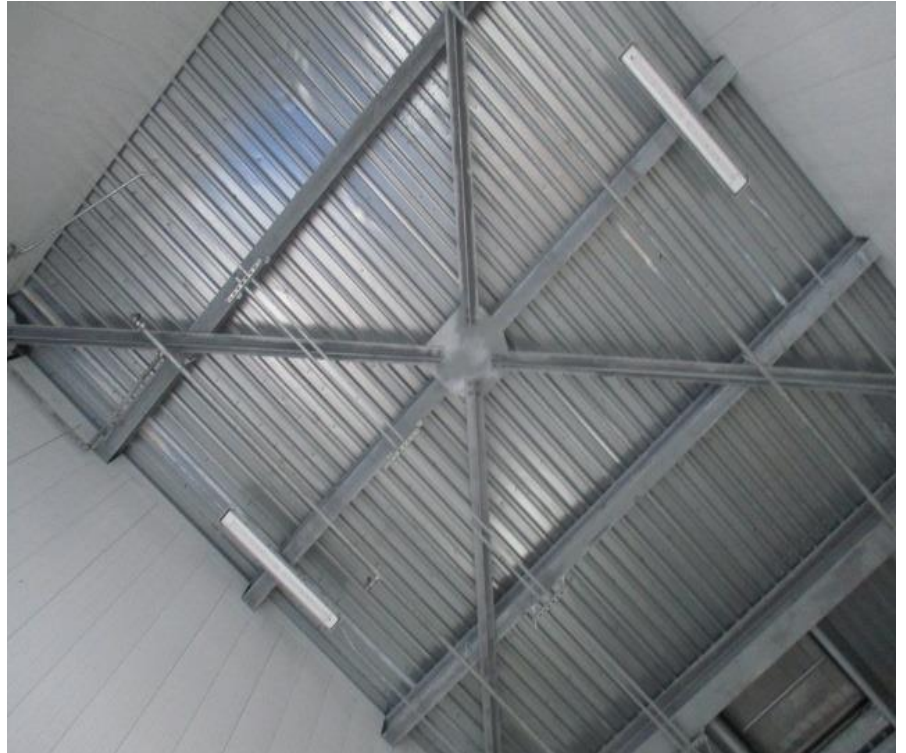
5. View of underside of roof deck at building interior

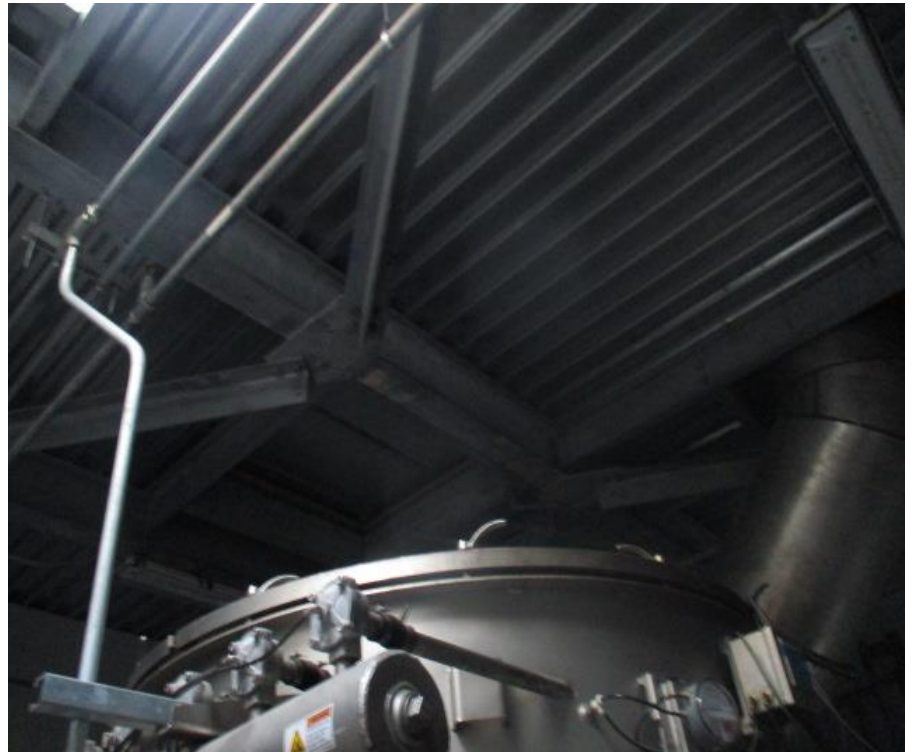
6. View of underside of roof deck at building interior
