INFRARED MOISTURE SURVEY
 CLIENT: PENMARK MANAGEMENT
 PROJECT: CLEARFIELD SQUARE
 ADDRESS: 1800 DASY STREET
 CLEARFIELD, PA
 DRAWING: ROOF PLAN

INFRARED MOISTURE SURVEY

CLIENT: PENMARK MANAGEMENT
PROJECT: CLEARFIELD SQUARE
ADDRESS: 1800 DASY STREET
CLEARFIELD, PA

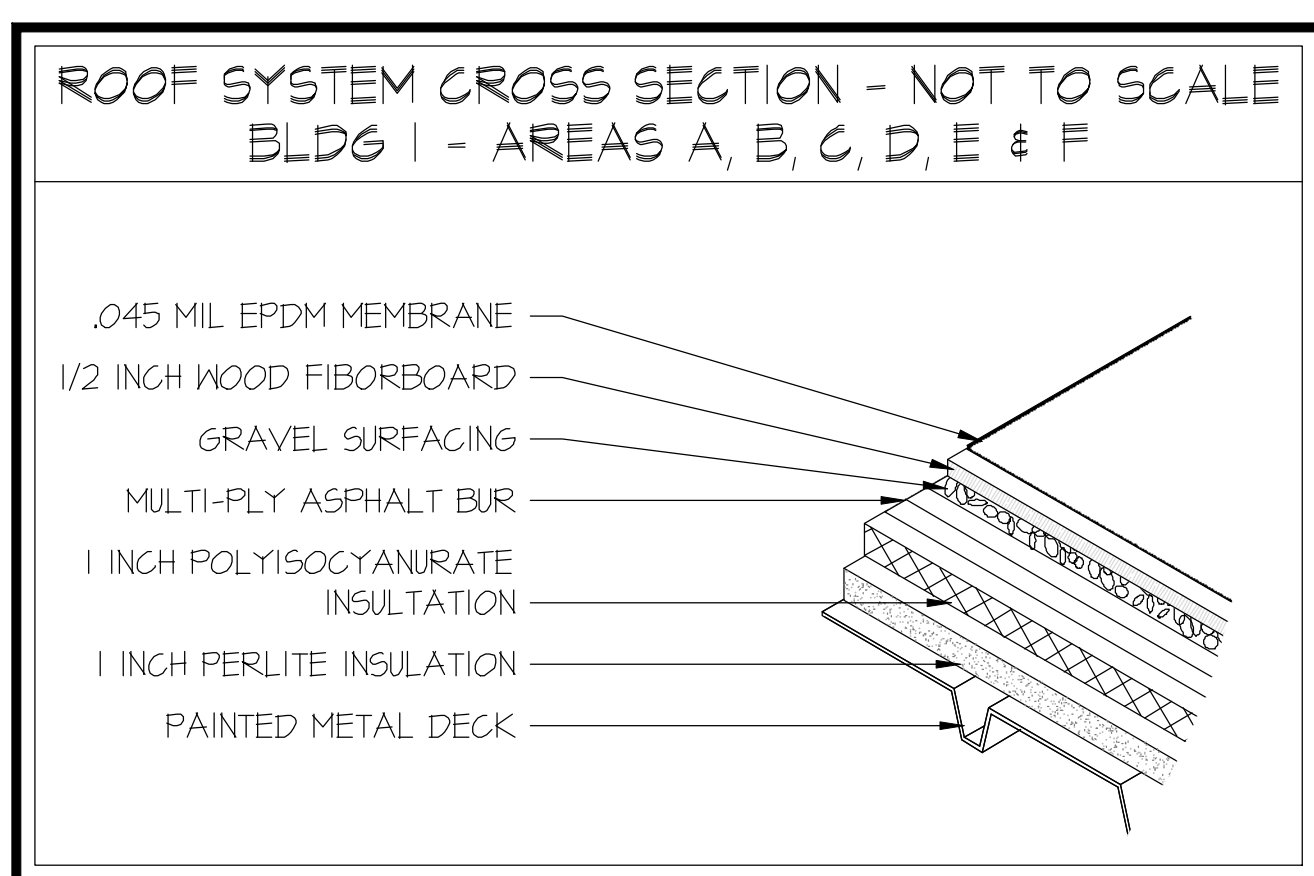
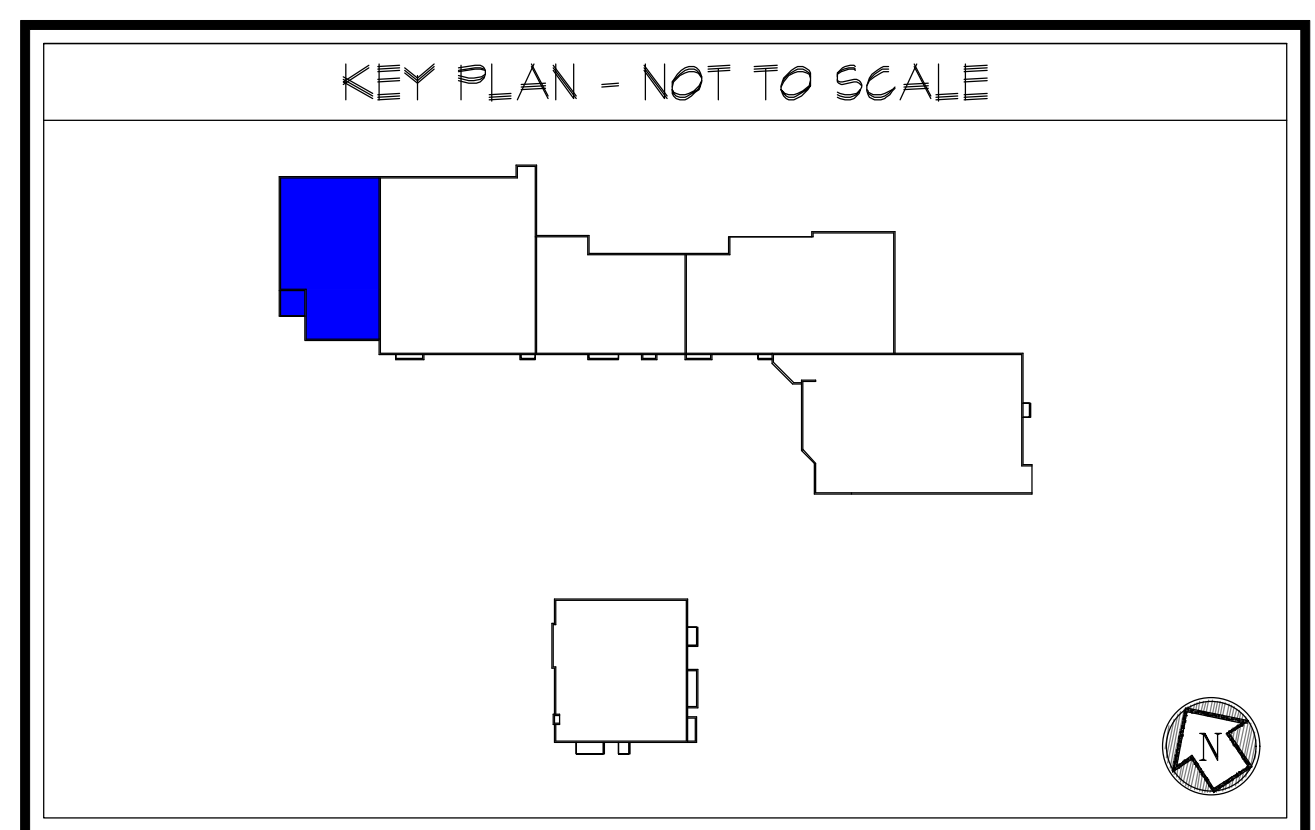
DEFICIENCY LIST	
	WET INSULATION

CONTOUR LEGEND			
BLDG 1 - AREAS A, B, C, D, E & F			
MOISTURE LEVEL	LEGEND	SQ. FT.	%
LEVEL I - DRY		69,145 SQ. FT. +/-	45.4%
LEVEL II - WET		83,426 SQ. FT. +/-	54.6%

TOTAL PROJECT ROOF AREA - 177,176 SQ. FT. +/-
 SCALE: 3/32"=1'-0"

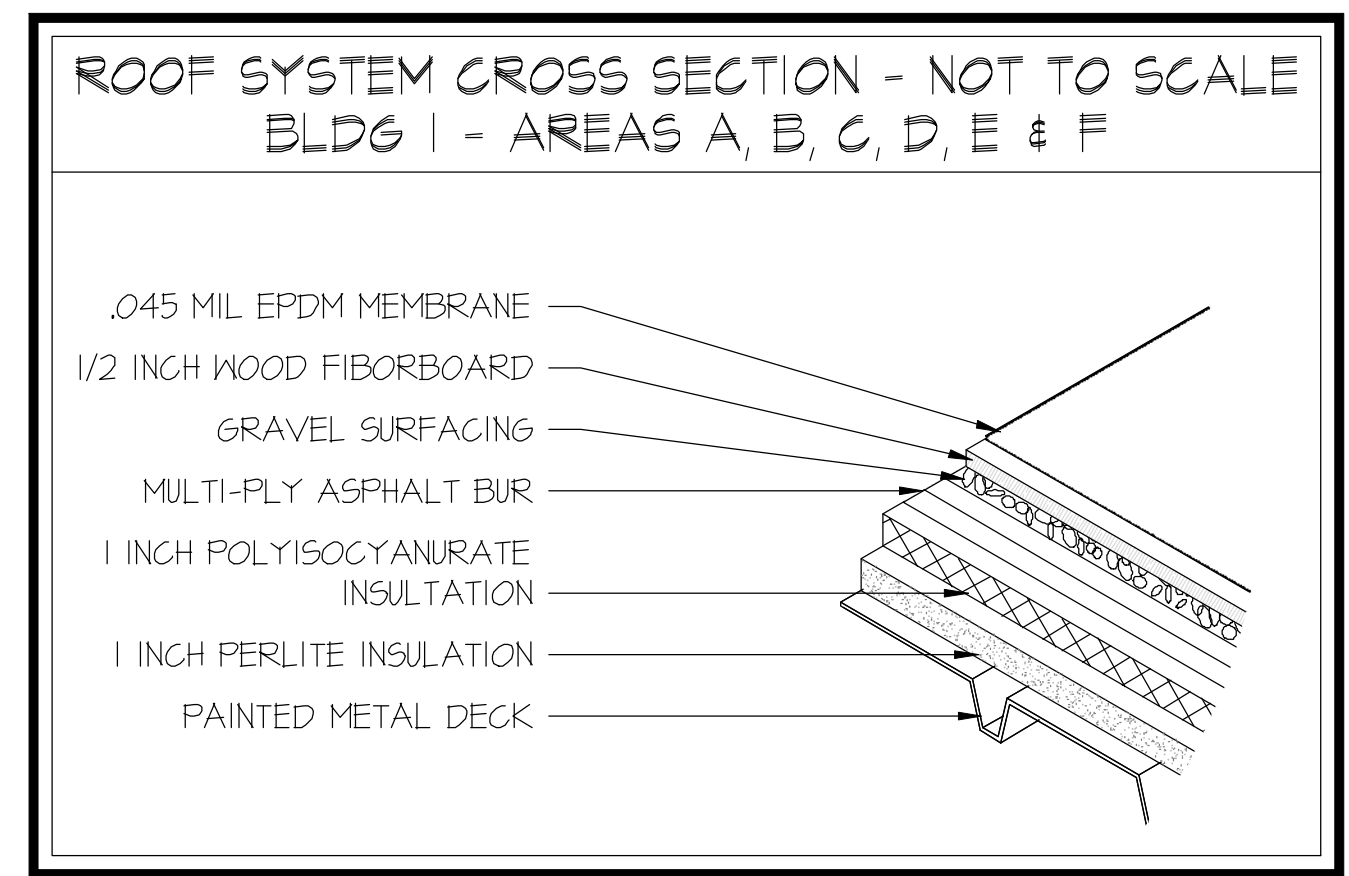
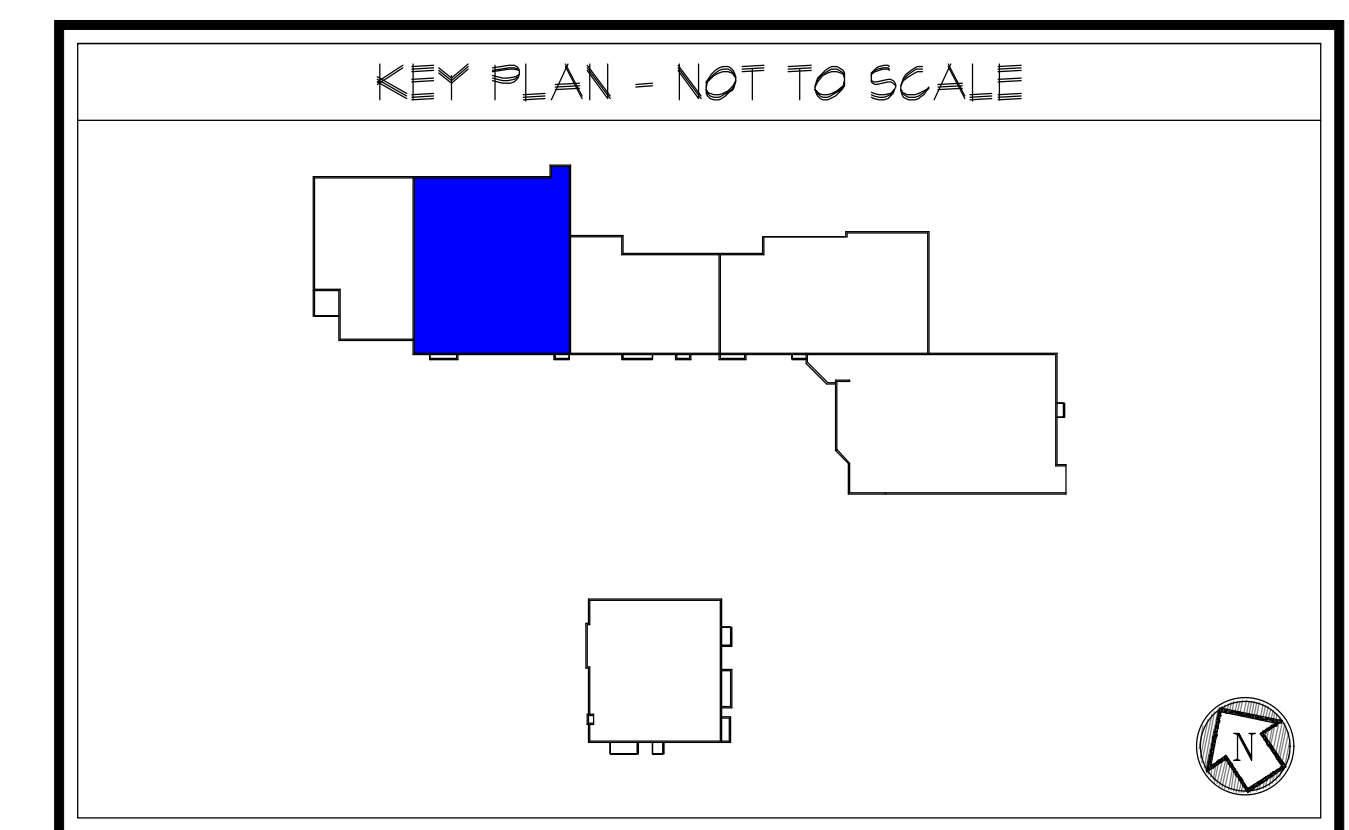
CONTOUR LEGEND			
BLDG I - AREAS A, B, C, D, E & F			
MOISTURE LEVEL	LEGEND	SQ. FT.	%
LEVEL I - DRY		69,145 SQ. FT. +/-	45.4%
LEVEL II - WET		83,426 SQ. FT. +/-	54.6%

1 TOTAL PROJECT ROOF AREA - 177,176 SQ. FT. +/-
A2 SCALE: 3/32"=1'-0"

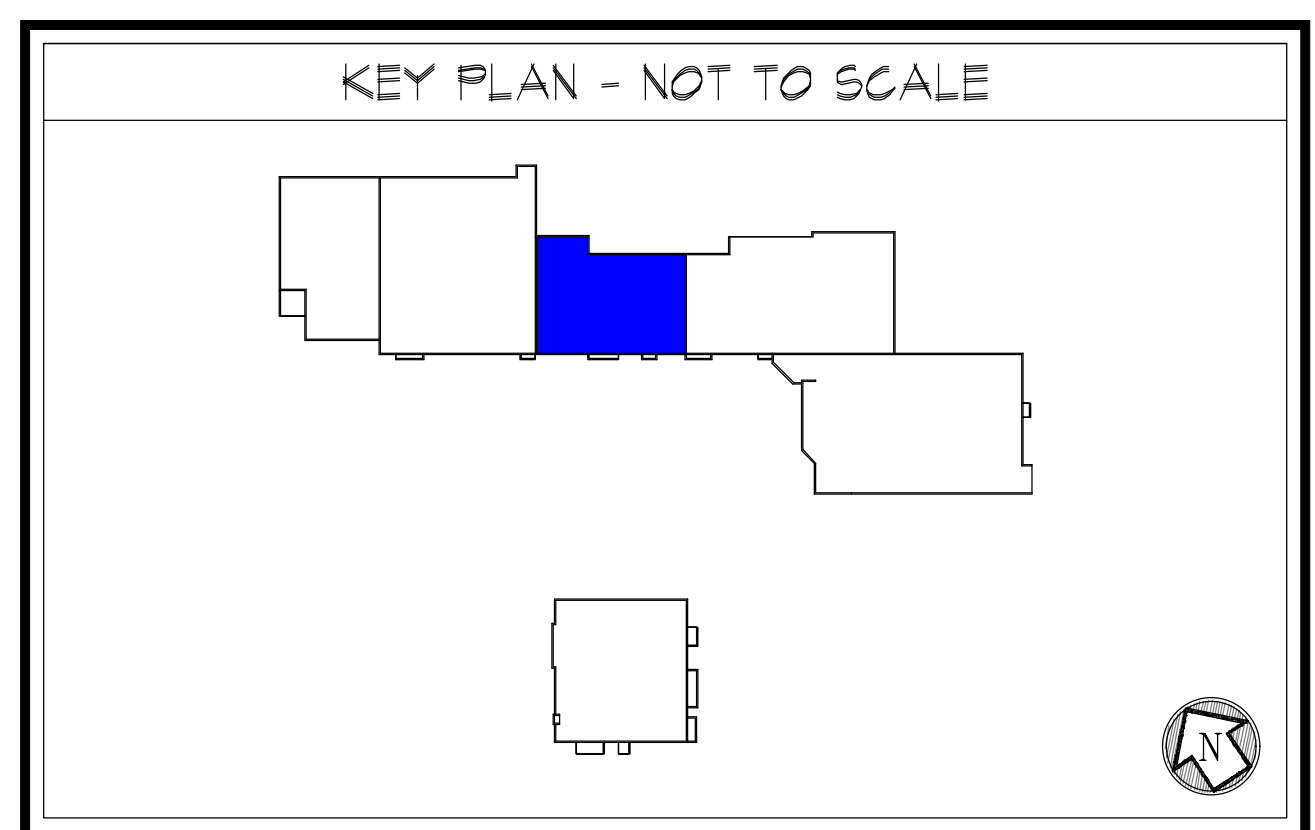
CONTOUR LEGEND			
BLDG 1 - AREAS A, B, C, D, E & F			
MOISTURE LEVEL	LEGEND	SQ. FT.	%
LEVEL I - DRY		69,145 SQ. FT. +/-	45.4%
LEVEL II - WET		83,426 SQ. FT. +/-	54.6%

1 TOTAL PROJECT ROOF AREA - 177,176 SQ. FT. +/-
A3 SCALE: 3/32"=1'-0"

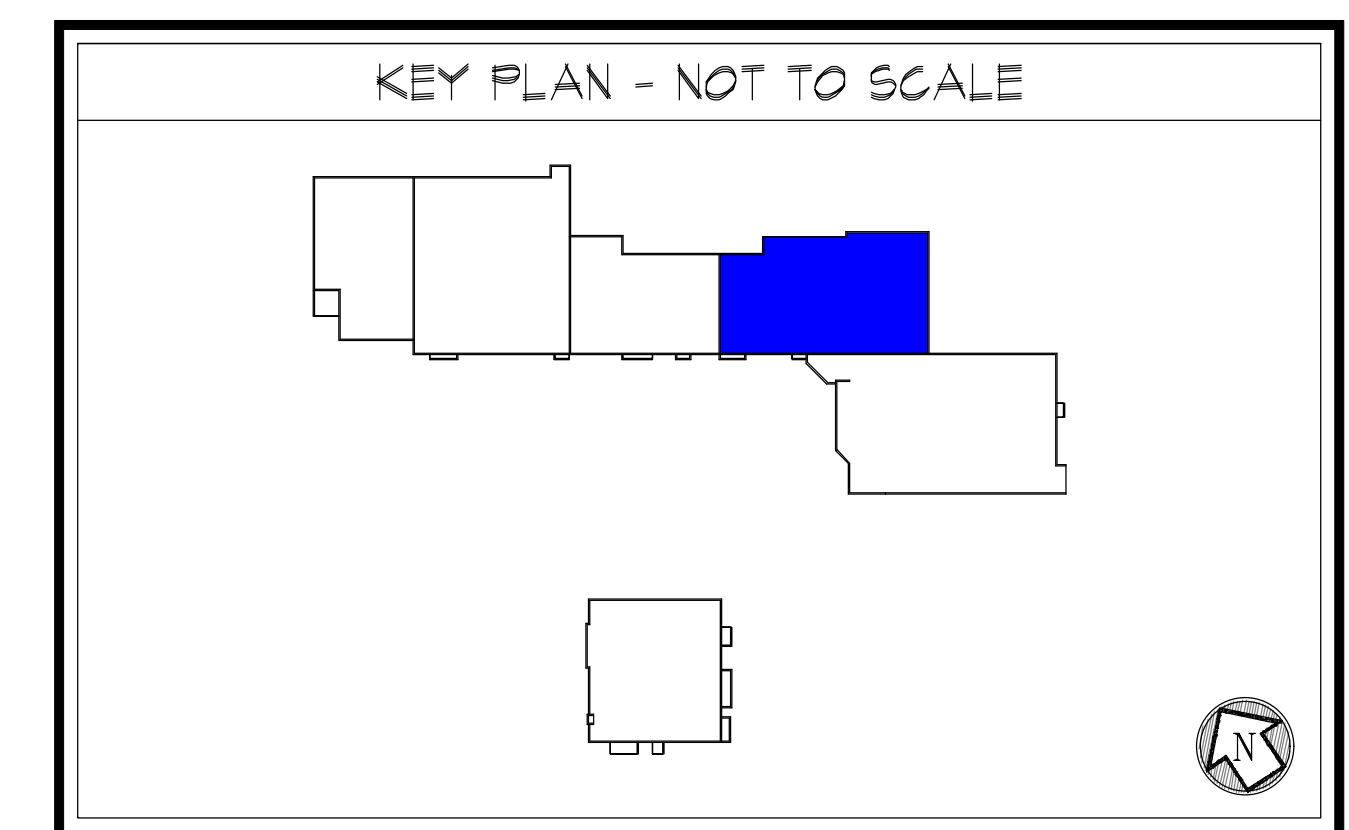
I TOTAL PROJECT ROOF AREA - 177,776 SQ. FT. +/-
A4 SCALE: 3/32"=1'-0"

CONTOUR LEGEND BLDG I - AREAS A, B, C, D, E & F

MOISTURE LEVEL	LEGEND	SQ. FT.	%
LEVEL I - DRY		69,145 SQ. FT. +/-	45.4%
LEVEL II - WET		83,426 SQ. FT. +/-	54.6%

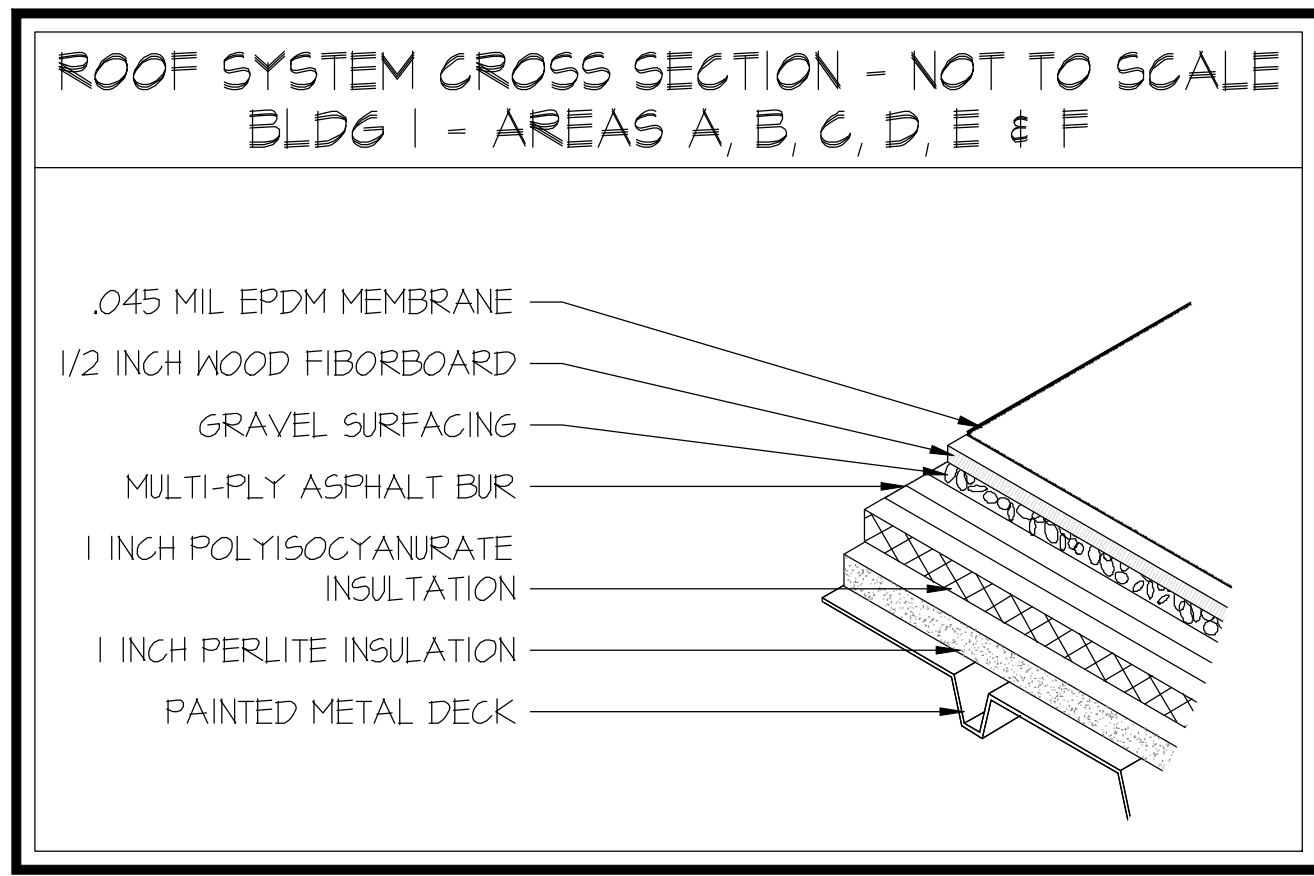
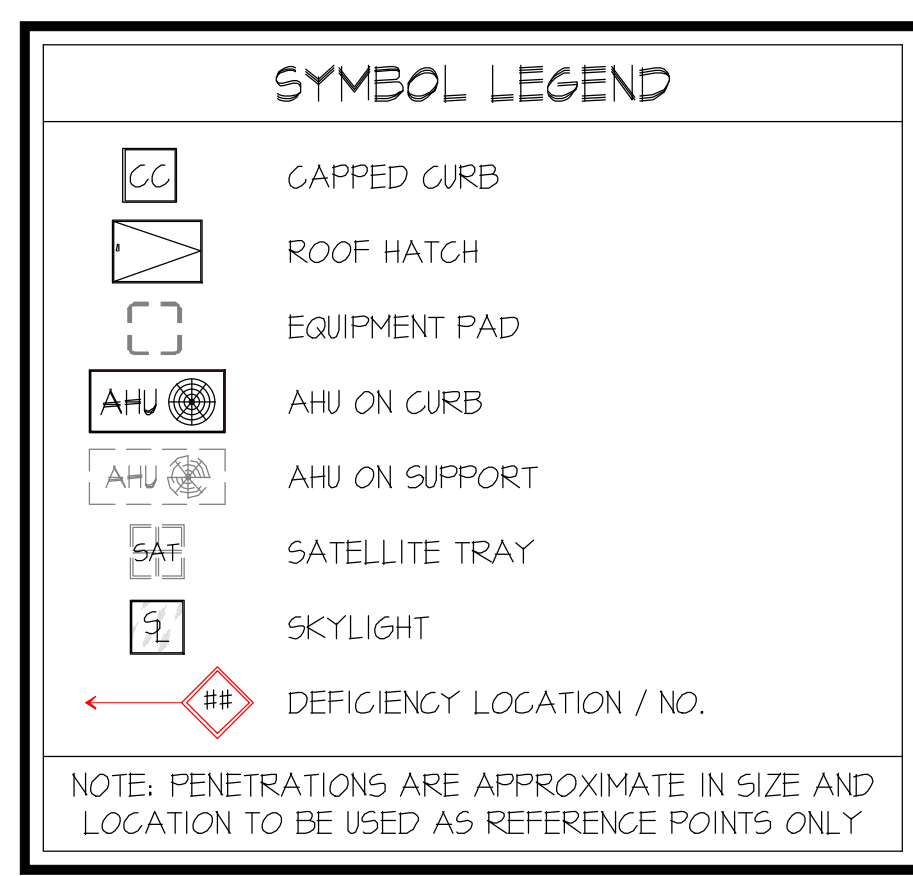
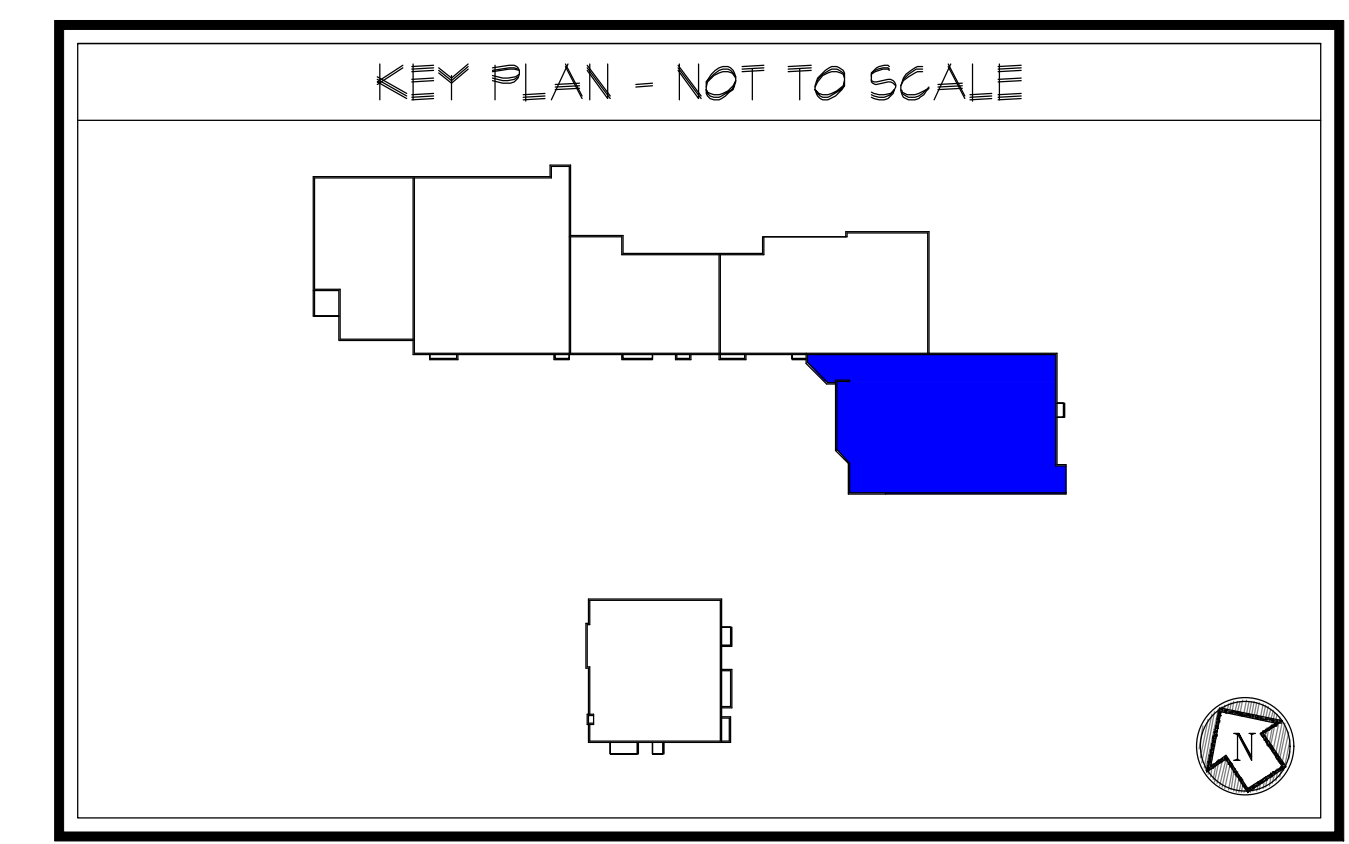
A5

TOTAL PROJECT ROOF AREA - 177,776 SQ. FT. +/-
SCALE: 3/32"=1'-0"

CONTOUR LEGEND BLDG I - AREAS A, B, C, D, E & F

MOISTURE LEVEL	LEGEND	SQ. FT.	%
LEVEL I - DRY		69,145 SQ. FT. +/-	45.4%
LEVEL II - WET		83,426 SQ. FT. +/-	54.6%

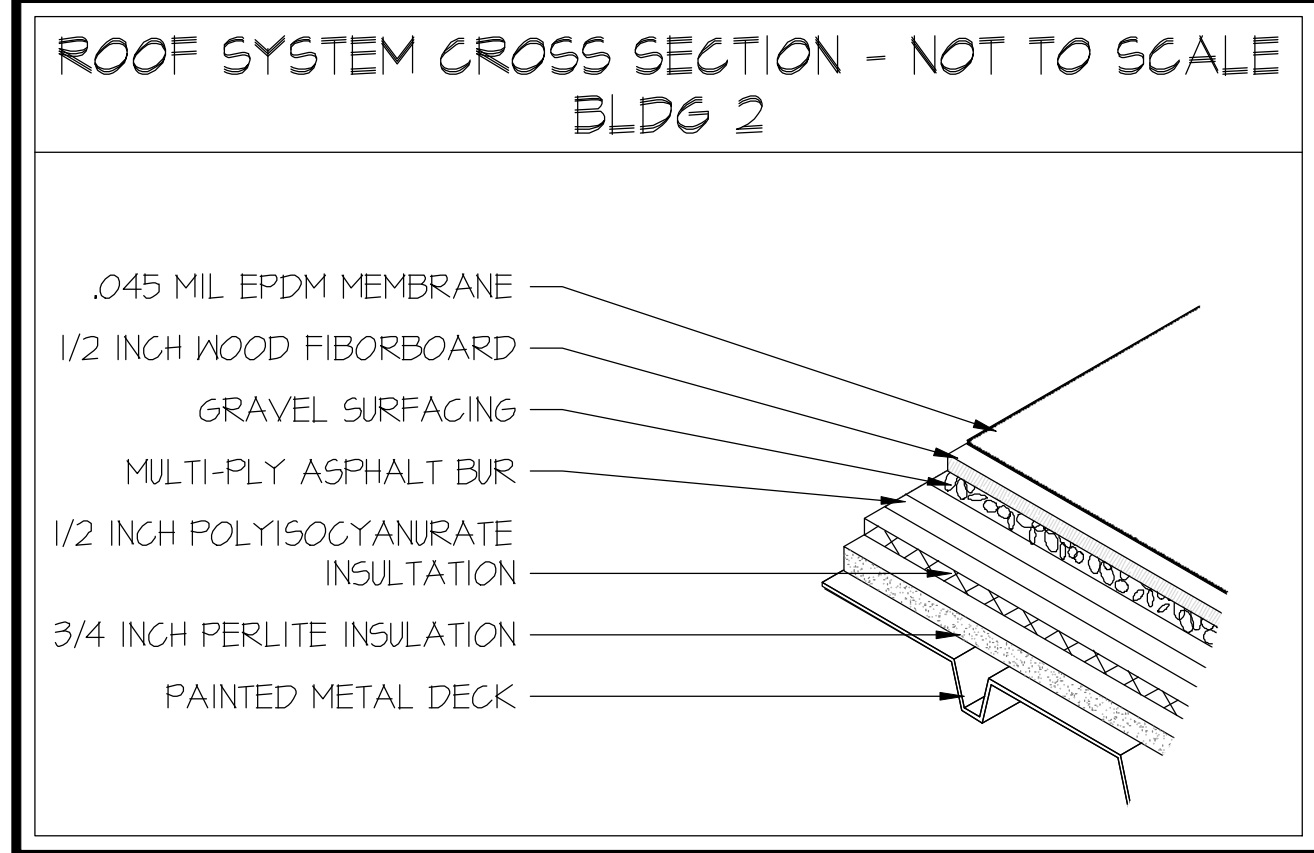
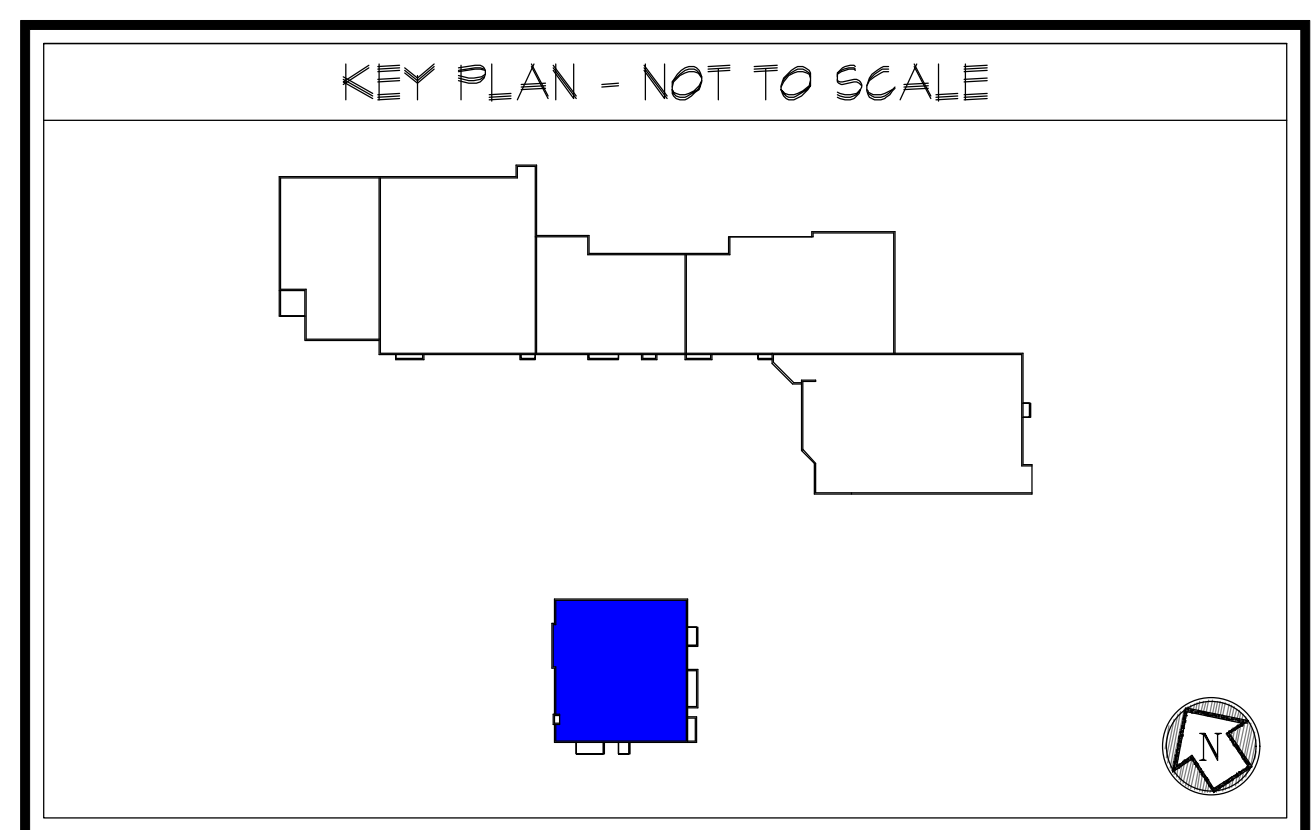
TOTAL PROJECT ROOF AREA - 177,776 SQ. FT. +/-
A6 SCALE: 3/32"=1'-0"

CONTOUR LEGEND BLDG 2			
MOISTURE LEVEL	LEGEND	SQ. FT.	%
LEVEL I - DRY		13,325 SQ. FT. +/-	52.4%
LEVEL II - WET		11,880 SQ. FT. +/-	47.1%
