Roof Systems Data Management

Dulles Technical Center

**22611 Markey Ct
Sterling, VA**

Roof System Condition Evaluation Report

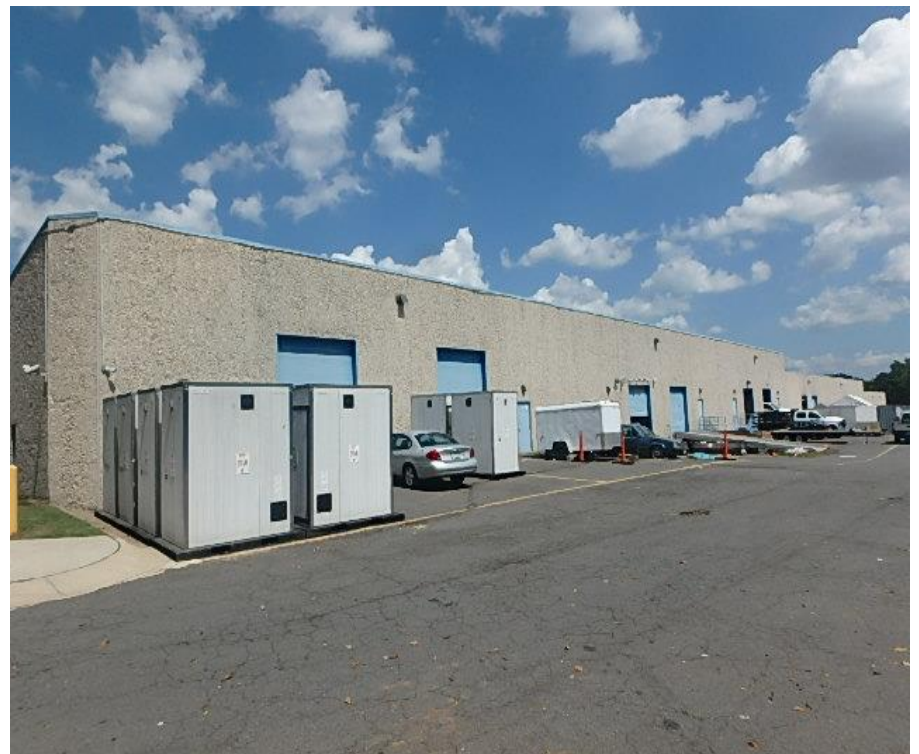
6. Building exterior rear elevation overview

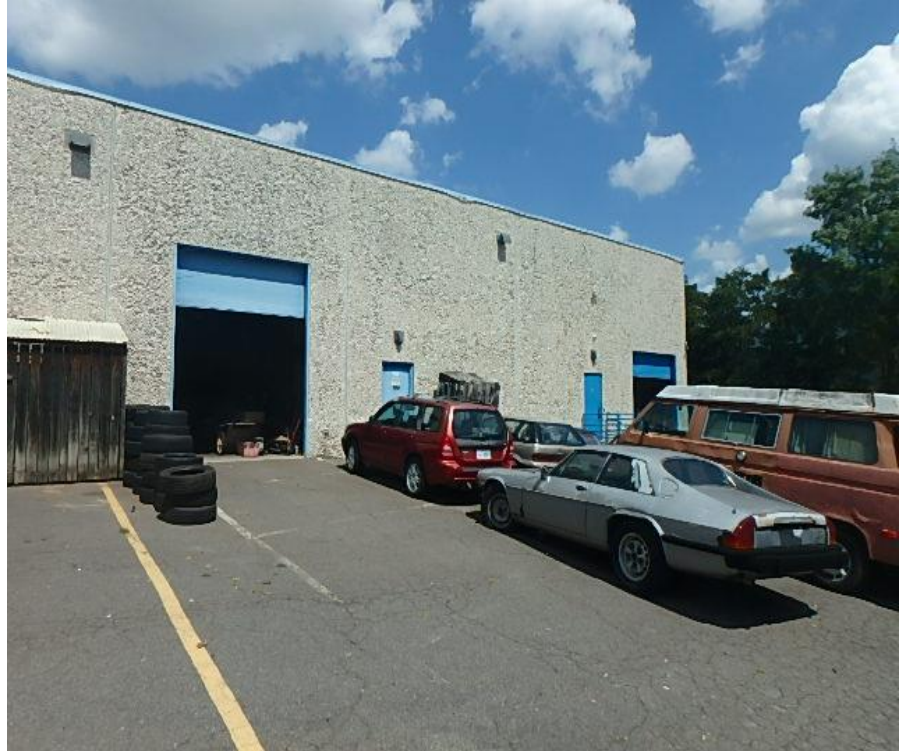
7. Building exterior rear elevation overview

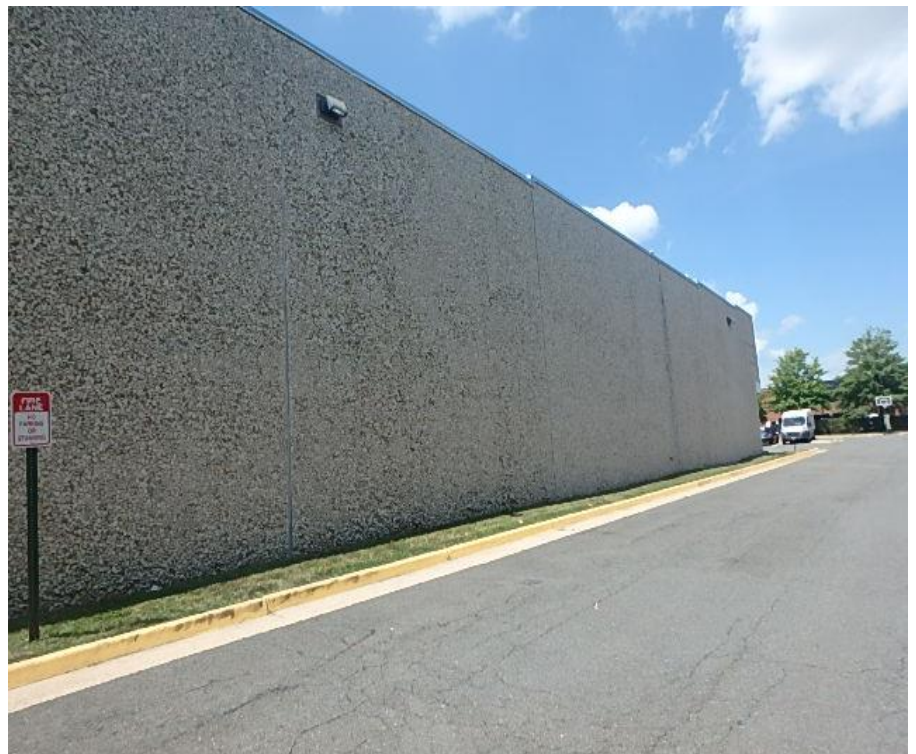
8. Building exterior side elevation overview

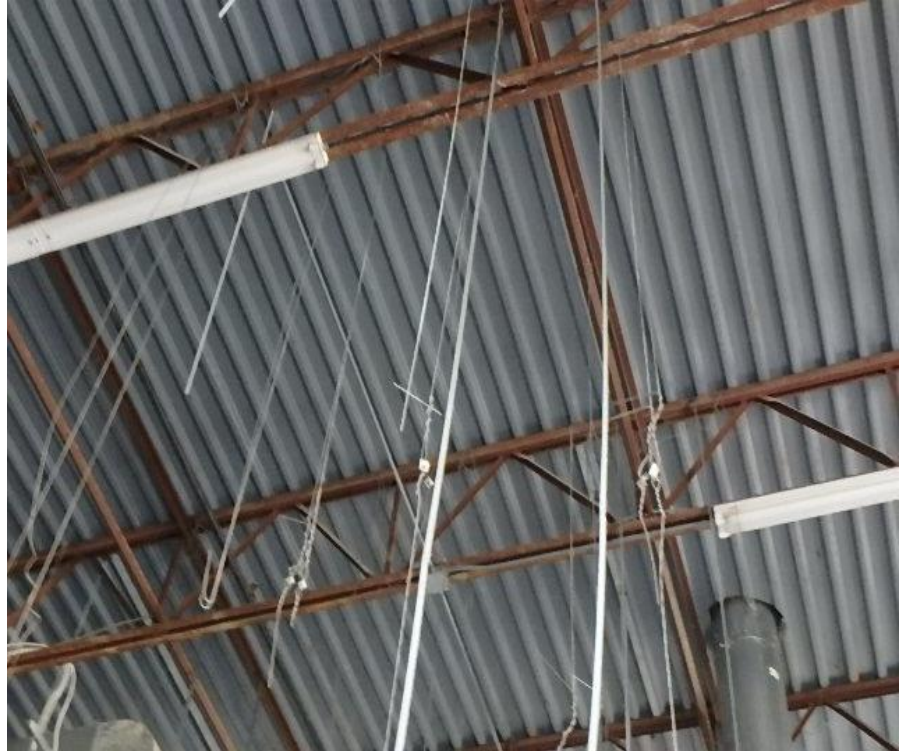
9. View of underside of roof deck at building interior

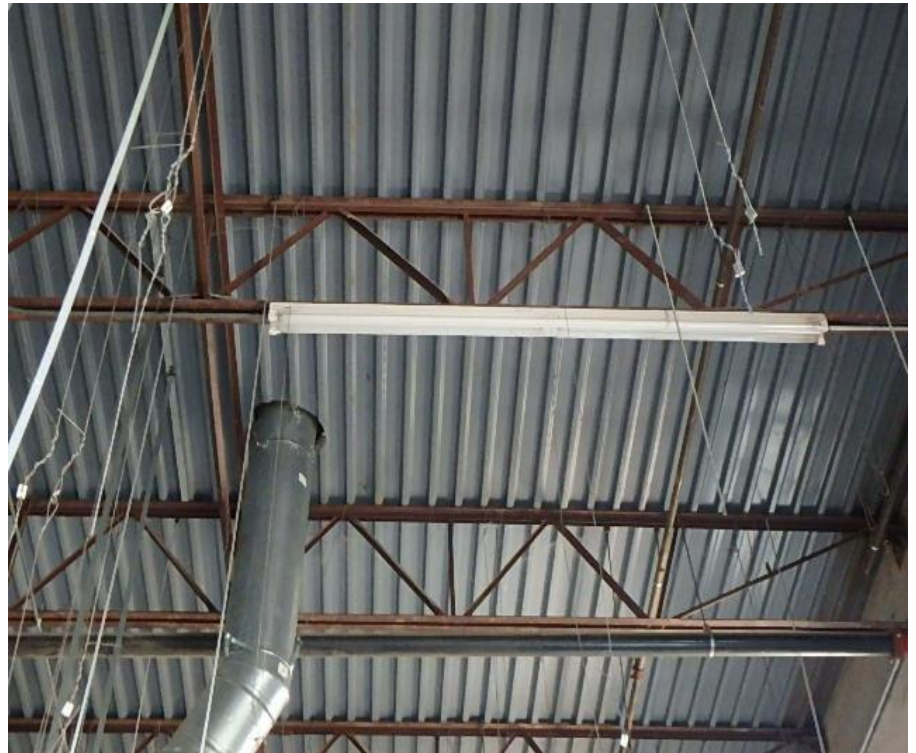
10. View of underside of roof deck at building interior

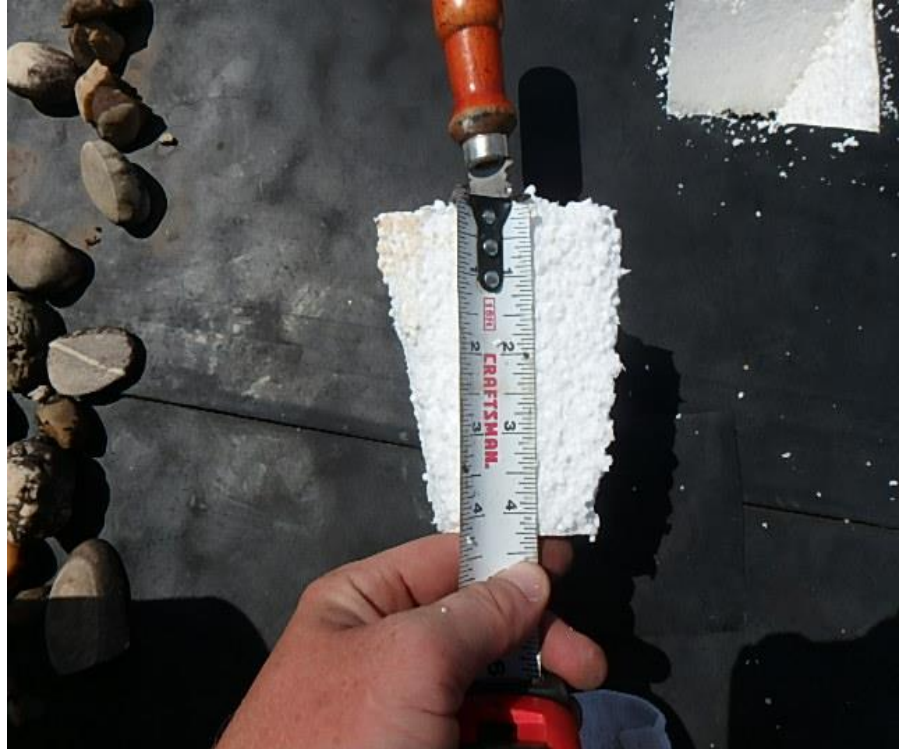
67. View of roof insulation measurement on Bldg 1 - Area C
