## **Domino Sugar Refinery**

# **Domino Sugar Facility**

**7412 N. Peters Street  
Arabi, LA**

**9/3/2022**

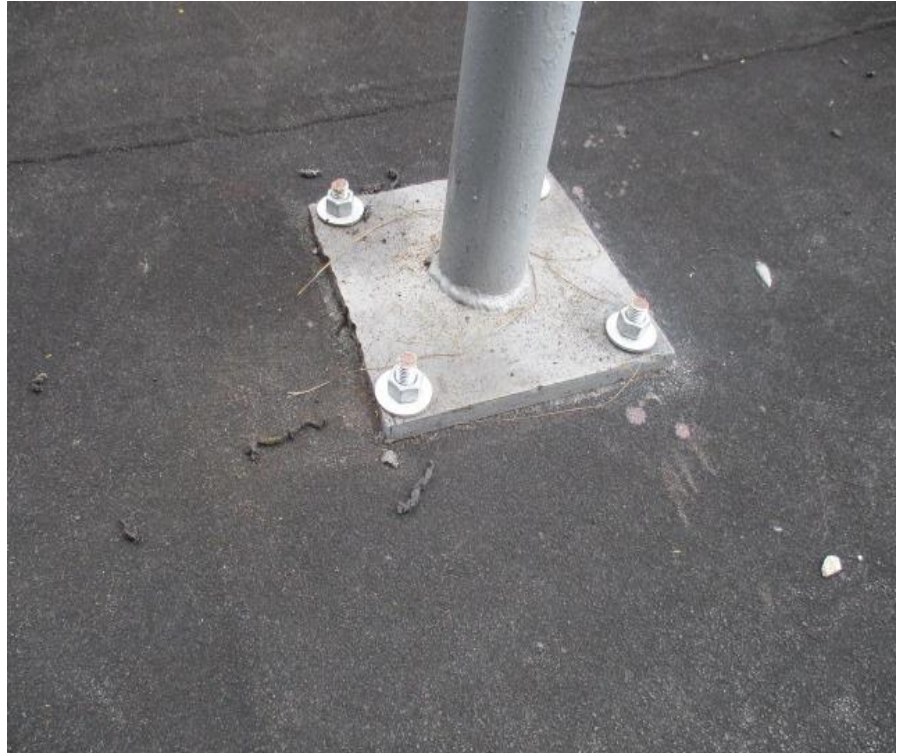
Roof Area - Bldg 8 - Area A

35. Deficiency #1 - Penetrations through roof surface have not been flashed

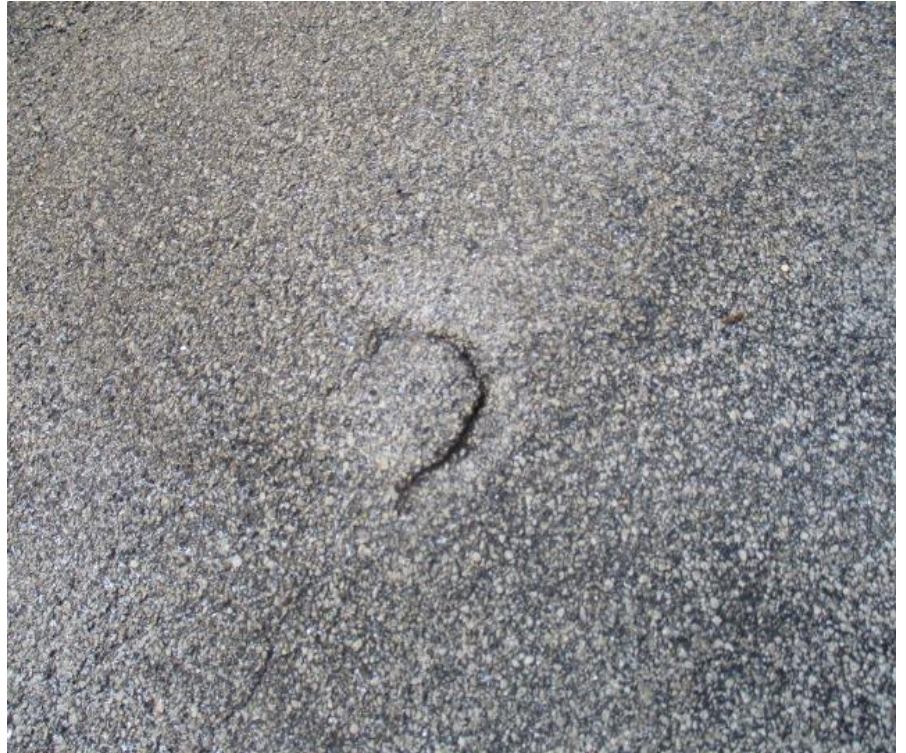
41. Deficiency #4 - Hole / puncture  
in membrane / felts

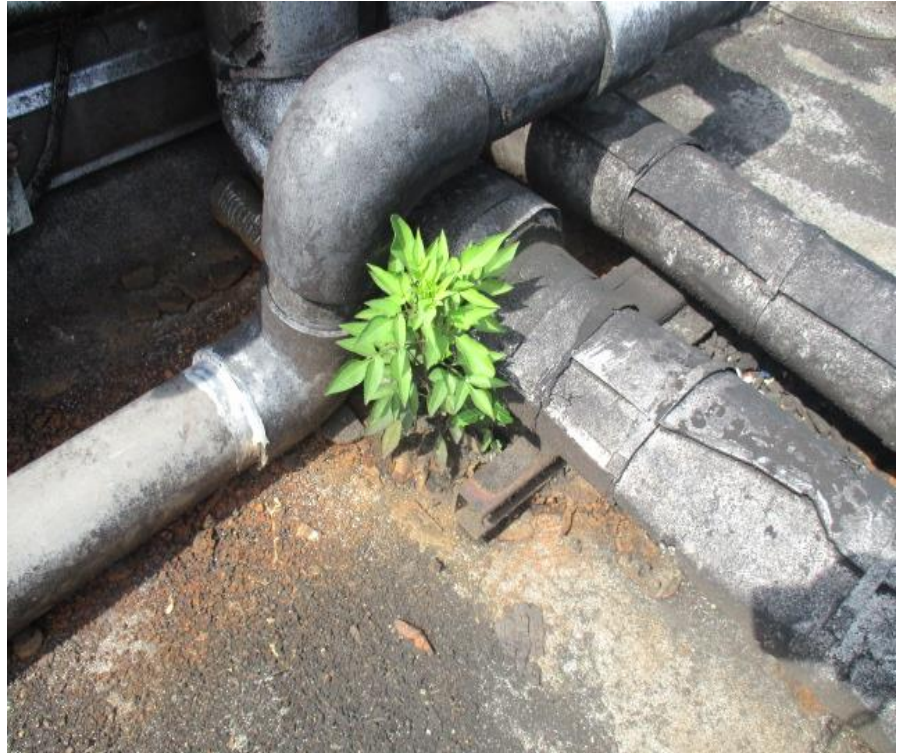
43. Deficiency #5 - Vegetative growth on roof surface

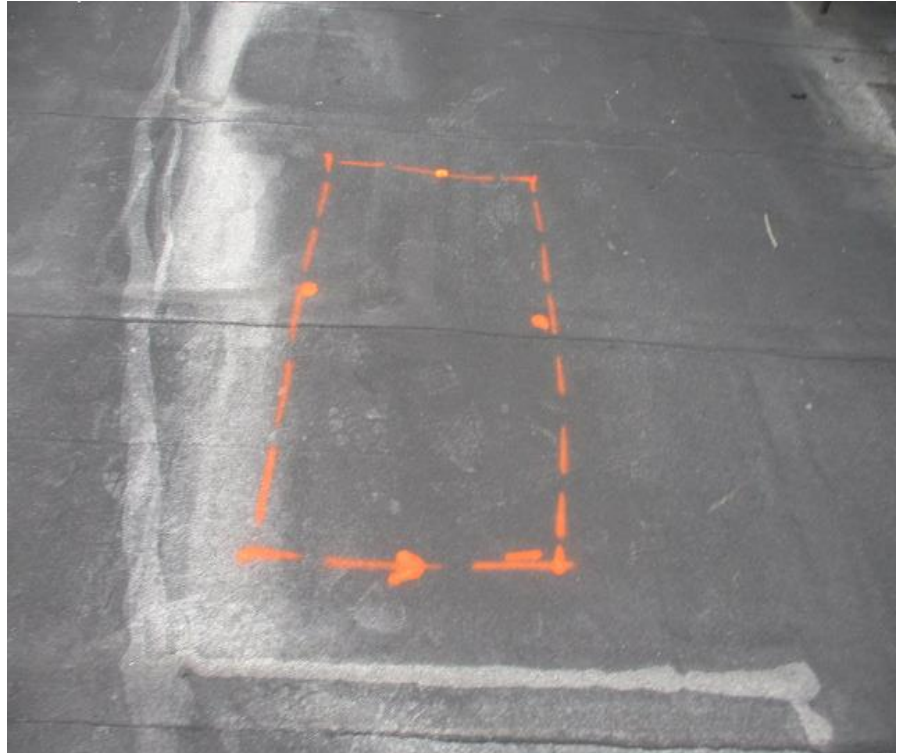
45. Deficiency #22 - Wet insulation /  
moisture entrapment

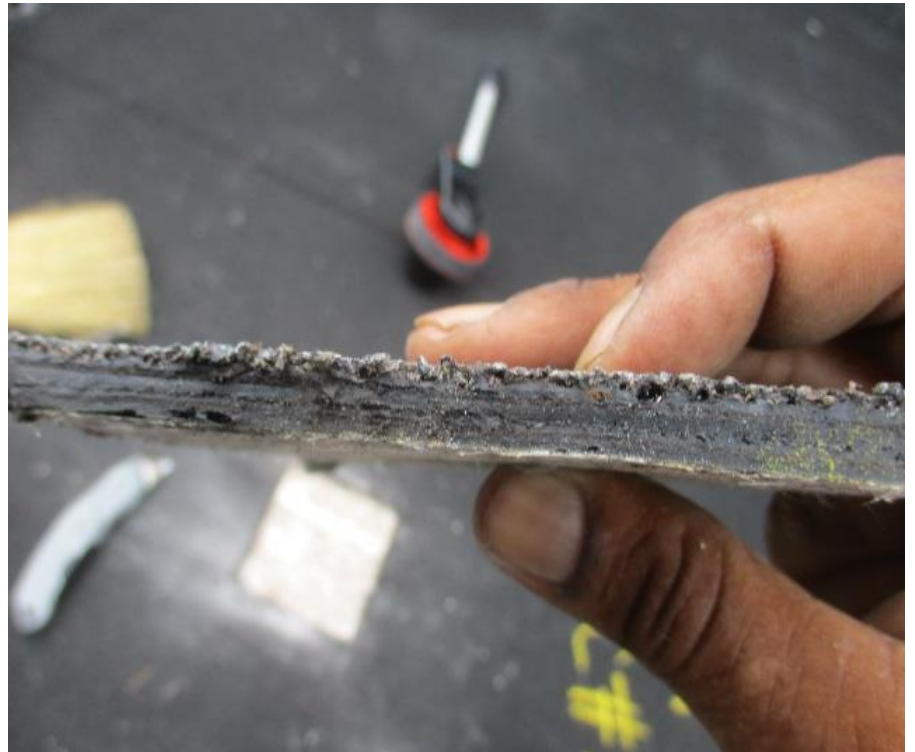
46. Test Cut #1 (Area A): View of  
modified bitumen plies

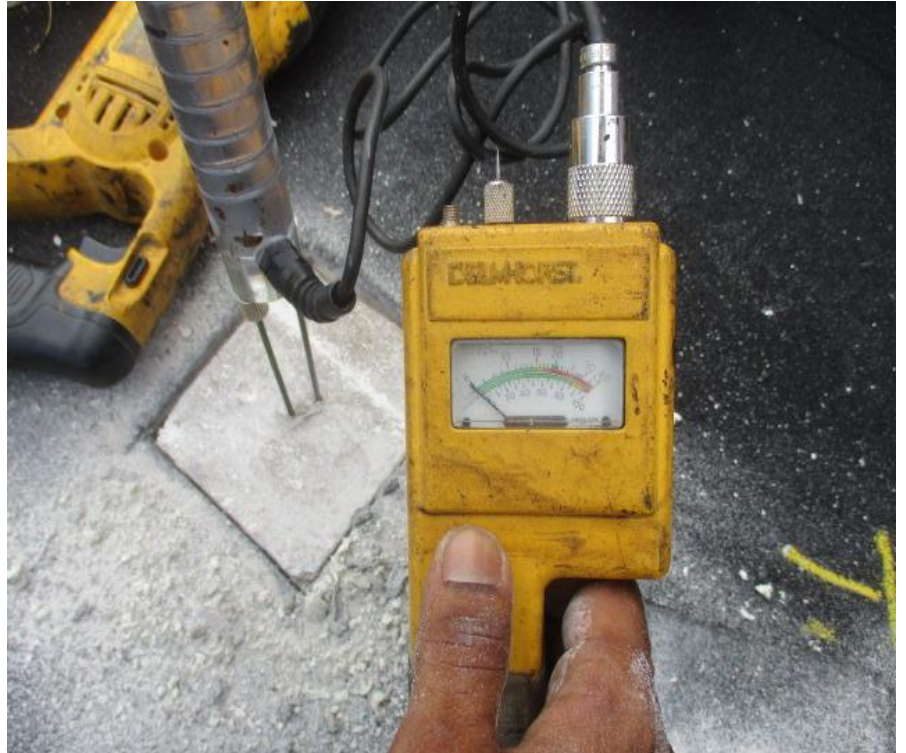
47. Test Cut #1 (Area A): Delmhorst moisture meter reading negative for moisture within the DensDeck sheathing layer

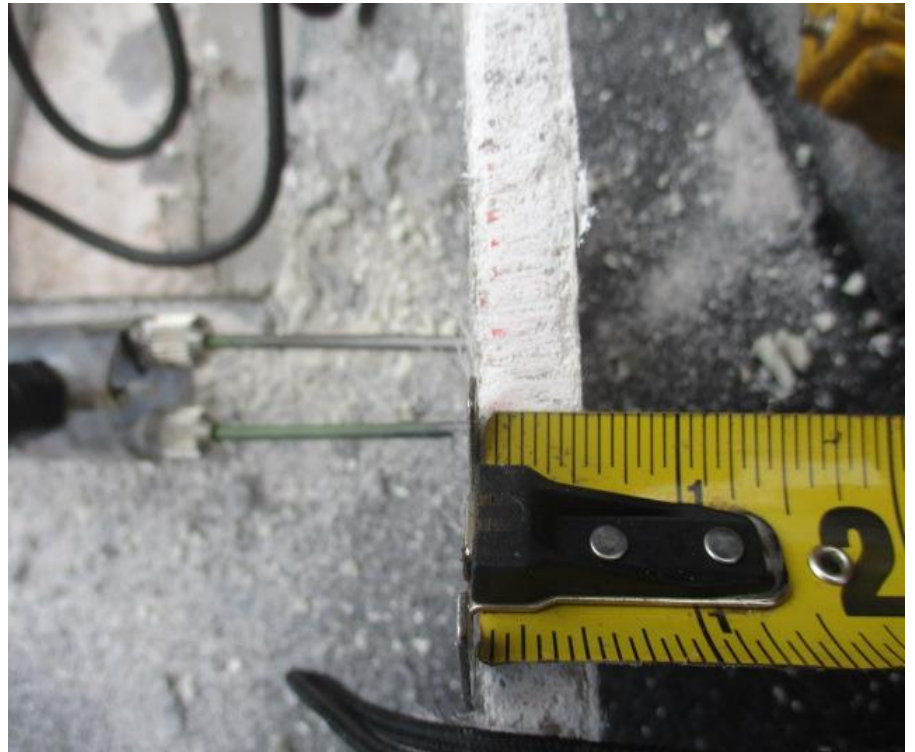
48. Test Cut #1 (Area A): DensDeck measurement

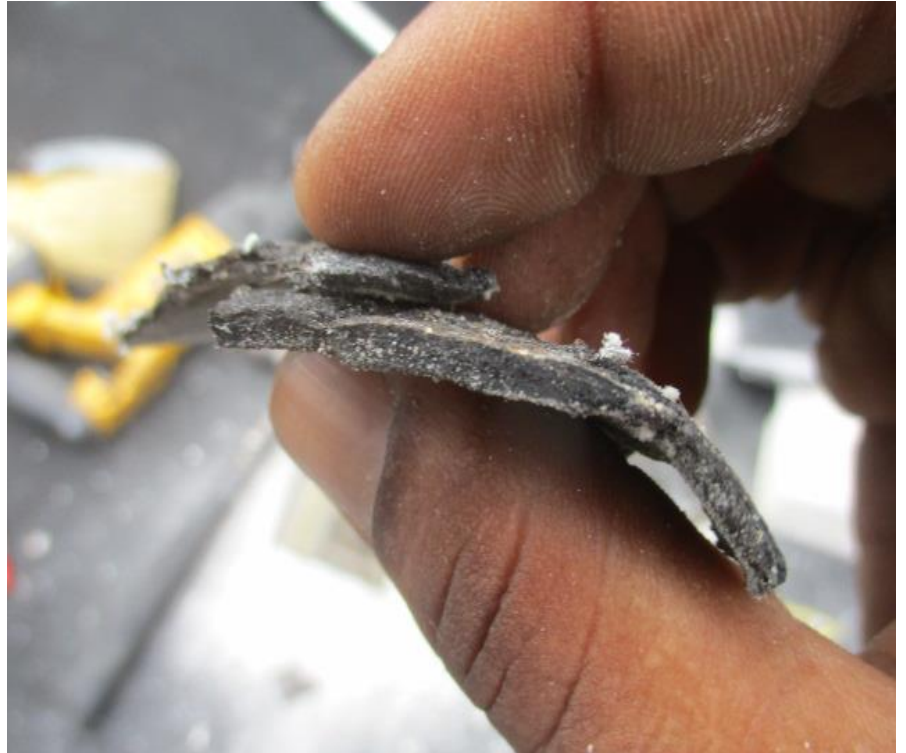
51. Test Cut #1 (Area A): View of smooth modified vapor retarder installed to structural decking

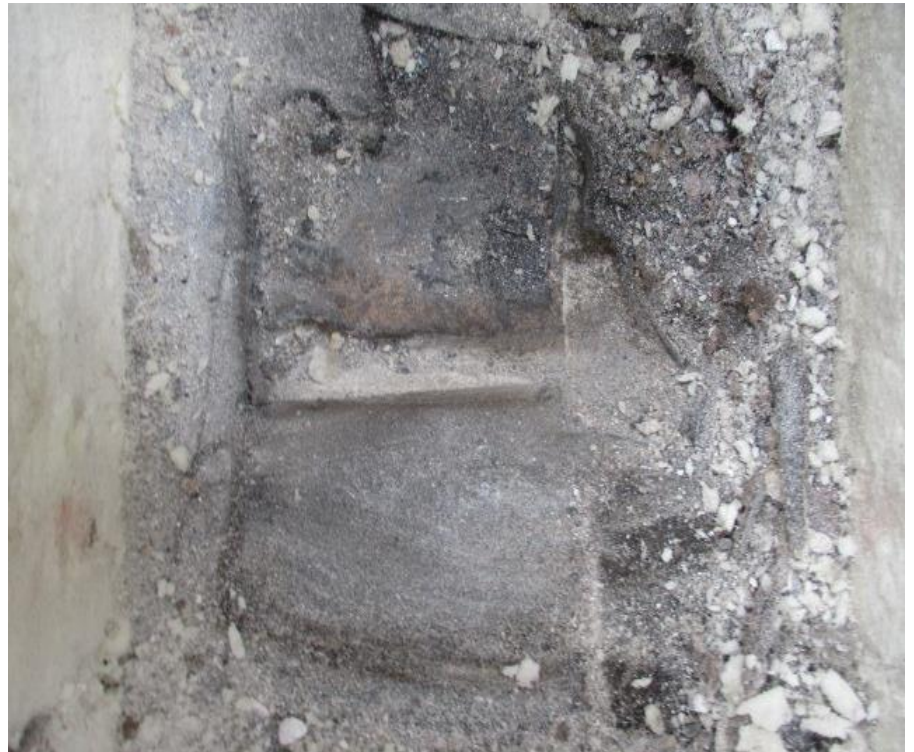
52. Test Cut #1 (Area A):  
Composition removed exposing a  
pre-cast concrete tee roof deck

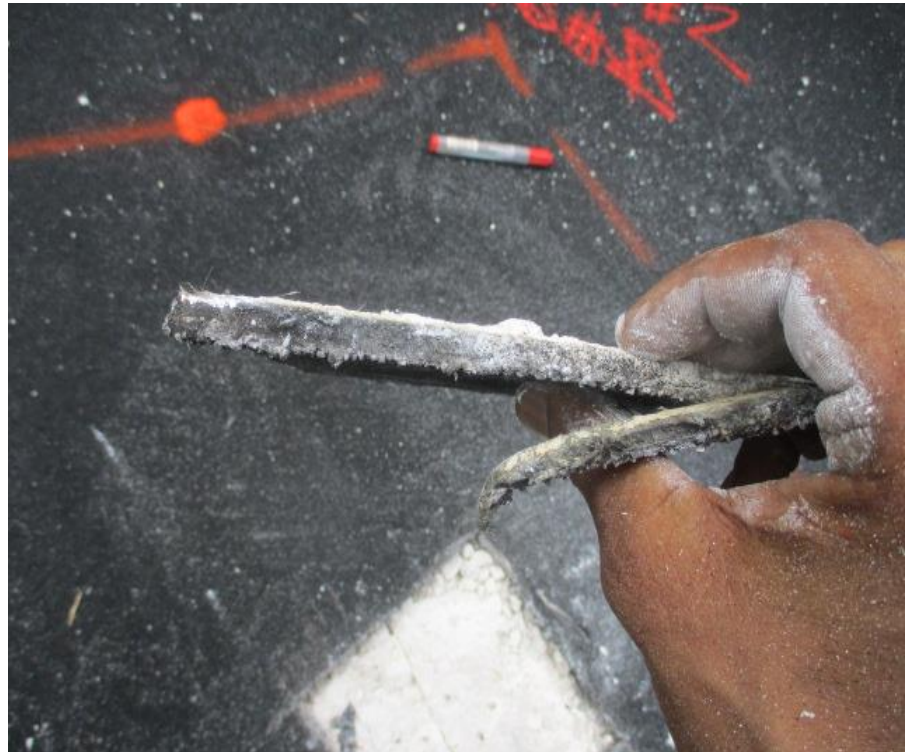
54. Probe #2 (Area A): View of  
modified bitumen plies

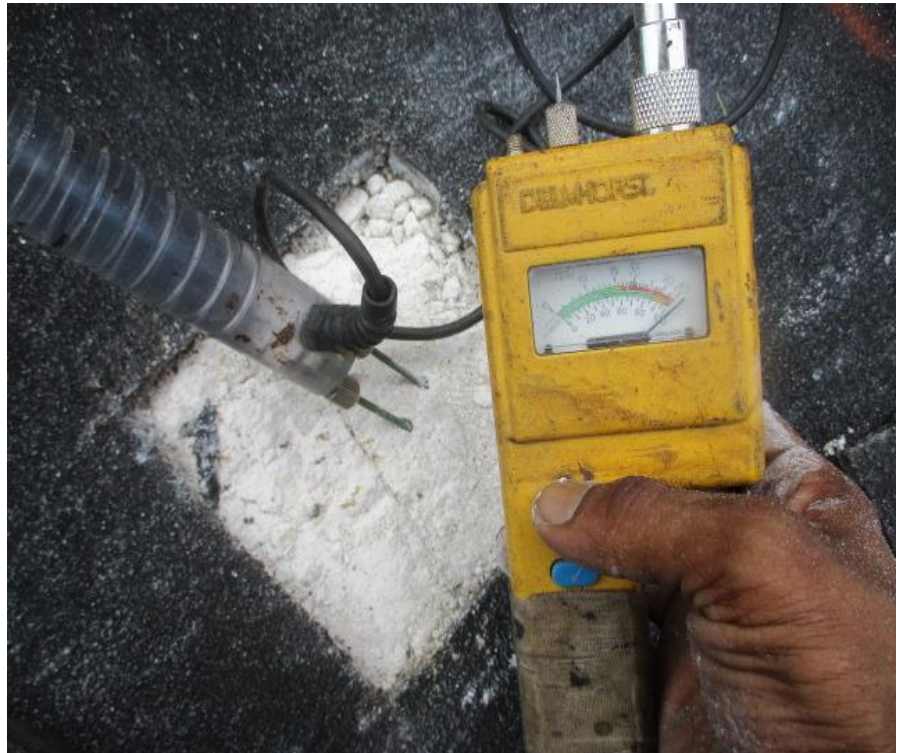
55. Probe #2 (Area A): Delmhorst moisture meter reading positive for moisture within the DensDeck sheathing layer.

Visible deterioration of DensDeck sheathing observed

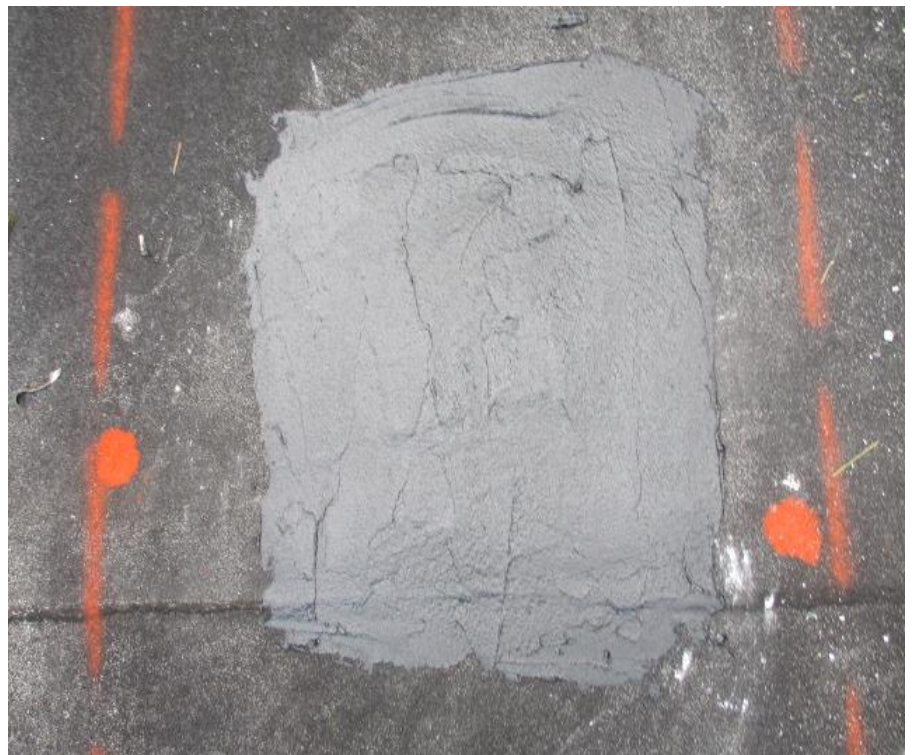
56. Probe #2 (Area A): View of RCS repair

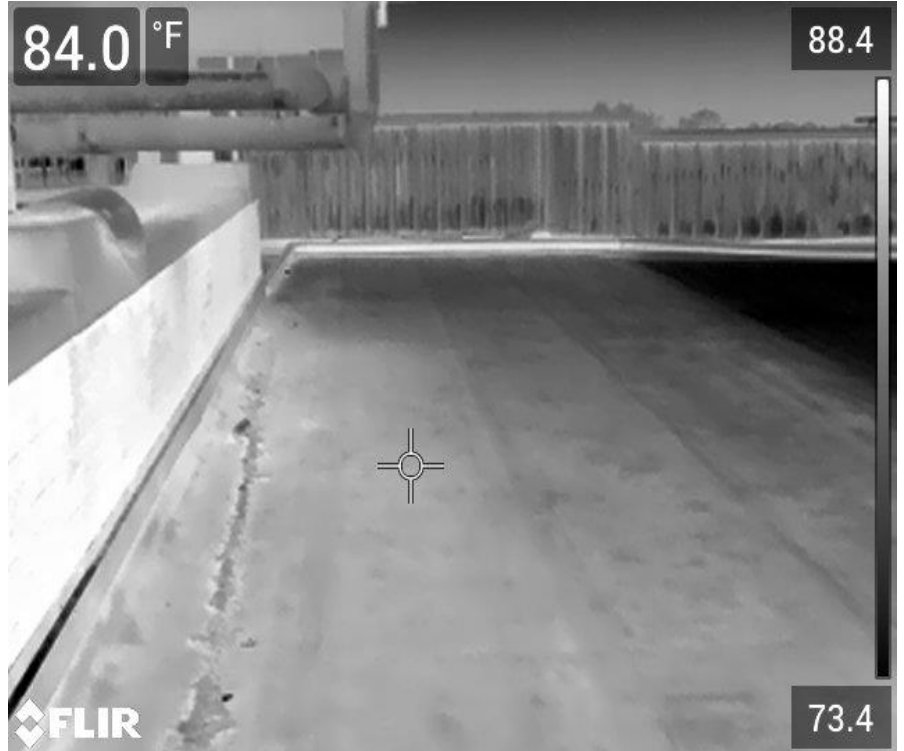
**61. Infrared image on Bldg 8 - Area A with no suspect wet areas observed**

**Note: thermal anomaly observed in photo is due to change in structural deck type / roof system composition**

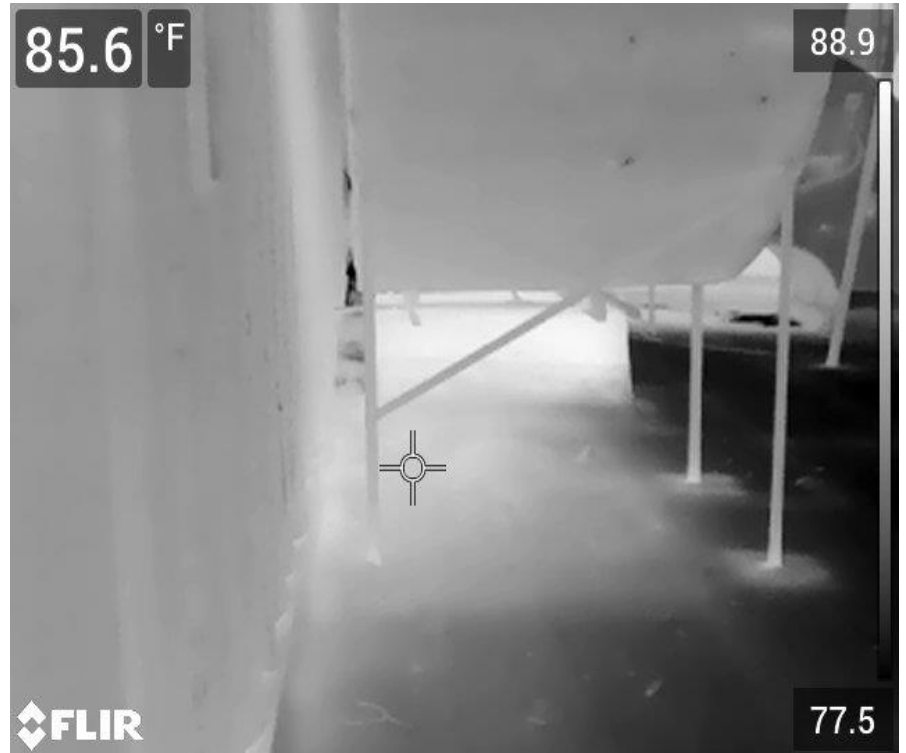
63. Infrared image on Bldg 8 - Area A with suspect wet areas observed

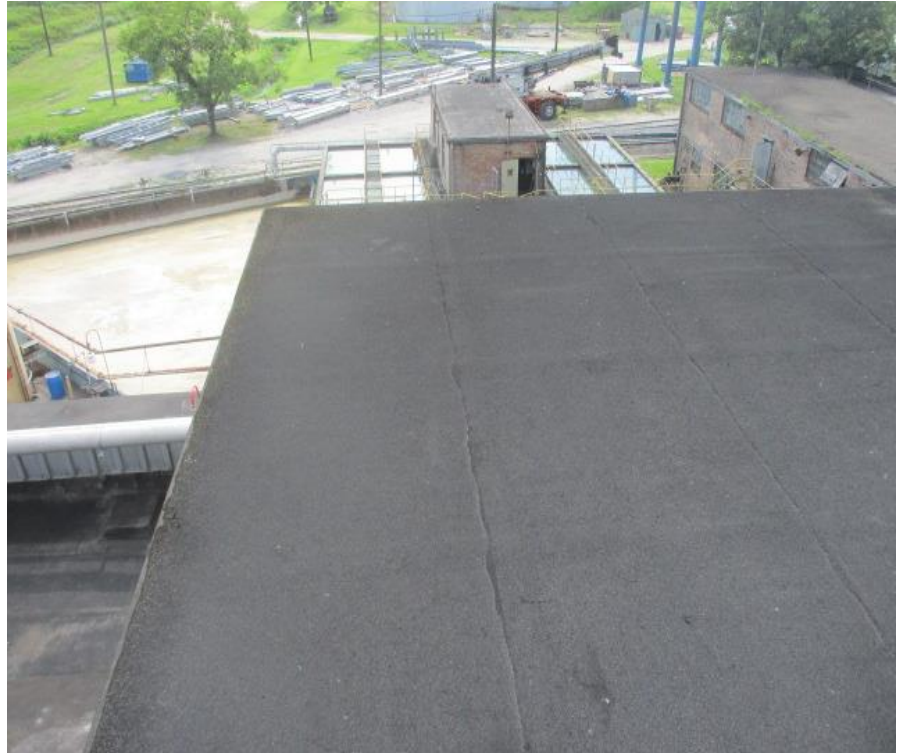
**1. Bldg 8 - Area B roof system overview**

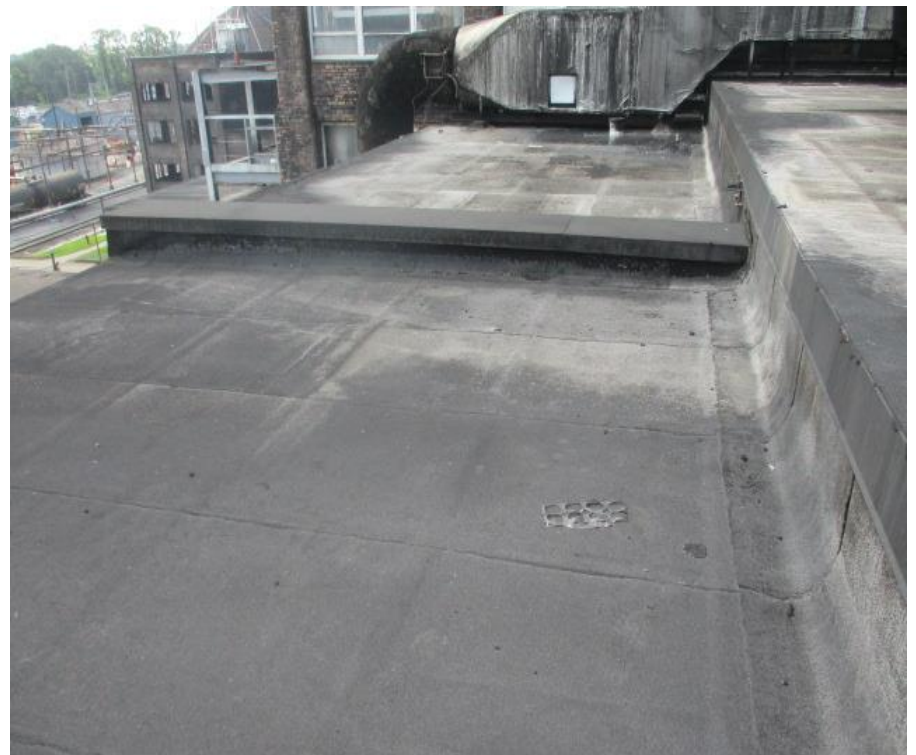
**2. Bldg 8 - Area B roof system overview**

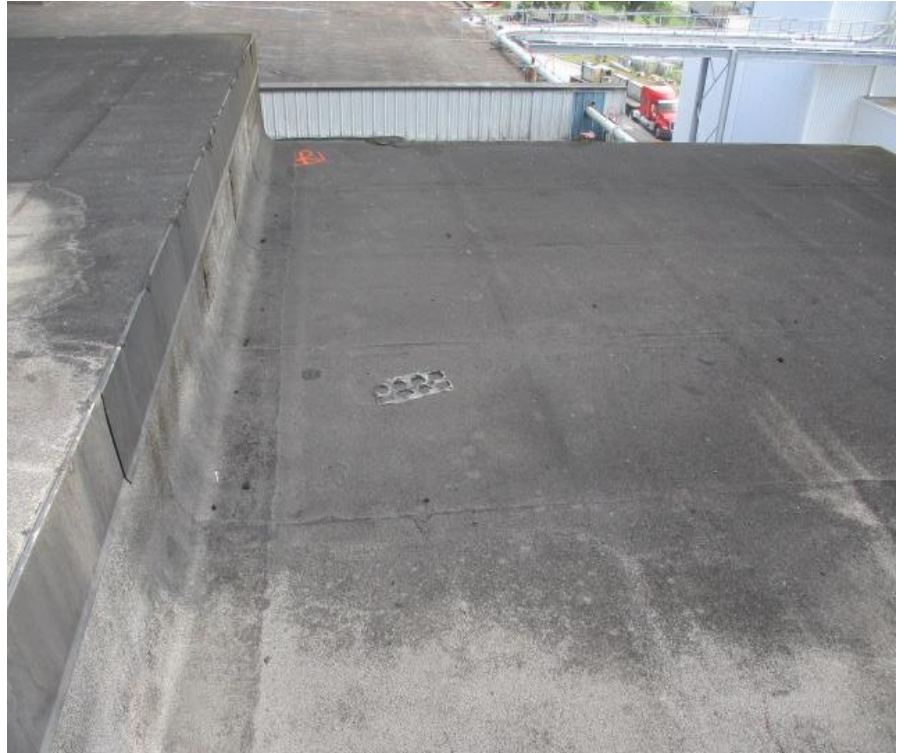
3. Bldg 8 - Area B roof system overview

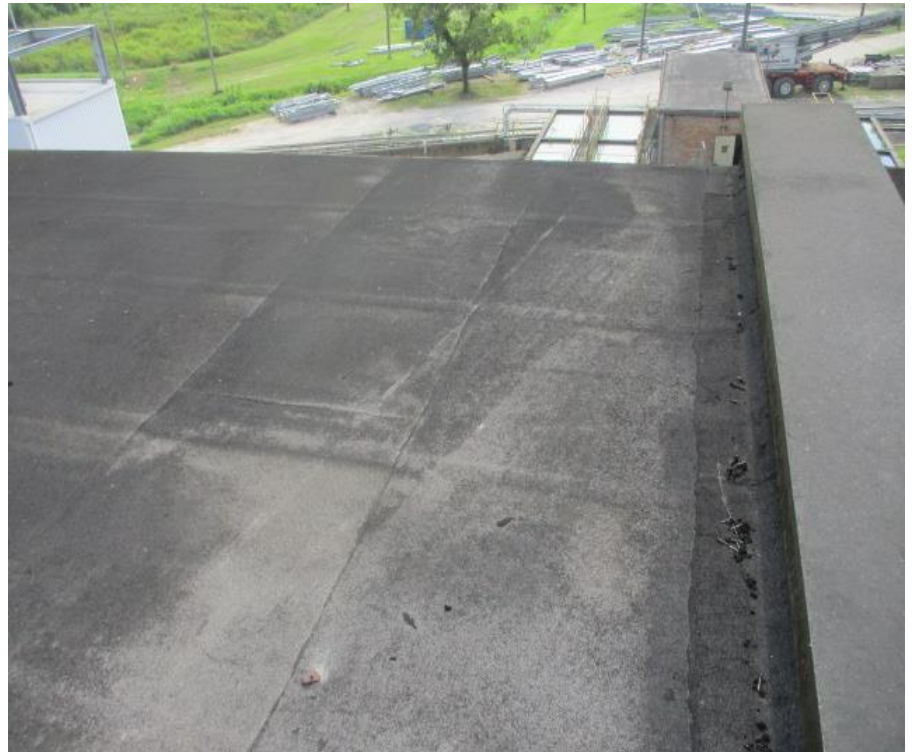
4. Bldg 8 - Area B roof system overview

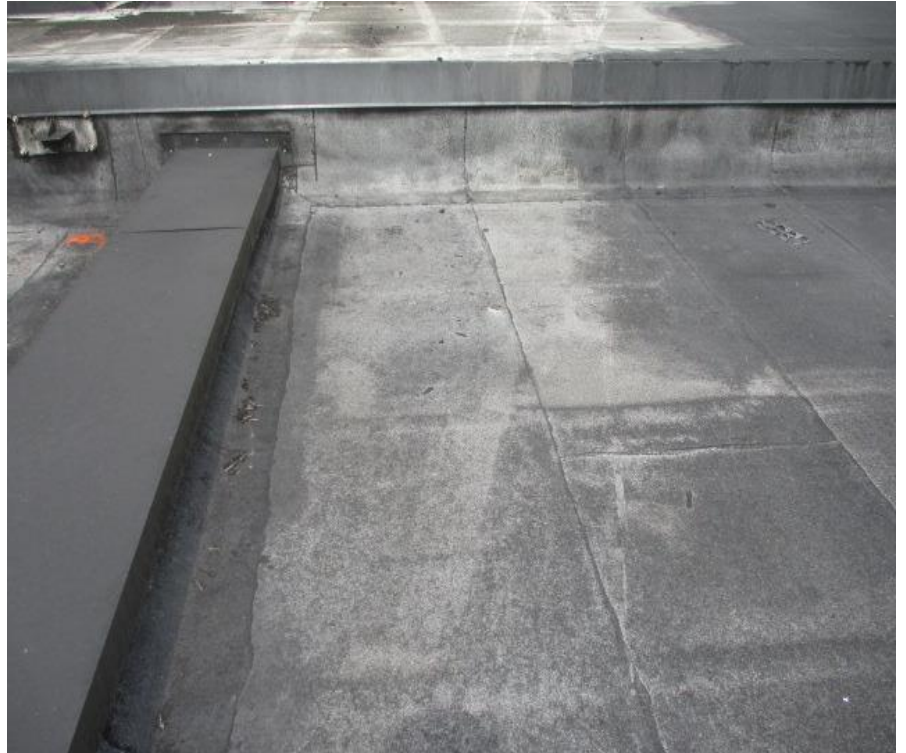
5. Bldg 8 - Area B roof system overview

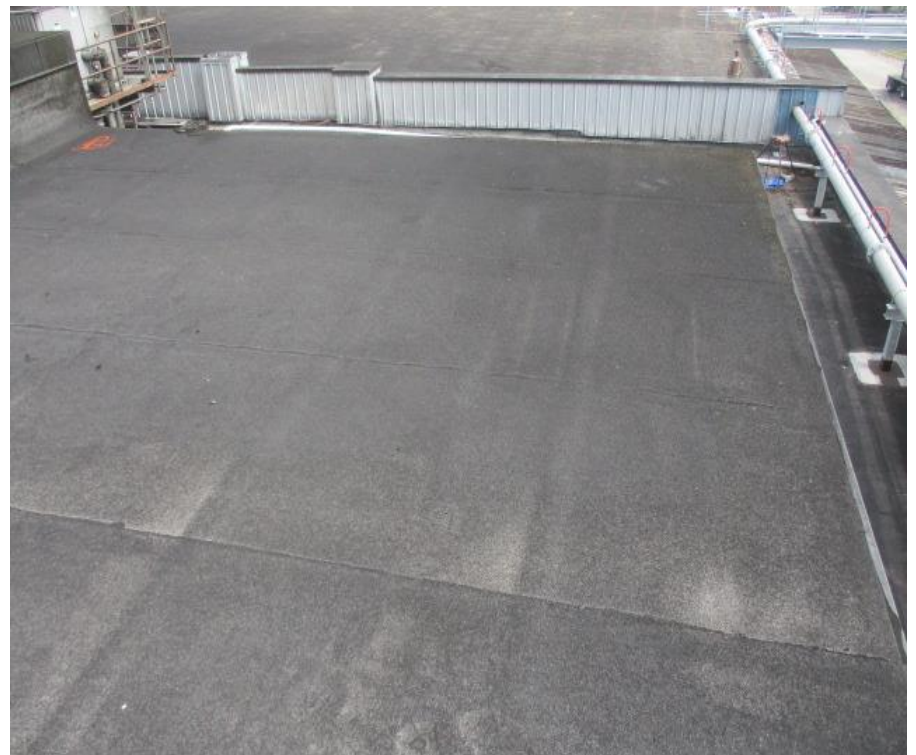
6. Bldg 8 - Area B roof system overview

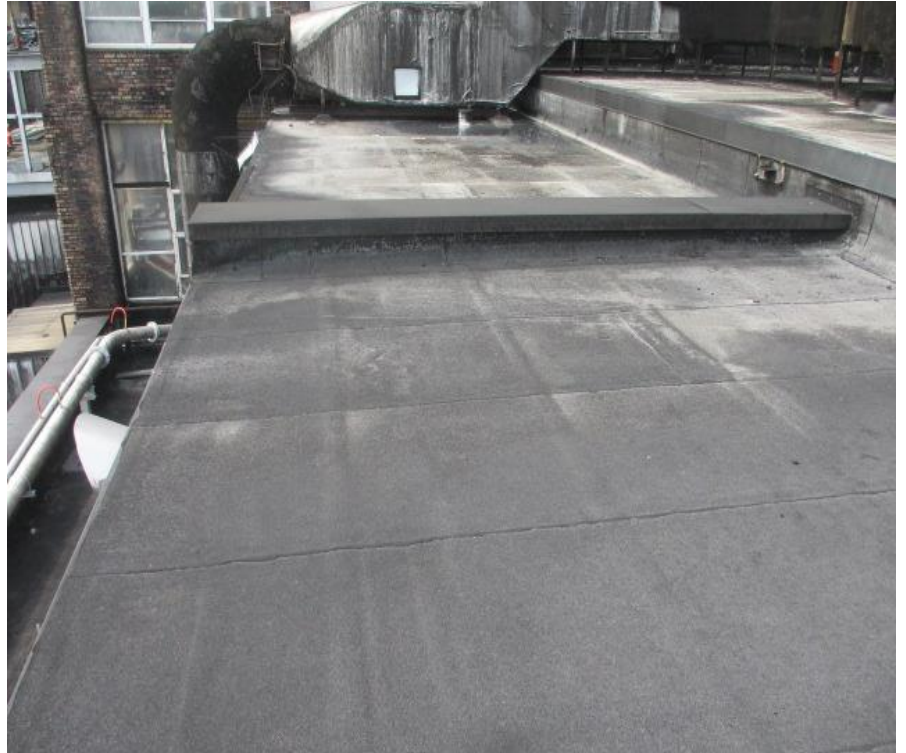
7. Bldg 8 - Area B roof system overview

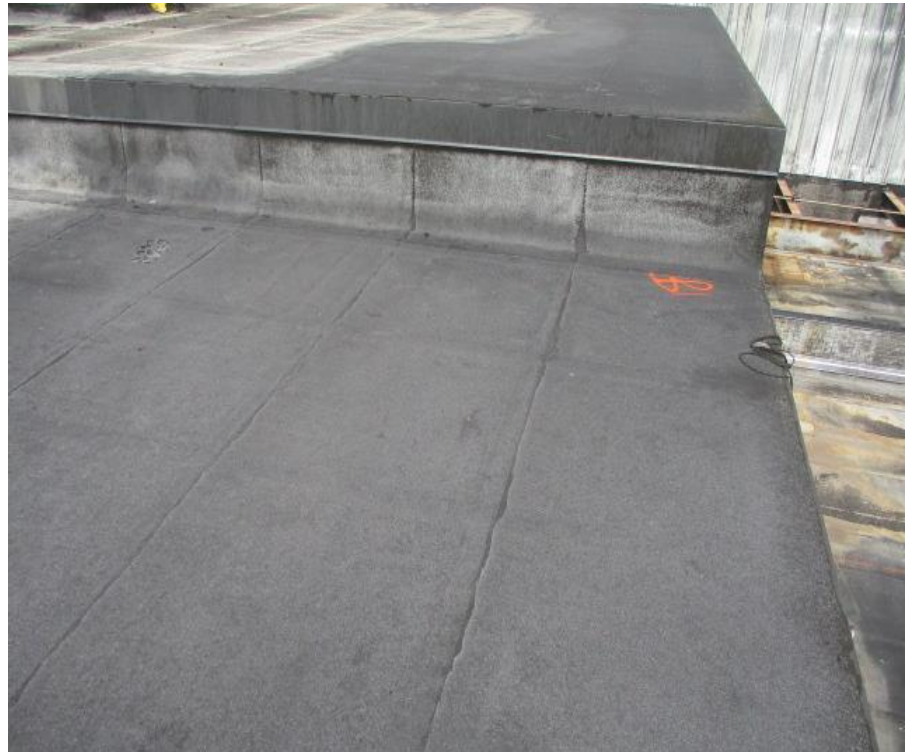
8. Bldg 8 - Area B roof system overview

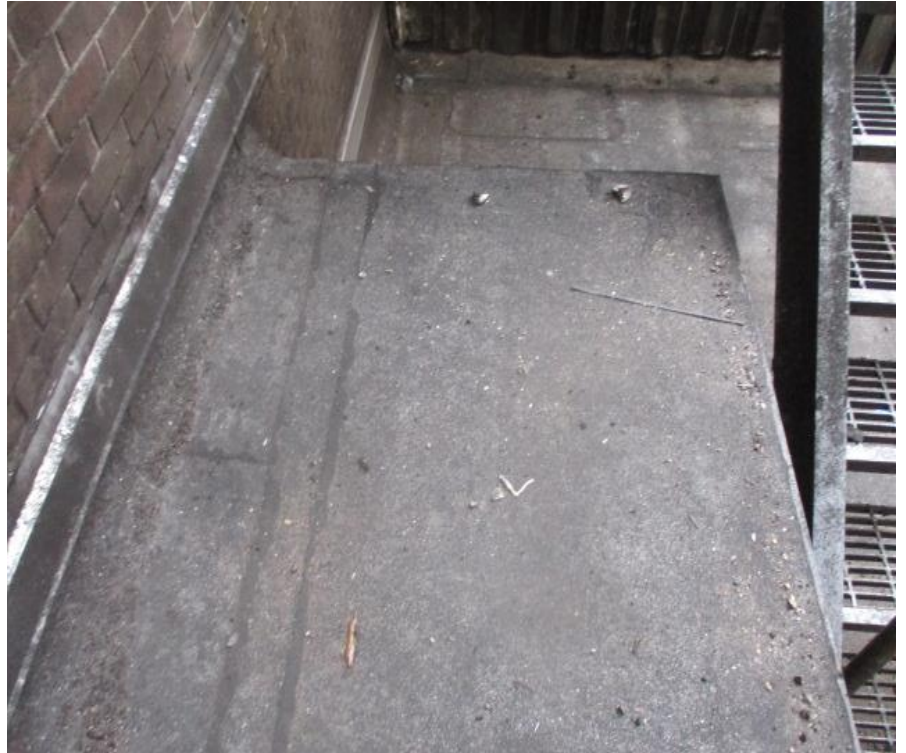
9. Bldg 8 - Area E1 roof system overview

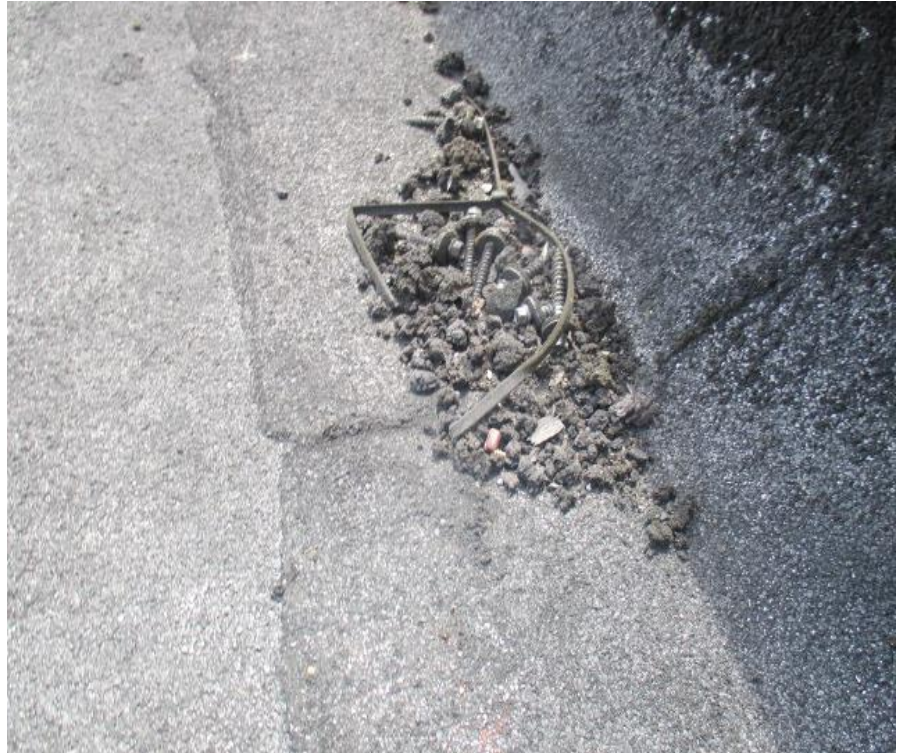
11. Deficiency #2 - Debris on roof surface

NUMBER	PRIORITY CODE	DEFICIENCY DESCRIPTION	QUANTITY	UNIT PRICE	REPAIR COST
		DEFICIENCY SOLUTION	UNITS		
2	M	Debris on roof surface	1	\$25.00	\$25.00
		Remove and properly dispose of all debris	Location		
9	M	Missing / deteriorated sealant at metal counter flashing	2	\$35.00	\$70.00
		Seal with industrial grade polyurethane sealant of a color to match existing	LnFt

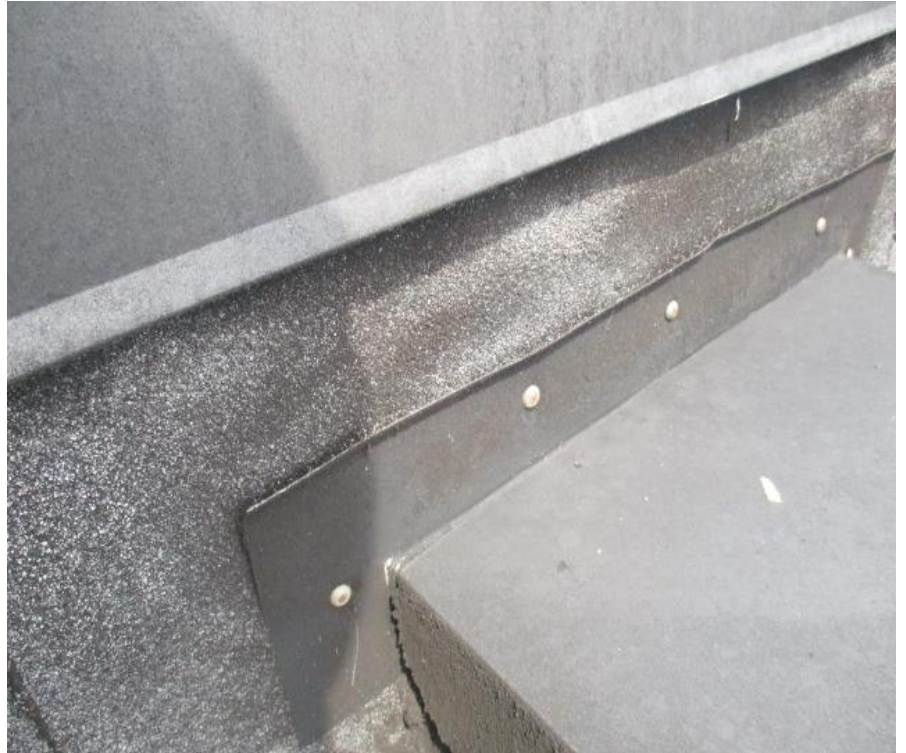
13. Deficiency #9 - Missing /  
deteriorated sealant at metal  
counter flashing

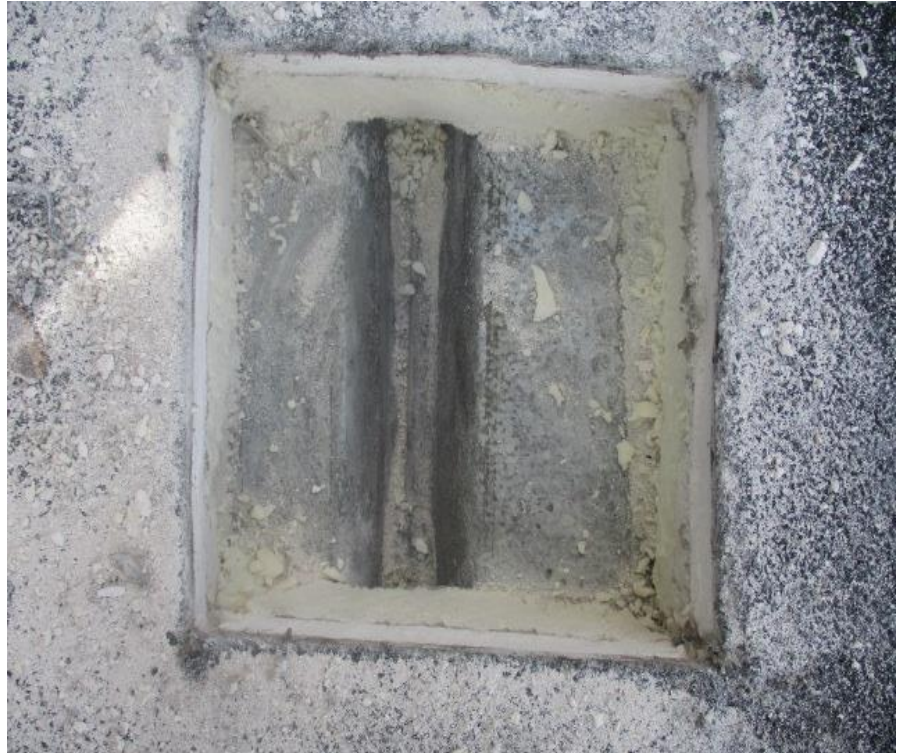
19. Test Cut #5 (Area B): View of roof composition removed exposing a galvanized metal deck

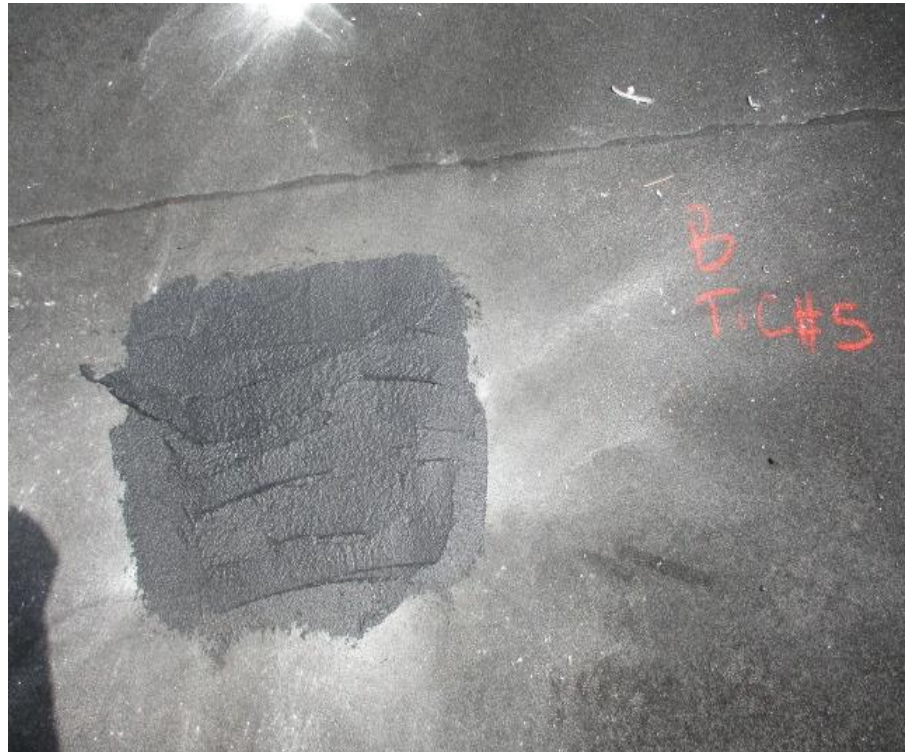
20. Test Cut #5 (Area B): View of RCS repair

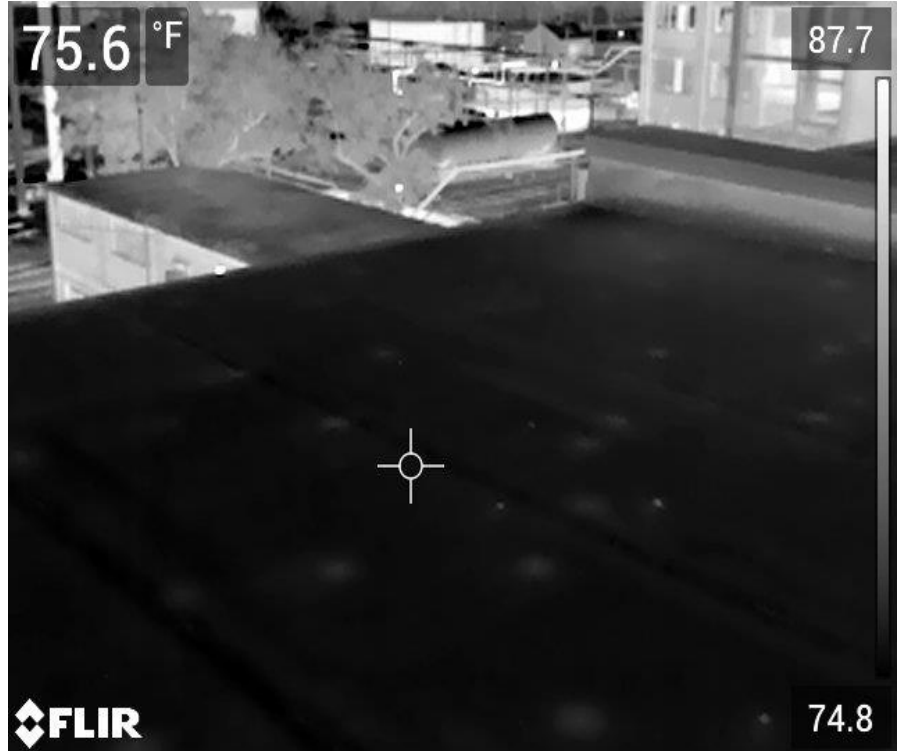
21. Infrared image on Bldg 8 - Area B with no suspect wet areas observed

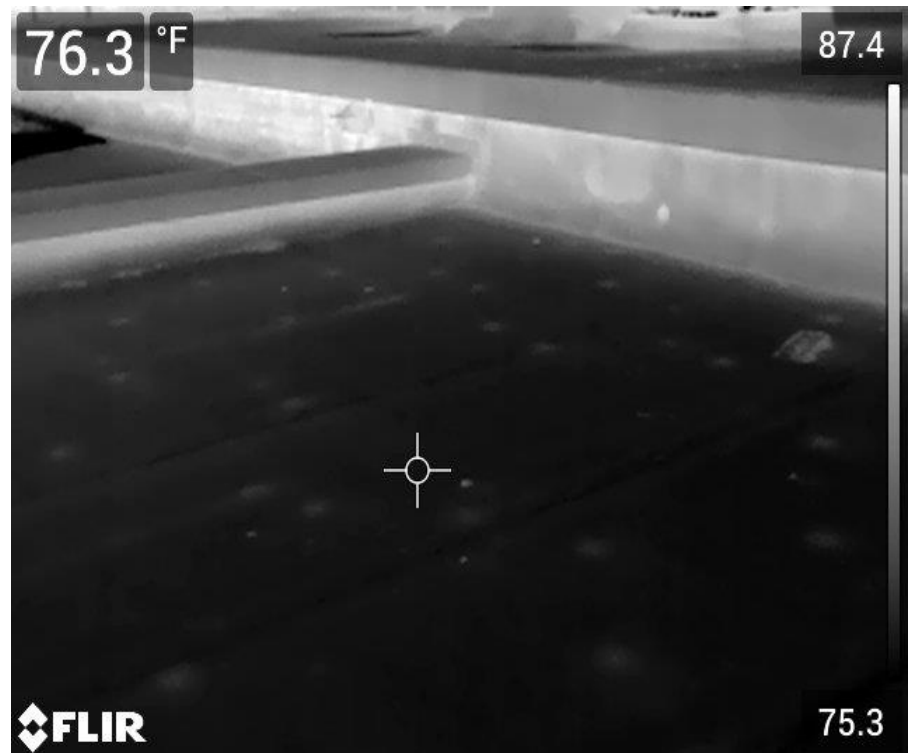
22. Infrared image on Bldg 8 - Area B with no suspect wet areas observed

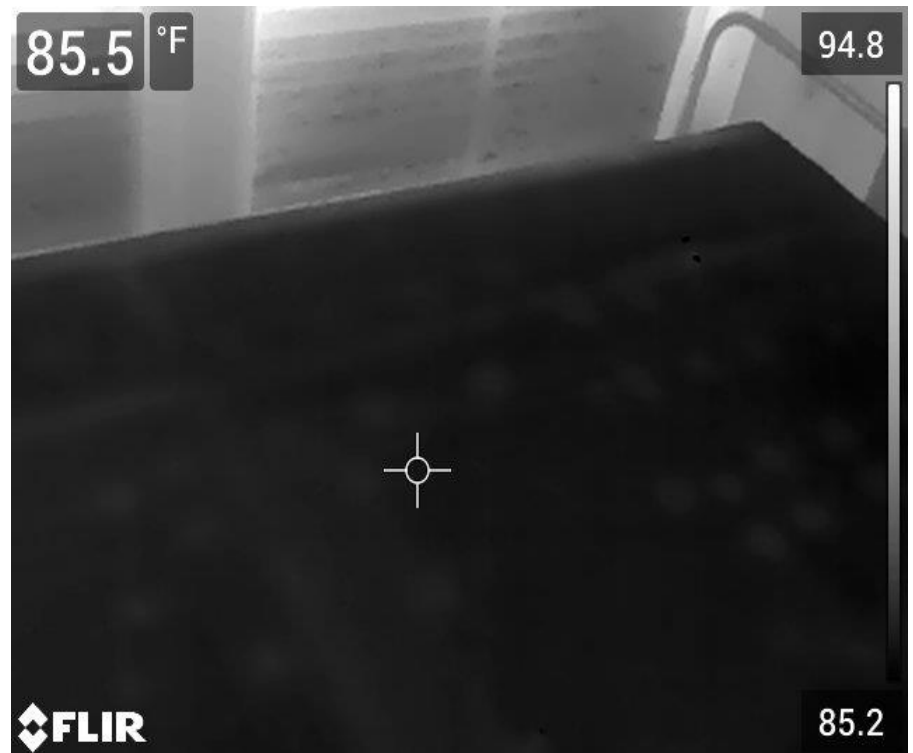
24. Infrared image on Bldg 8 - Area E1 with no suspect wet areas observed

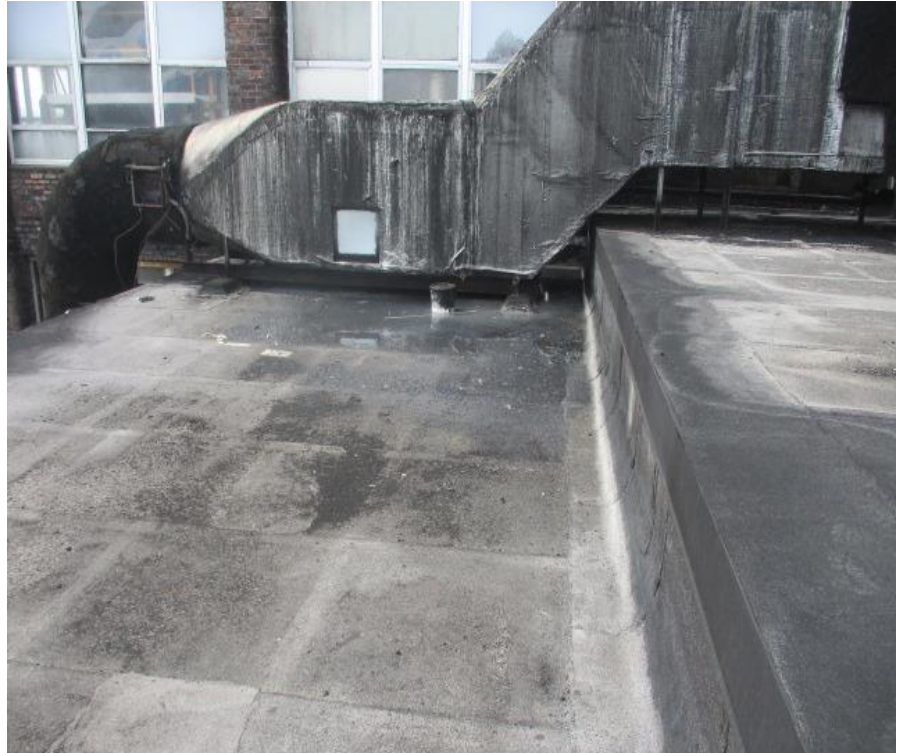
**1. Bldg 8 - Area B1 roof system  
overview**

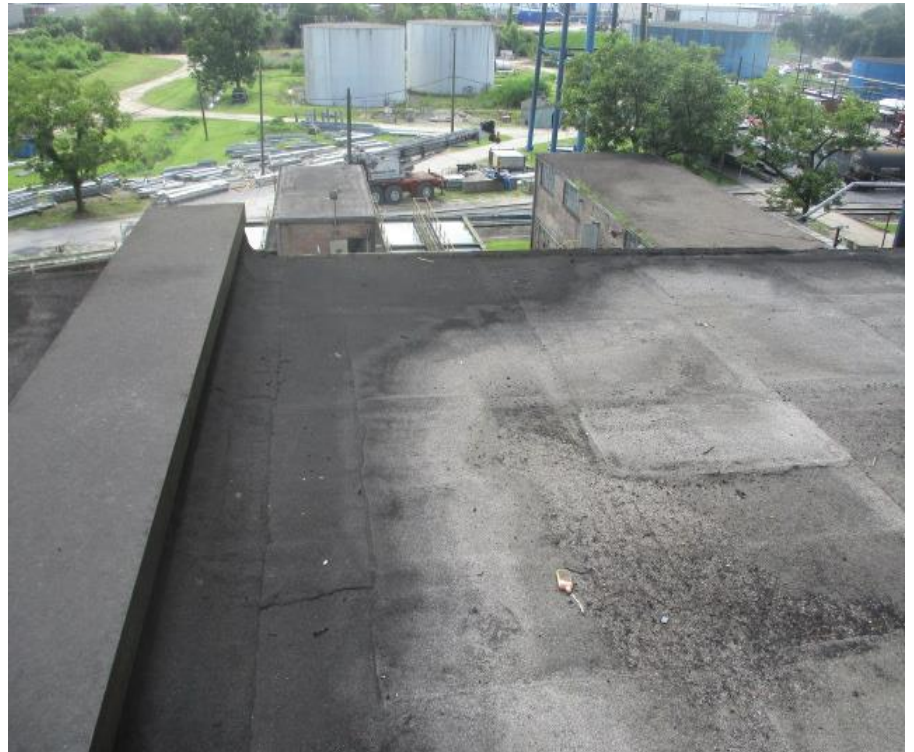
**2. Bldg 8 - Area B1 roof system  
overview**

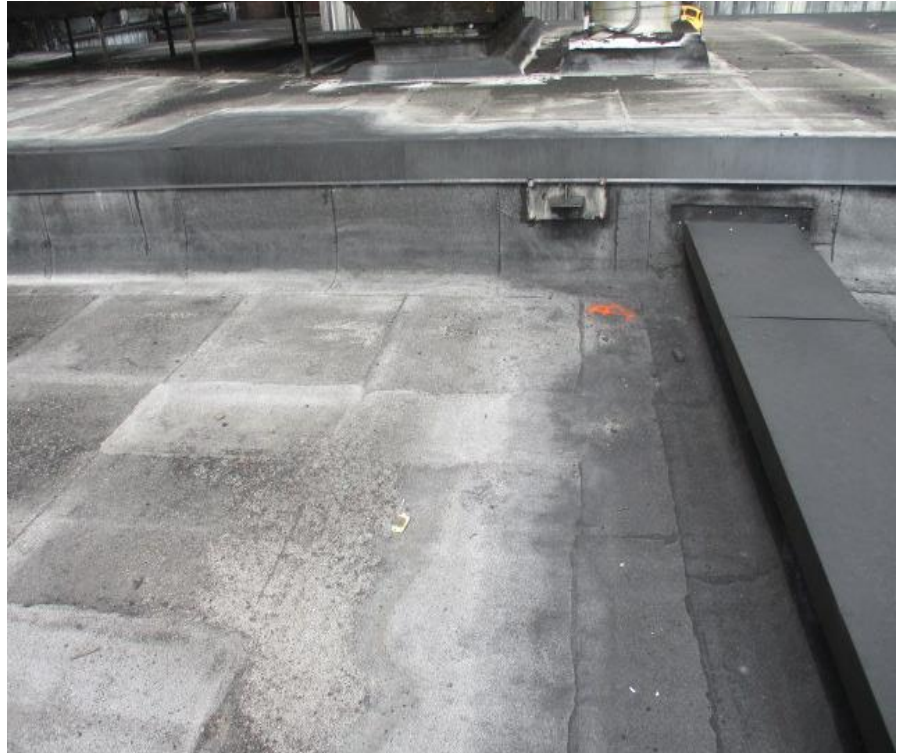
3. Bldg 8 - Area B1 roof system overview
