## **Domino Sugar Refinery**

# **Domino Sugar Facility**

**7412 N. Peters Street  
Arabi, LA**

**9/3/2022**

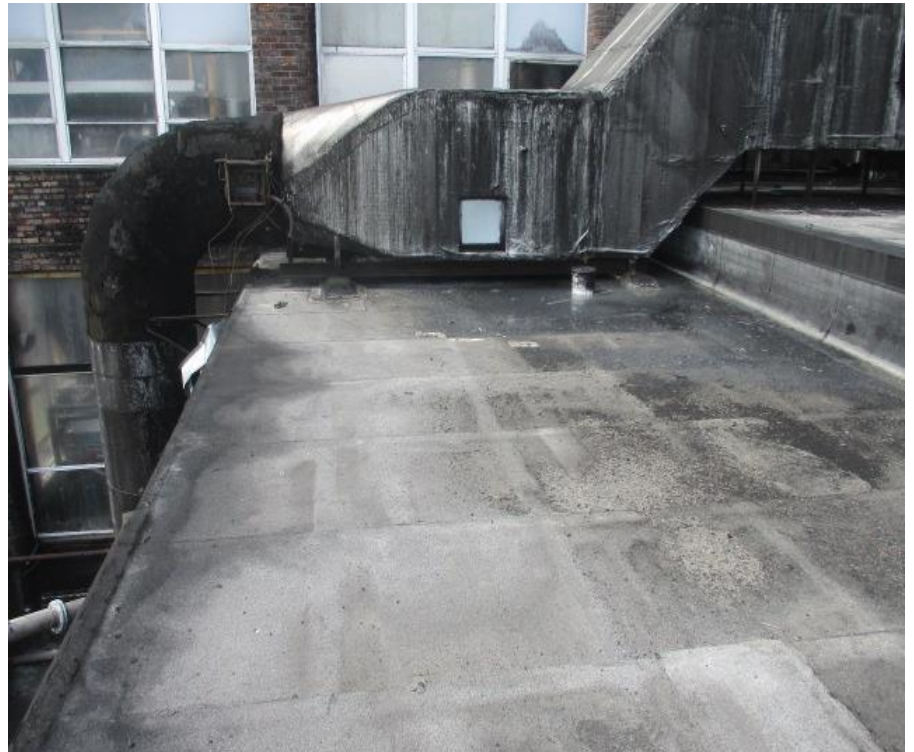
4. Bldg 8 - Area B1 roof system overview

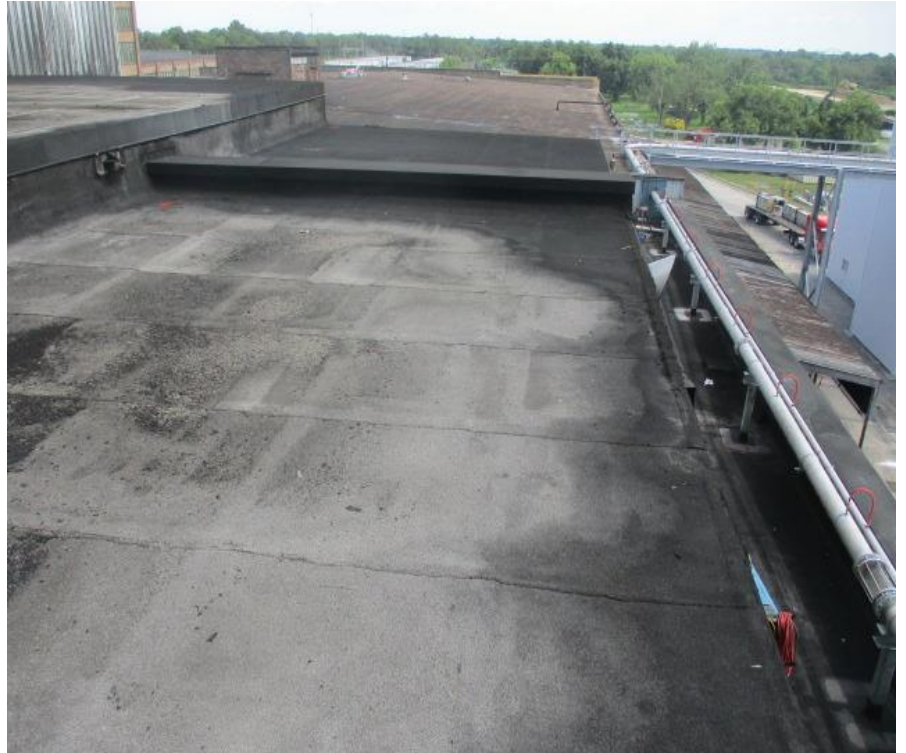
**5. Bldg 8 - Area B1 roof system overview**

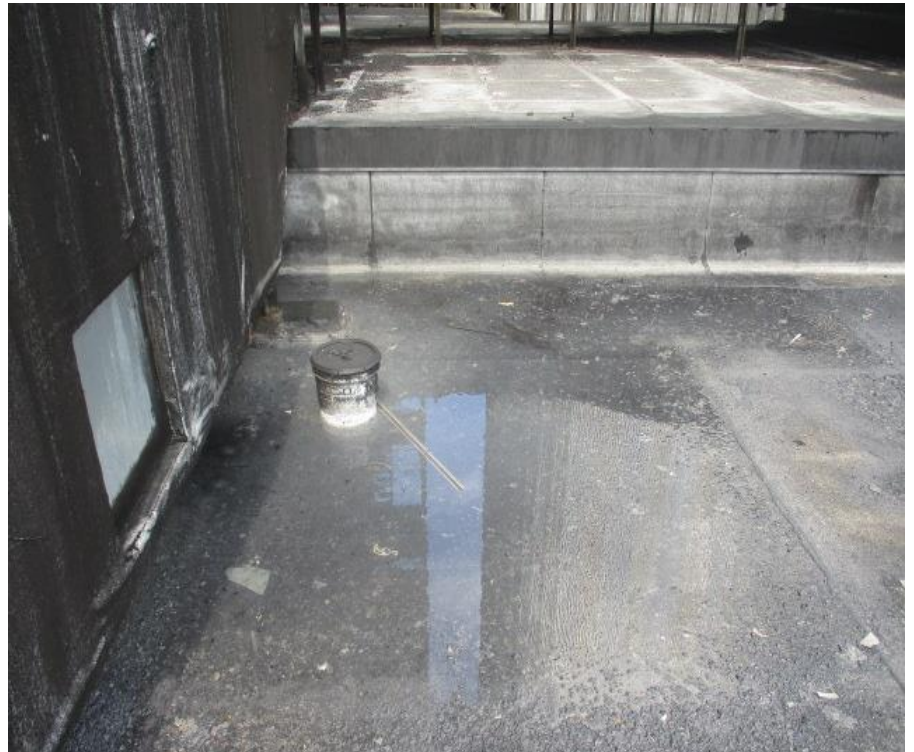
**6. Bldg 8 - Area B1 roof system overview**

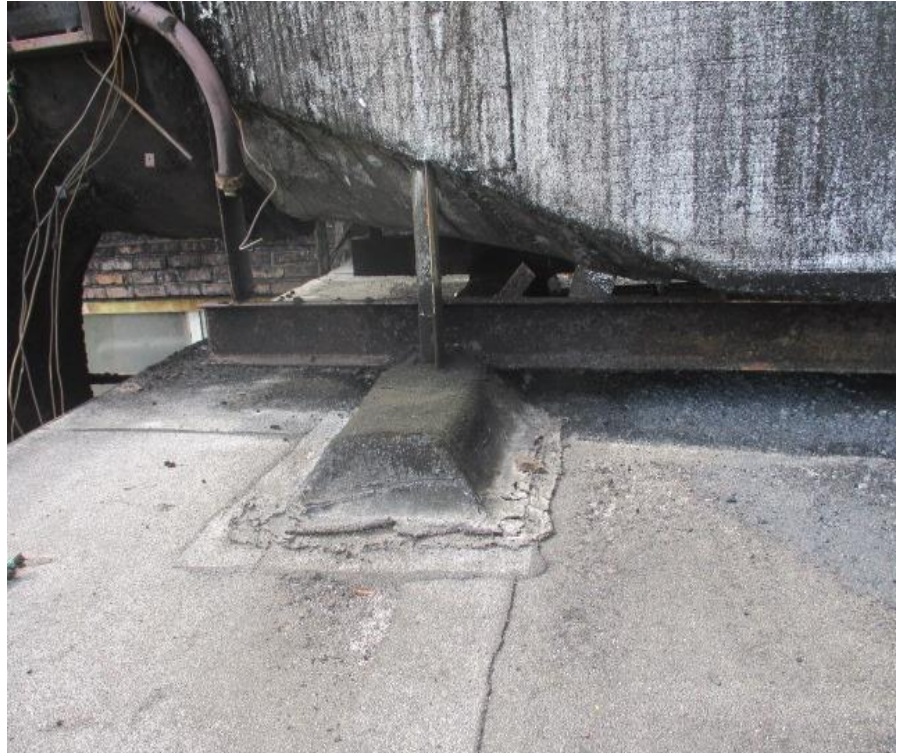
7. Bldg 8 - Area B1 roof system overview

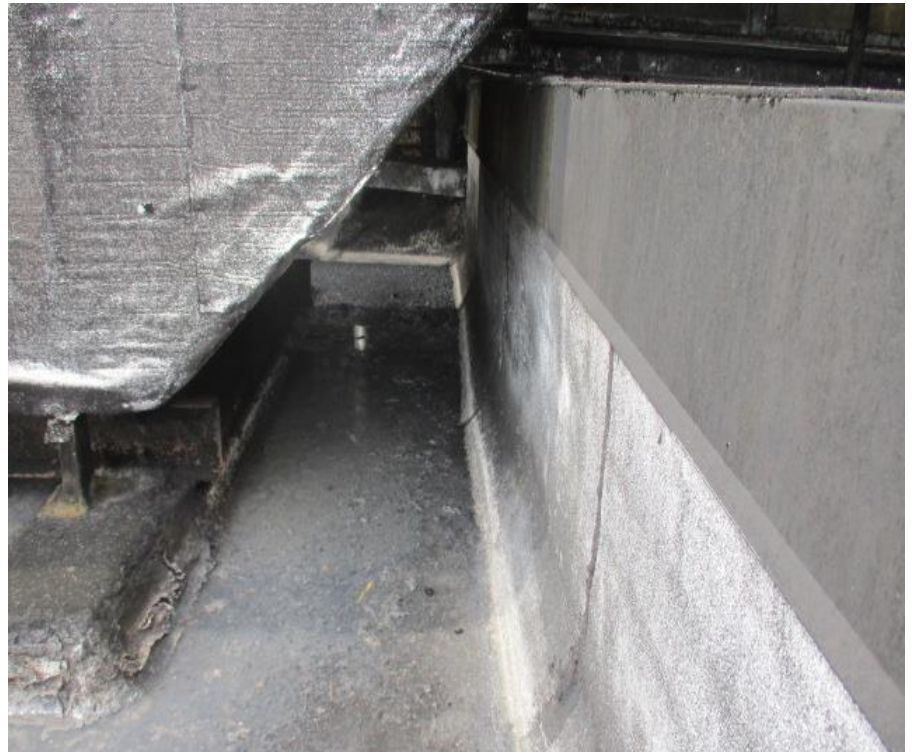
8. Bldg 8 - Area B1 roof system overview

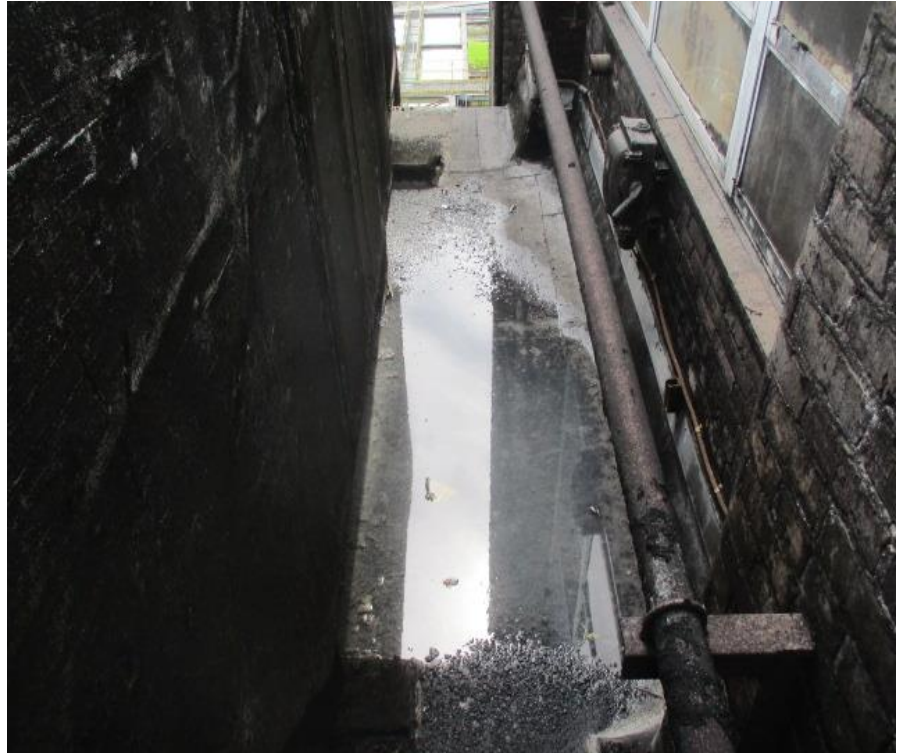
9. Bldg 8 - Area B1 roof system overview

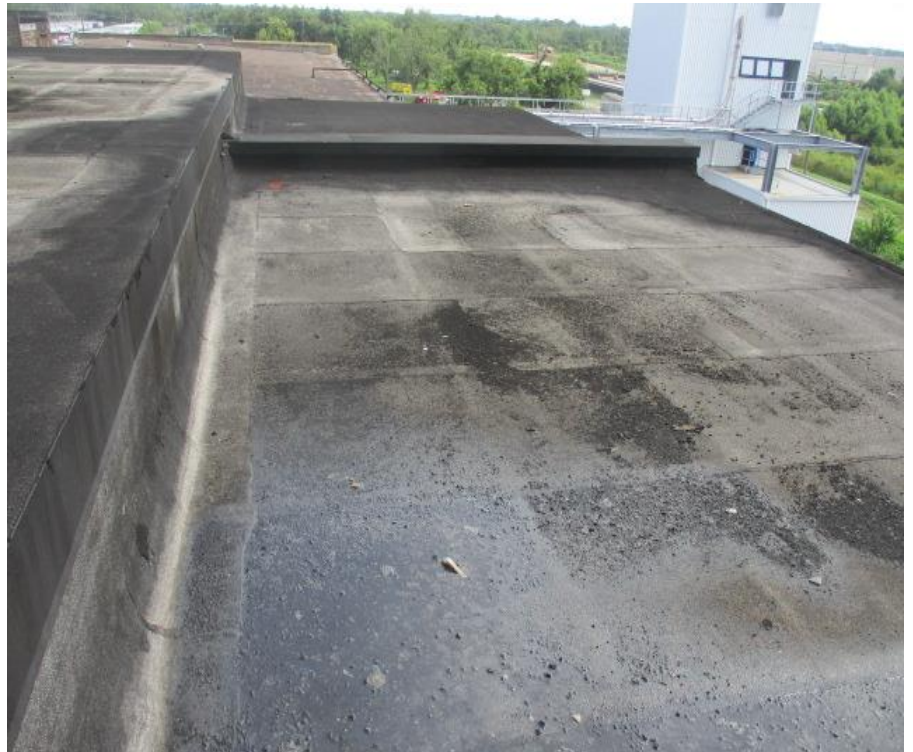
10. Bldg 8 - Area B1 roof system overview

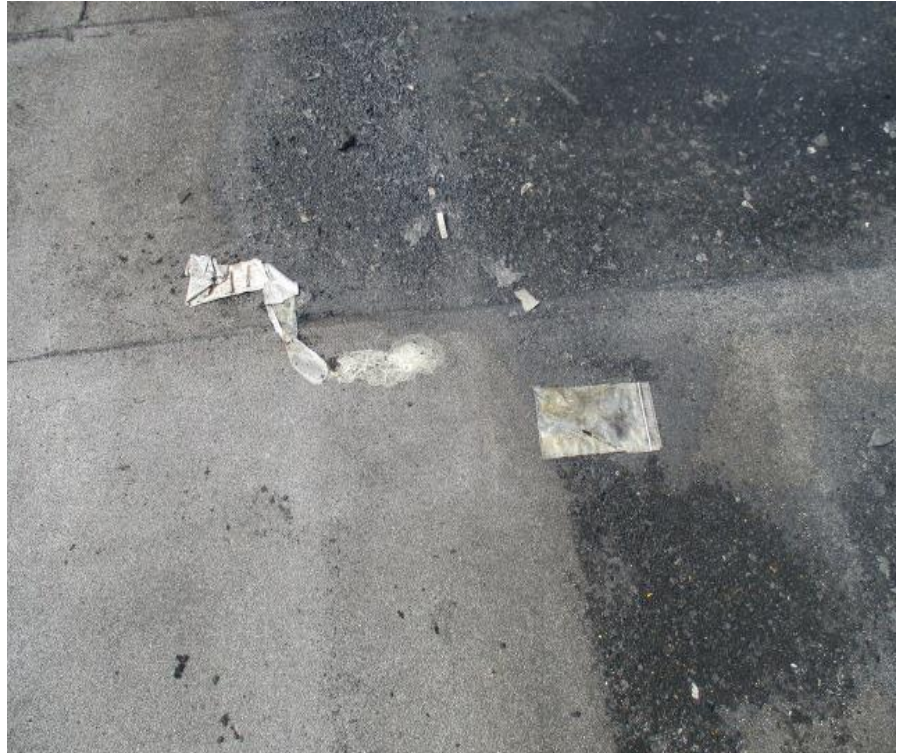
11. Deficiency #2 - Debris on roof surface

NUMBER	PRIORITY CODE	DEFICIENCY DESCRIPTION	QUANTITY	UNIT PRICE	REPAIR COST
		DEFICIENCY SOLUTION	UNITS		
2	M	Debris on roof surface	1	\$25.00	\$25.00
		Remove and properly dispose of all debris	Location		
3	M	Open flashing	2	\$225.00	\$450.00
		Repair with a (3) three course application of flashing grade roof cement and reinforcing fabric	Locations		
6	M	Damaged metal edge	25	\$65.00	\$1,625.00
		Replace damaged metal edge to match existing in material and profile properly flashed into the existing roof system with compatible roofing materials	LnFt		
7	MN	Ponding water observed on roof surface	1		
		Monitor and address at time of roof system replacement or as needed to maintain watertight integrity of the roof system	Area		
8	MN	Incomplete flashing at built-in sleeper	14		
		Monitor and address at time of roof system replacement or as needed to maintain watertight integrity	LnFt

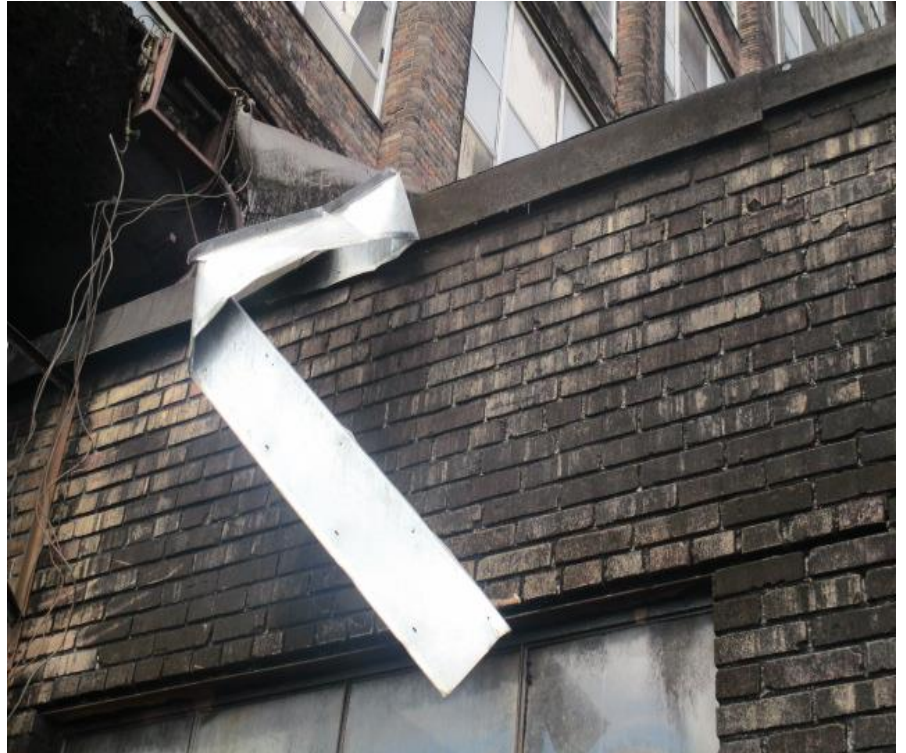
15. Deficiency #6 - Damaged metal edge

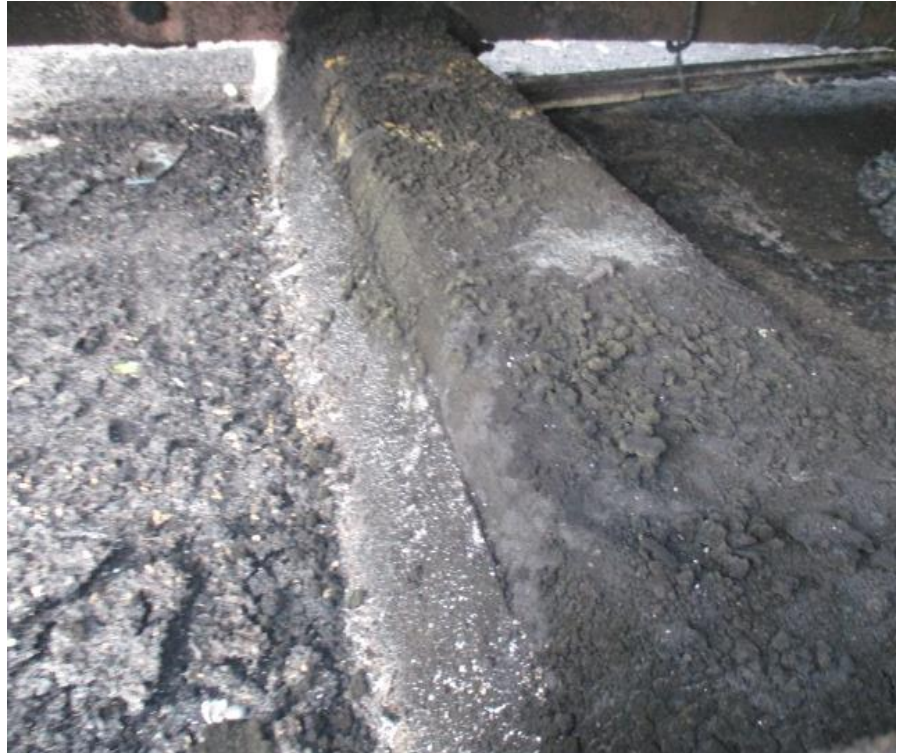
17. Deficiency #8 - Incomplete flashing at built-in sleeper

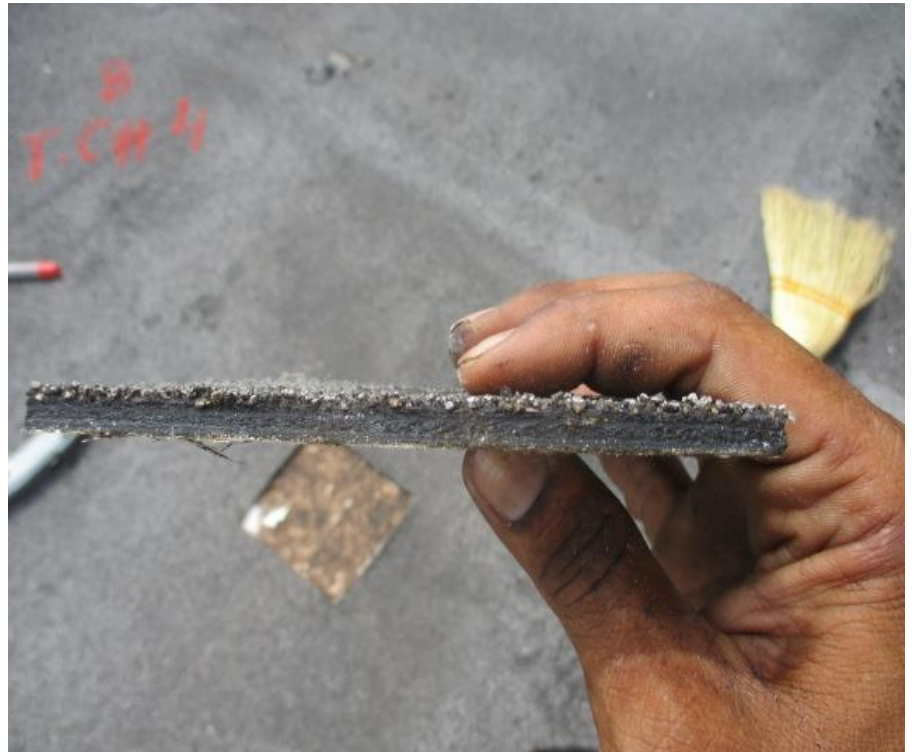
<b><i>TEST CUT / PROBE NUMBER</i></b>	<b>4</b>
<b><i>Test Cut Size</i></b>	<b>6" x 6"</b>
<b><i>Troxler Reading</i></b>	<b>N/A</b>
<b><i>Infra-red Reading</i></b>	<b>Negative</b>
<b><i>Delmhorst Reading</i></b>	<b>Dry</b>
<b><i>Deck Condition</i></b>	<b>Fair</b>
<b><i>Vapor Retarder Condition</i></b>	<b>N/A</b>
<b><i>Insulation Condition</i></b>	<b>Good</b>
<b><i>Membrane Condition</i></b>	<b>Poor</b>

18. Test Cut #4 (Area B1): View of modified bitumen plies

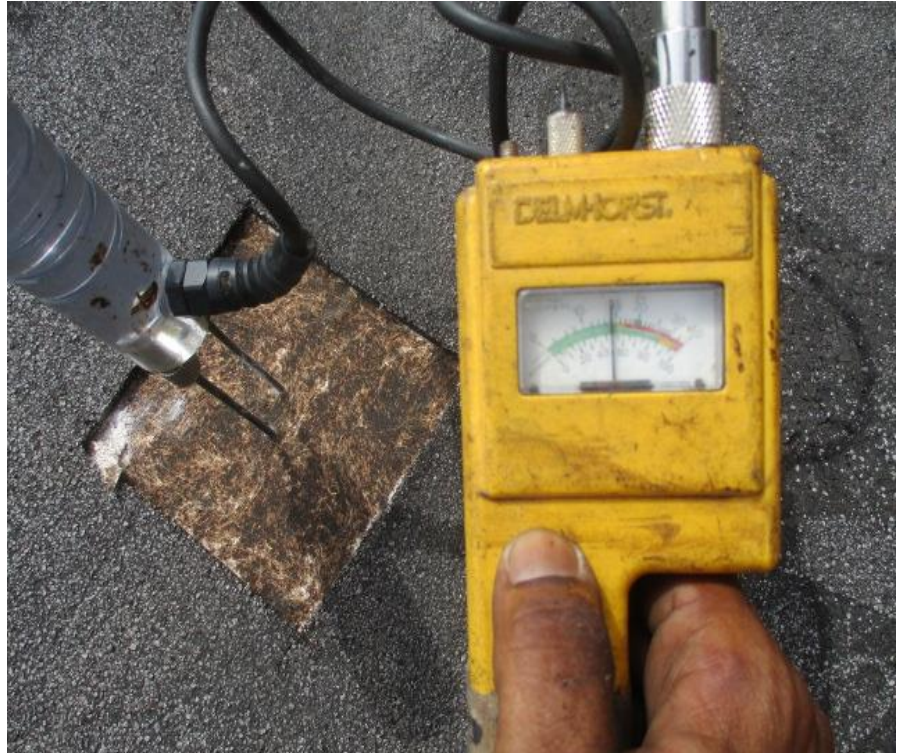
19. Test Cut #4 (Area B1): Delmhorst moisture meter reading negative for moisture within the DensDeck sheathing layer

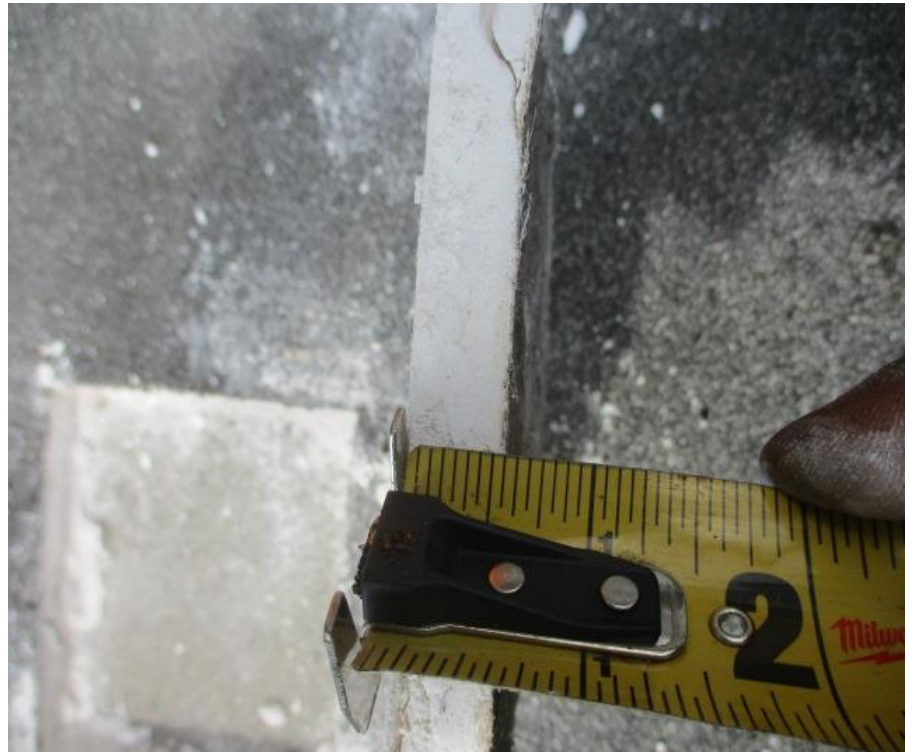
20. Test Cut #4 (Area B1): View of DensDeck measurement

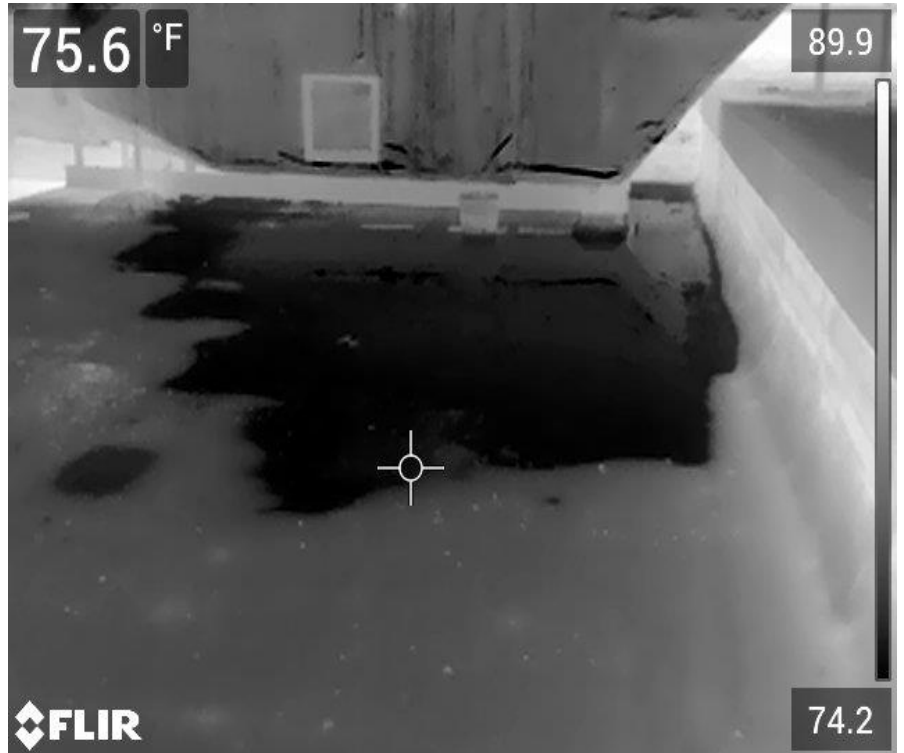
25. Infrared image on Bldg 8 - Area B1 with no suspect wet areas observed

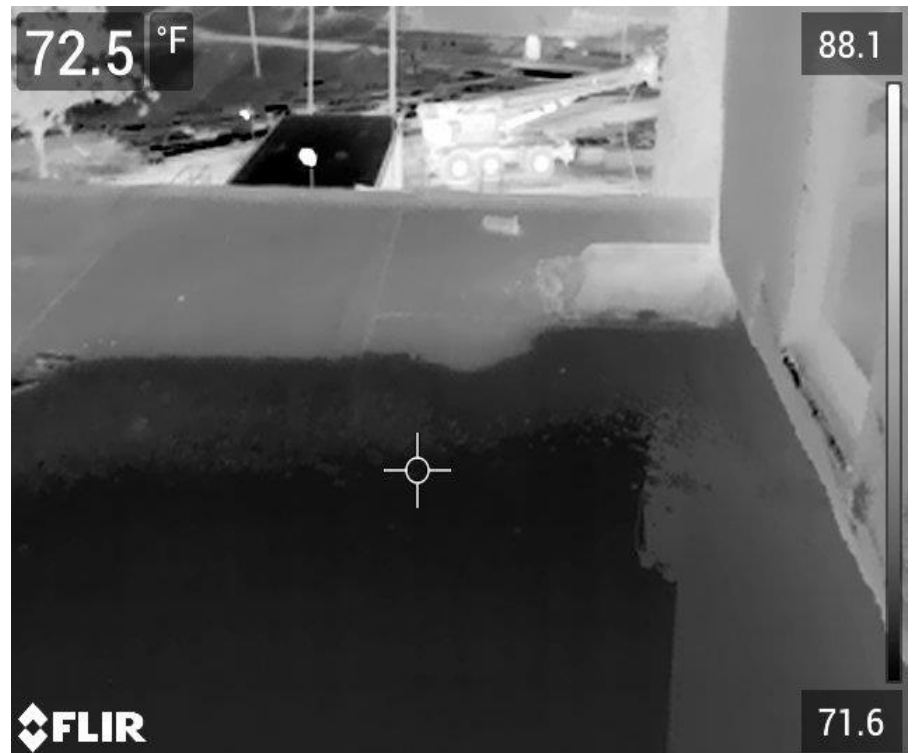
26. Infrared image on Bldg 8 - Area B1 with no suspect wet areas observed

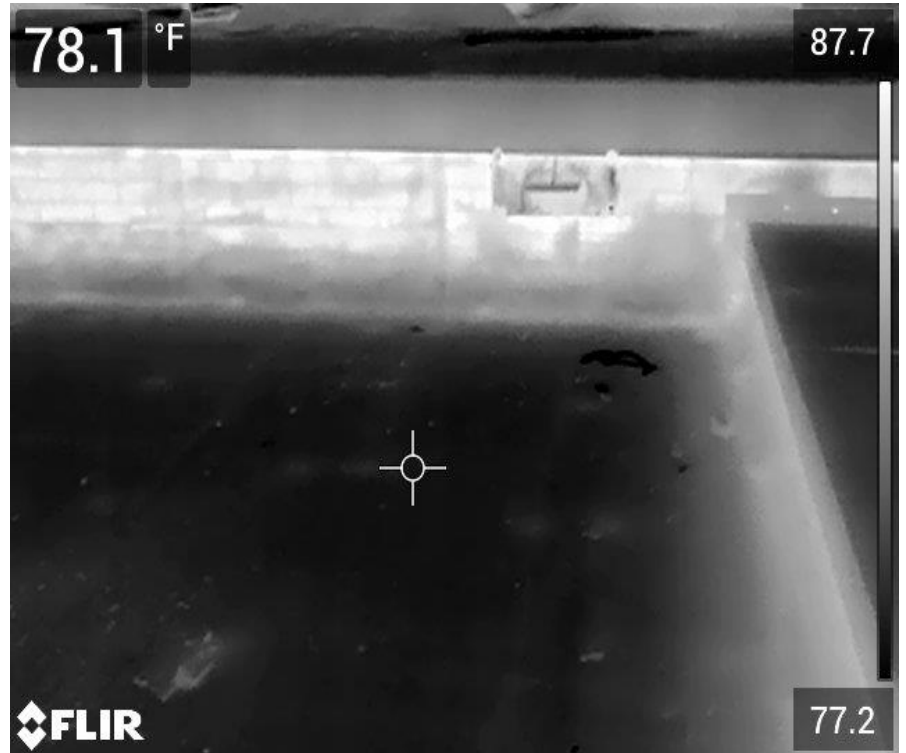
27. Infrared image on Bldg 8 - Area B1 with no suspect wet areas observed

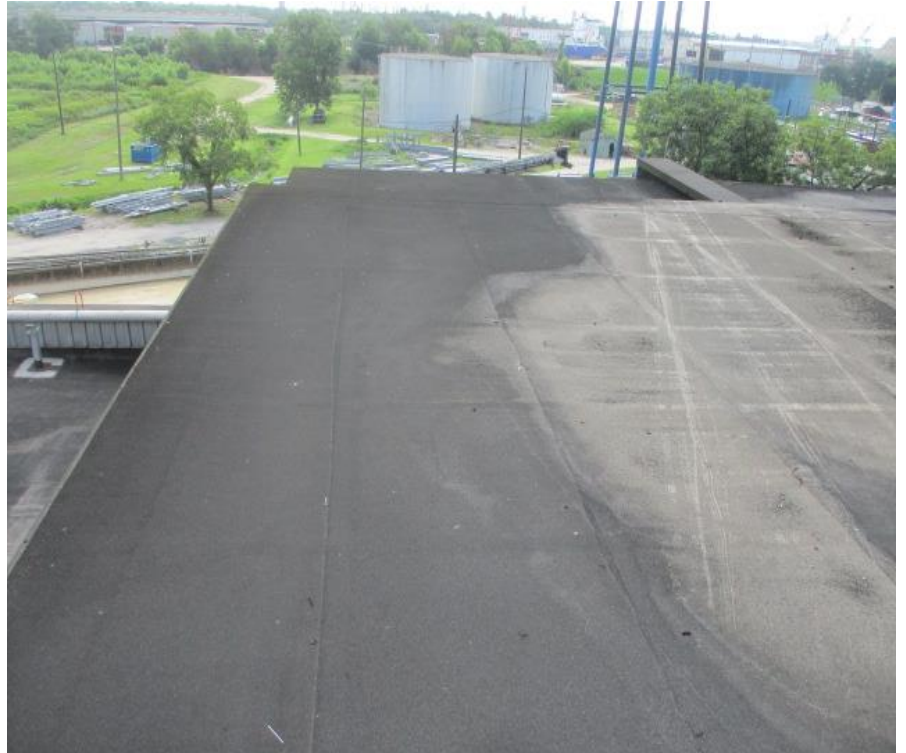
**1. Bldg 8 - Area C roof system  
overview**

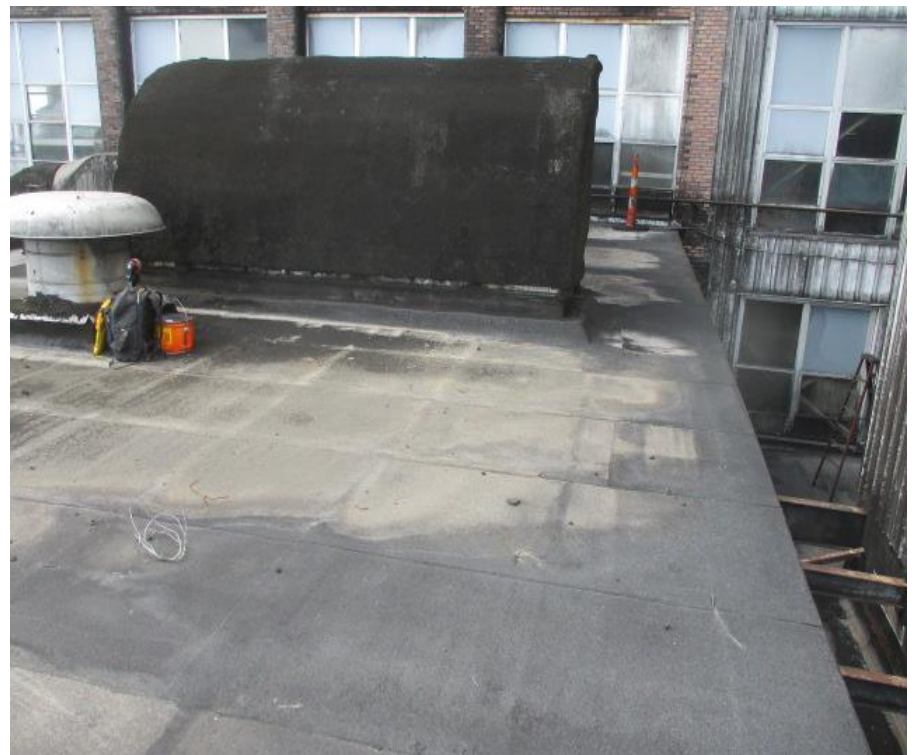
**2. Bldg 8 - Area C roof system  
overview**

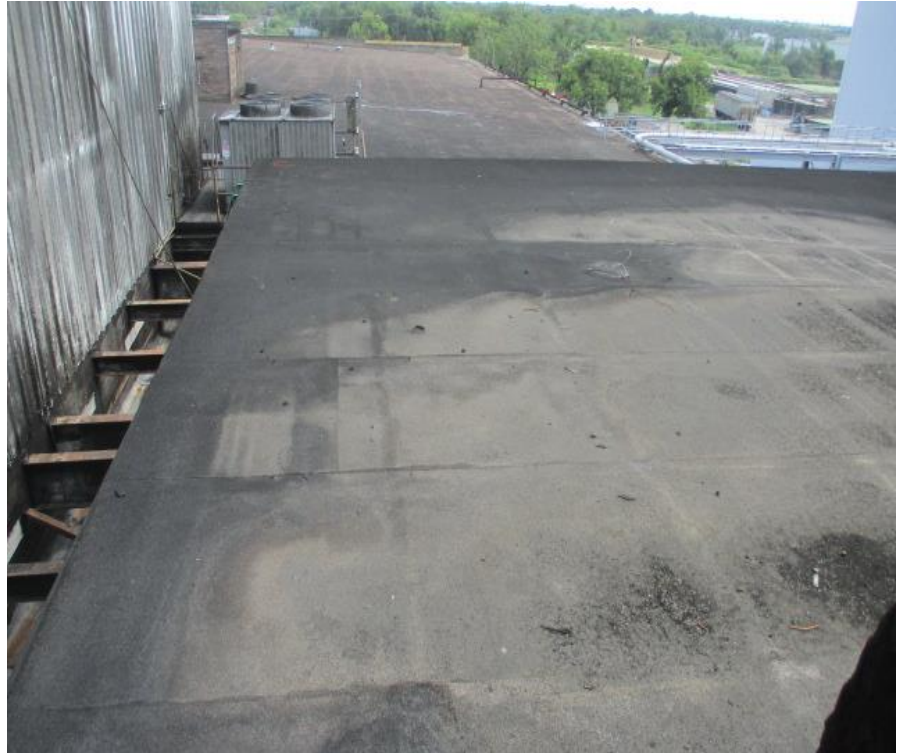
**3. Bldg 8 - Area C roof system  
overview**

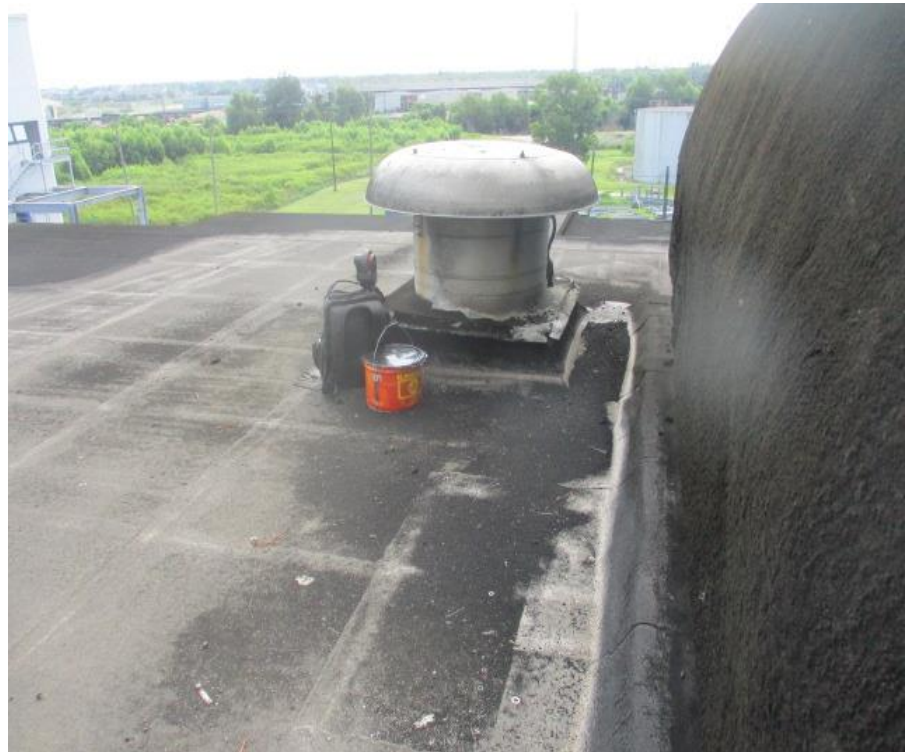
**4. Bldg 8 - Area C roof system  
overview**

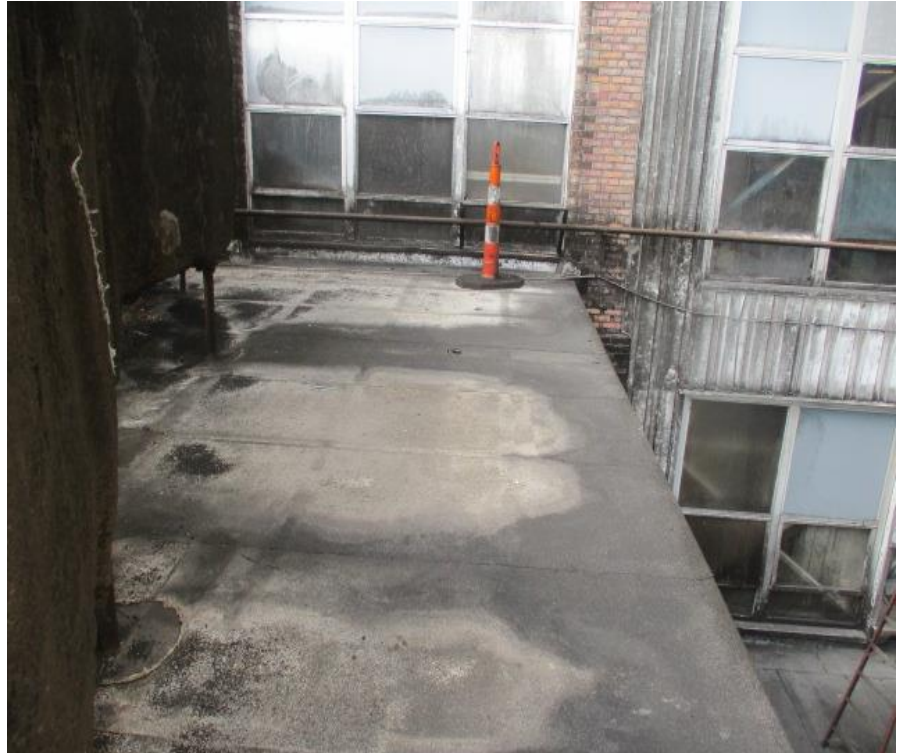
5. Bldg 8 - Area C roof system overview

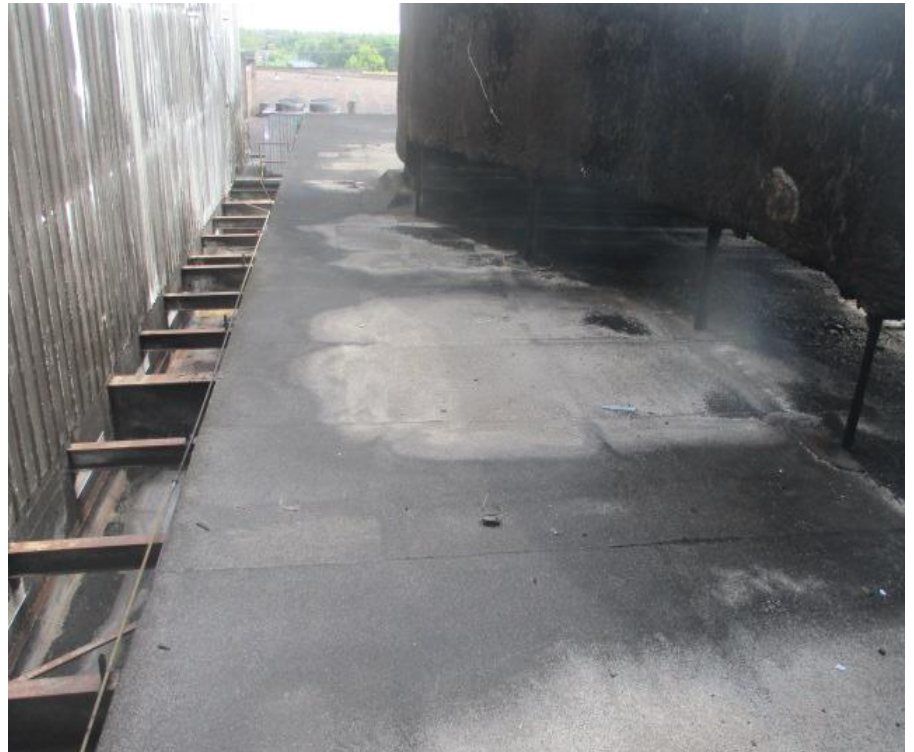
6. Bldg 8 - Area C roof system overview

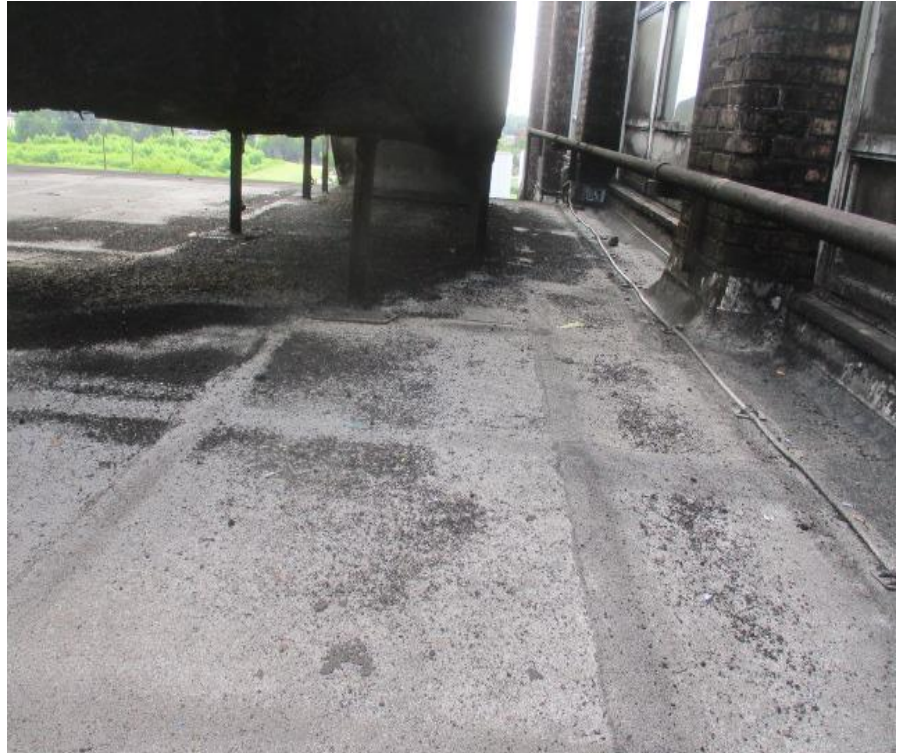
7. Bldg 8 - Area C roof system overview

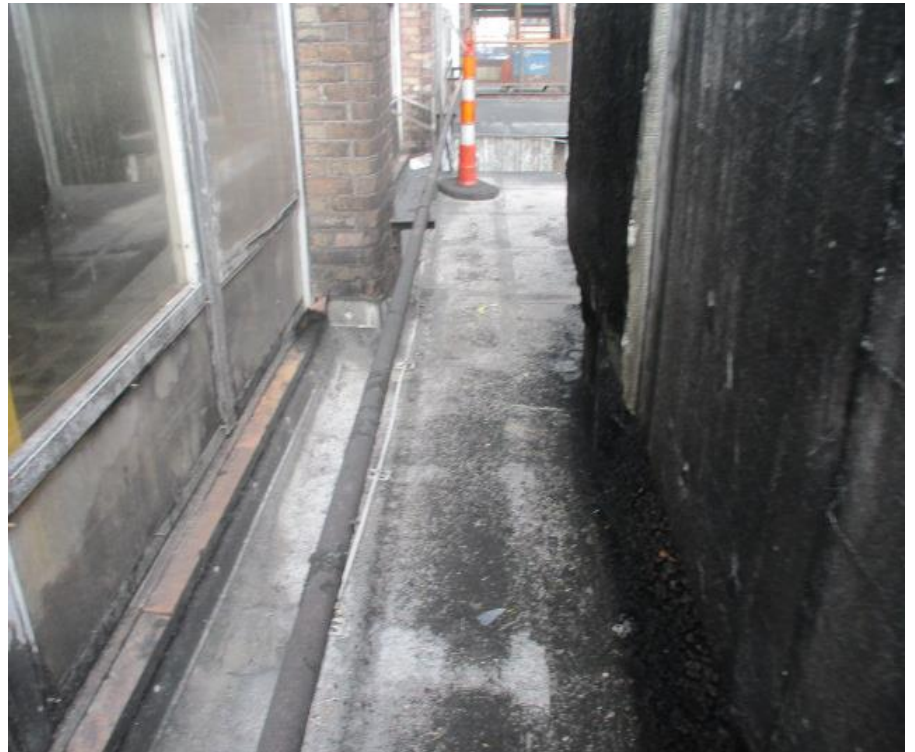
8. Bldg 8 - Area C roof system overview

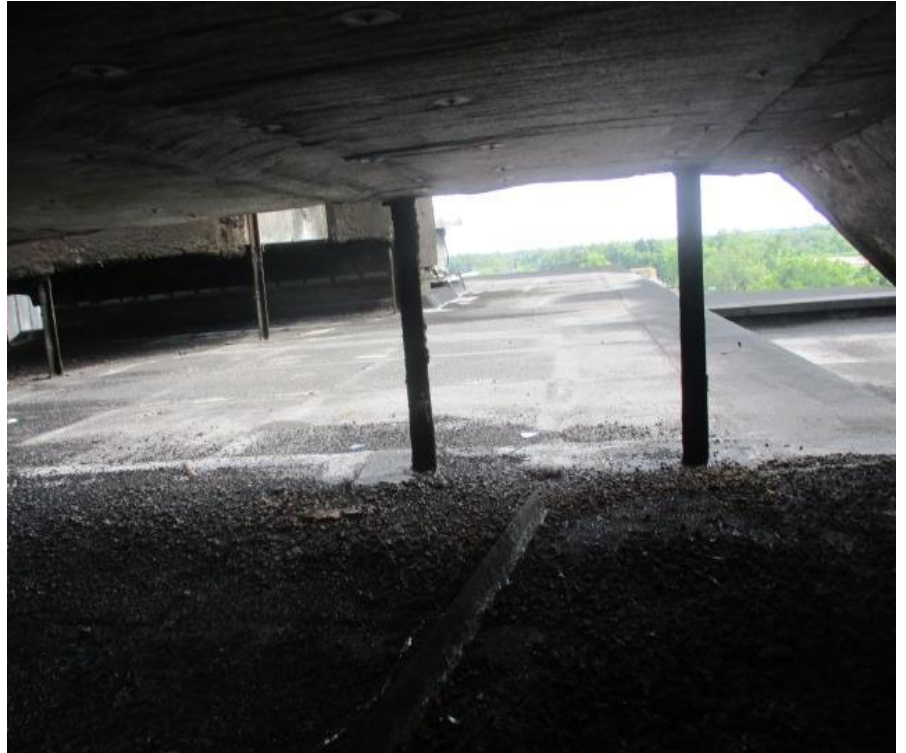
9. Bldg 8 - Area C roof system overview

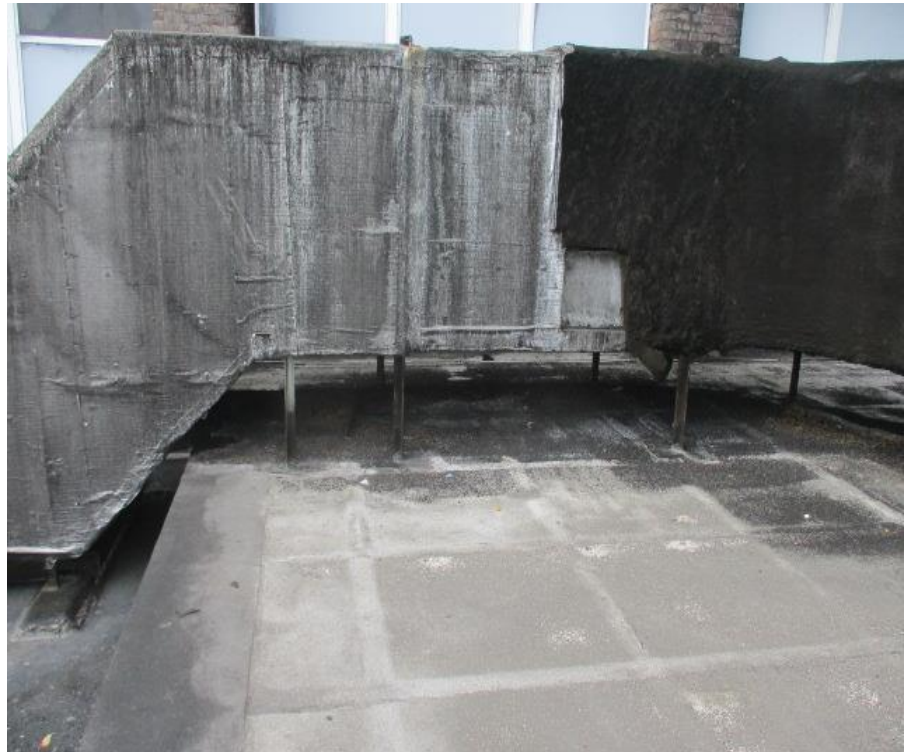
10. Bldg 8 - Area C roof system overview

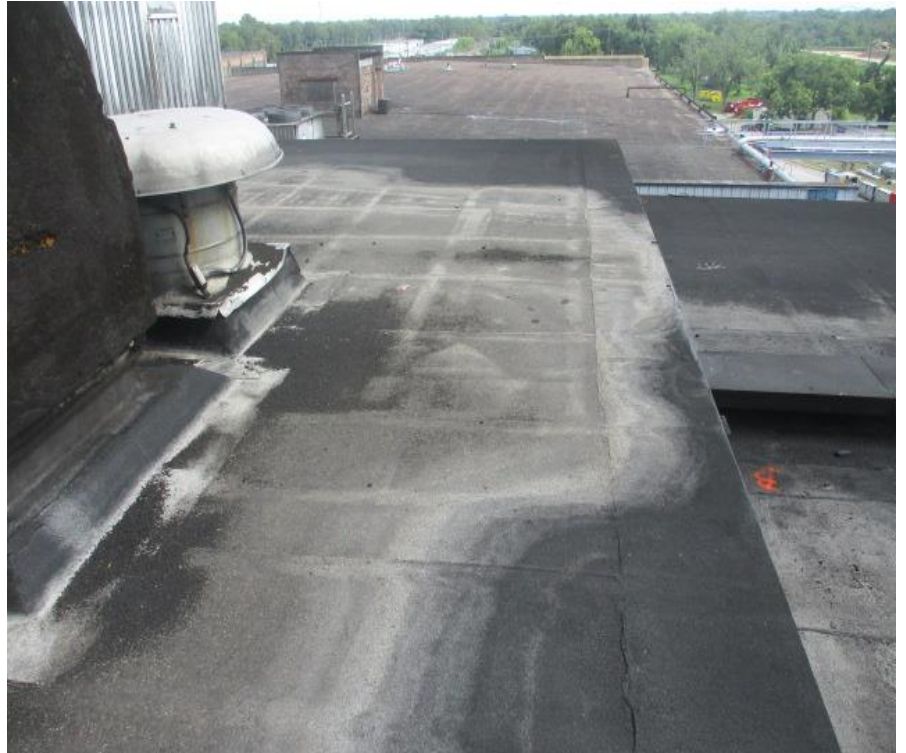
**11. Bldg 8 - Area C roof system  
overview**

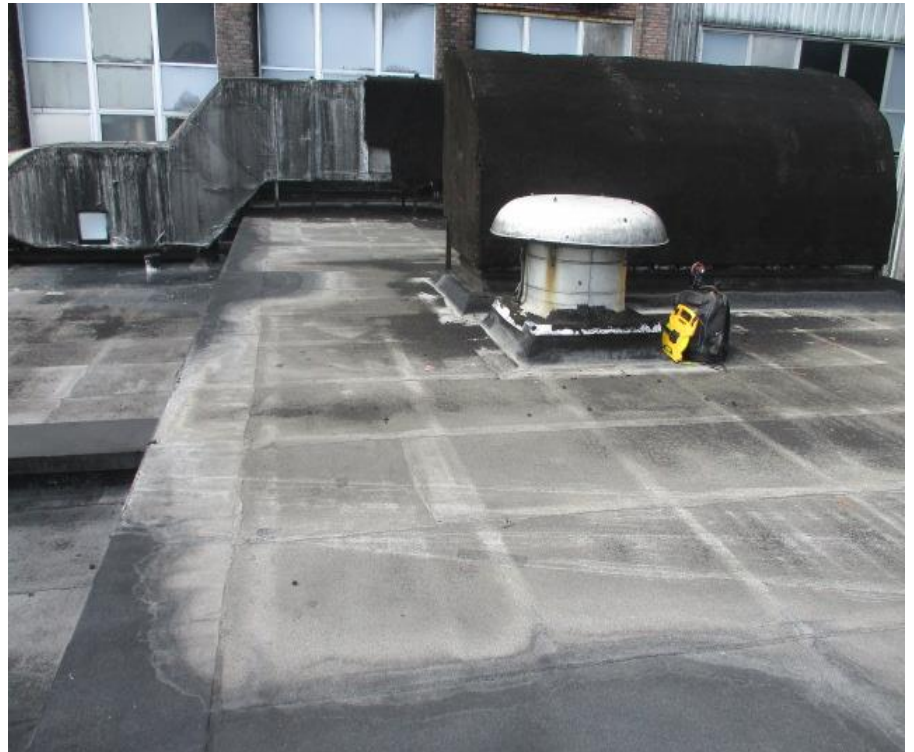
**12. Bldg 8 - Area C roof system  
overview**

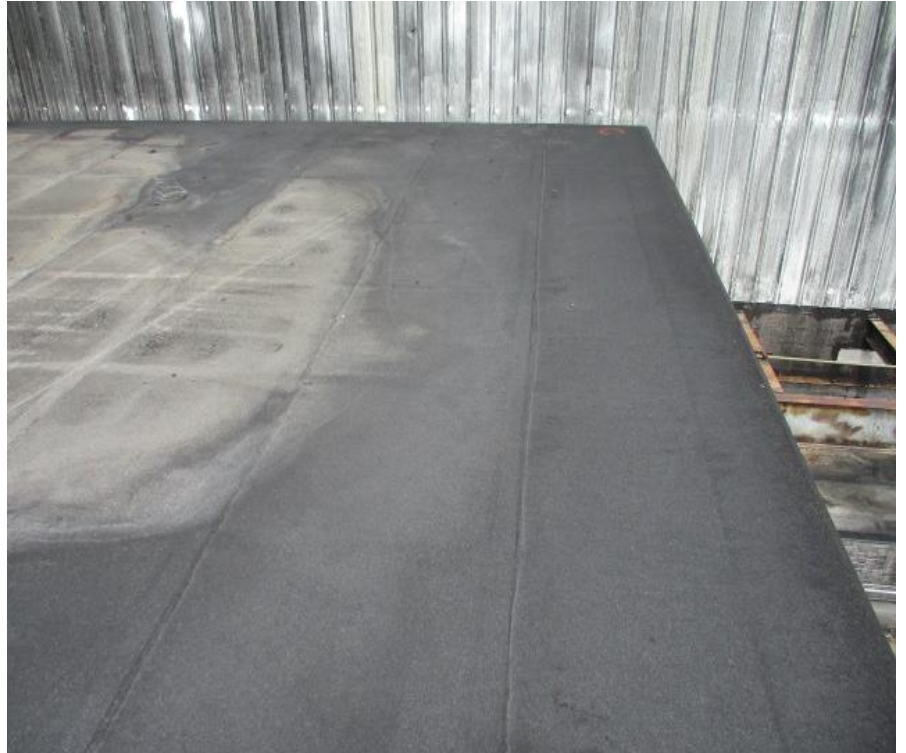
**13. Bldg 8 - Area C roof system overview**

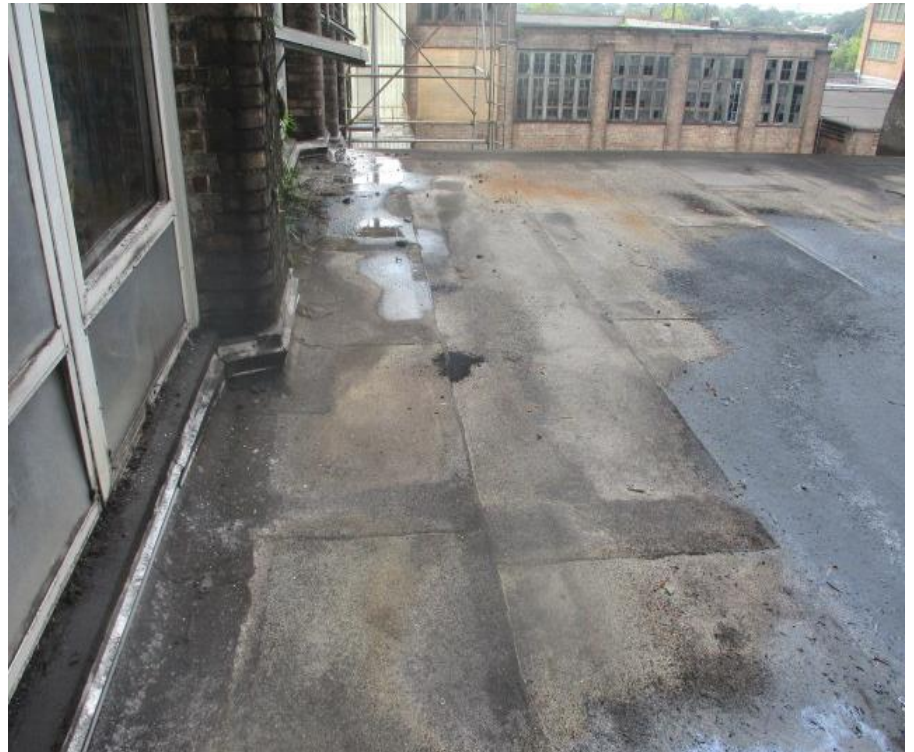
**14. Bldg 8 - Area F roof system overview**

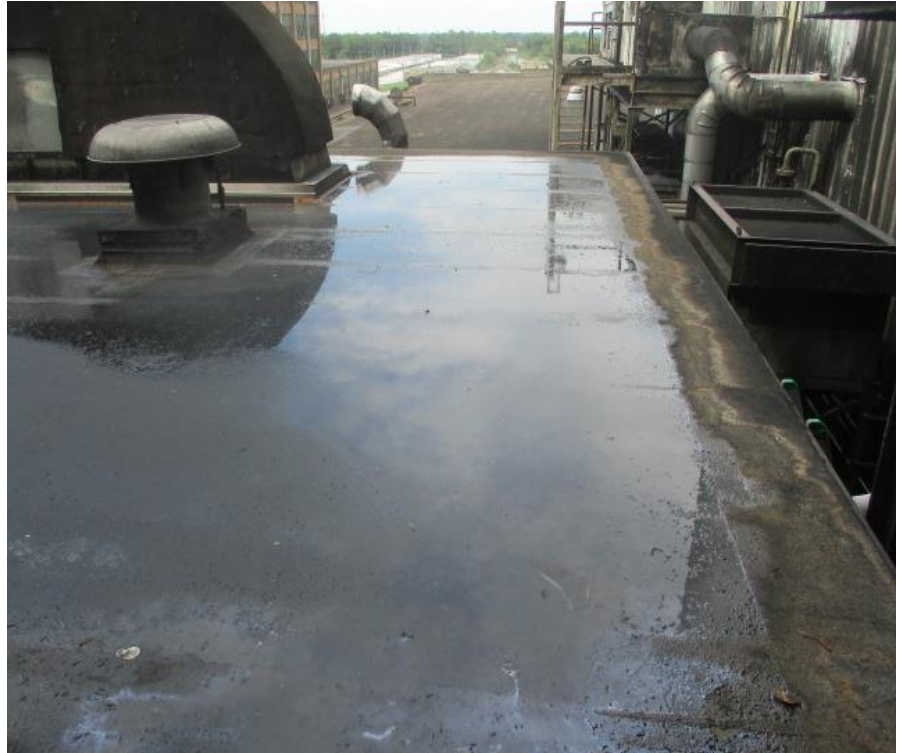
**15. Bldg 8 - Area F roof system  
overview**

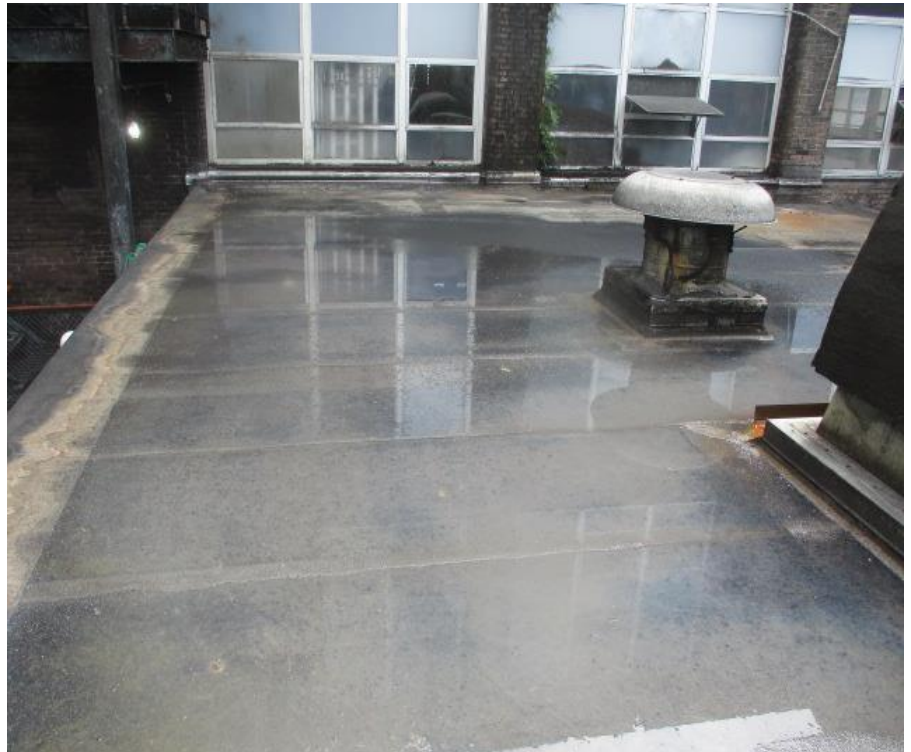
**16. Bldg 8 - Area F roof system  
overview**
