## **Domino Sugar Refinery**

# **Domino Sugar Facility**

**7412 N. Peters Street  
Arabi, LA**

**9/3/2022**

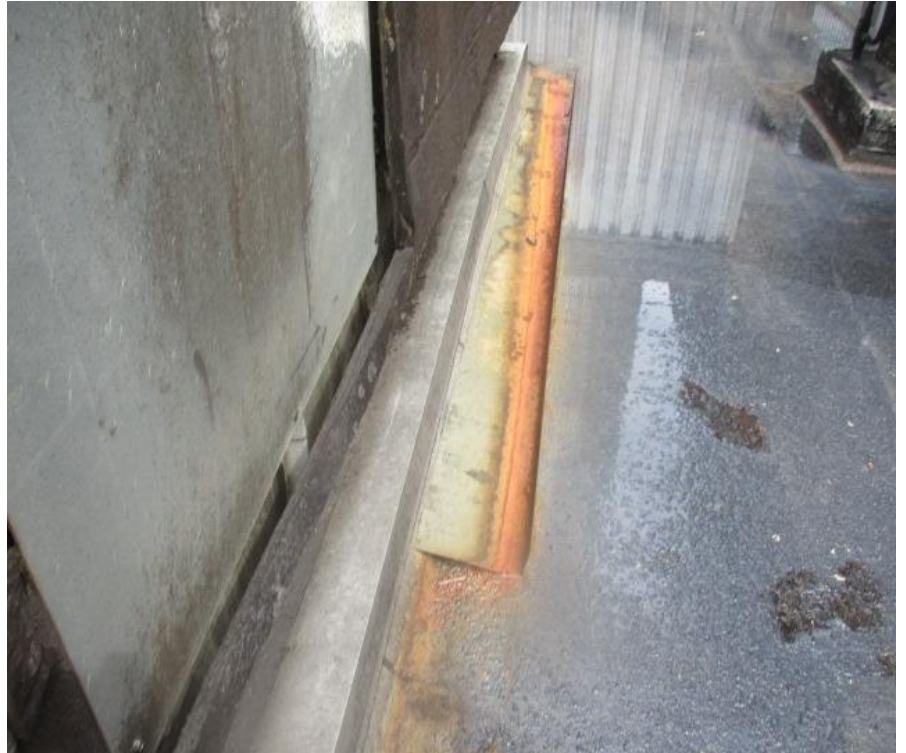
35. Deficiency #2 - Debris on roof surface

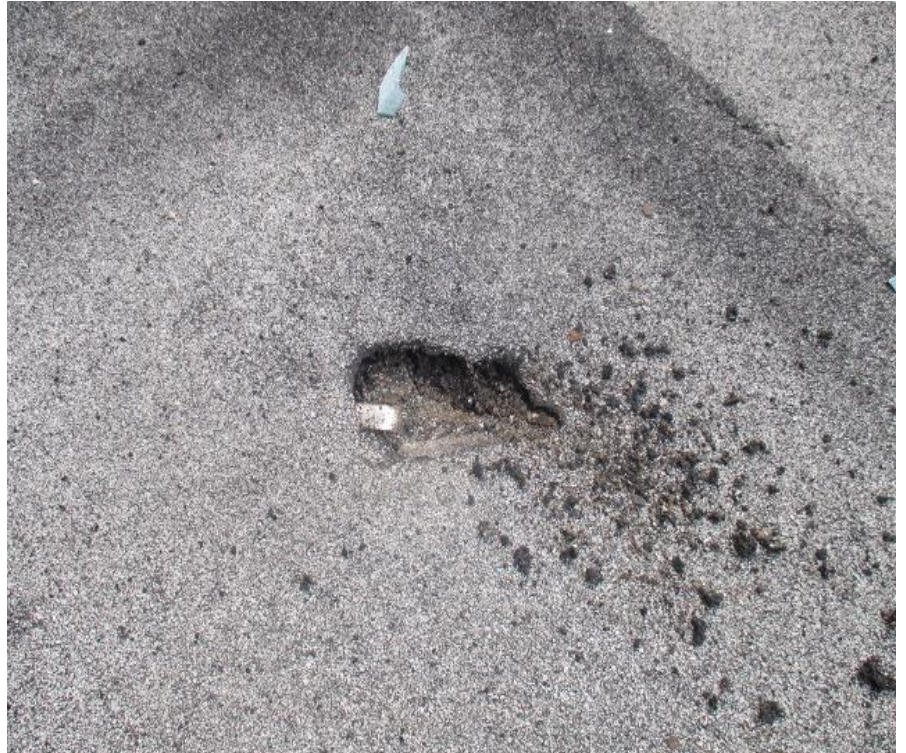
39. Deficiency #4 - Hole / puncture  
in membrane / felts

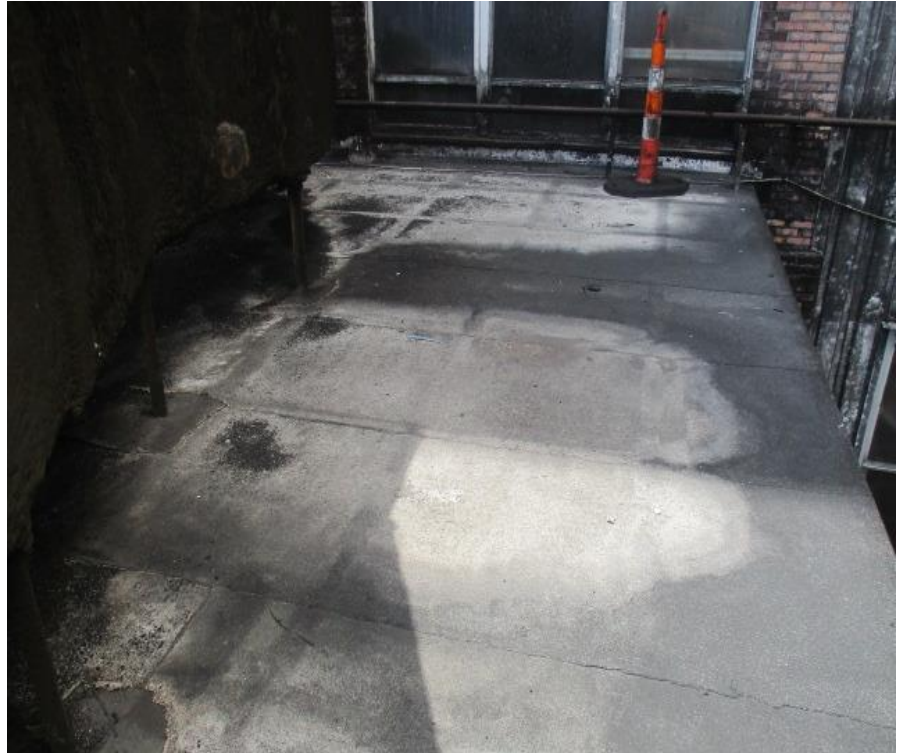
41. Deficiency #7 - Ponding water  
observed on roof surface

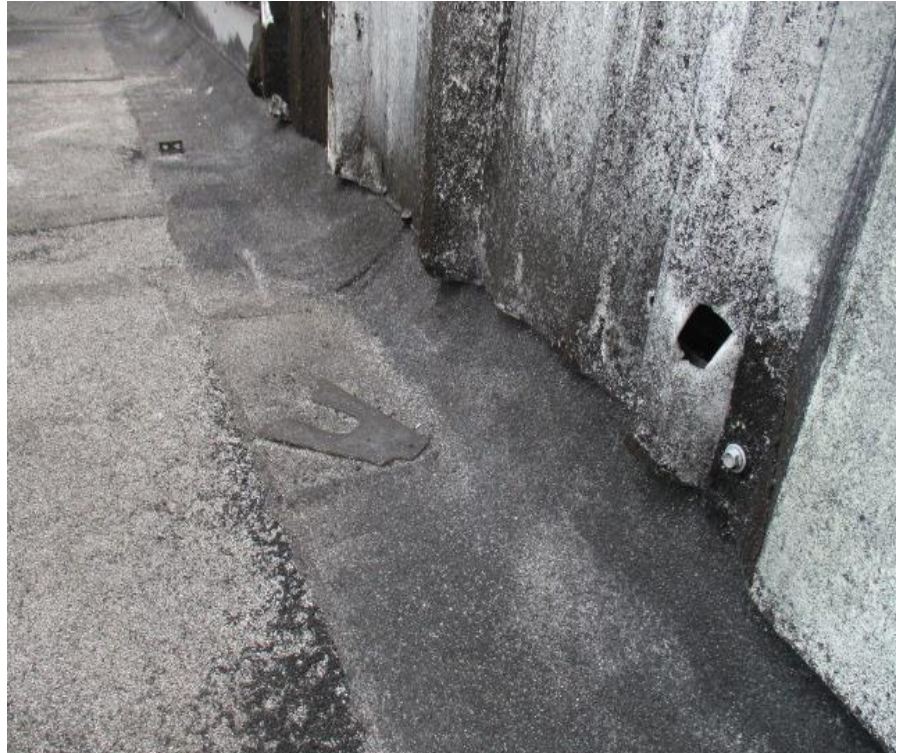
**43. Deficiency #11 - Improper wall flashing detail - flashing membrane not properly terminated and counter flashed by metal Z-metal panel closure**

Remove bottom course of fasteners from vertical panel assembly. Where required, install additional mechanical flashing termination (stagger termination fasteners 8" o.c. max). Install Z-metal panel closure below panel assembly and resecure the bottom fastening course of the panel assembly though the subsequent Z-metal panel closure.	LnFt		
14	M	Open lap in field membrane	1	\$275.00	\$275.00
		Repair with a (5) five course application of flashing grade roof cement and reinforcing fabric	LnFt

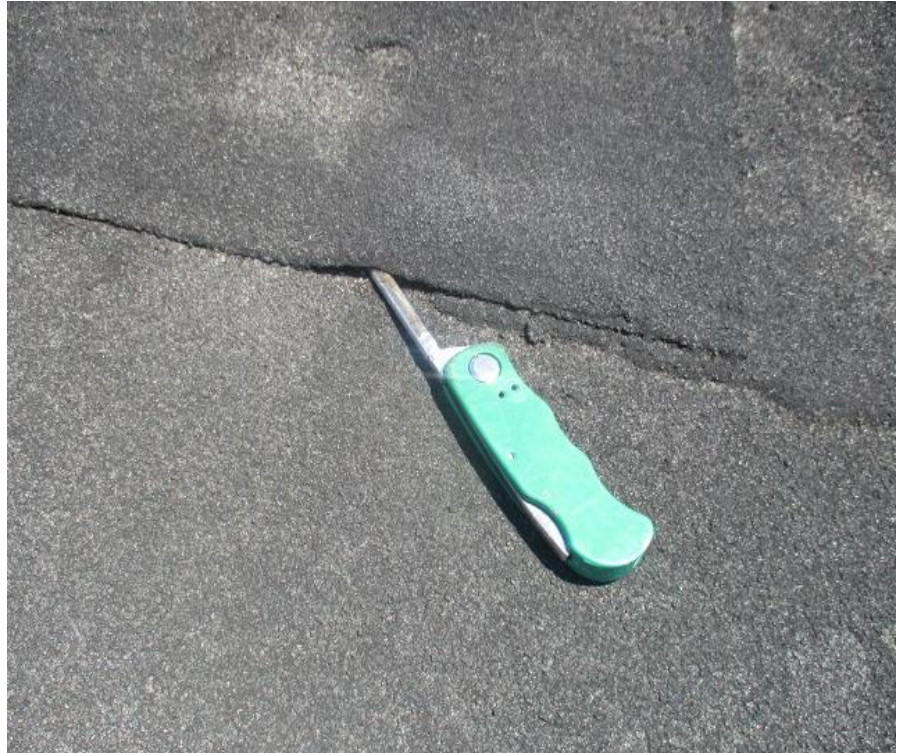
45. Deficiency #14 - Open lap in field membrane

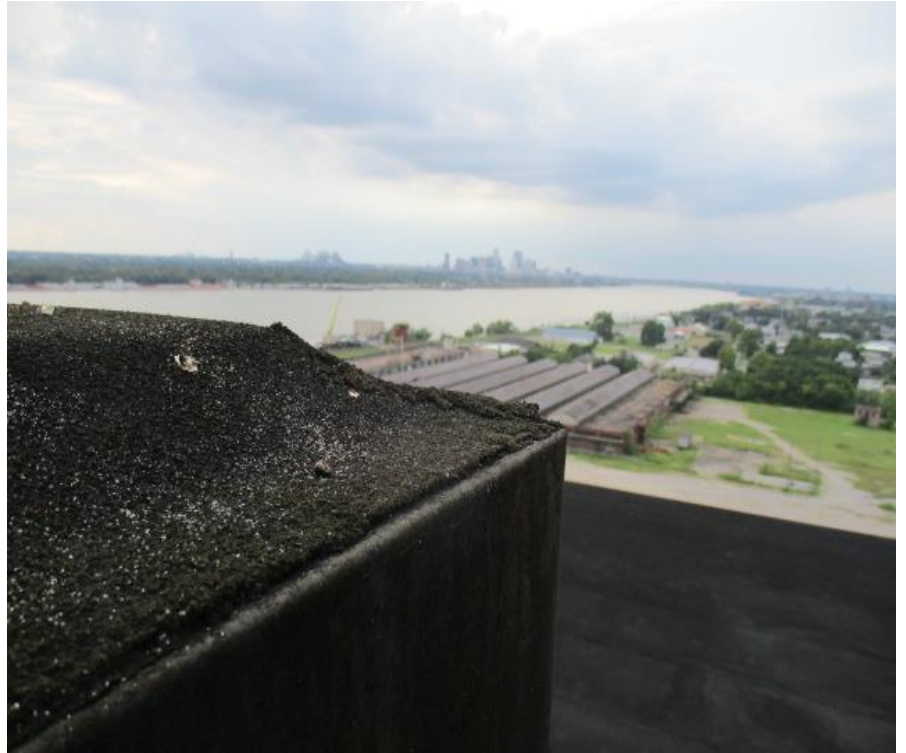
**47. Deficiency #16 - Improper roof edge detail - additional wood blocking to match insulation height required at roof area perimeter**

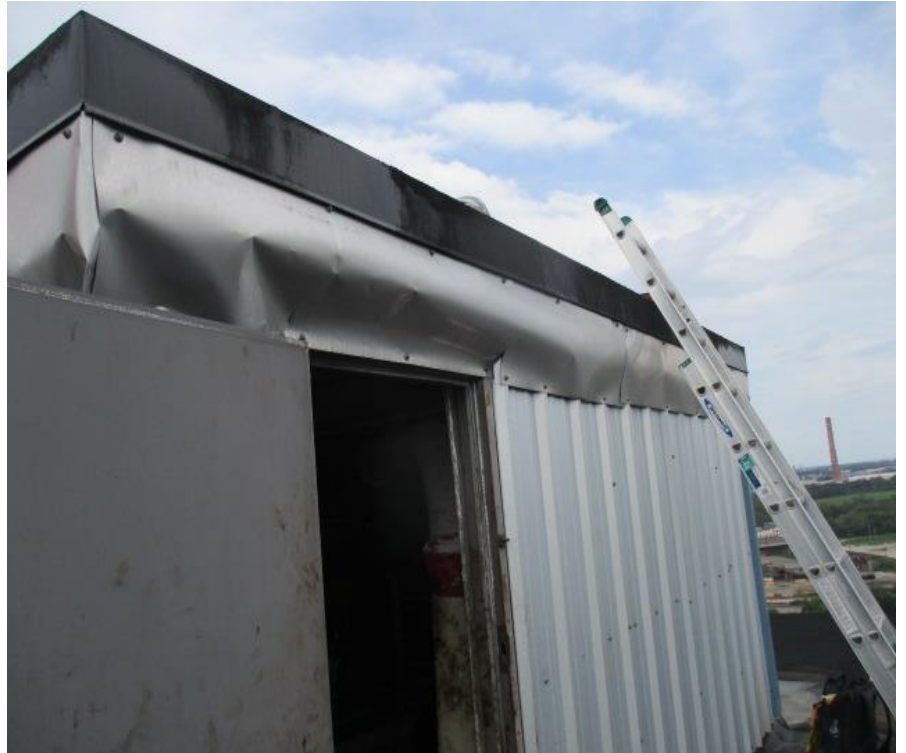
**49. Deficiency #17 - Improperly fabricated & installed fascia metal - as fabricated and installed perimeter edge does not meet ANSI/SPRI/FM4435 ES-1 wind design standard for edge systems used with low slope roofing systems**

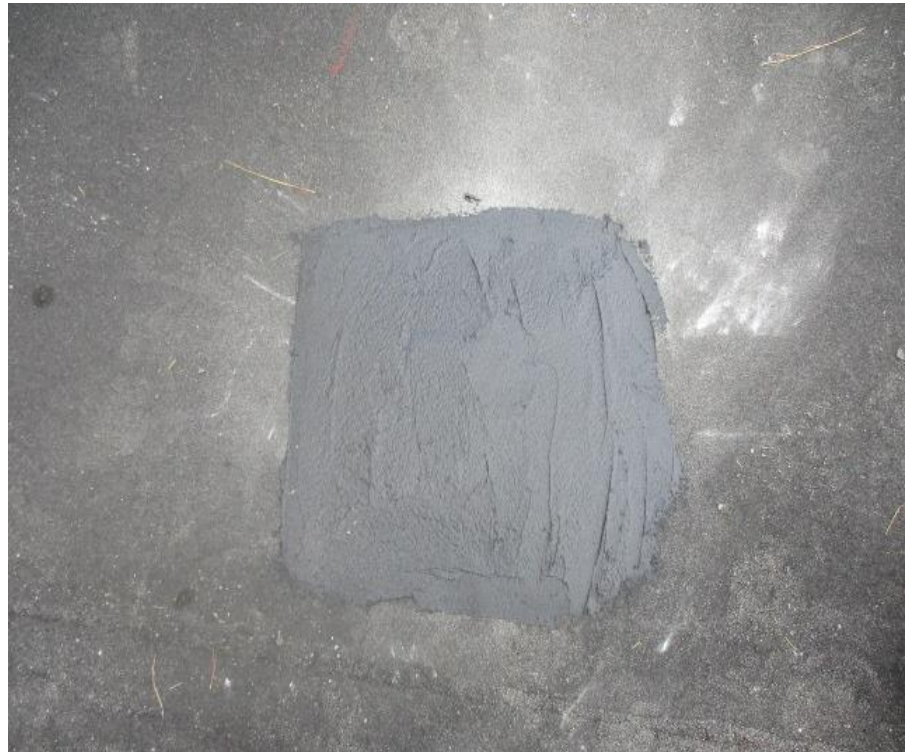
56. Test Cut #6 (Area C): View of  
RCS repair

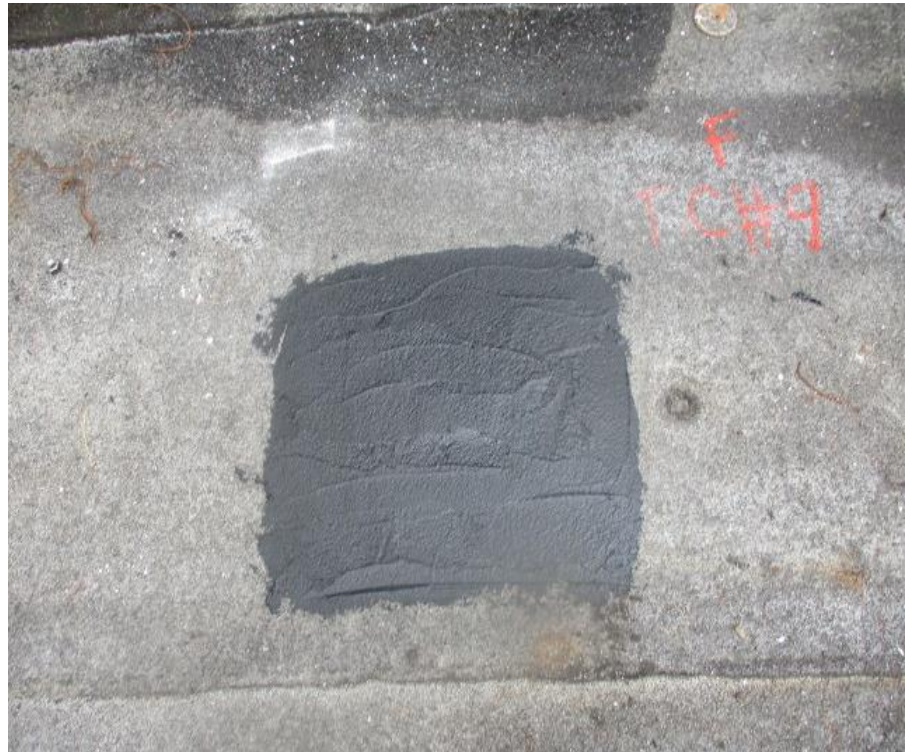
62. Test Cut #9 (Area F): View of RCS repair

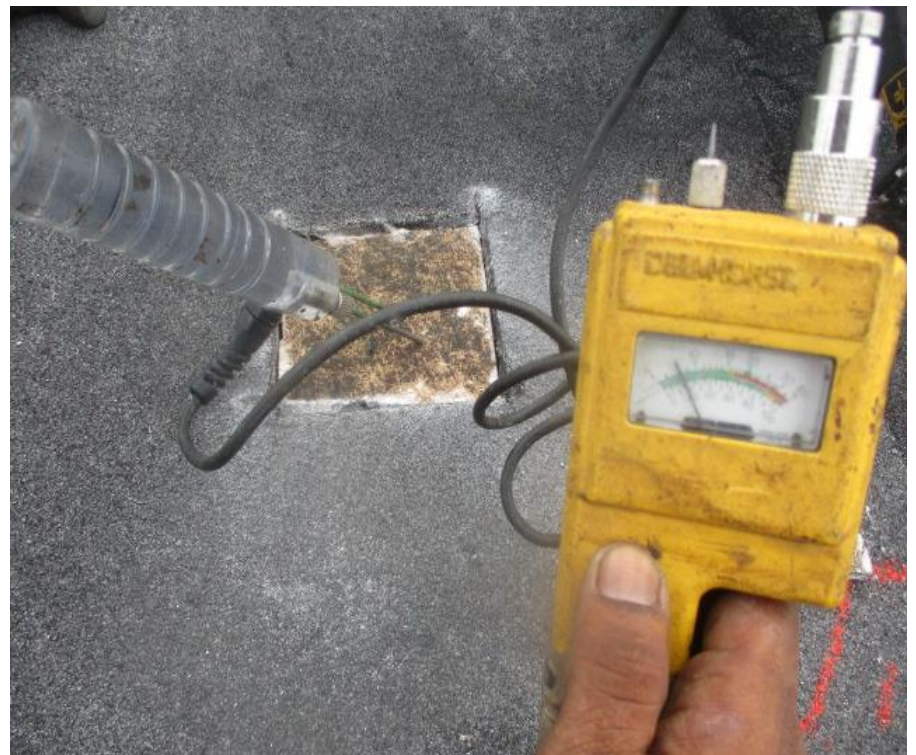
64. Test Cut #11 (Area G):  
Delmhorst moisture meter reading  
negative for moisture within the  
DensDeck sheathing layer

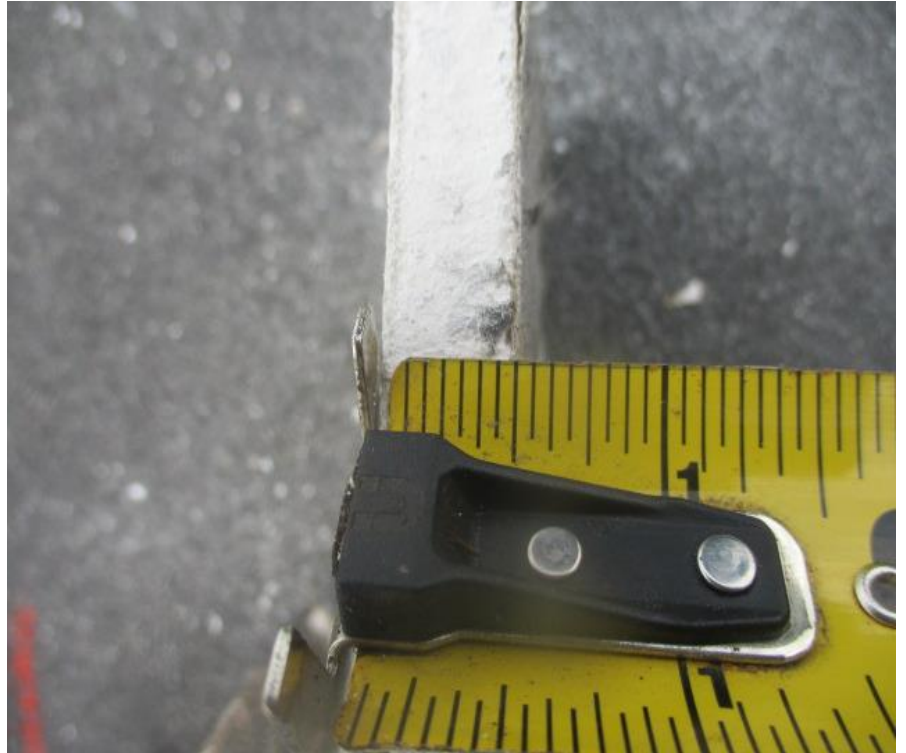
65. Test Cut #11 (Area G): View of DensDeck measurement

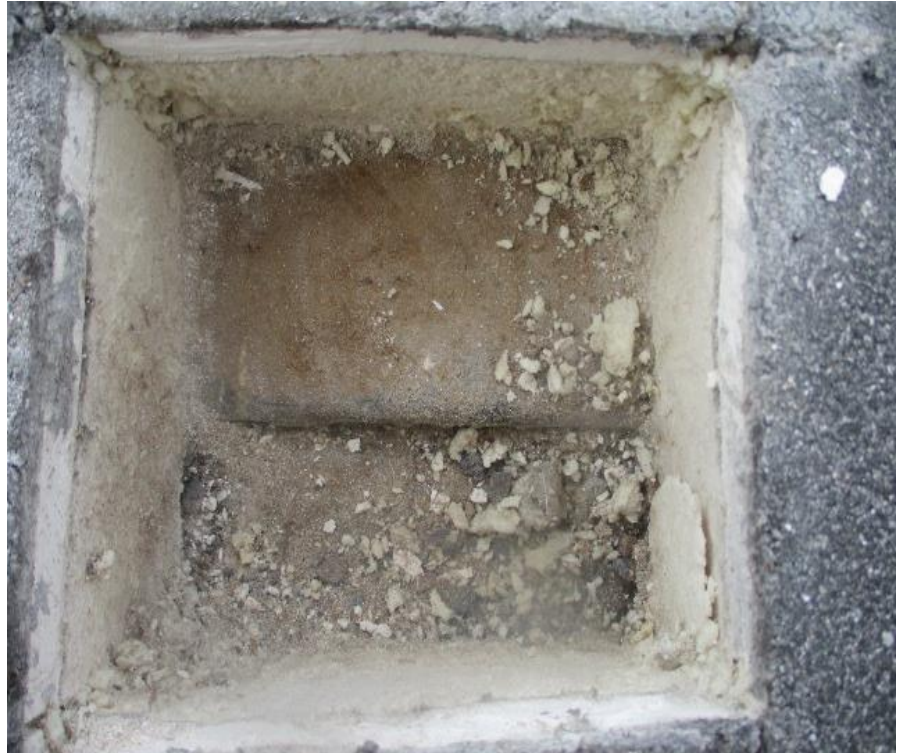
67. Test Cut #11 (Area G): View of roof composition removed exposing a galvanized metal deck

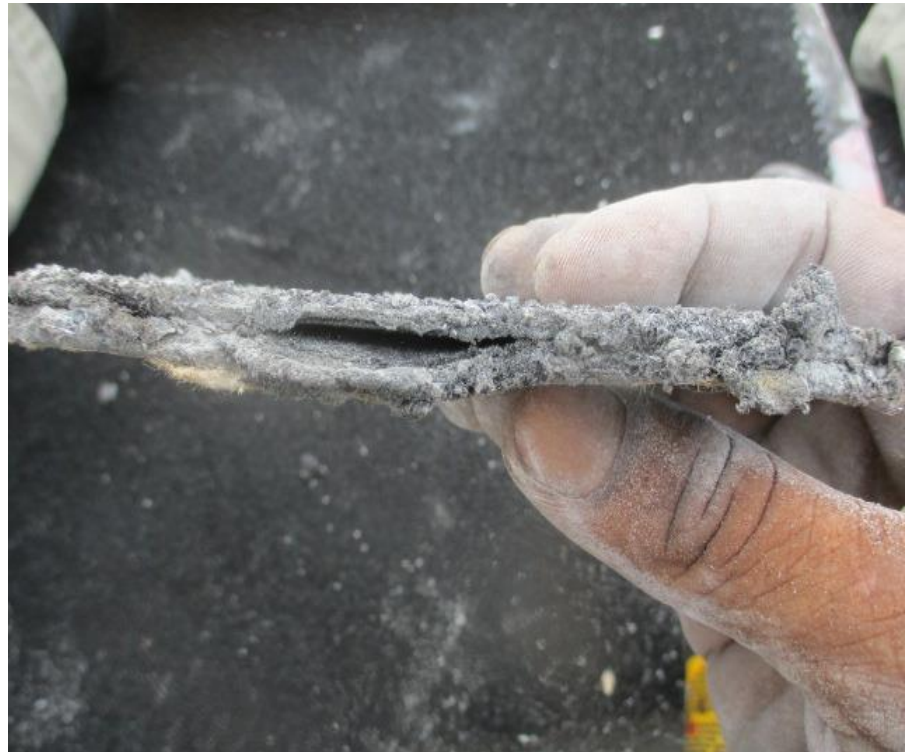
68. Test Cut #12 (Area G): Modified bitumen plies

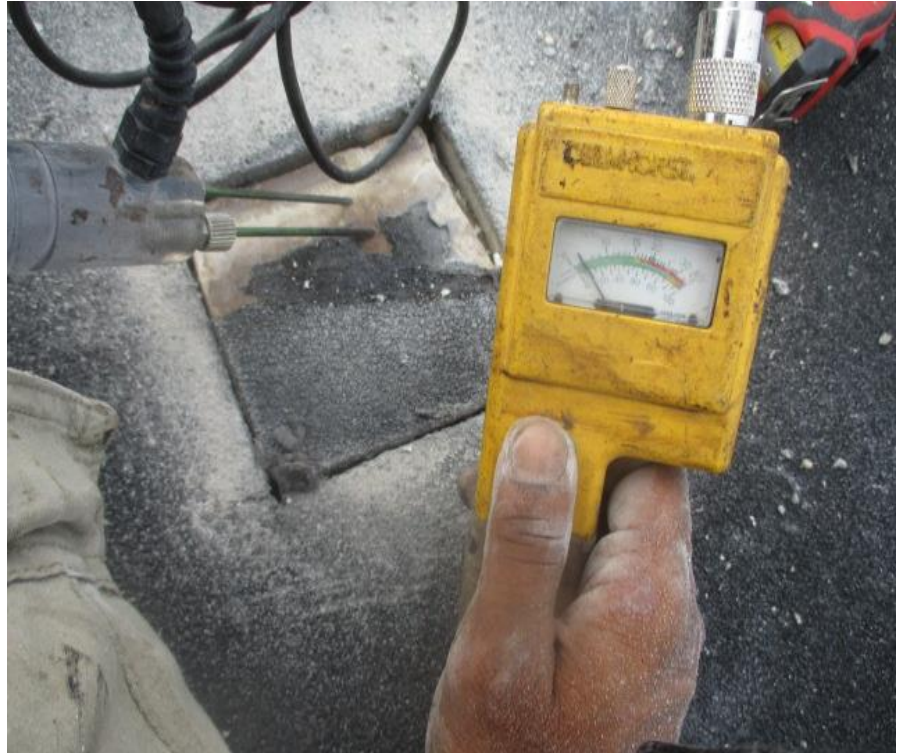
69. Test Cut #12 (Area G):  
Delmhorst moisture meter reading  
negative for moisture within the  
DensDeck sheathing layer

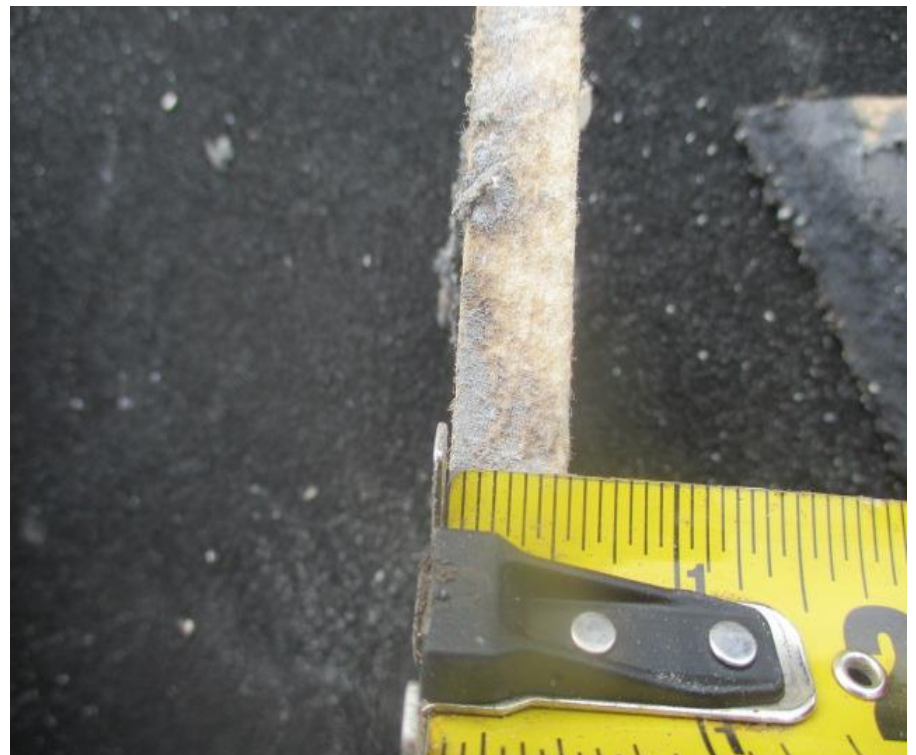
70. Test Cut #12 (Area G): DensDeck  
sheathing measurement

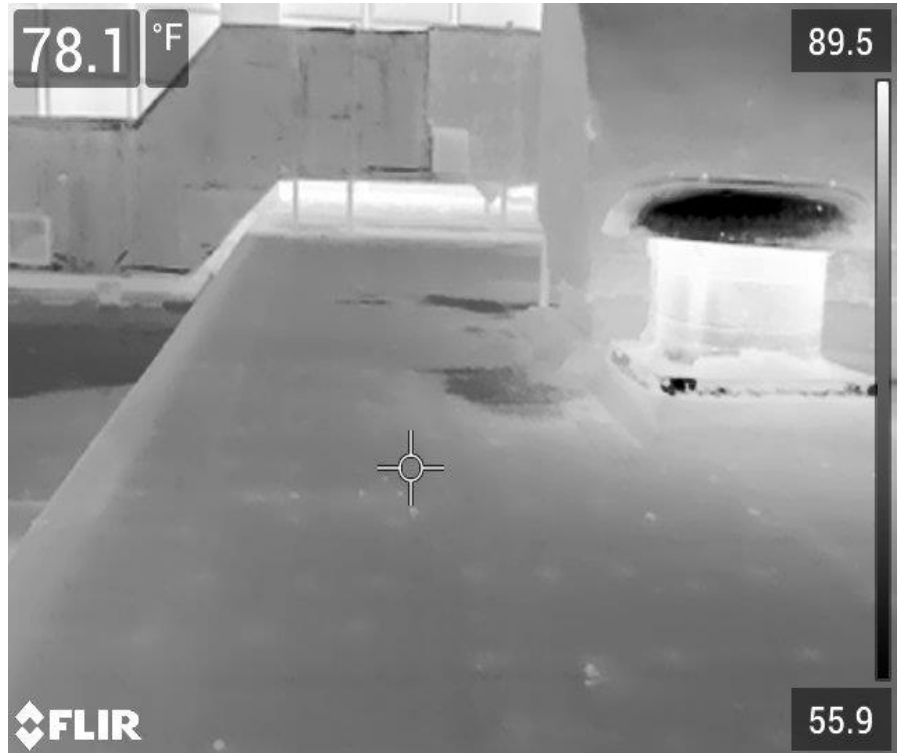
75. Infrared image on Bldg 8 - Area C with no suspect wet areas observed

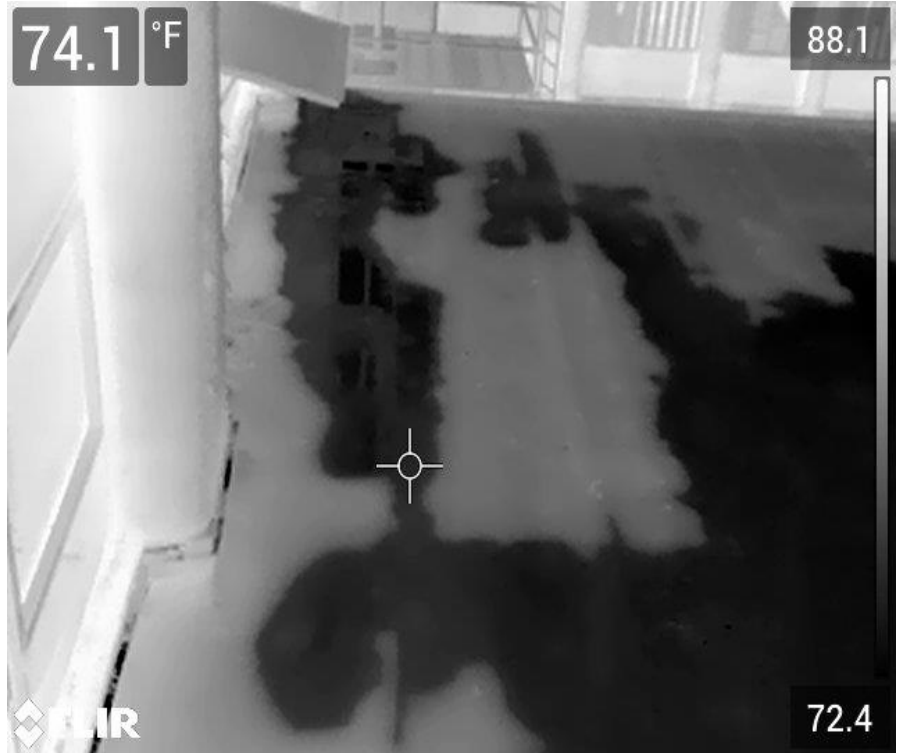
77. Infrared image on Bldg 8 - Area F with no suspect wet areas observed

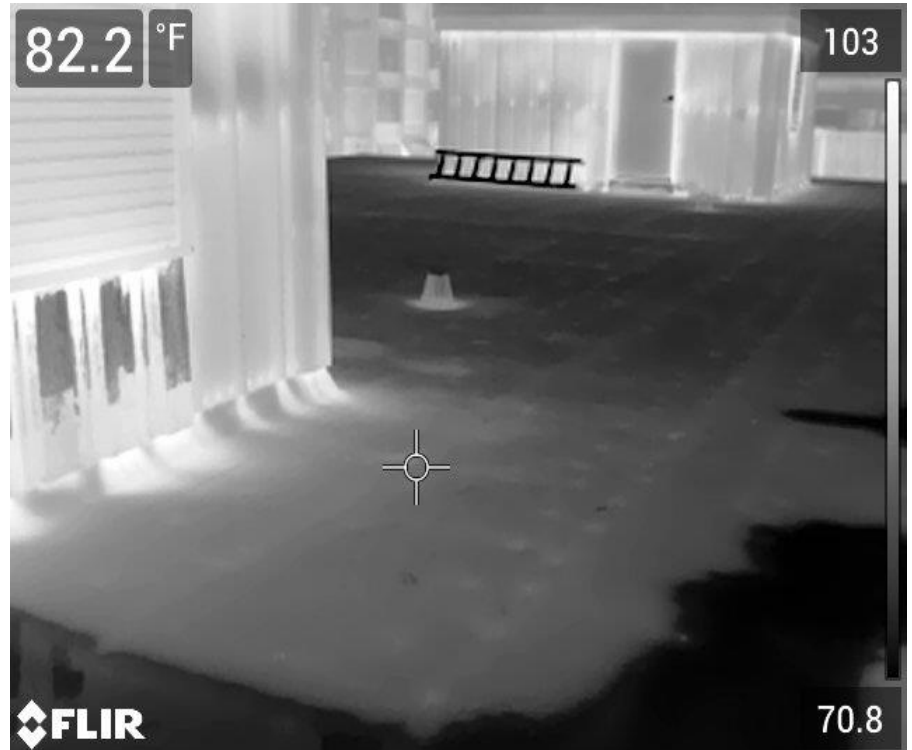
78. Infrared image on Bldg 8 - Area G with no suspect wet areas observed

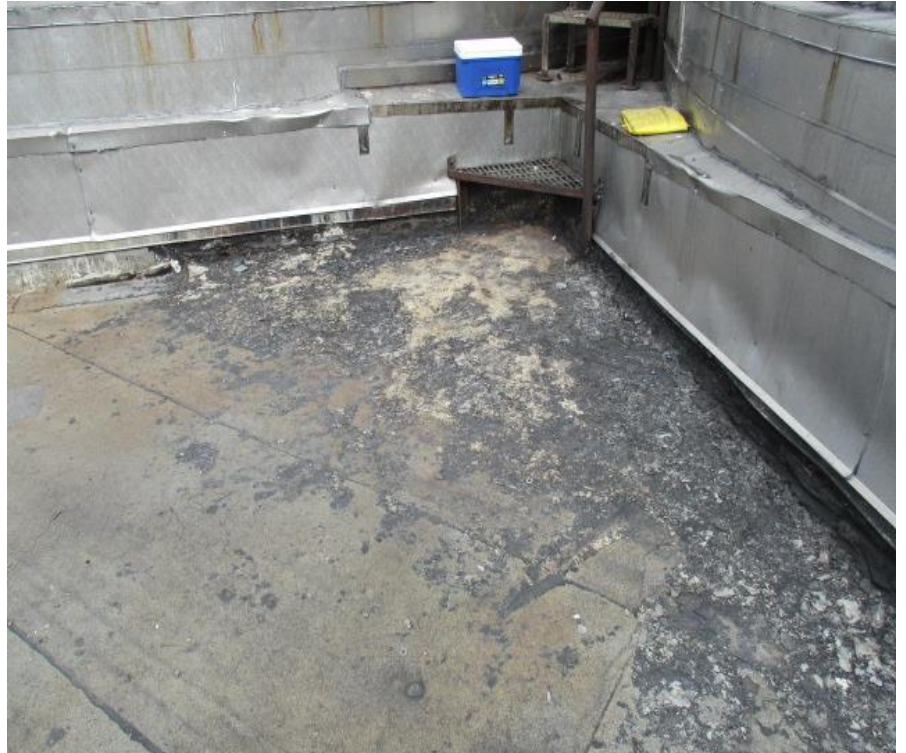
55. Deficiency #4 - Hole / puncture  
in membrane / felts

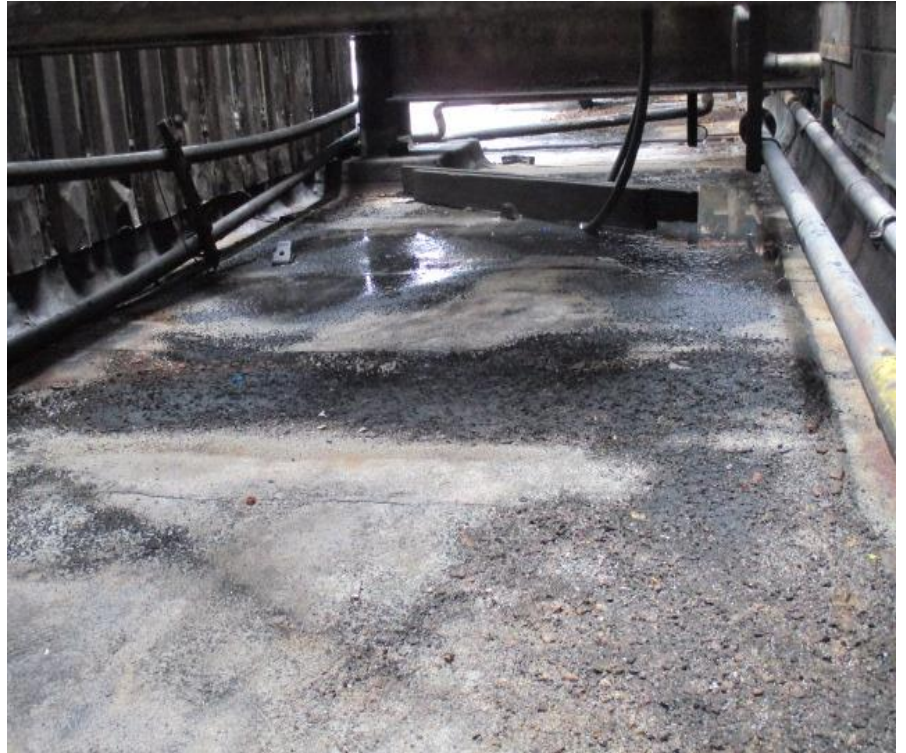
**57. Deficiency #7 - Ponding water  
observed on roof surface**

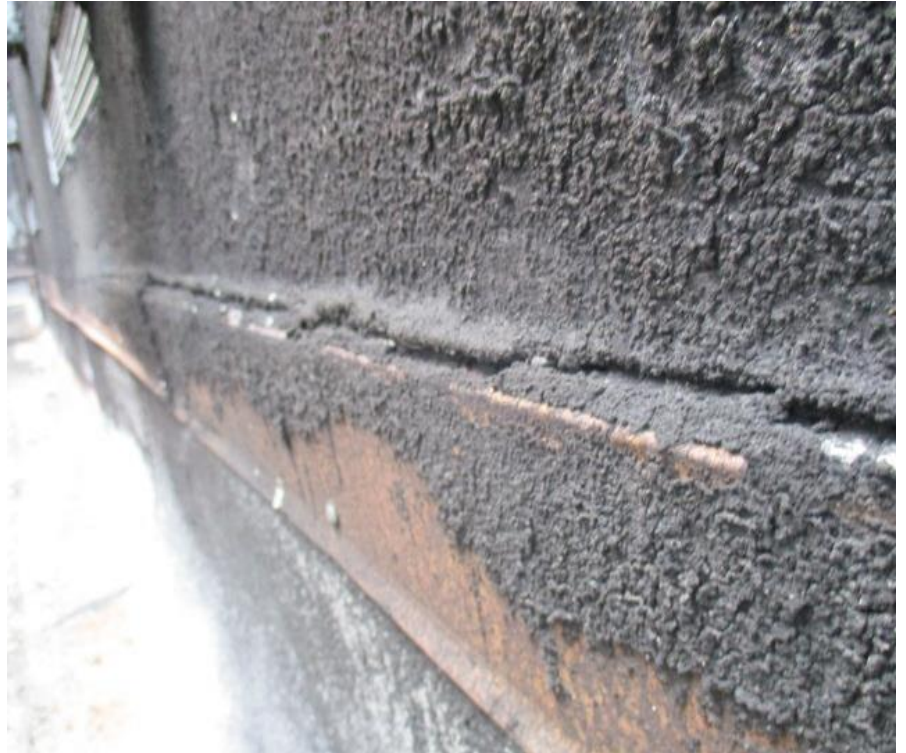
10	MN	Rust developing on metal component	1		
		Monitor address at time of replacement	Location		
11	M	Improper wall flashing detail - flashing membrane not properly terminated and counter flashed by metal Z-metal panel closure	112	\$175.00	\$19,600.00
		Remove bottom course of fasteners from vertical panel assembly. Where required, install additional mechanical flashing termination (stagger termination fasteners 8" o.c. max). Install Z-metal panel closure below panel assembly and resecure the bottom fastening course of the panel assembly though the subsequent Z-metal panel closure.	LnFt

59. Deficiency #9 - Missing /  
deteriorated sealant at metal  
counter flashing

Deficiency #10 - Rust developing on  
metal component

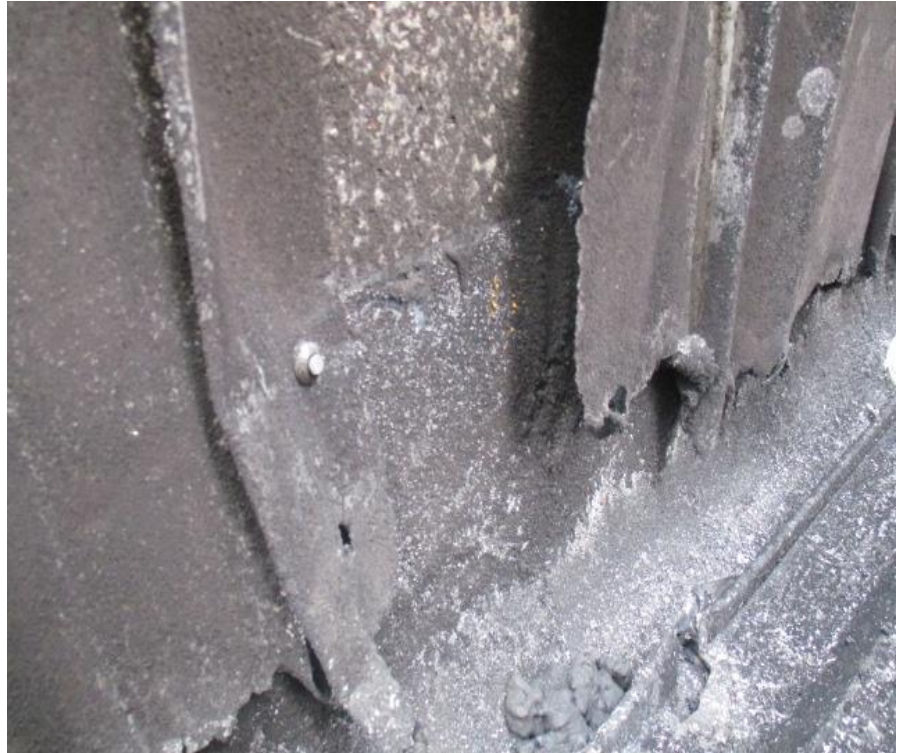
61. Deficiency #11 - Improper wall flashing detail - flashing membrane not properly terminated and counter flashed by metal Z-metal panel closure

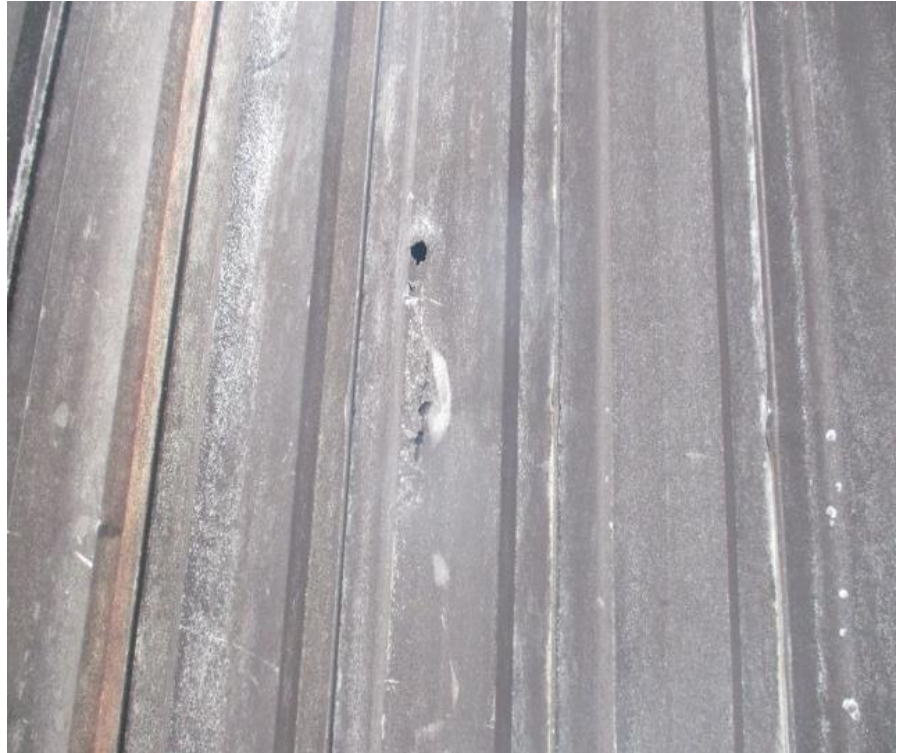
**65. Deficiency #13 - Damaged /  
missing vertical metal panels**

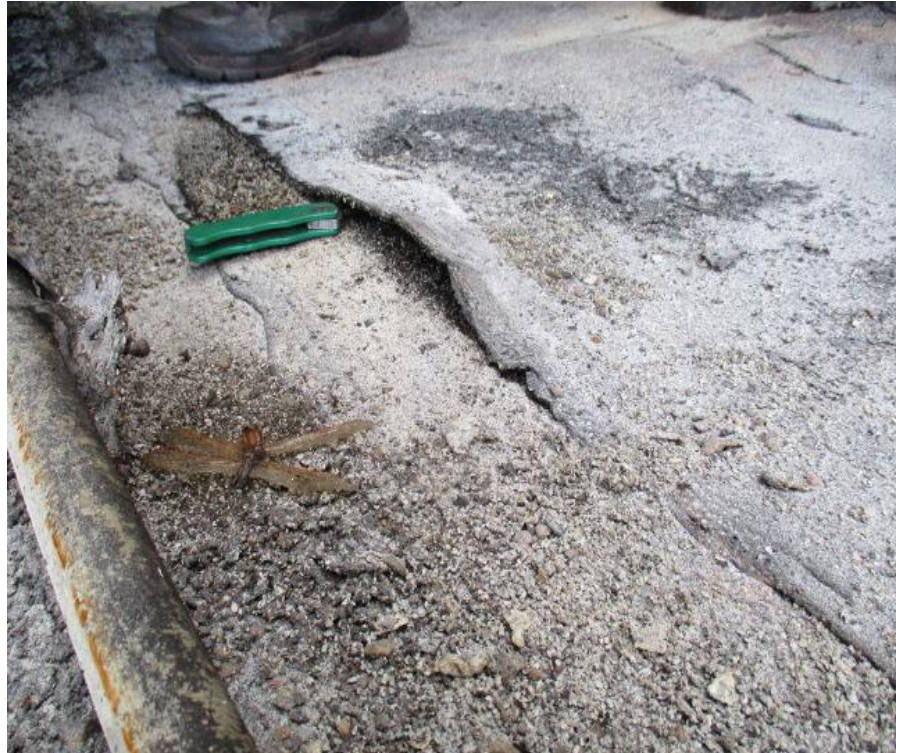
67. Deficiency #14 - Open lap in field membrane

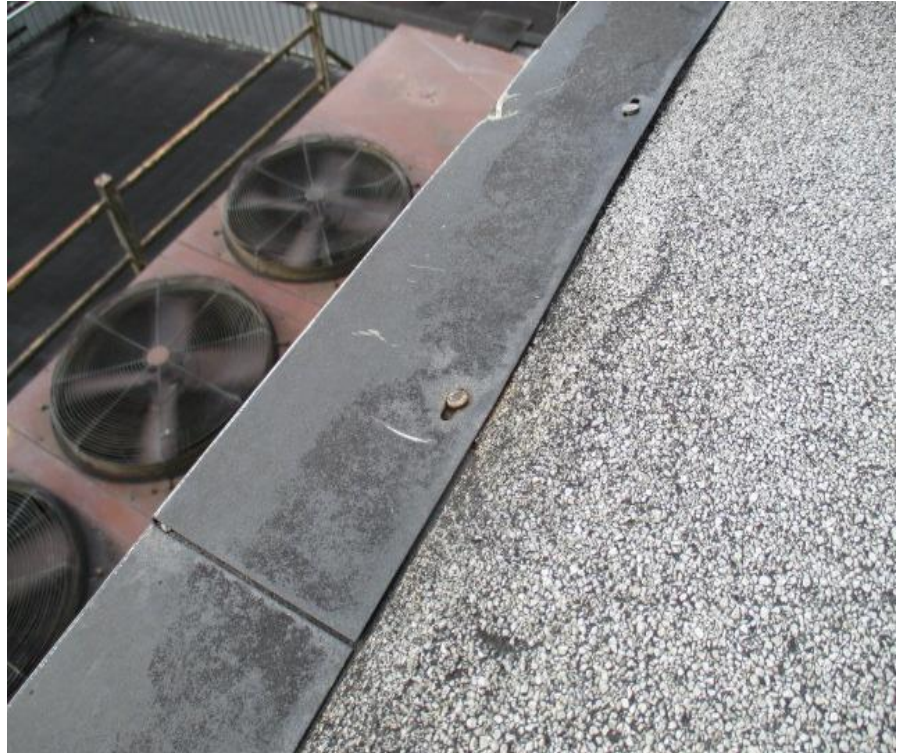
**69. Deficiency #15 - Improper edge detail - insufficient fastening pattern & edge metal not properly stripped into roof system**

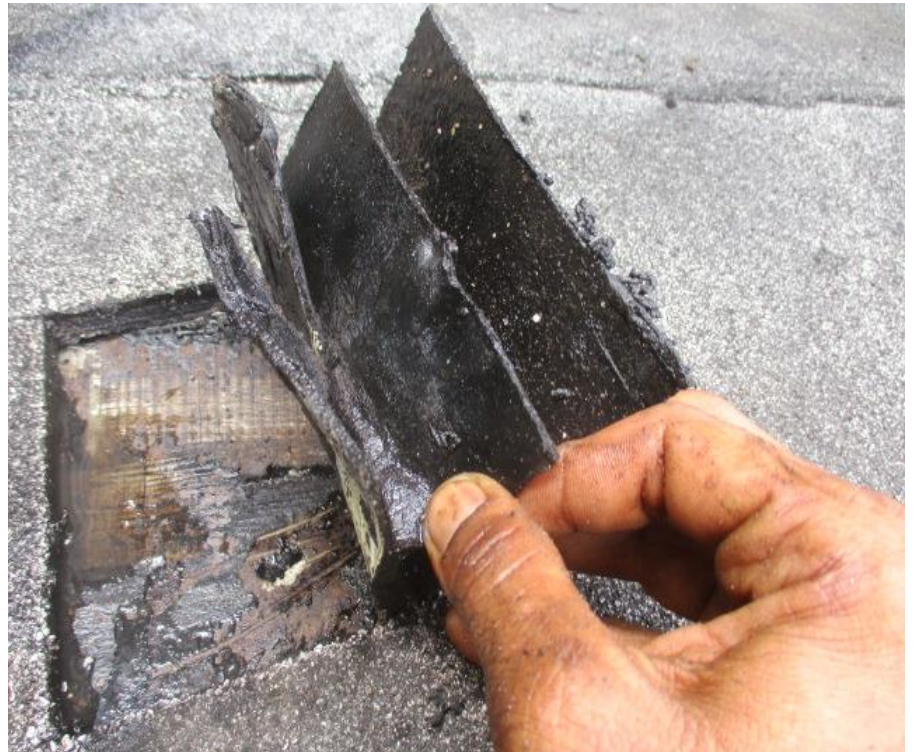
<b><i>TEST CUT / PROBE NUMBER</i></b>	<b>7</b>	<b>10</b>
<b><i>Test Cut Size</i></b>	6" x 6"	6" x 6"
<b><i>Troxler Reading</i></b>	N/A	N/A
<b><i>Infra-red Reading</i></b>	N/A	N/A
<b><i>Delmhorst Reading</i></b>	Dry	Wet
<b><i>Deck Condition</i></b>	Good	Good
<b><i>Vapor Retarder Condition</i></b>	N/A	N/A
<b><i>Insulation Condition</i></b>	N/A	N/A
<b><i>Membrane Condition</i></b>	Poor	Poor

**70. Test Cut #7 (Area D): View of modified bitumen plies**

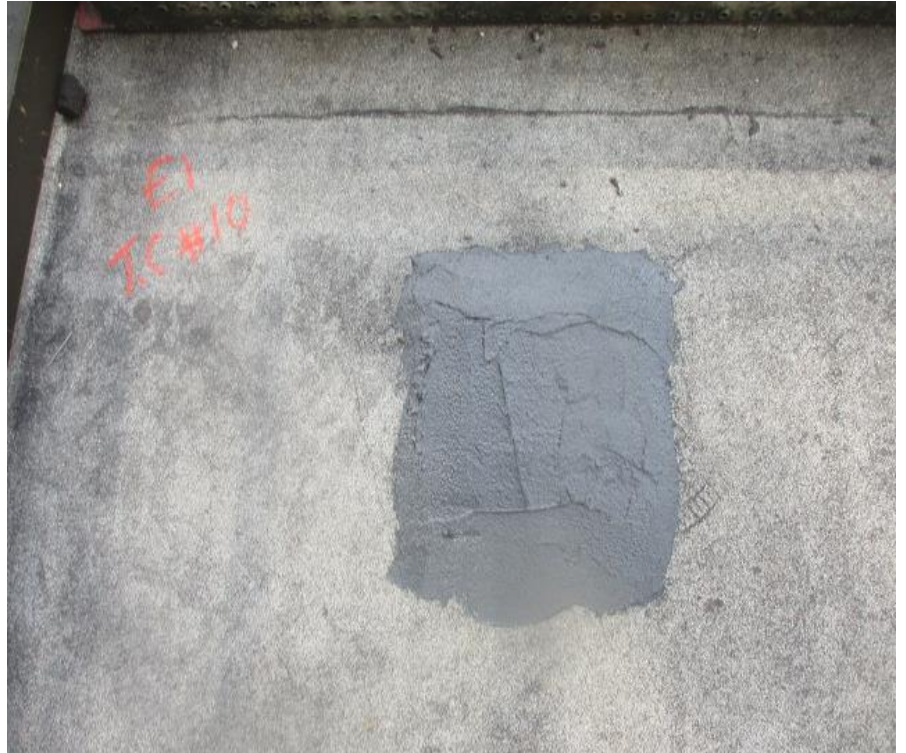
75. Test Cut #10 (Area E2): View of  
RCS repair

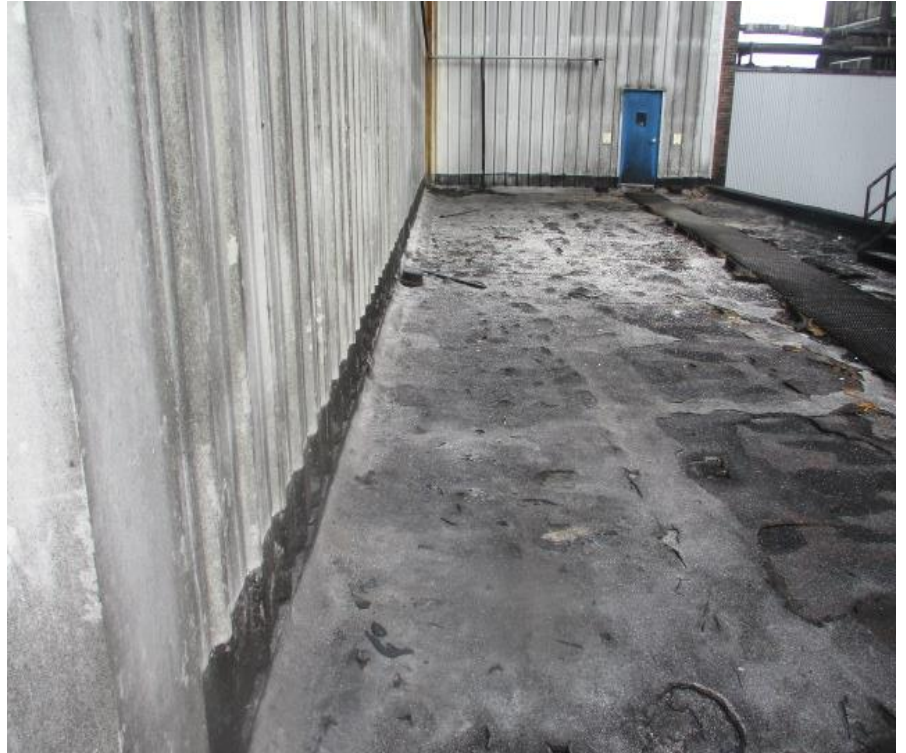
1. Bldg 8 - Area H roof system overview

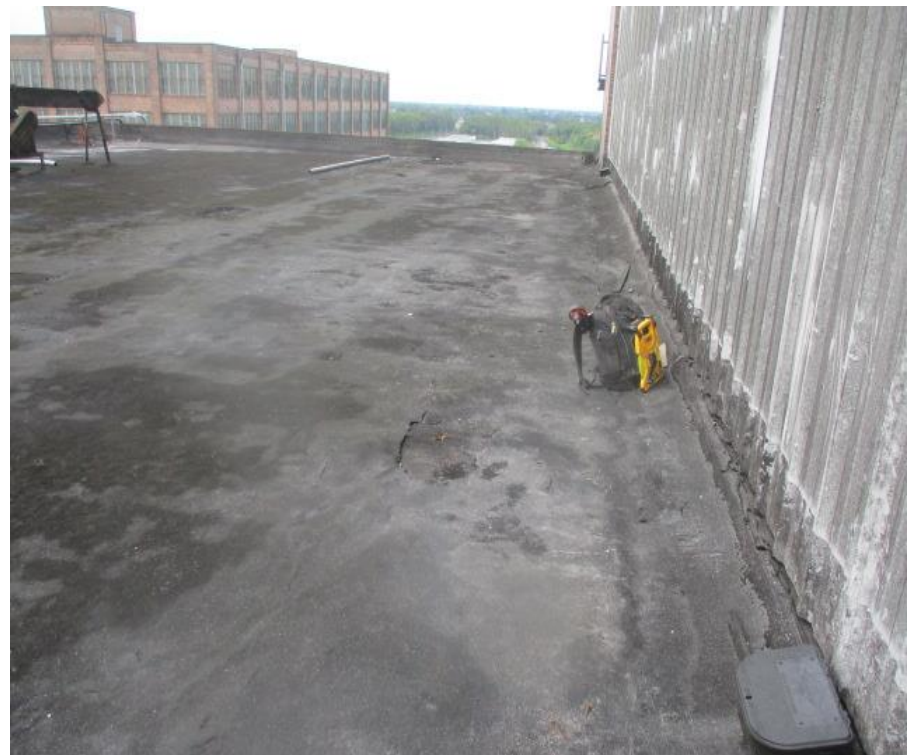
2. Bldg 8 - Area H roof system overview

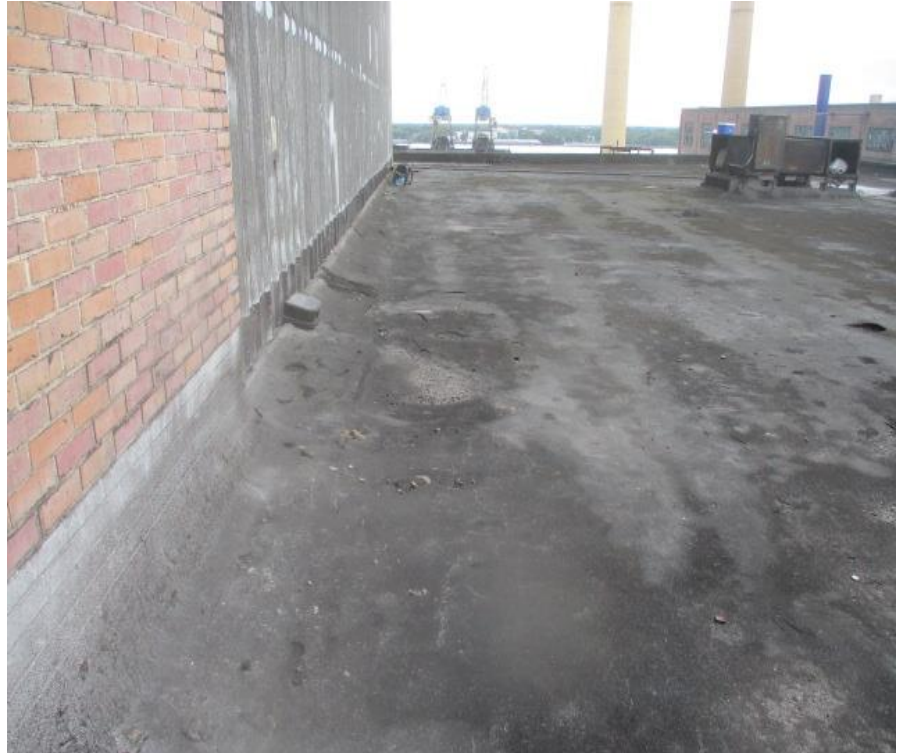
**3. Bldg 8 - Area H roof system  
overview**

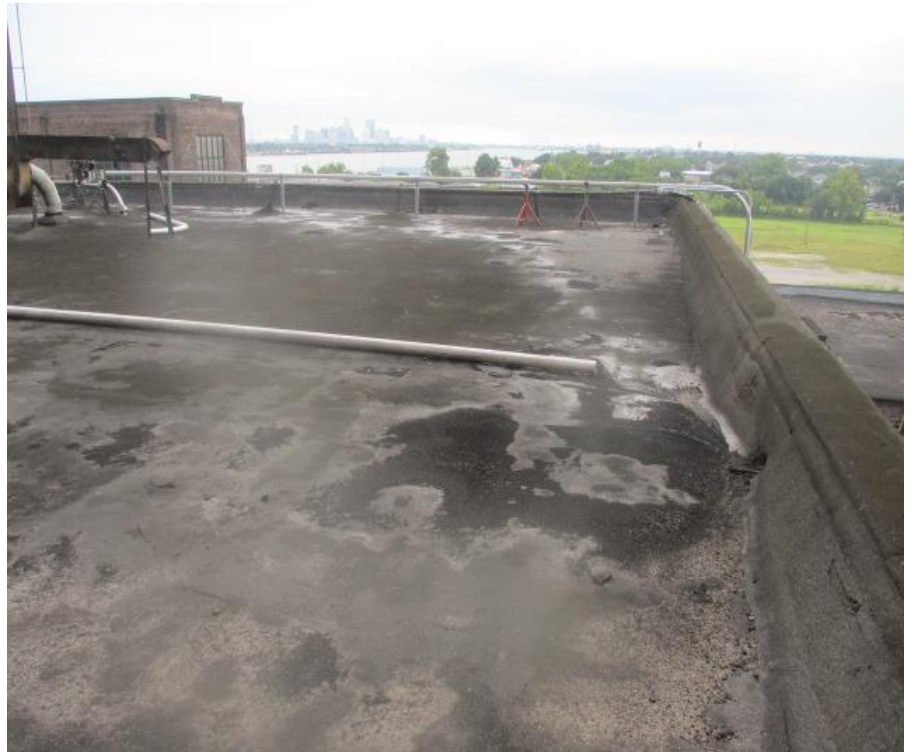
**4. Bldg 8 - Area H roof system  
overview**

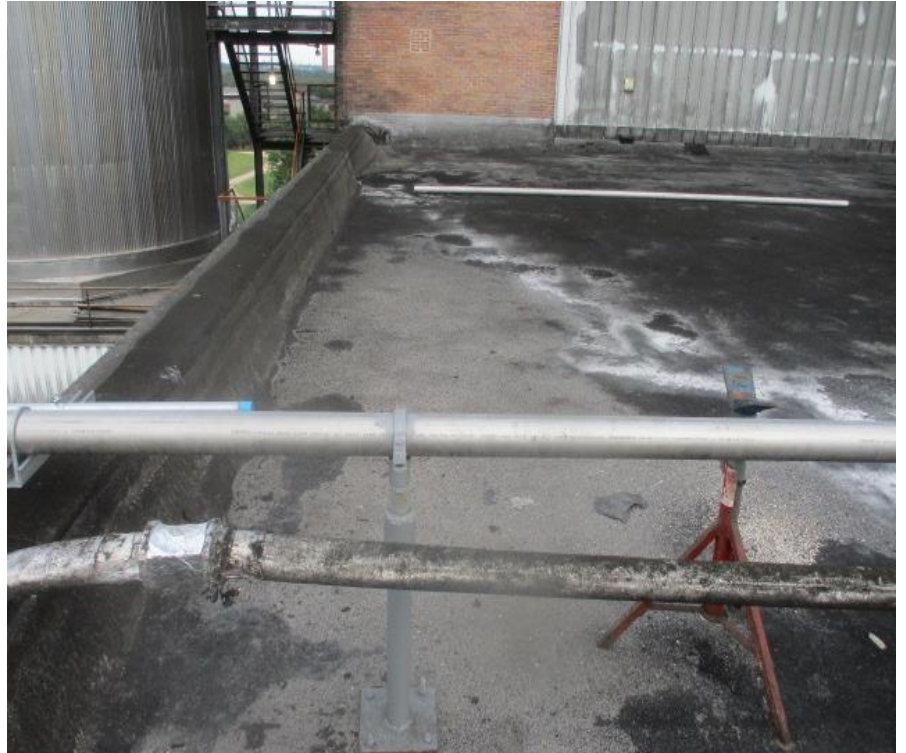
5. Bldg 8 - Area H roof system overview
