## **Domino Sugar Refinery**

# **Domino Sugar Facility**

**7412 N. Peters Street  
Arabi, LA**

**9/3/2022**

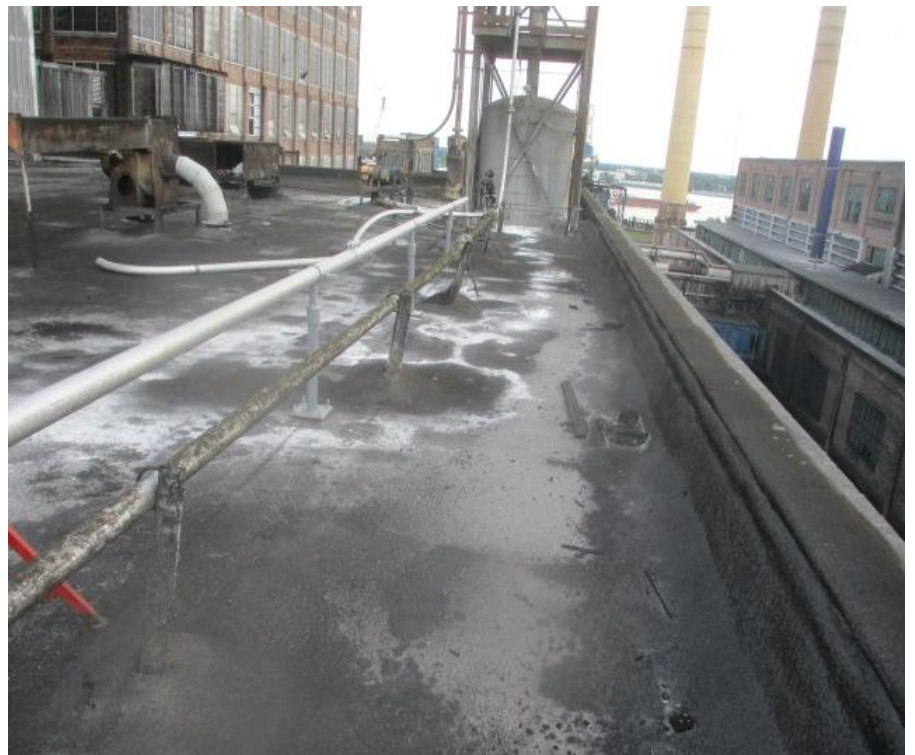
6. Bldg 8 - Area H roof system overview

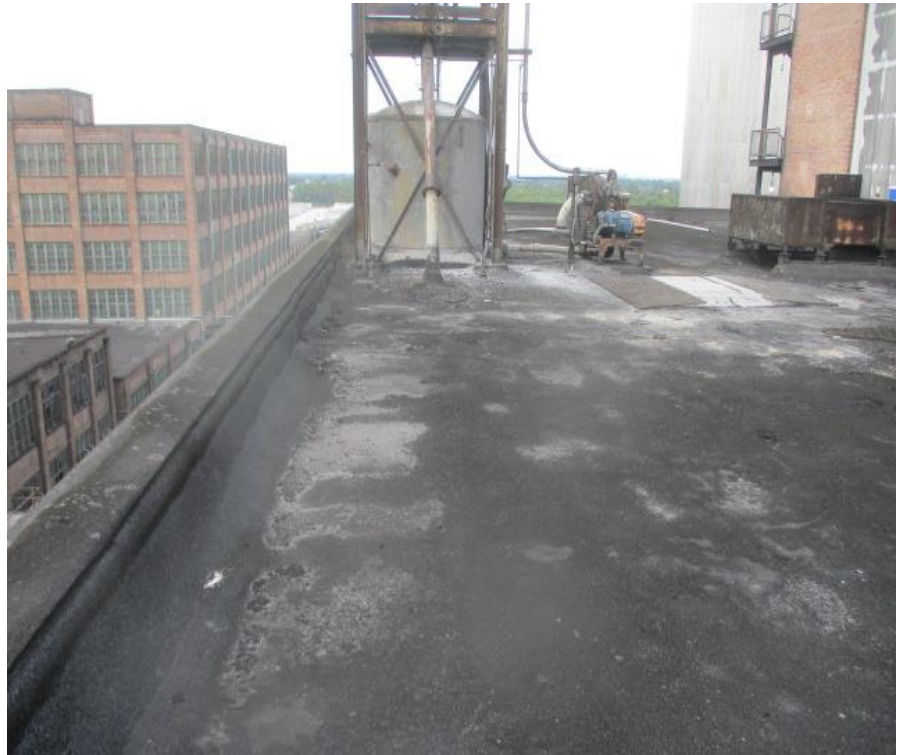
**7. Bldg 8 - Area H roof system  
overview**

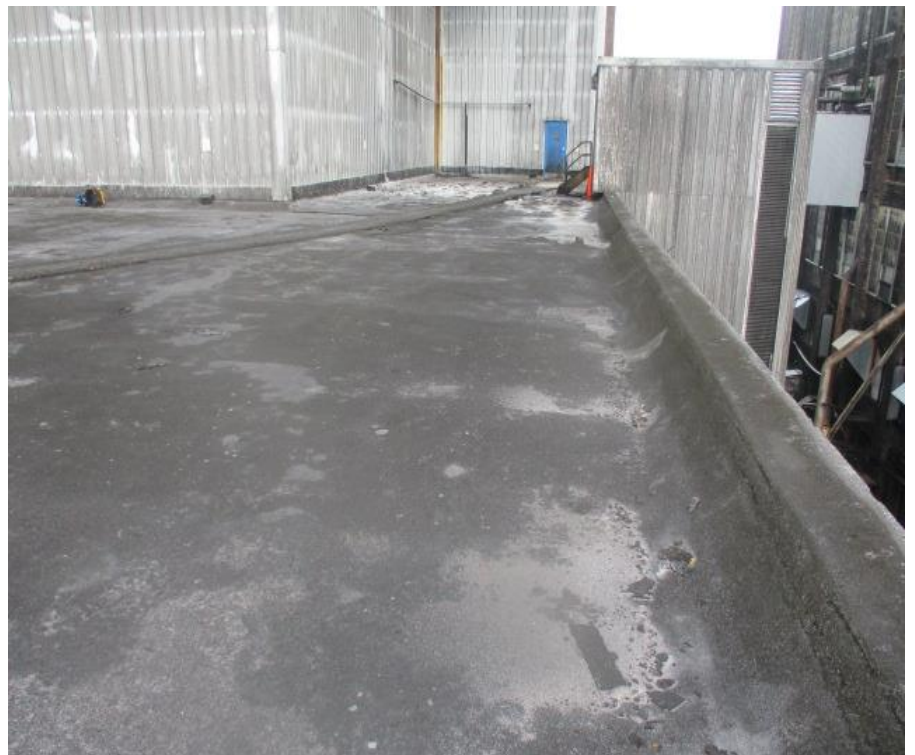
**8. Bldg 8 - Area H roof system  
overview**

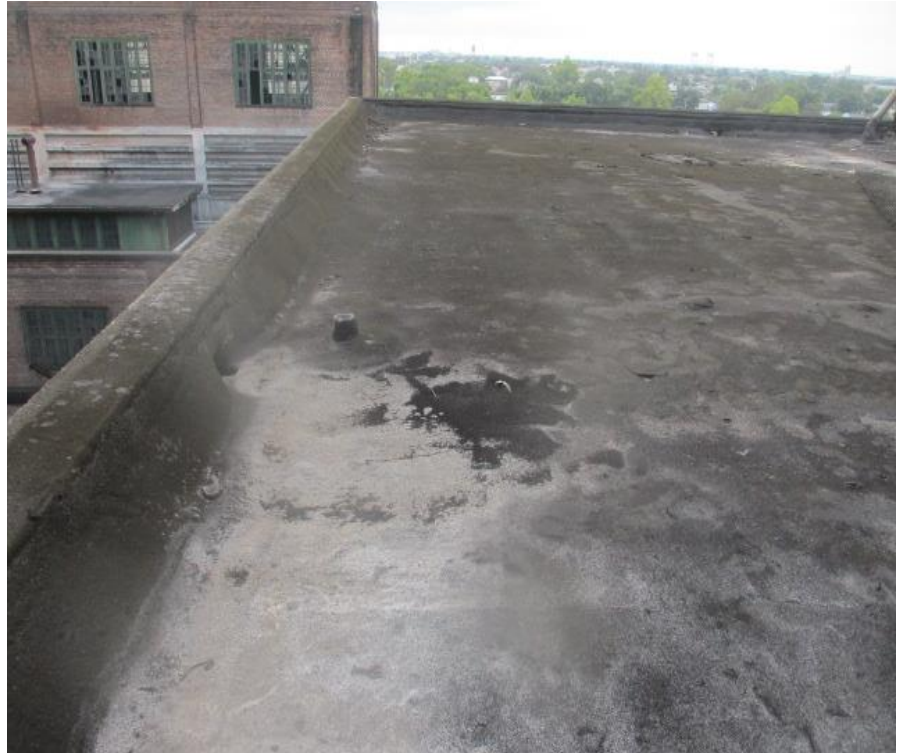
**9. Bldg 8 - Area H roof system overview**

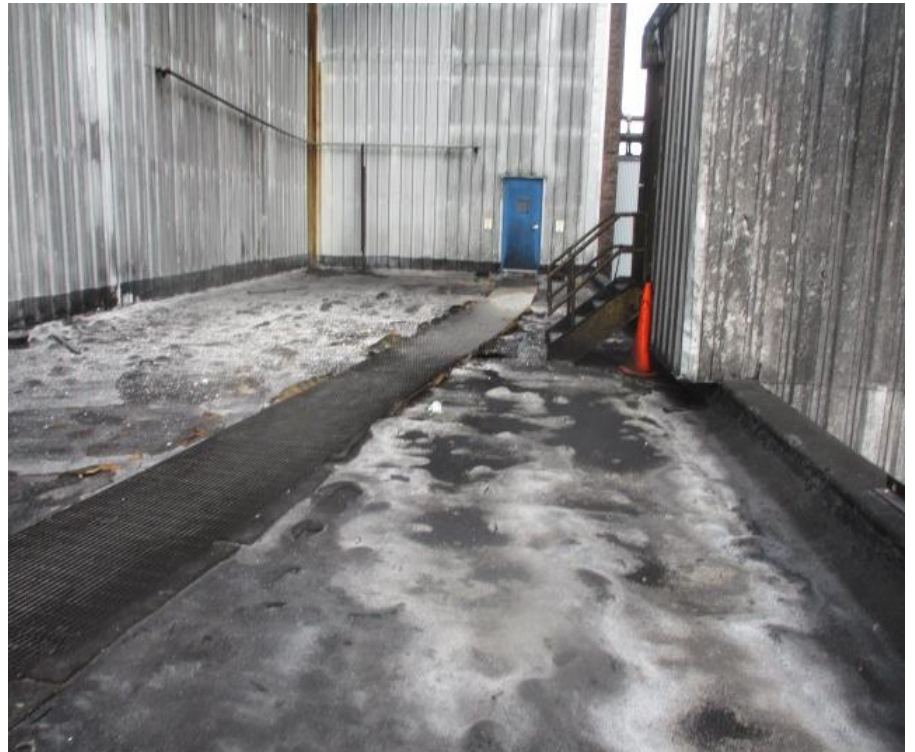
**10. Bldg 8 - Area H roof system overview**

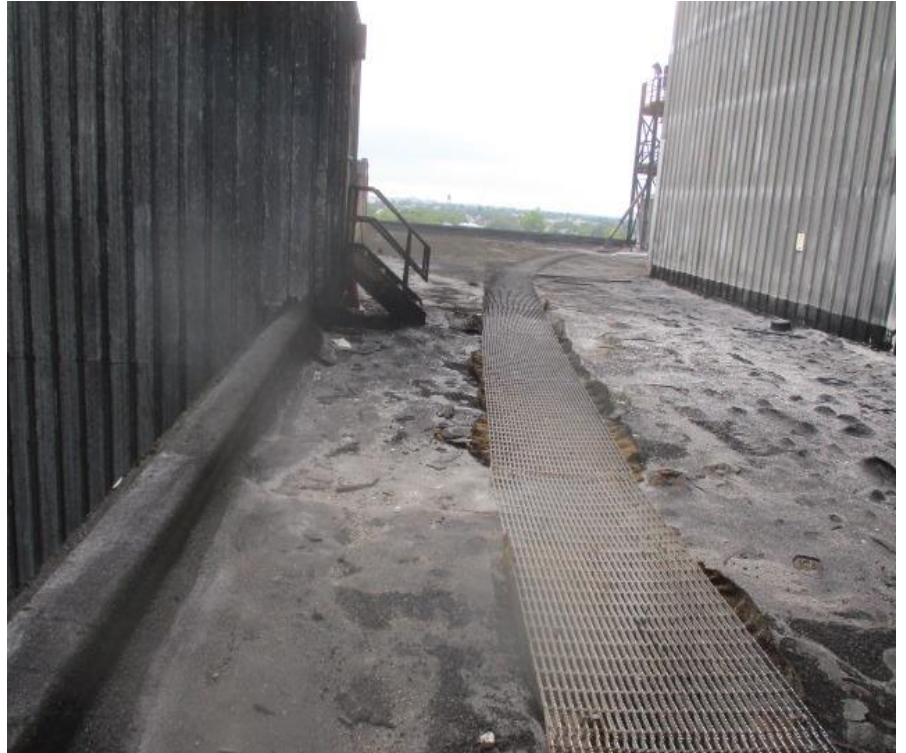
11. Bldg 8 - Area H roof system overview

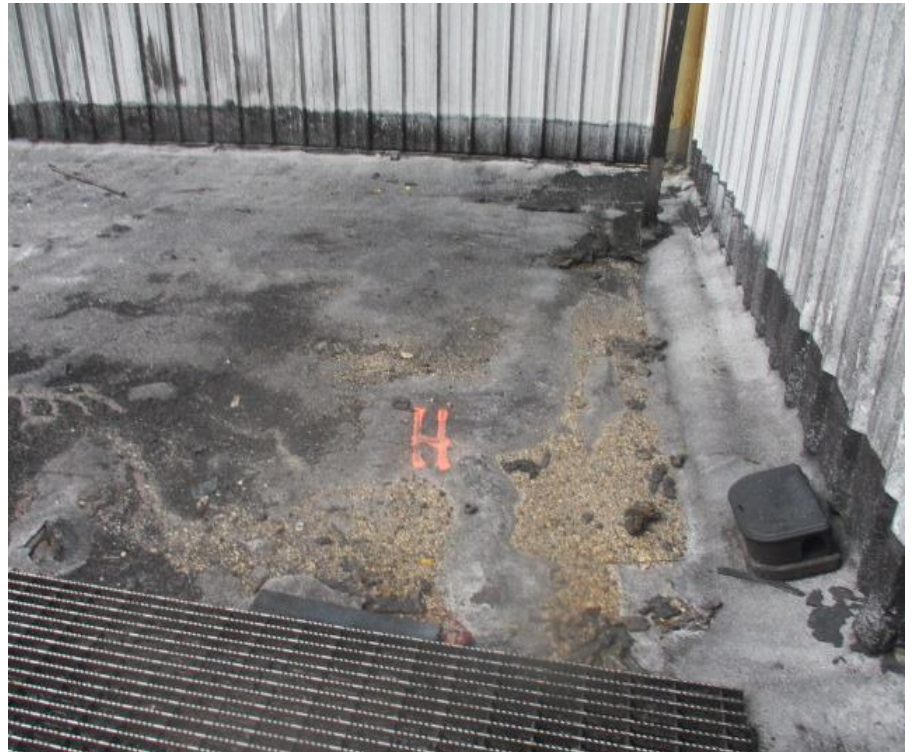
12. Bldg 8 - Area H roof system overview

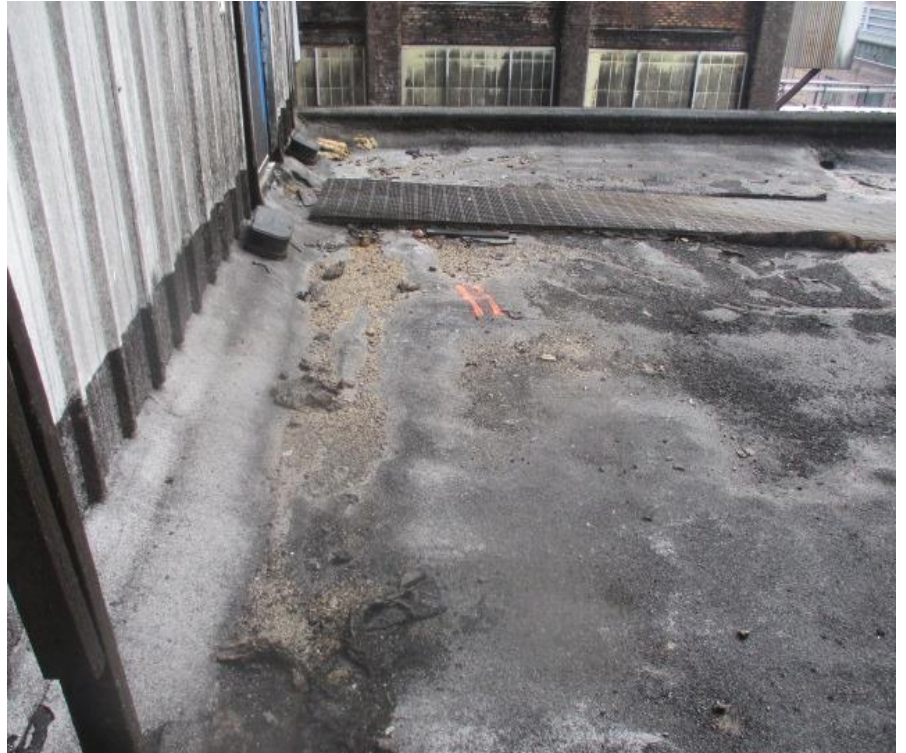
13. Bldg 8 - Area H roof system overview

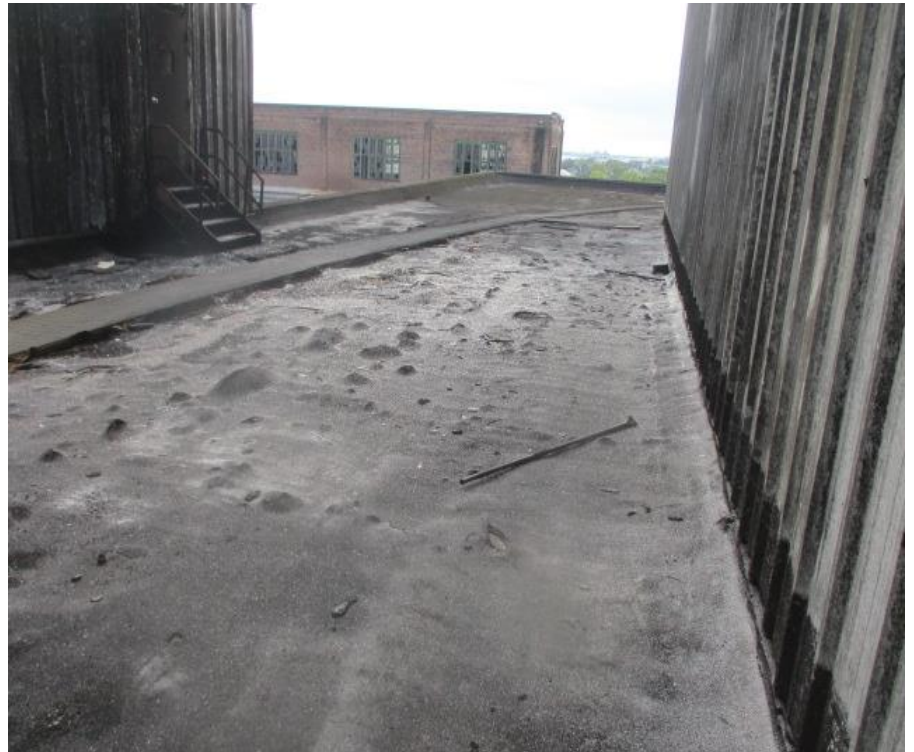
14. Bldg 8 - Area H roof system overview

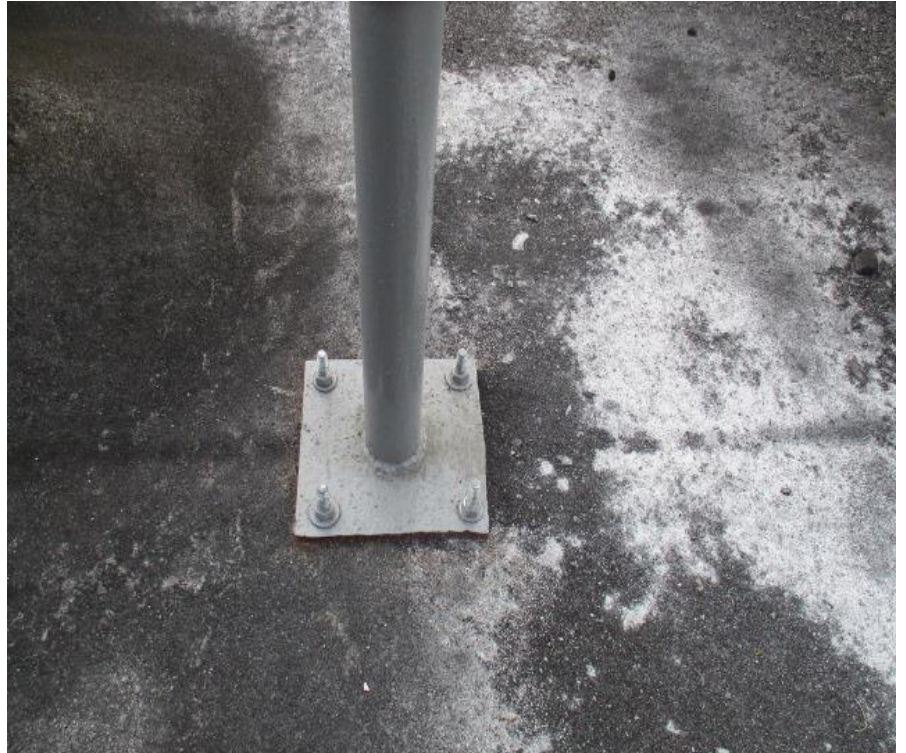
15. Deficiency #1 - Penetrations through roof surface have not been flashed

NUMBER	PRIORITY CODE	DEFICIENCY DESCRIPTION	QUANTITY	UNIT PRICE	REPAIR COST
		DEFICIENCY SOLUTION	UNITS		
1	MN	Penetrations through roof surface have not been flashed	2		
		Address condition by completion of recommended roof system replacement	Locations		
2	MN	Debris on roof surface	3		
		Address condition by completion of recommended roof system replacement	Locations		
20	MN	Deteriorated roof coating on PUF	1		
		Address condition by completion of recommended roof system replacement	Typical		
21	MN	Missing downspout	1		
		Address condition by completion of recommended roof system replacement	Location		
22	MN	Wet insulation / moisture entrapment	8,205		
		Address condition by completion of recommended roof system replacement	SqFt

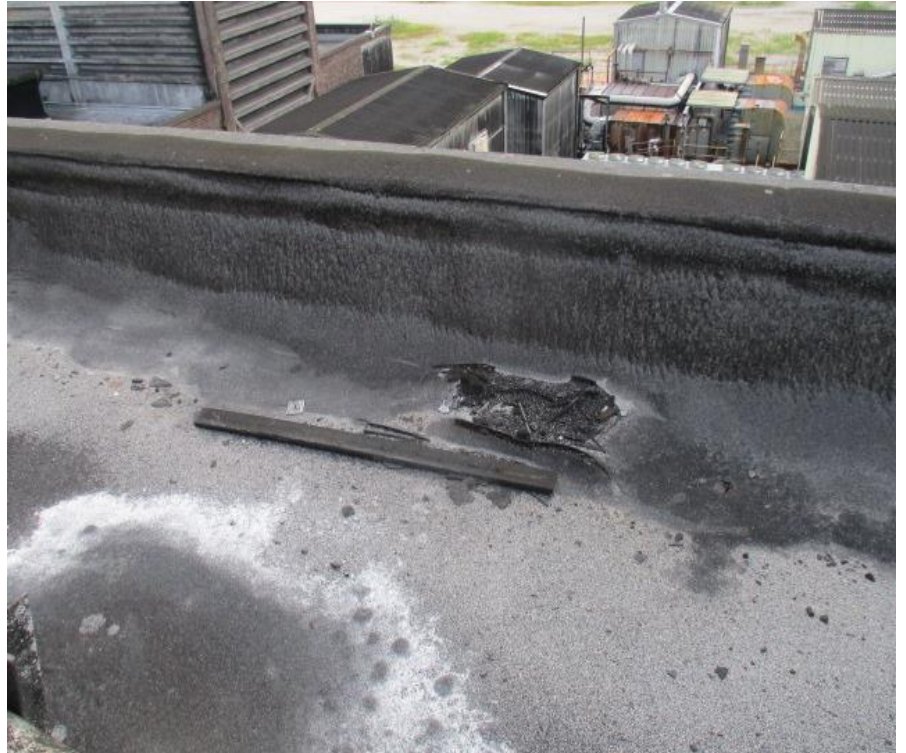
17. Deficiency #2 - Debris on roof surface

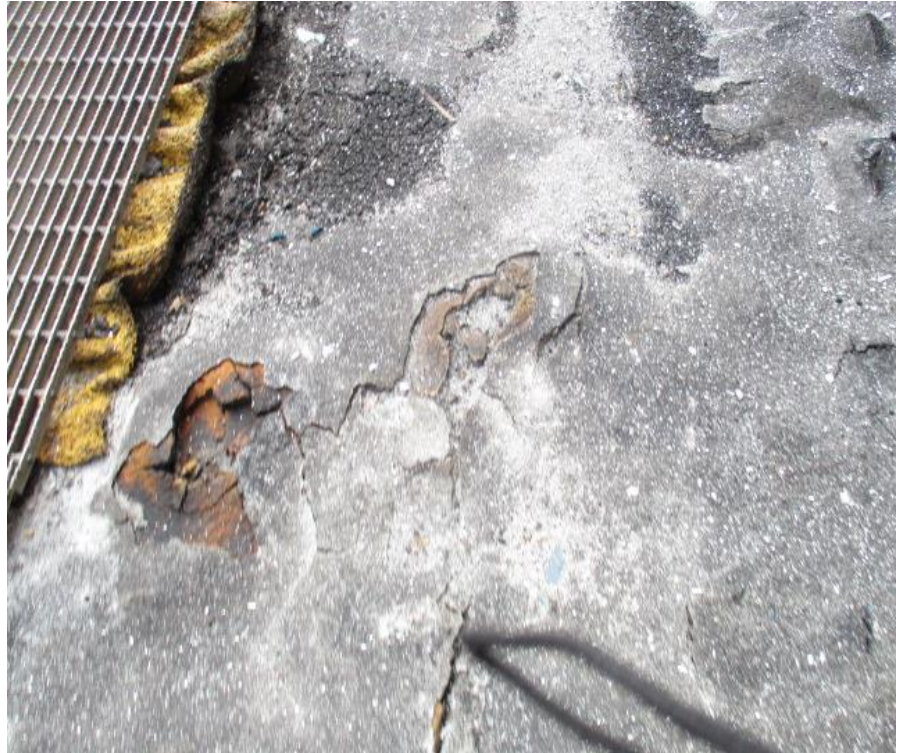
19. Deficiency #20 - Deteriorated  
roof coating on PUF

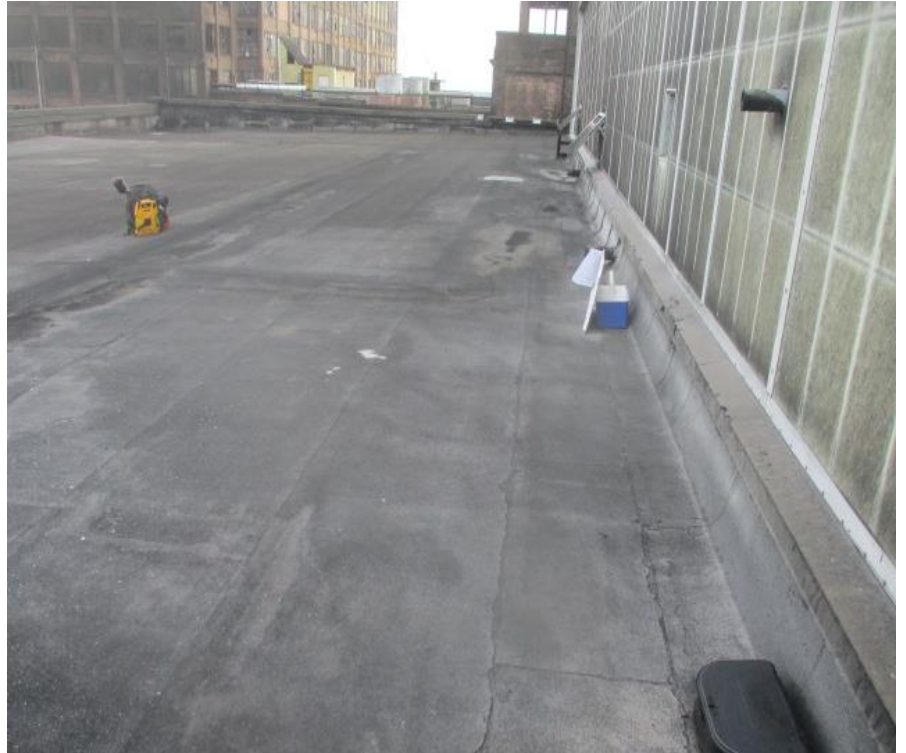
**1. Bldg 8 - Area I roof system  
overview**

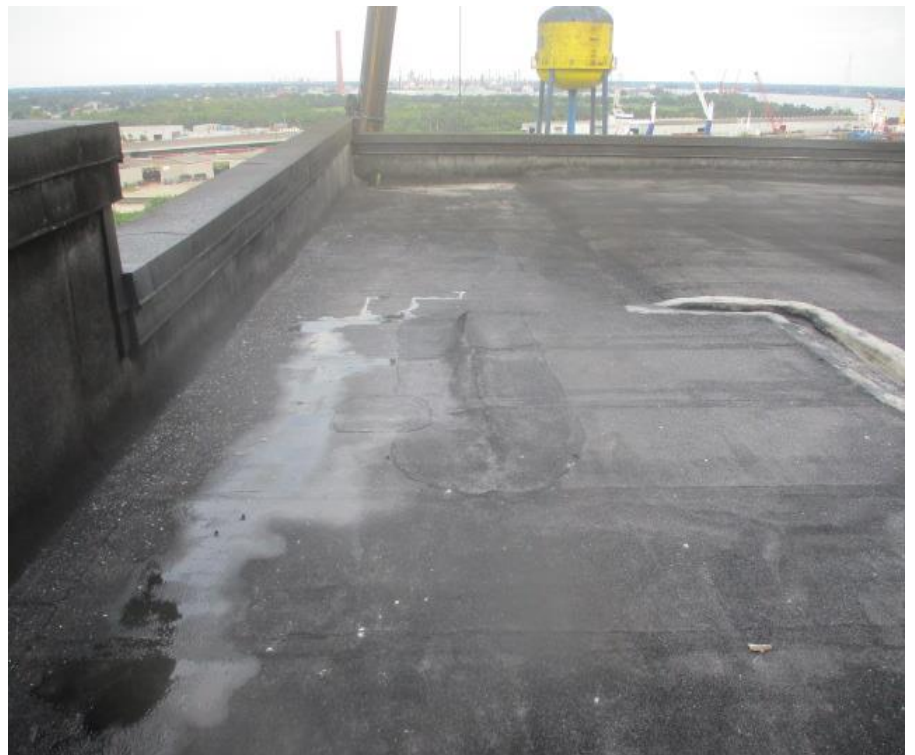
**2. Bldg 8 - Area I roof system  
overview**

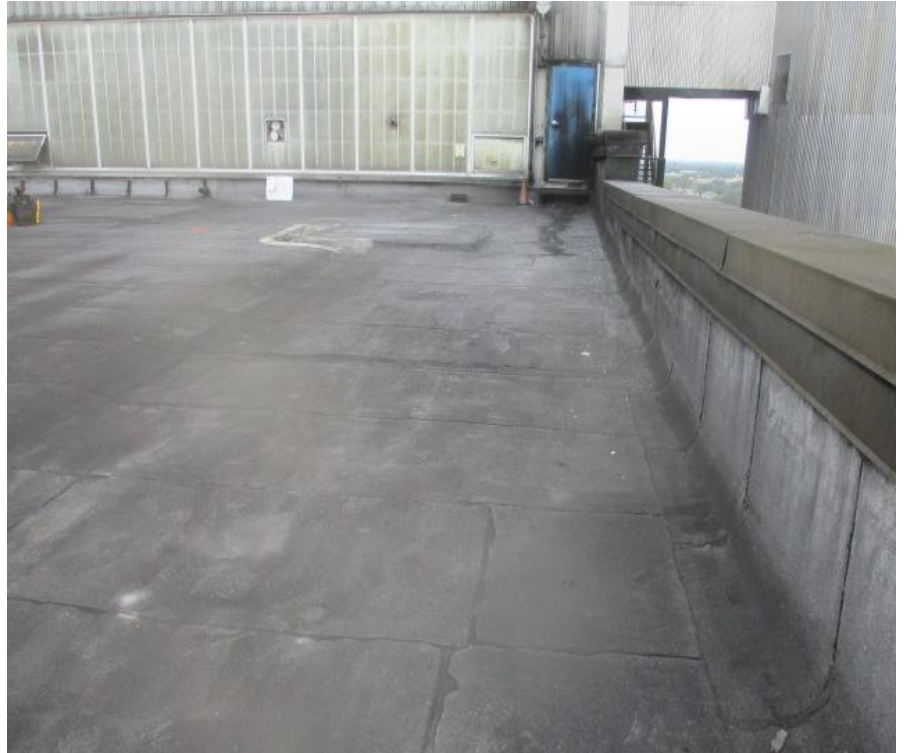
3. Bldg 8 - Area I roof system overview

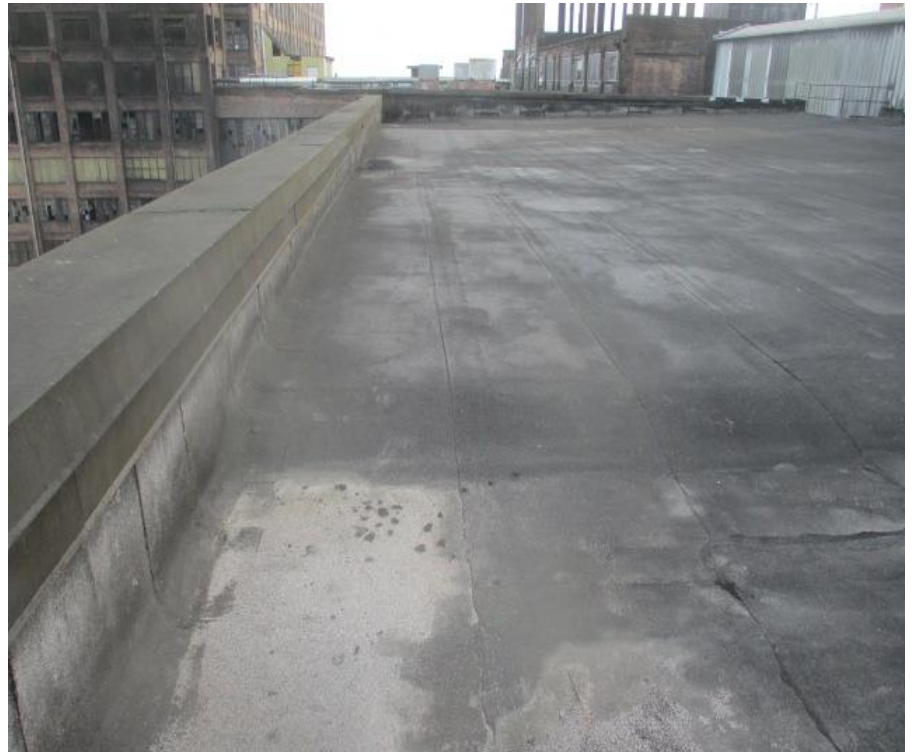
4. Bldg 8 - Area I roof system overview

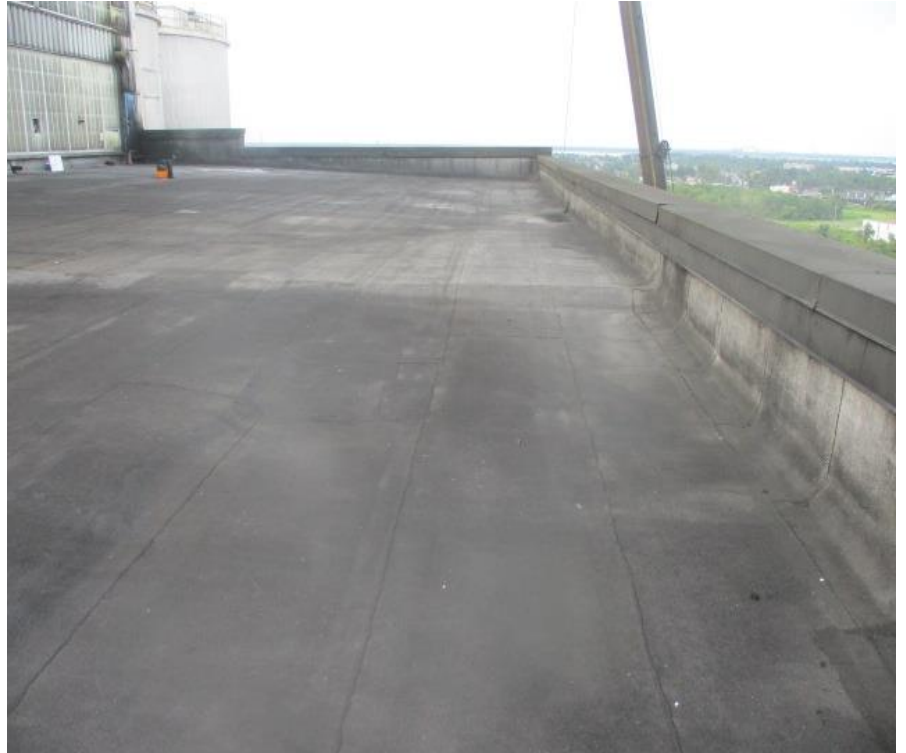
**5. Bldg 8 - Area I roof system  
overview**

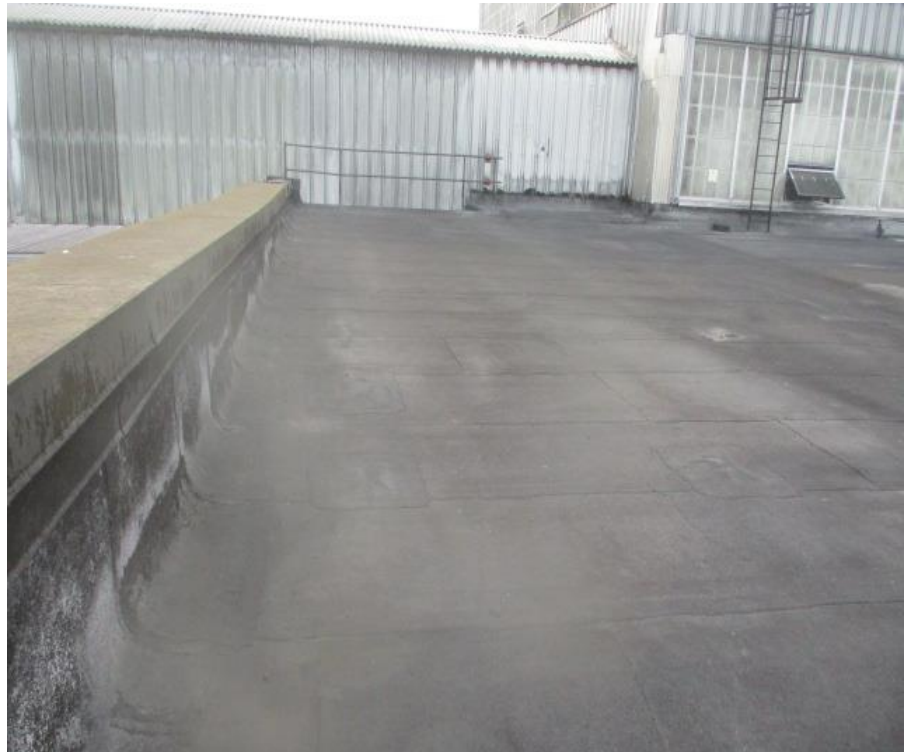
**6. Bldg 8 - Area I roof system  
overview**

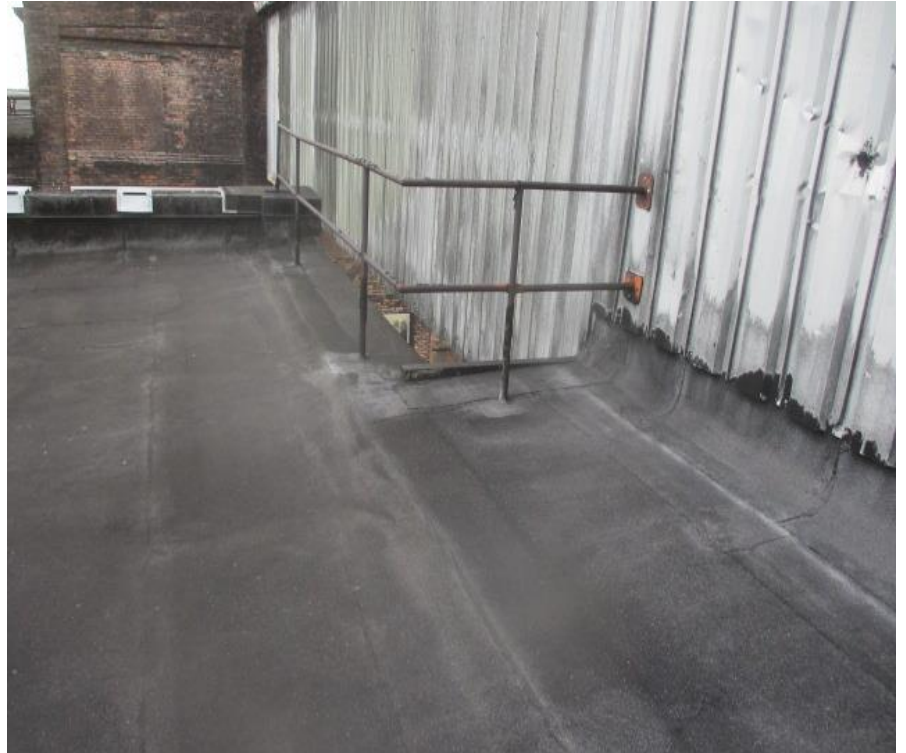
7. Bldg 8 - Area I roof system overview

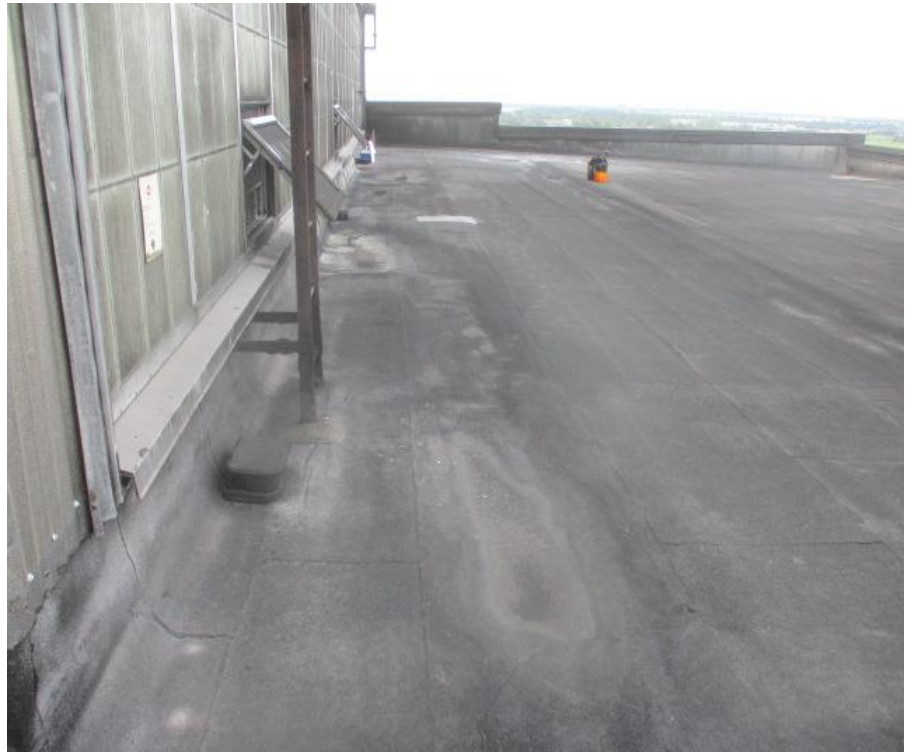
8. Bldg 8 - Area I roof system overview

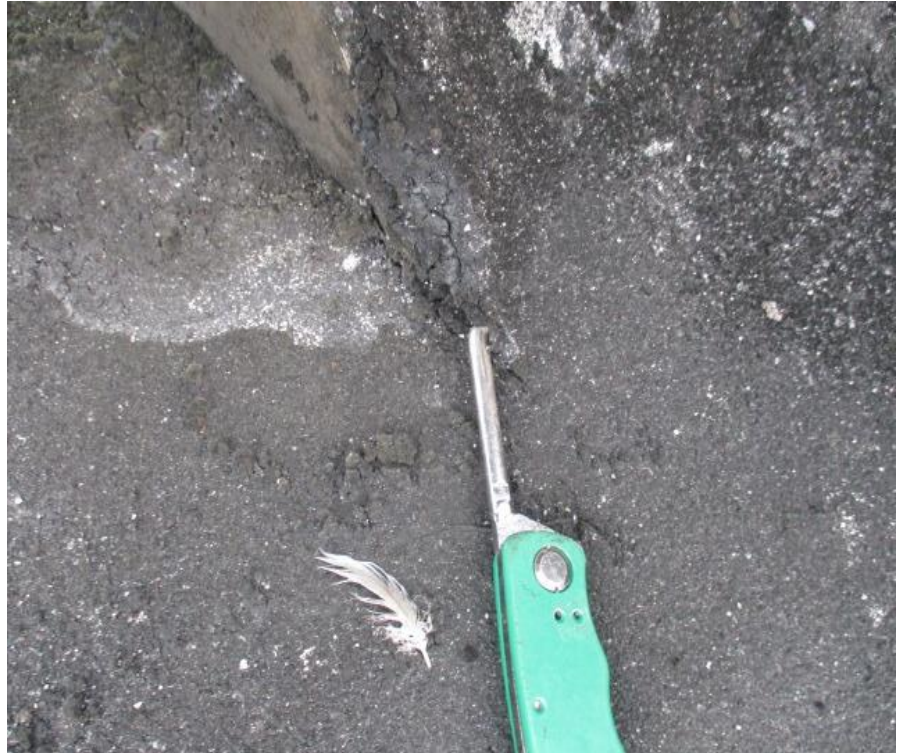
9. Deficiency #3 - Open flashing

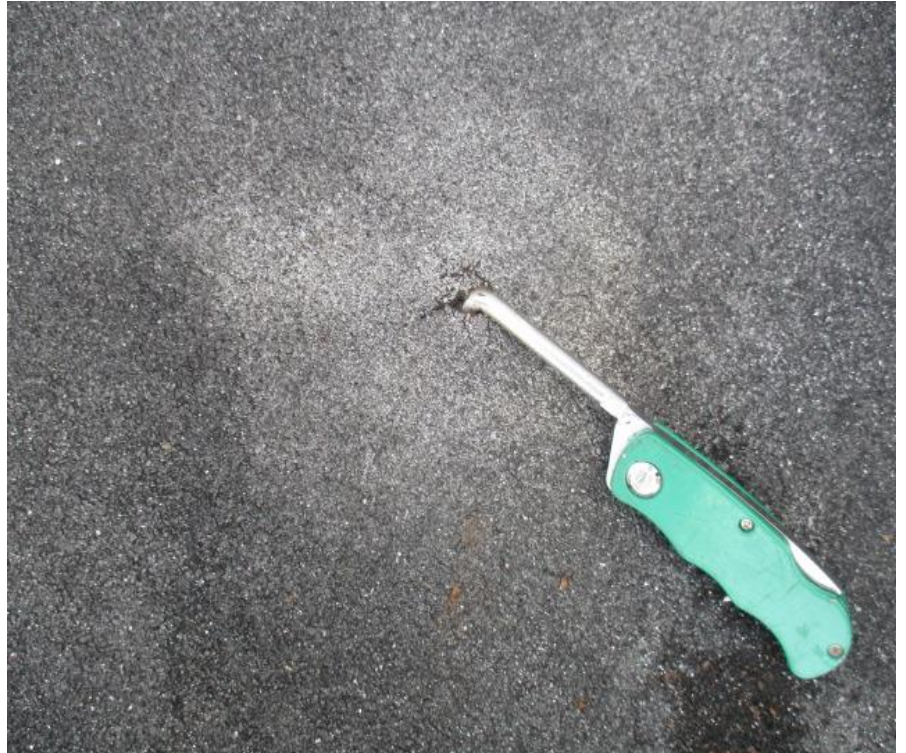
11. Deficiency #4 - Hole / puncture  
in membrane / felts

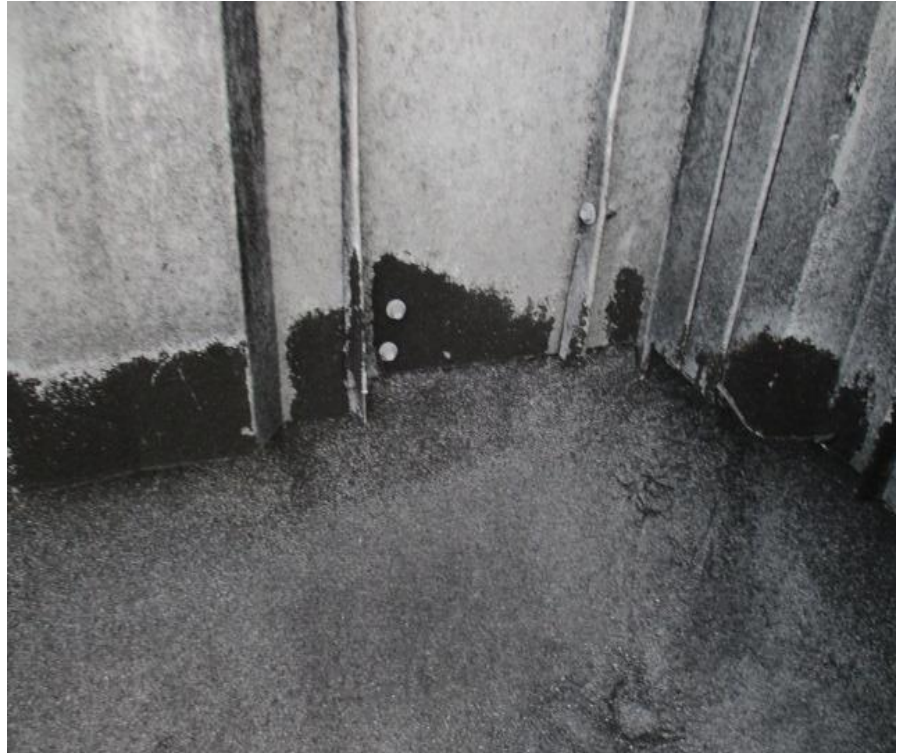
13. Deficiency #11 - Wall flashing membrane open - incomplete flashing detail

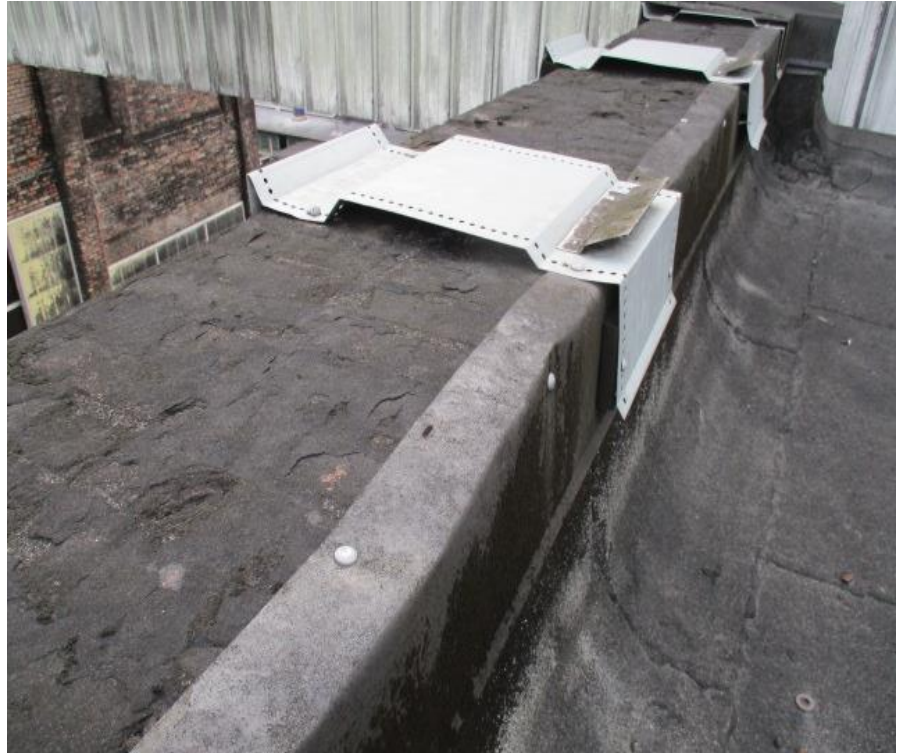
**15. Deficiency #18 - Damaged /  
missing metal coping**

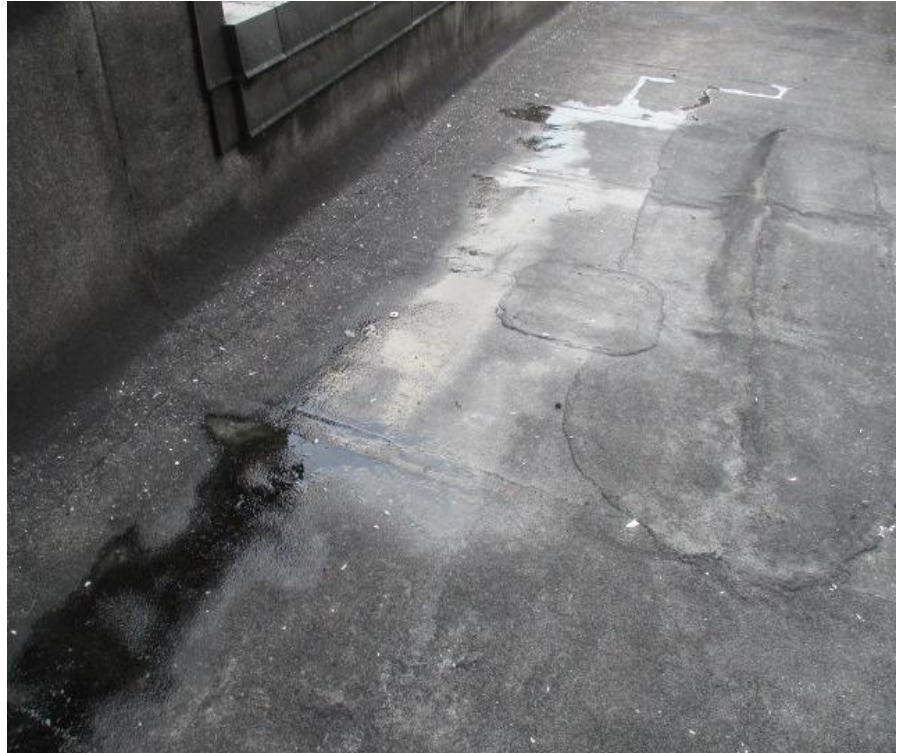
17. Deficiency #19 - Chemical  
contamination on roof membrane

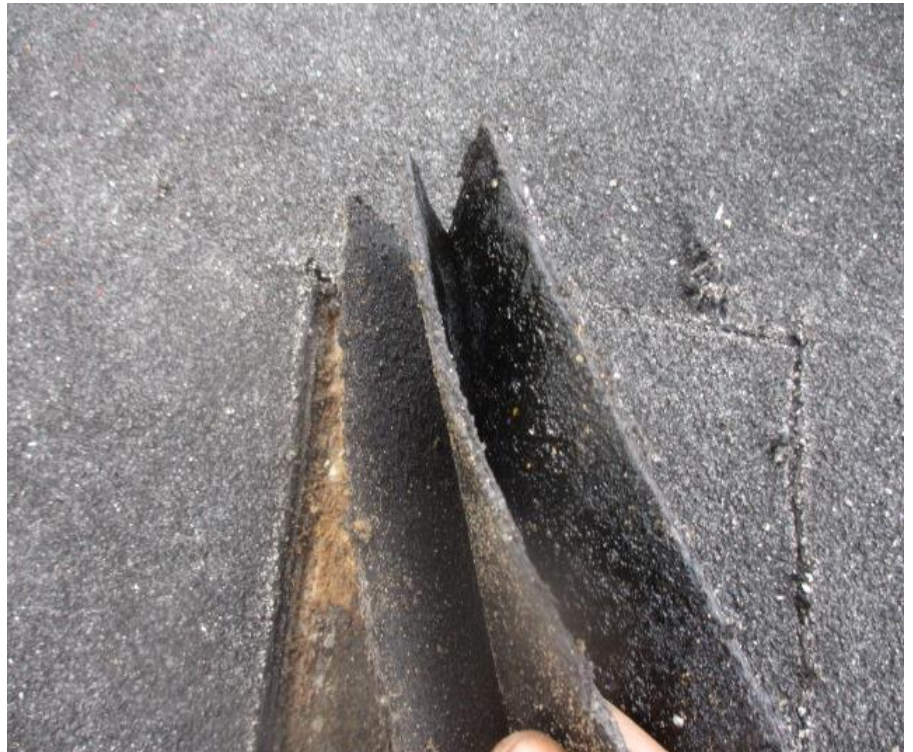
18. Test Cut #13 (Area I): View of  
modified bitumen plies

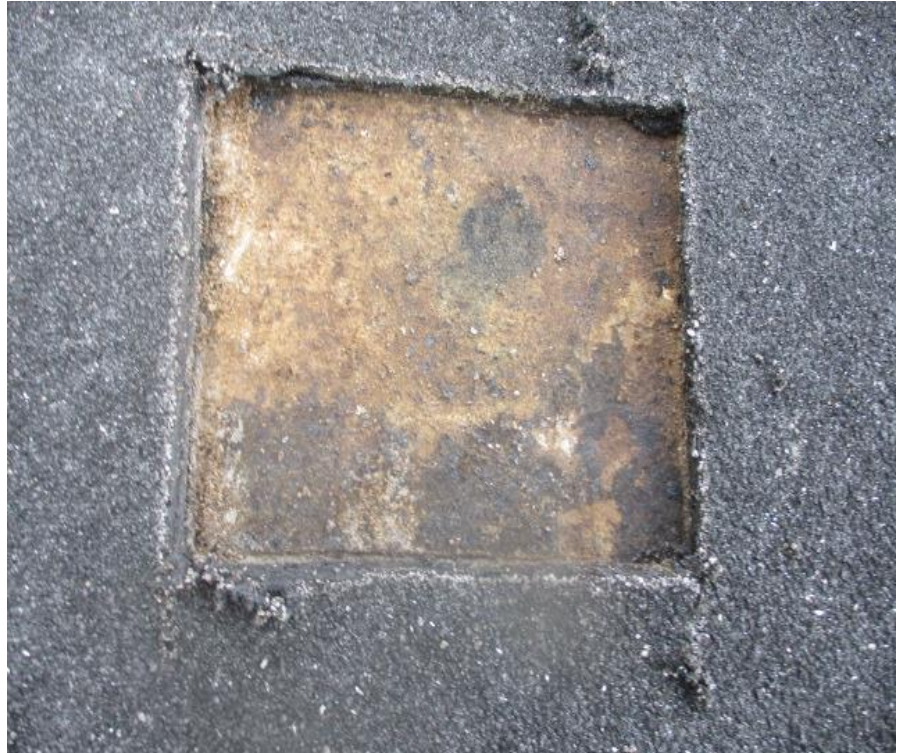
19. Test Cut #13 (Area I): View of roof membrane removed exposing a structural concrete roof deck

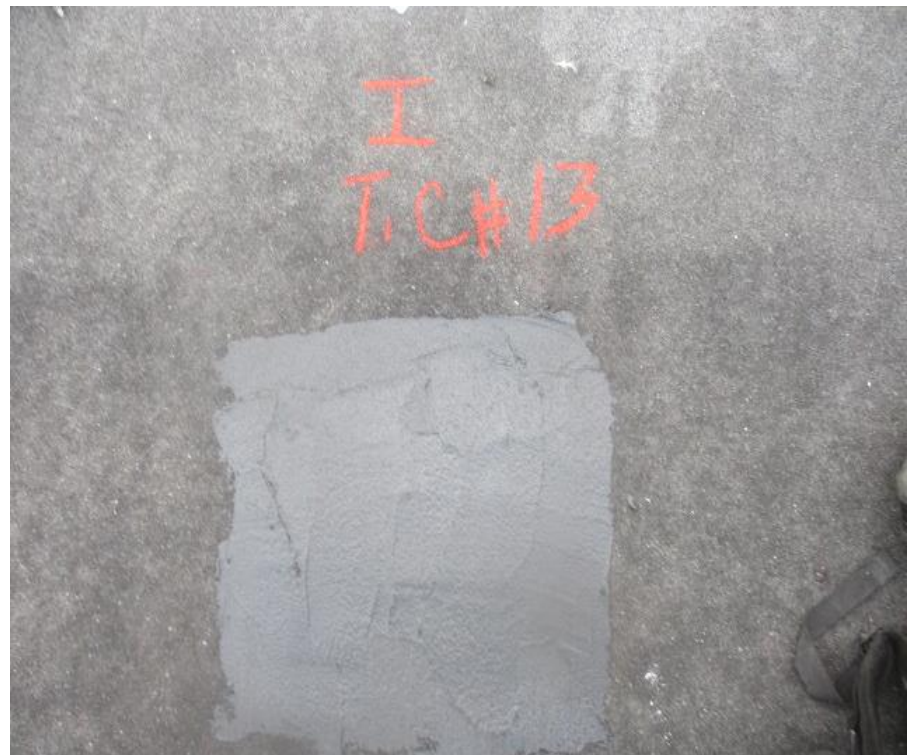
20. Test Cut #13 (Area I): View of RCS repair

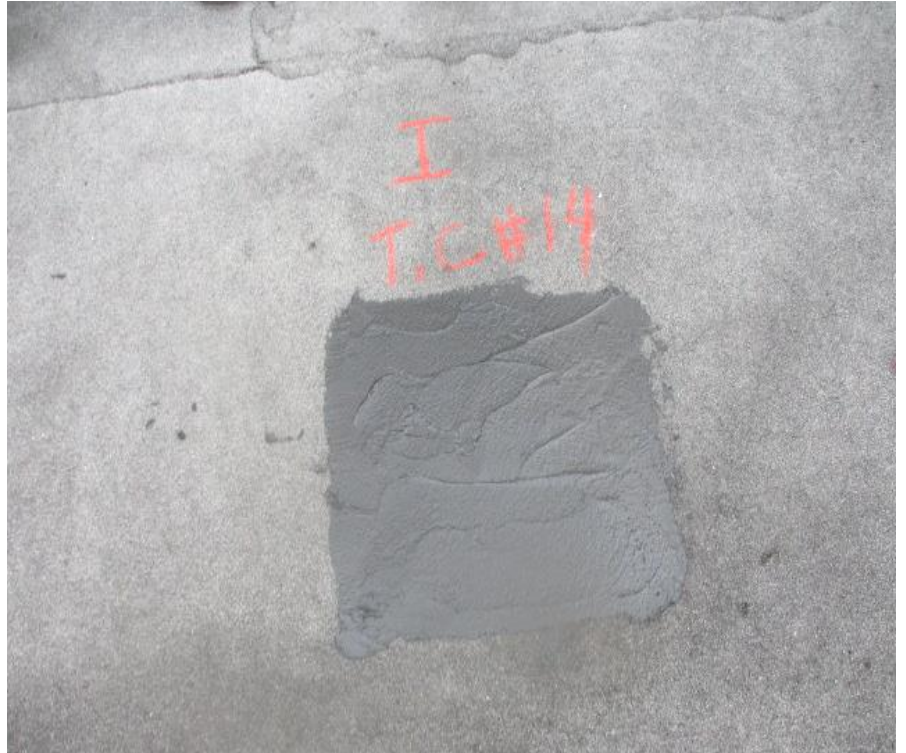
23. Test Cut #14 (Area I): View of  
RCS repair

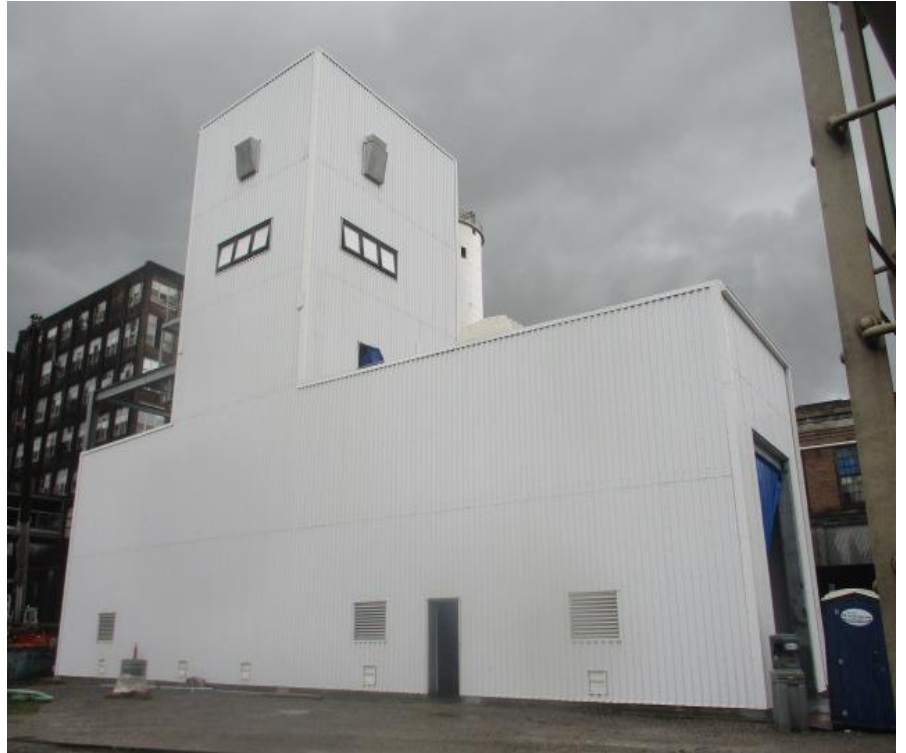
1. Building exterior elevation  
overview

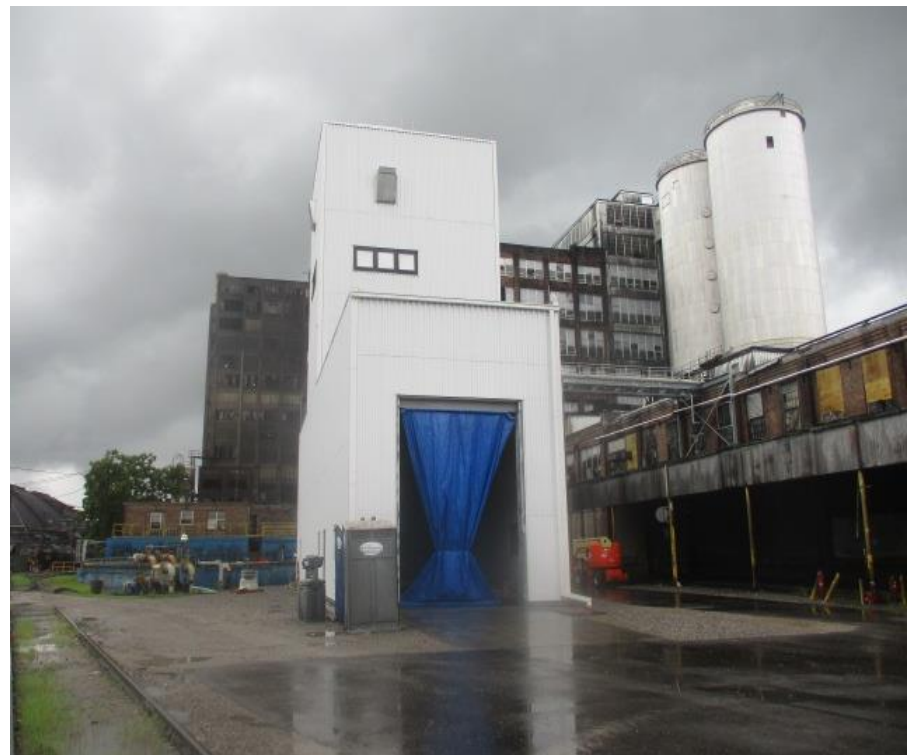
2. Building exterior elevation  
overview

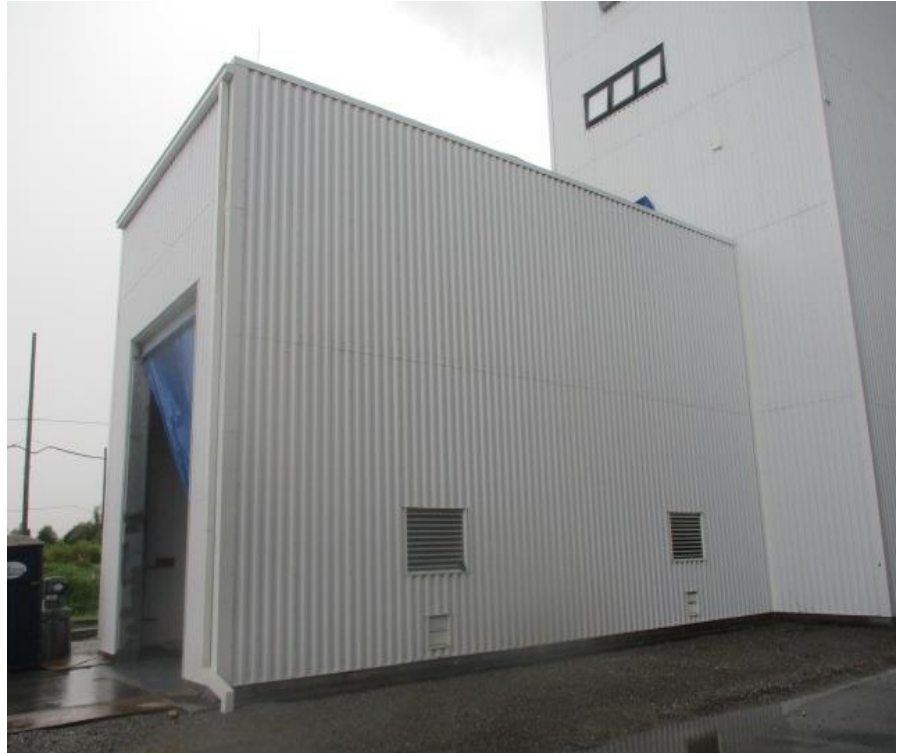
3. Building exterior elevation overview

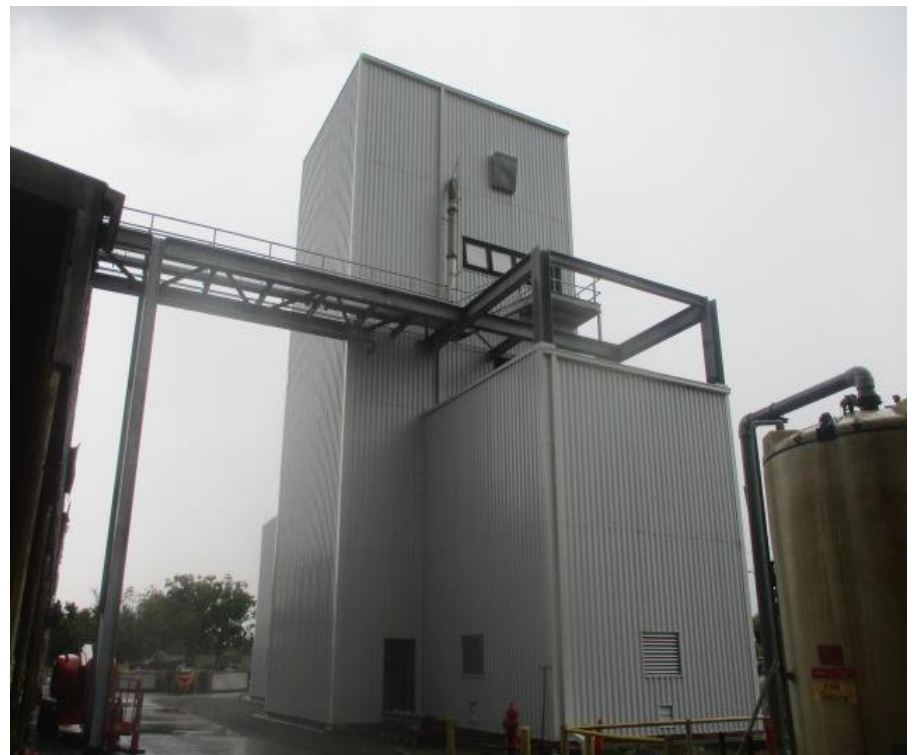
4. Building exterior elevation overview
