## **Domino Sugar Refinery**

# **Domino Sugar Facility**

**7412 N. Peters Street  
Arabi, LA**

**9/3/2022**

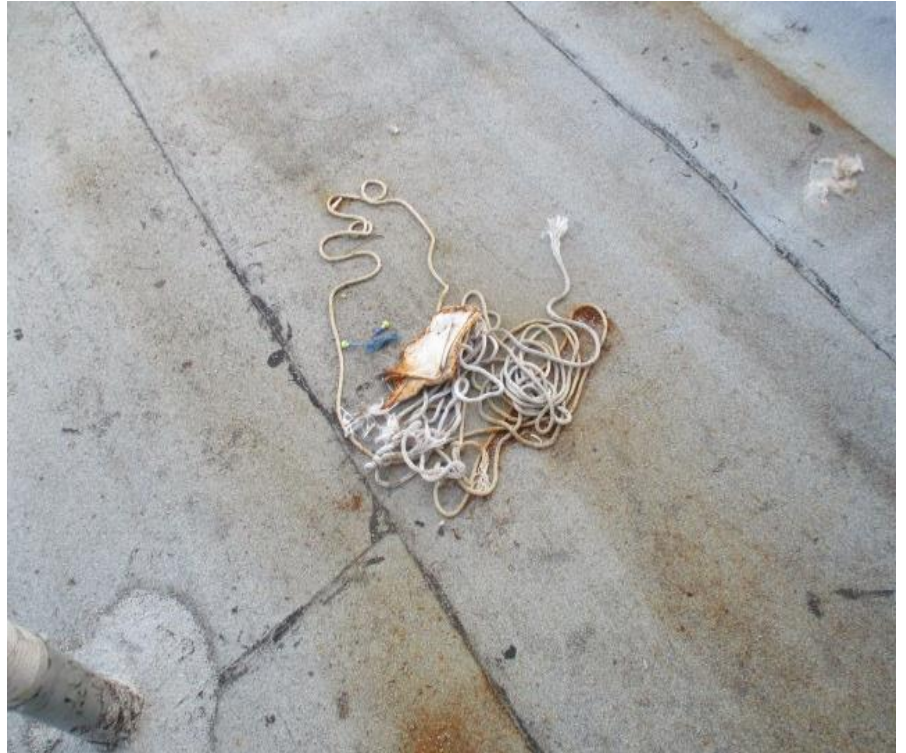
31. Deficiency #2 - Debris on roof surface

NUMBER	PRIORITY CODE	DEFICIENCY DESCRIPTION	QUANTITY	UNIT PRICE	REPAIR COST
		DEFICIENCY SOLUTION	UNITS		
2	M	Debris on roof surface	1	\$25.00	\$25.00
		Remove and properly dispose of all debris	Location		
3	M	Open flashing	4	\$225.00	\$900.00
		Repair with a (3) three course application of flashing grade roof cement and reinforcing fabric	Locations

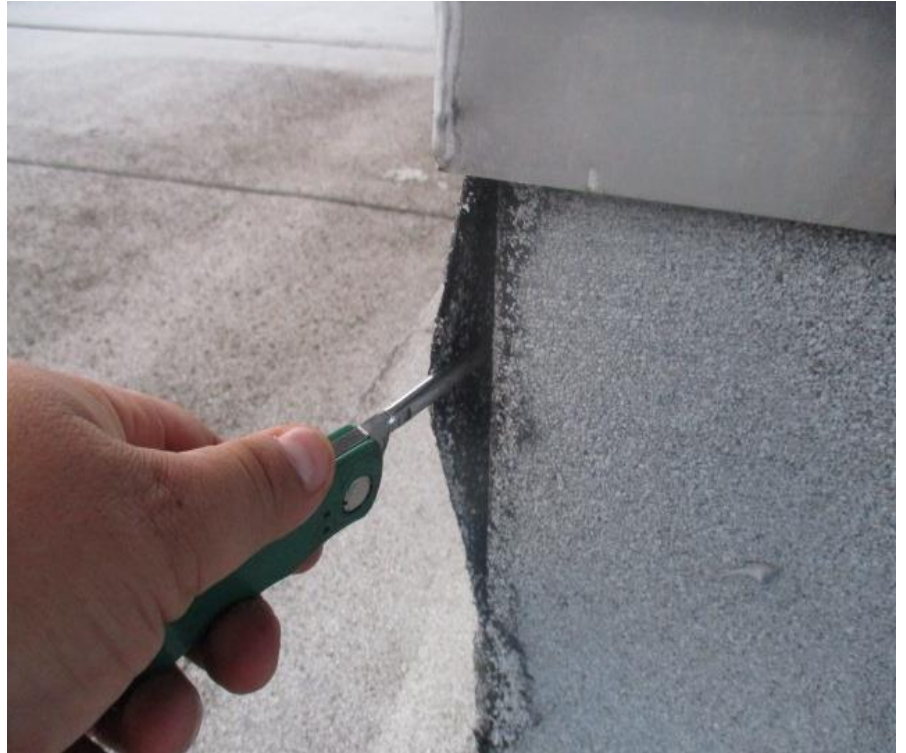
33. Deficiency #3 - Open flashing
