Roof Systems Data Management

Dulles Technical Center

**22611 Markey Ct
Sterling, VA**

Roof System Condition Evaluation Report

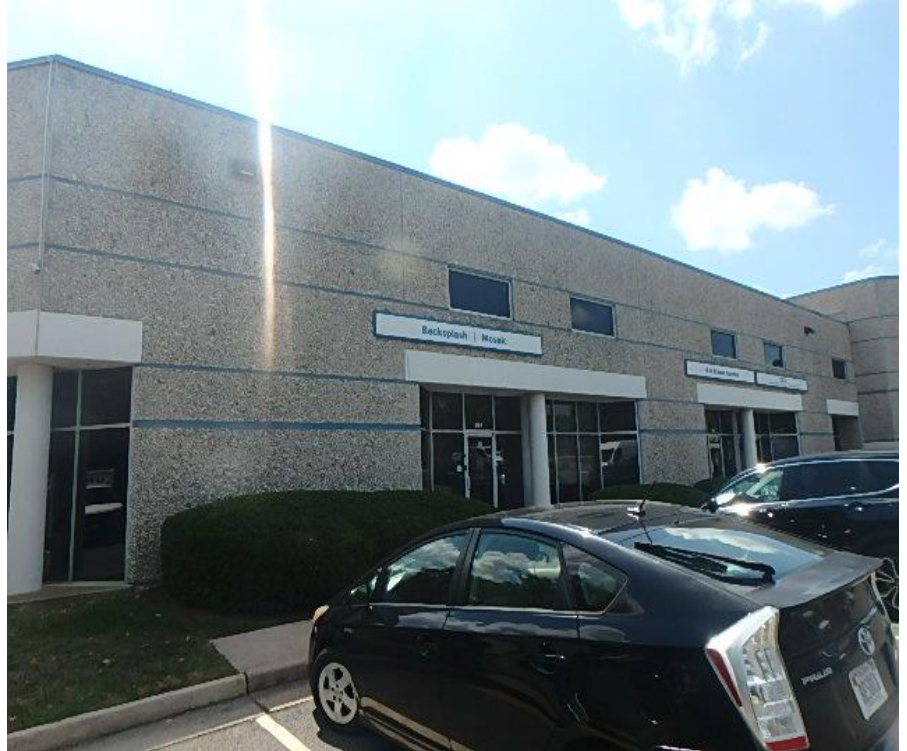
1. Building exterior front elevation overview

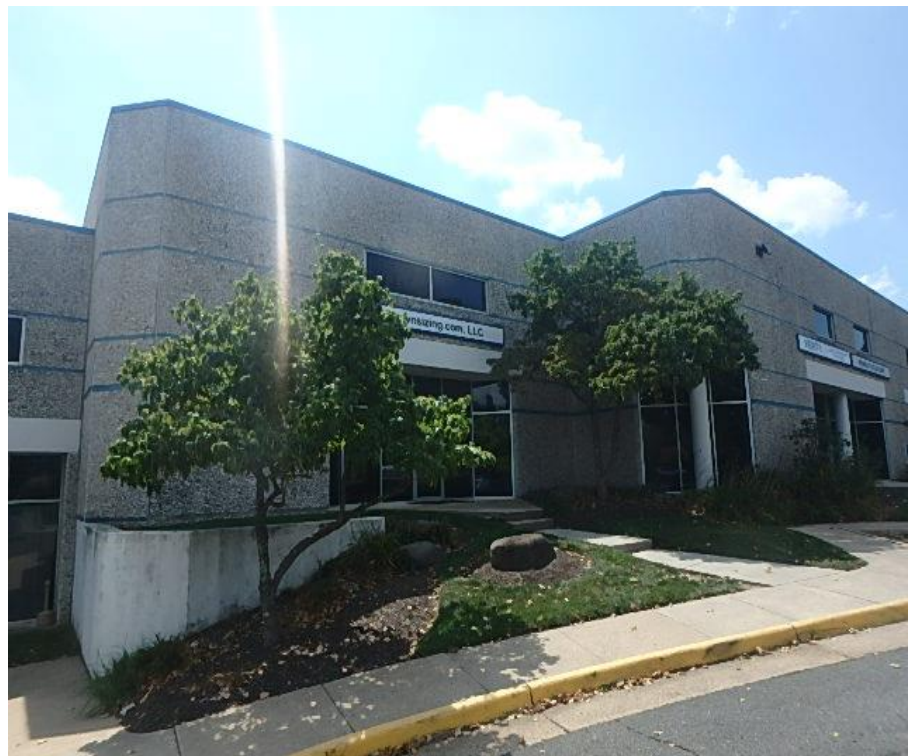
2. Building exterior front elevation overview

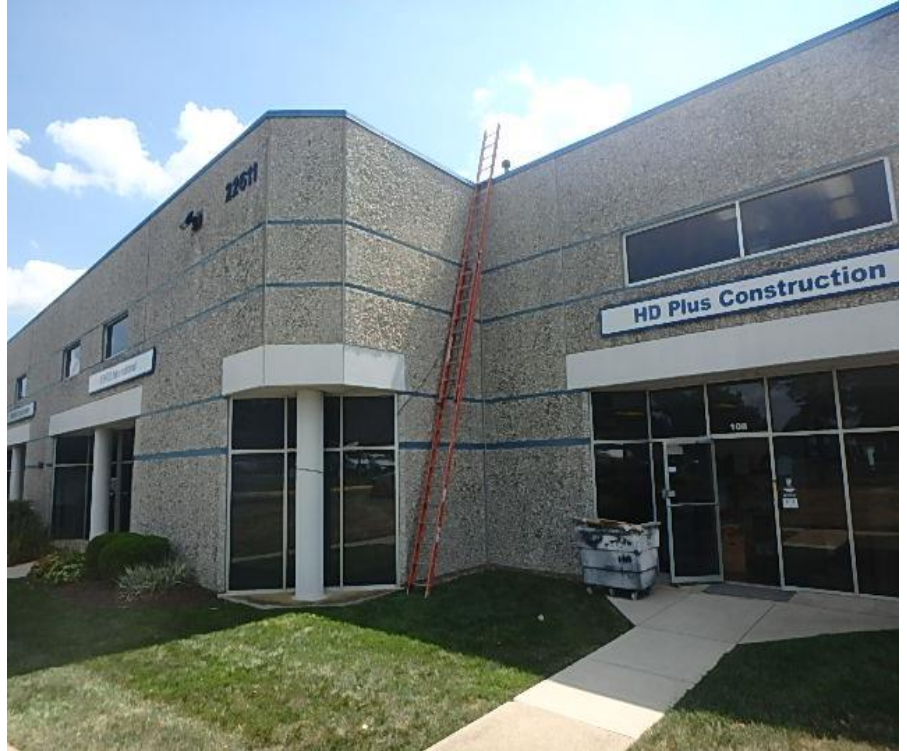
3. Building exterior front elevation overview

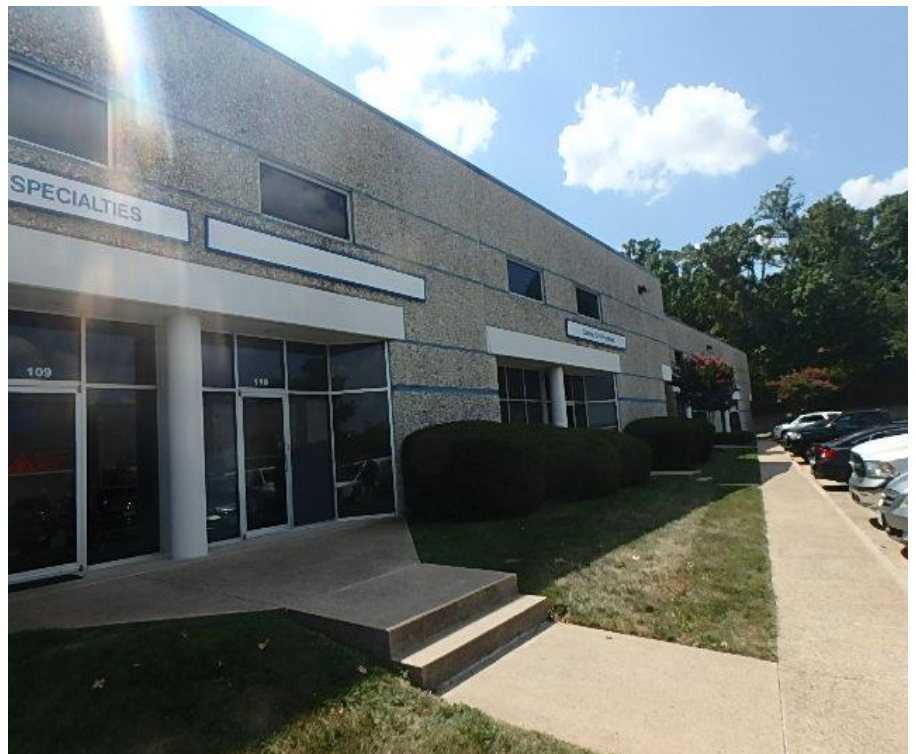
4. Building exterior front elevation overview

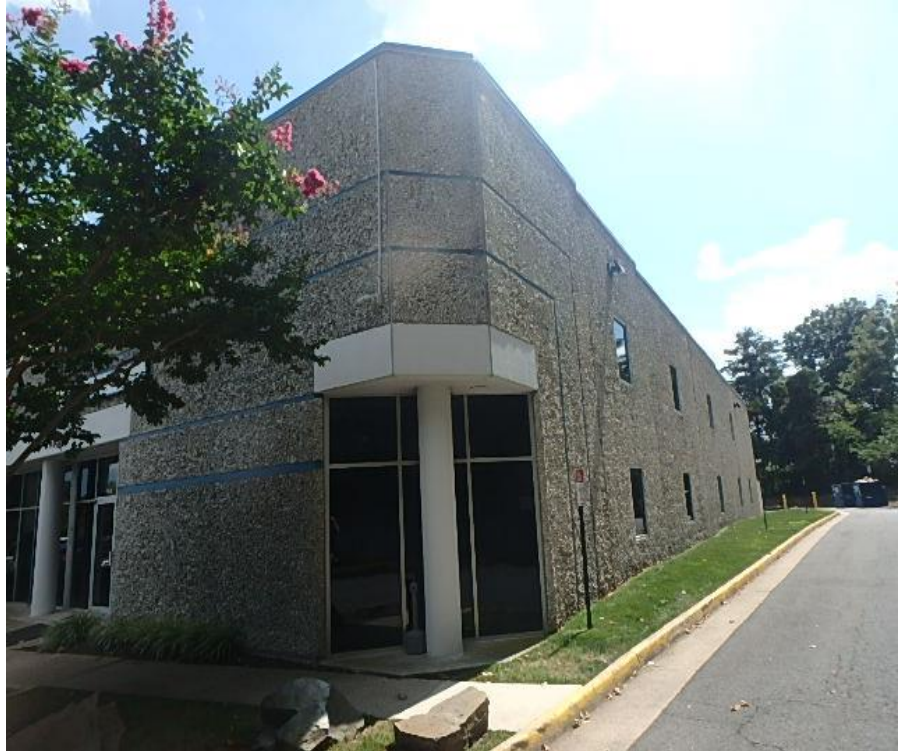
5. Building exterior front & side elevation overview

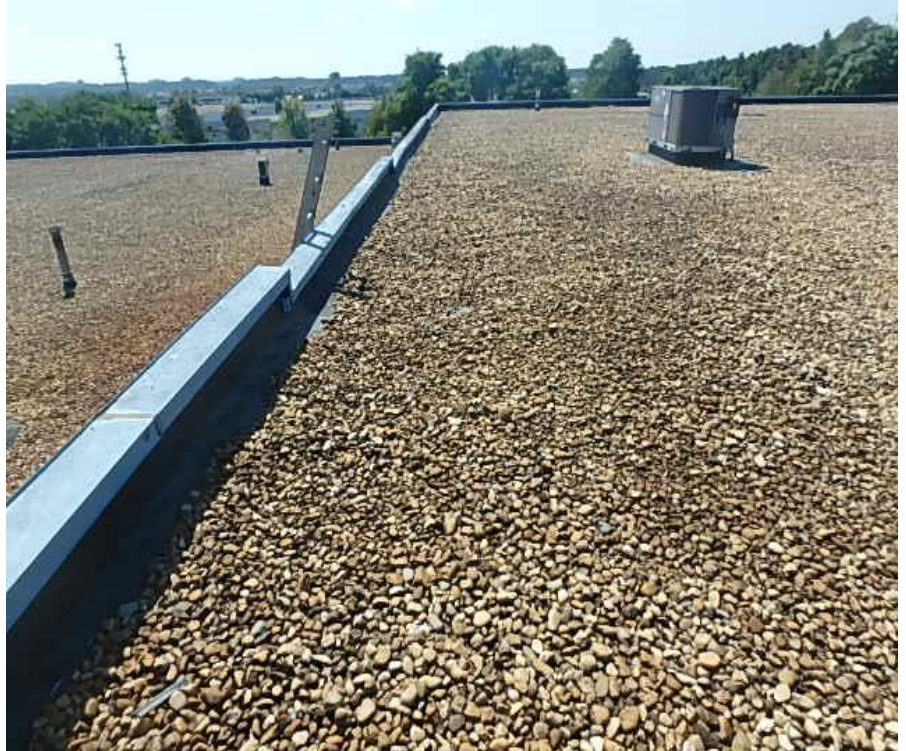
11. Bldg 1 - Area A roof system overview

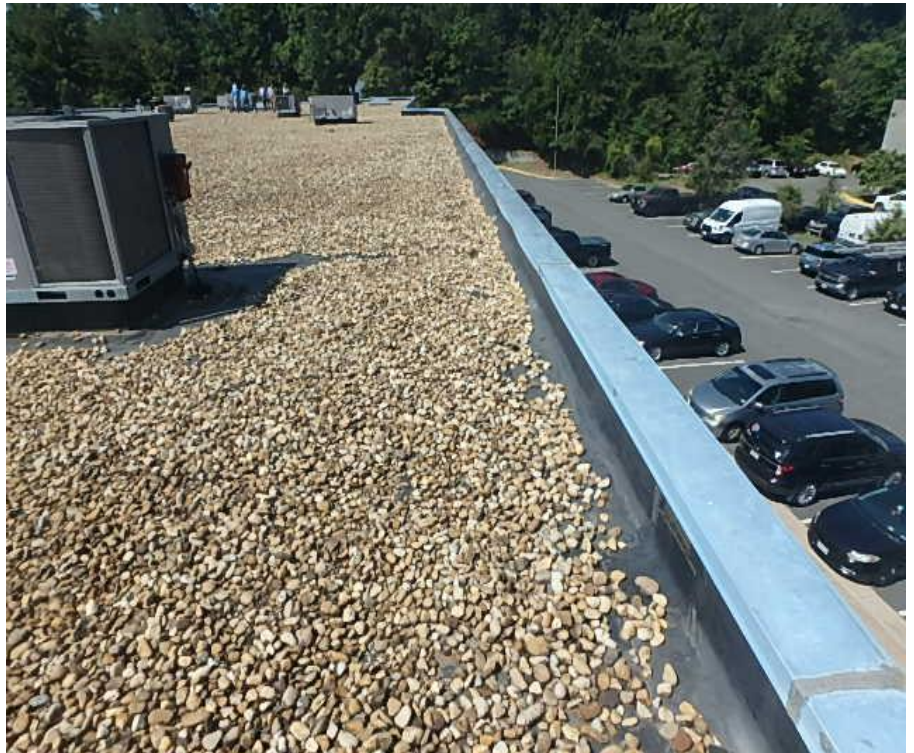
12. Bldg 1 - Area A roof system overview

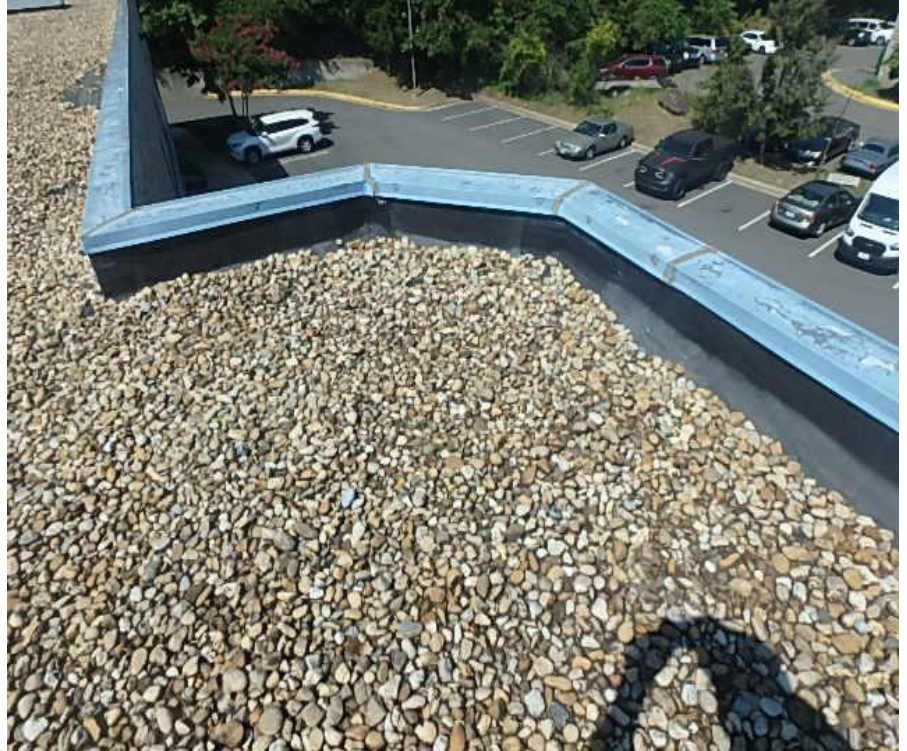
13. Bldg 1 - Area A roof system overview

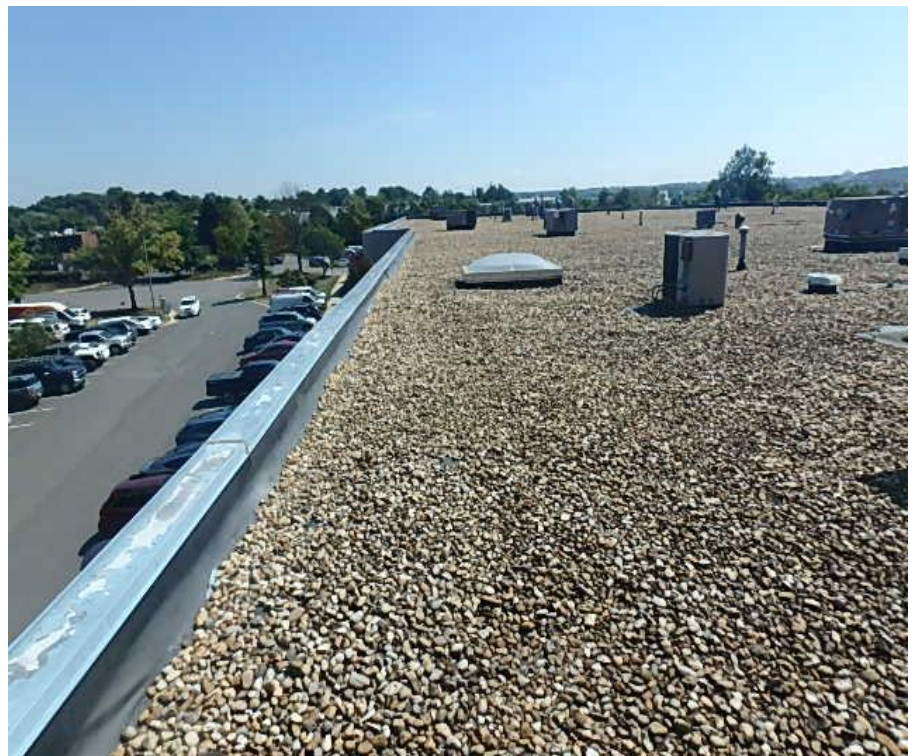
14. Bldg 1 - Area A roof system overview

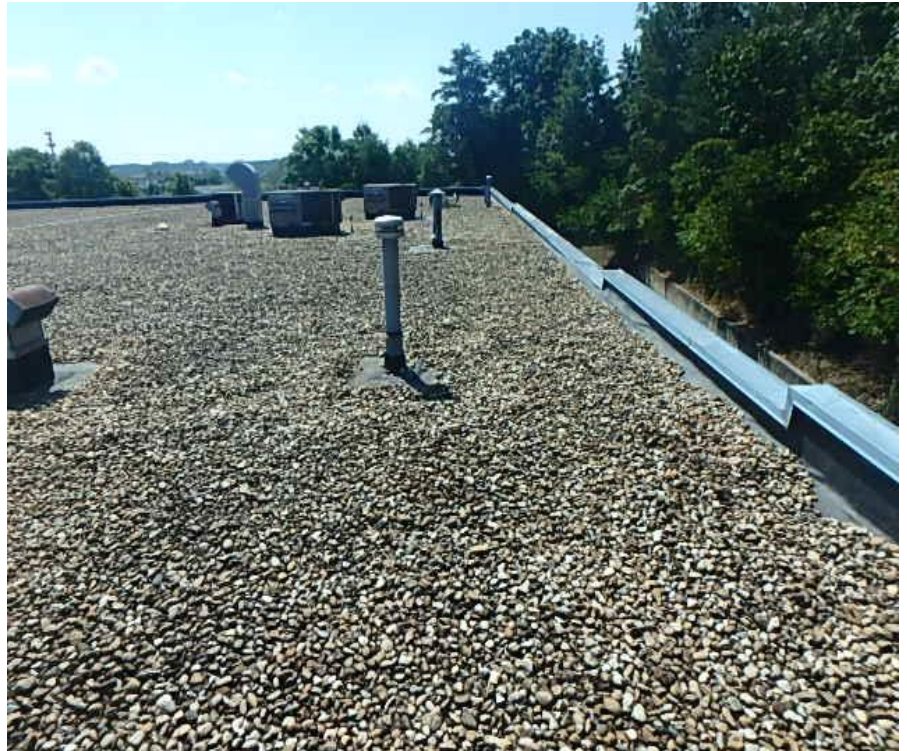
15. Bldg 1 - Area A roof system overview

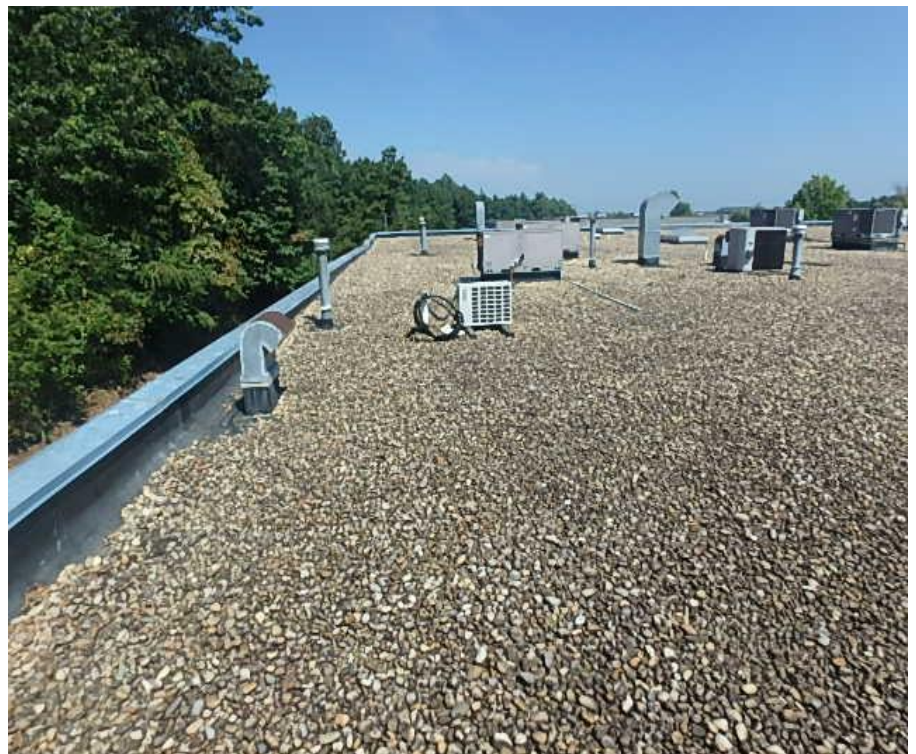
16. Bldg 1 - Area A roof system overview

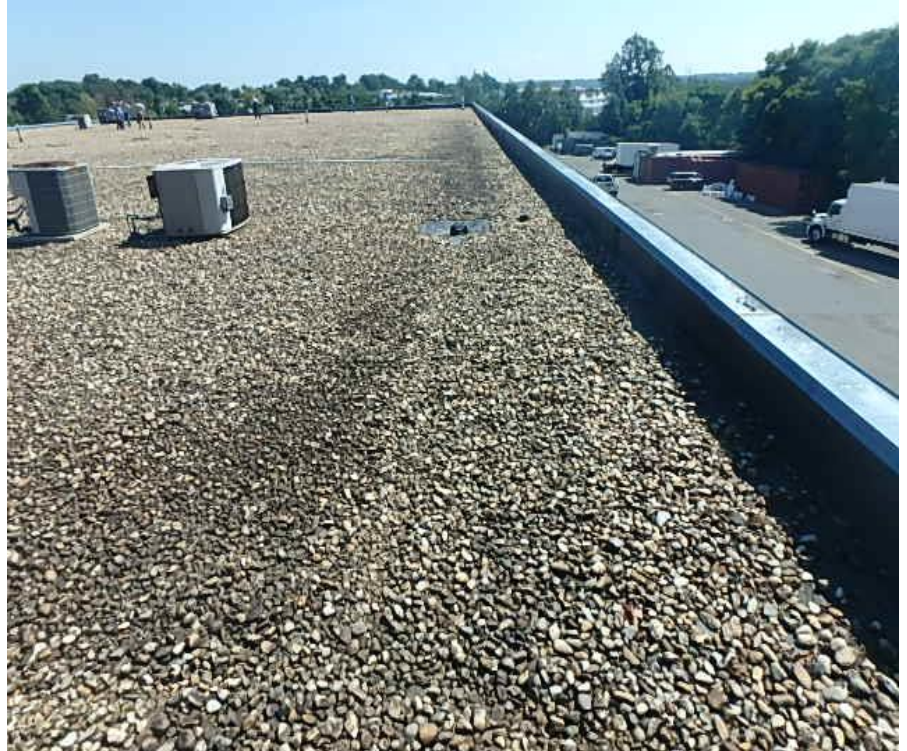
17. Bldg 1 - Area A roof system overview

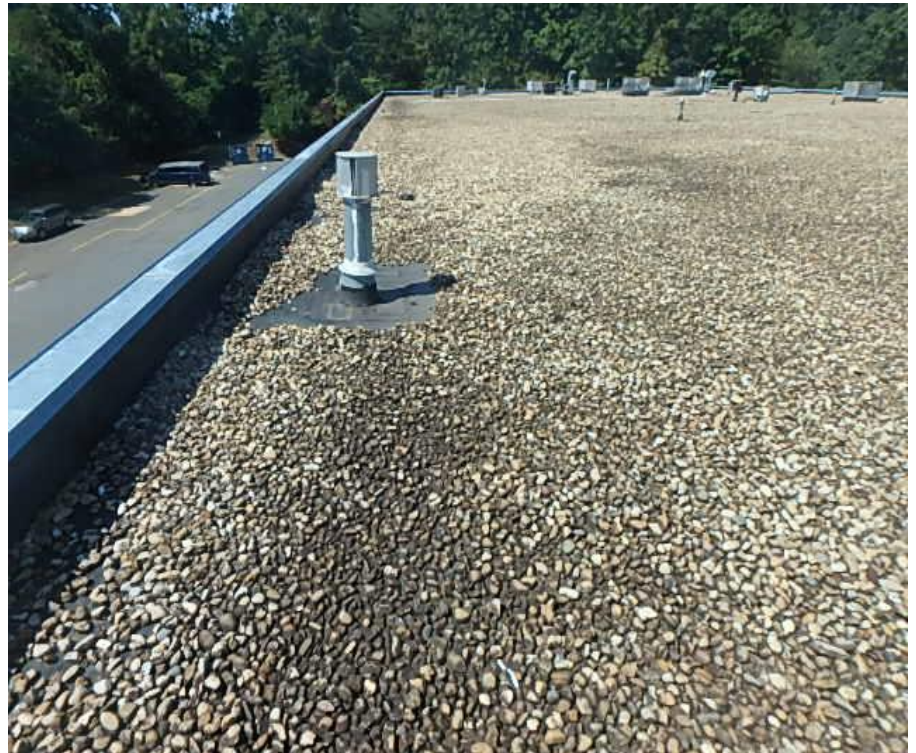
18. Bldg 1 - Area A roof system overview

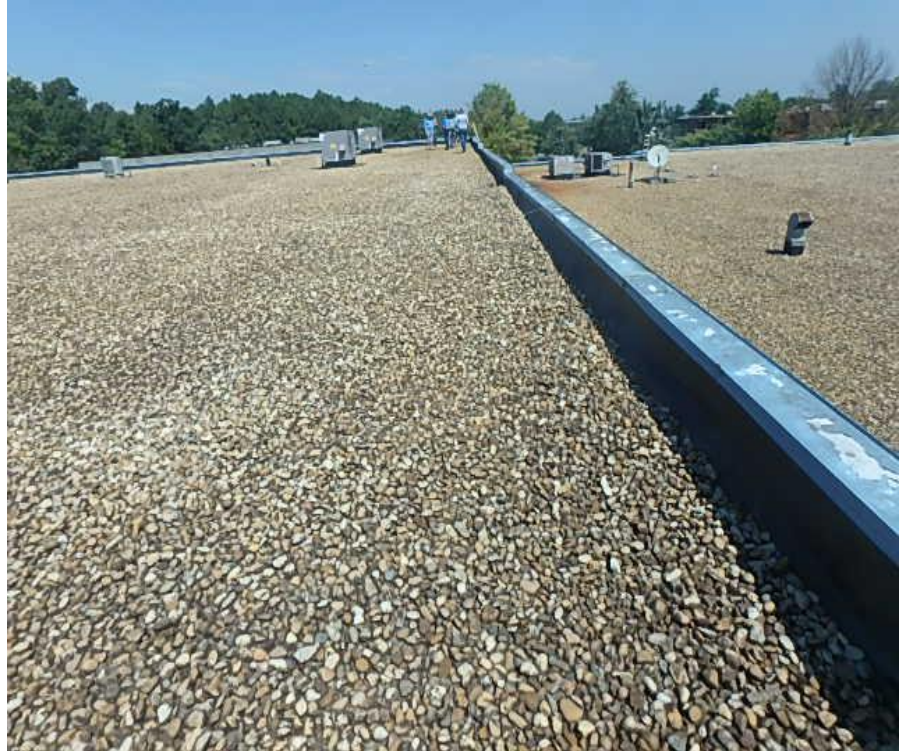
19. Bldg 1 - Area A roof system overview

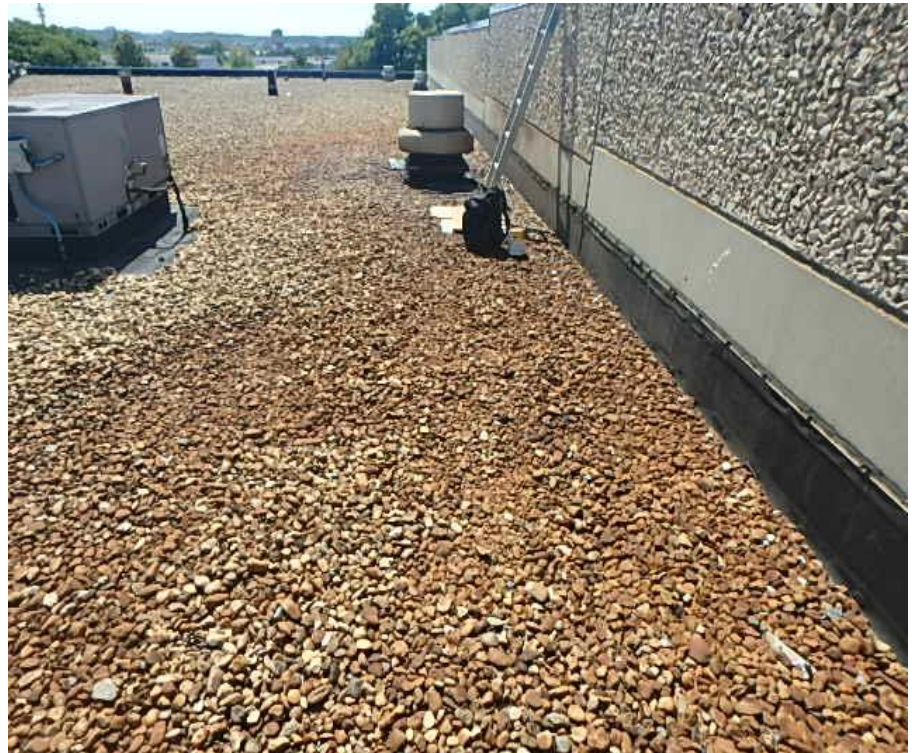
20. Bldg 1 - Area B roof system overview

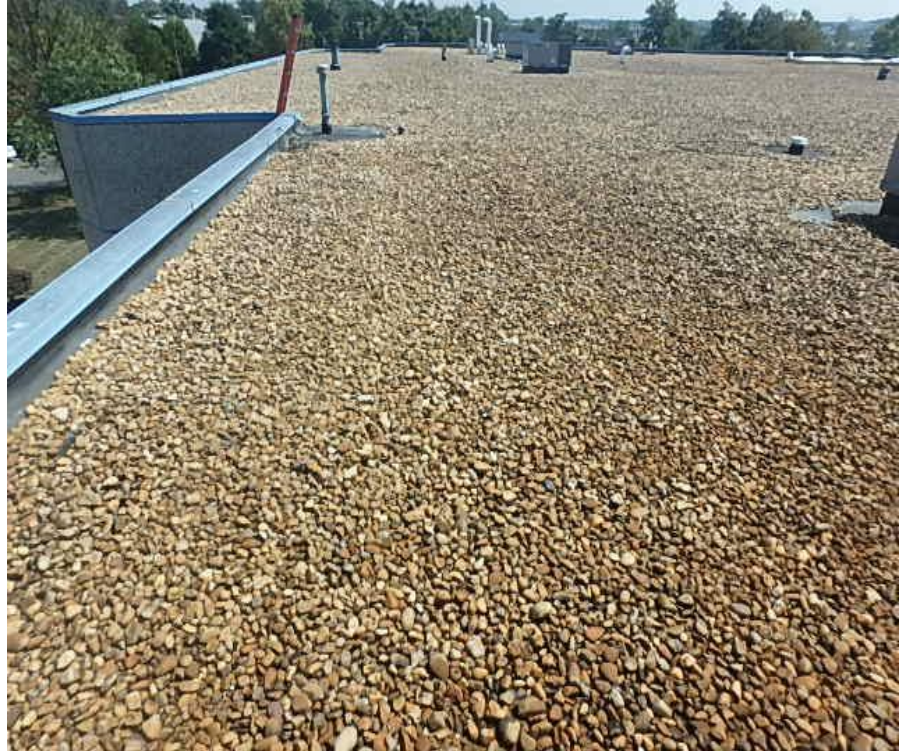
21. Bldg 1 - Area B roof system overview

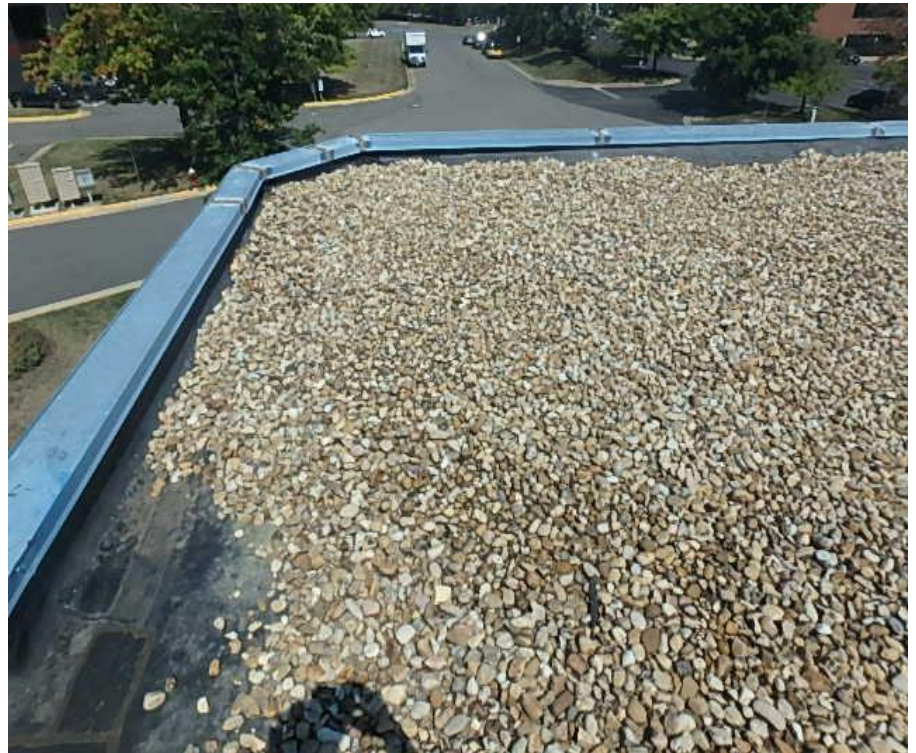
22. Bldg 1 - Area B roof system overview

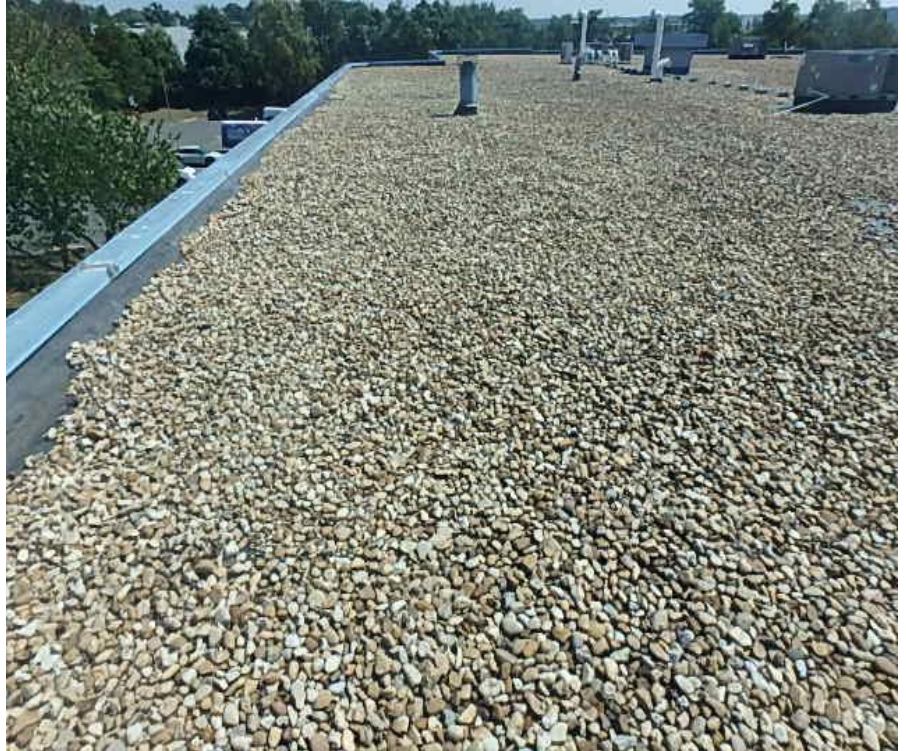
23. Bldg 1 - Area B roof system overview

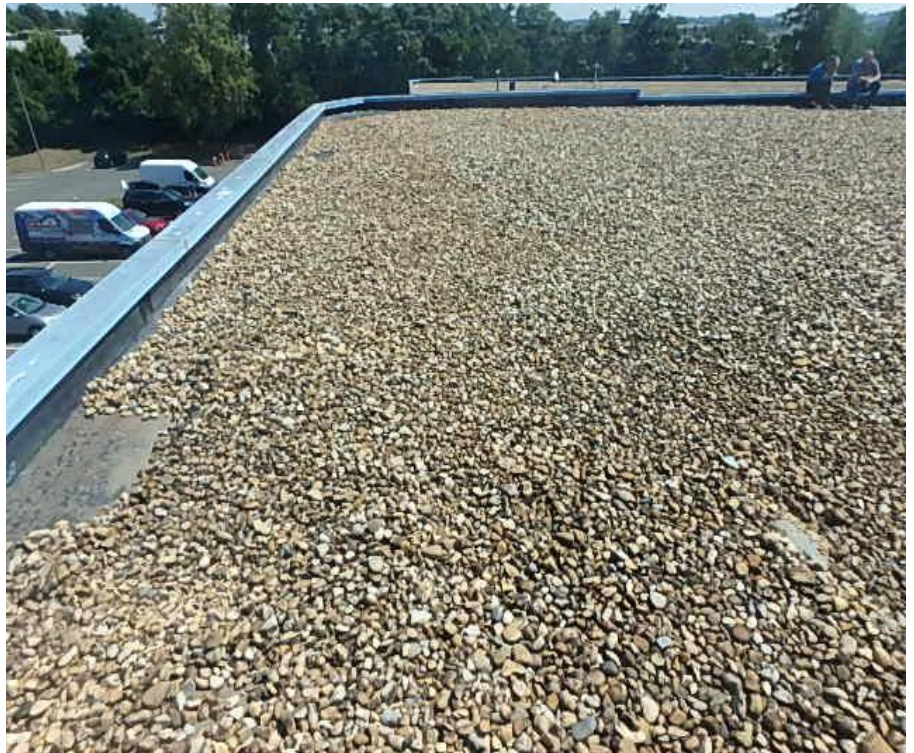
24. Bldg 1 - Area B roof system overview

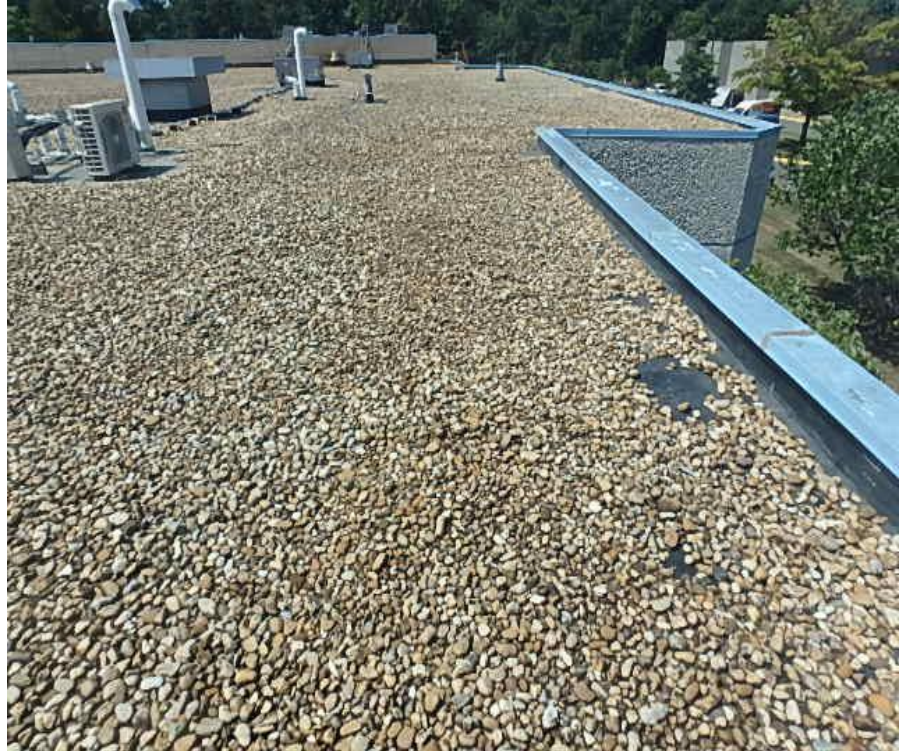
25. Bldg 1 - Area B roof system overview

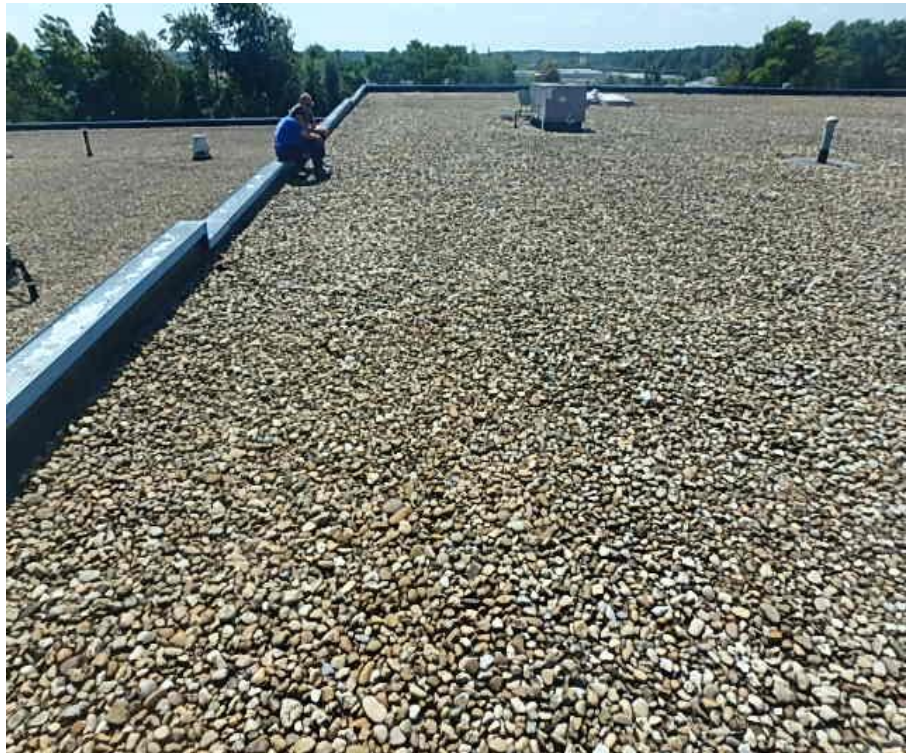
26. Bldg 1 - Area B roof system overview

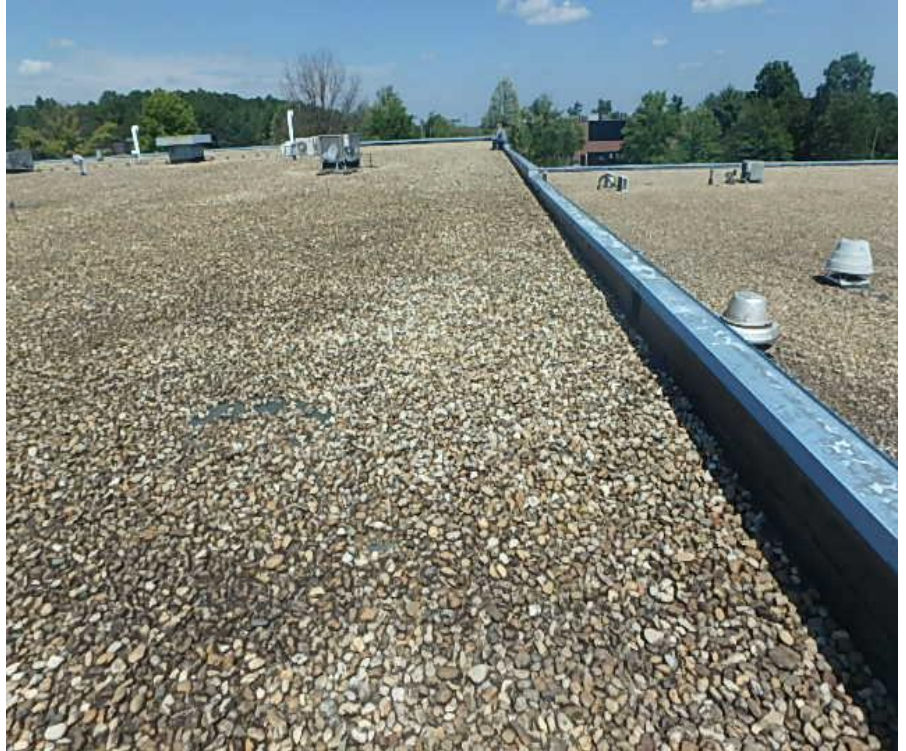
27. Bldg 1 - Area B roof system overview

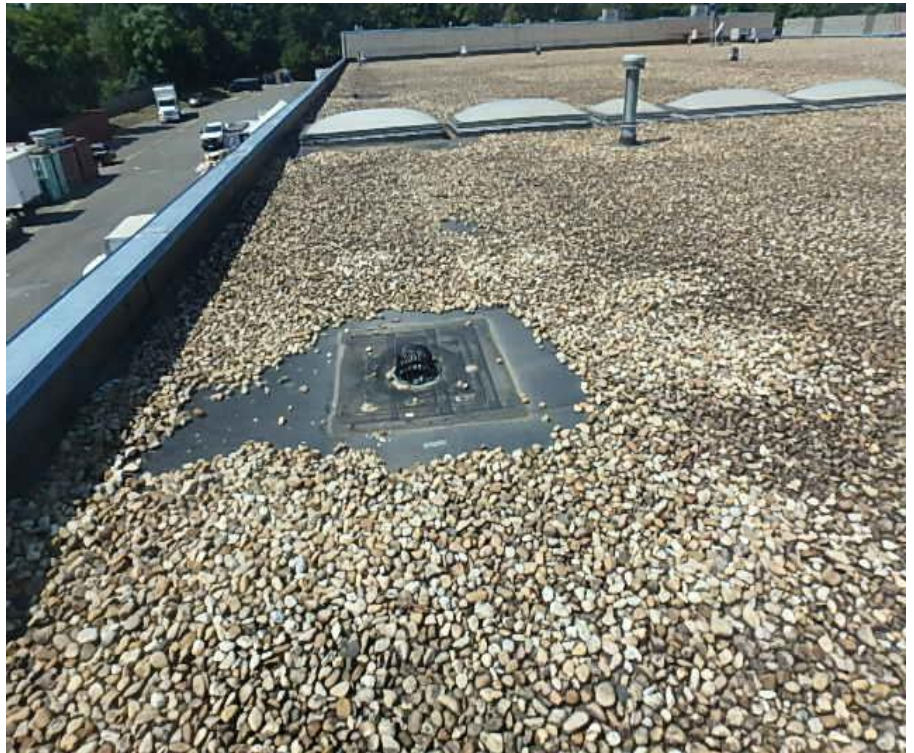
28. Bldg 1 - Area B roof system overview

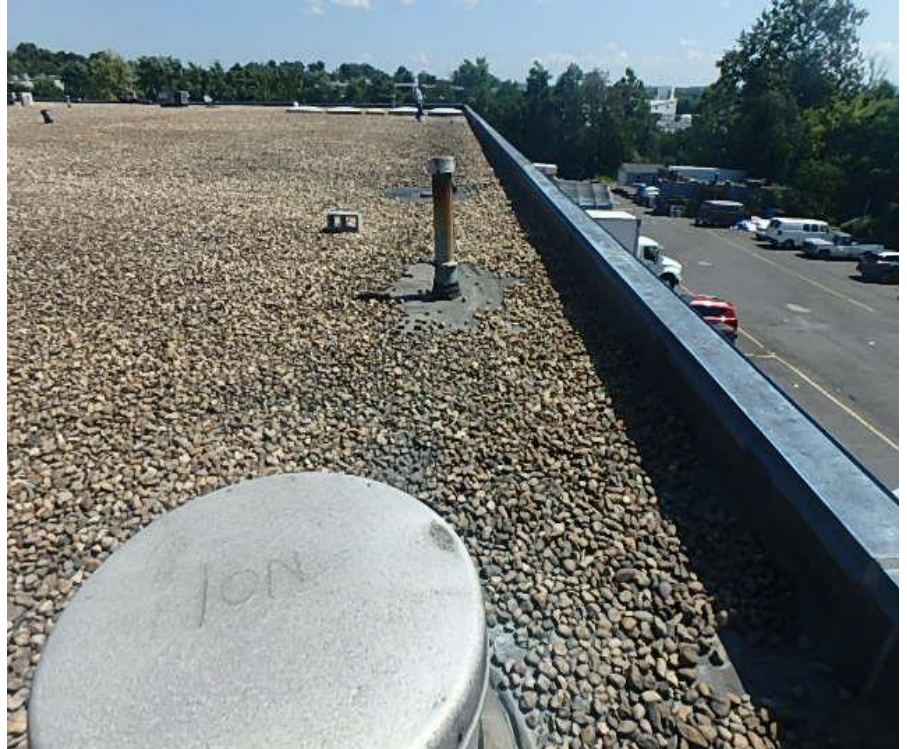
29. Bldg 1 - Area B roof system overview

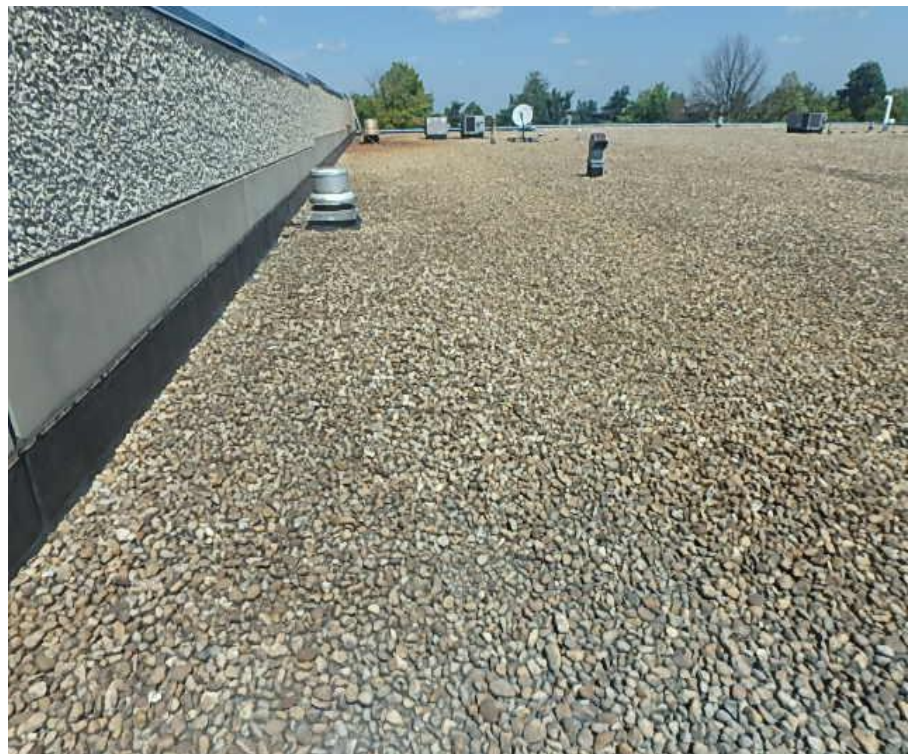
30. Bldg 1 - Area B roof system overview

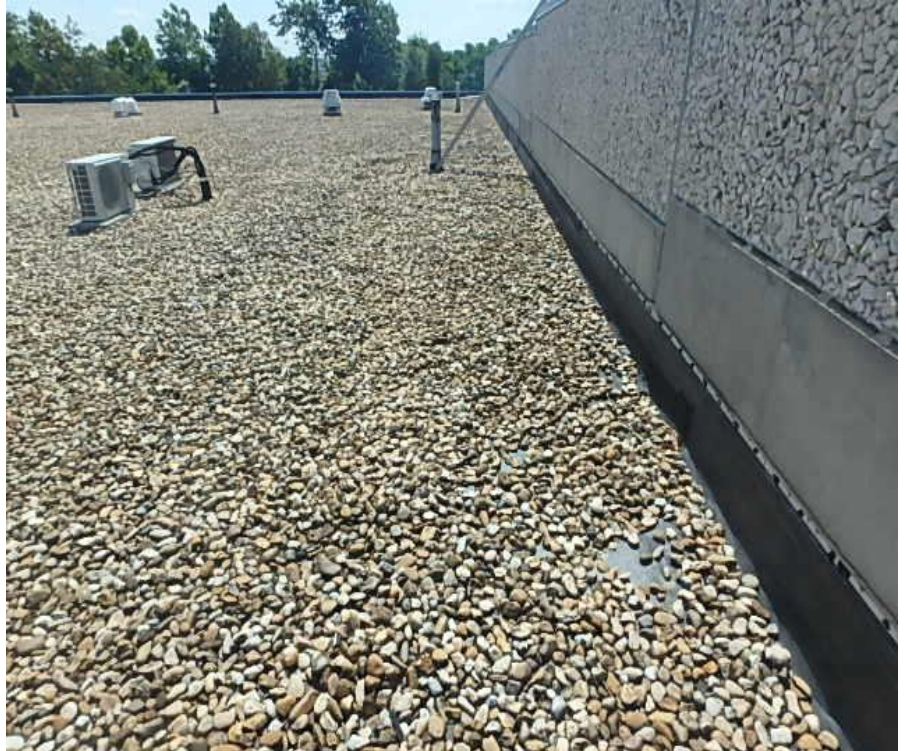
31. Bldg 1 - Area C roof system overview

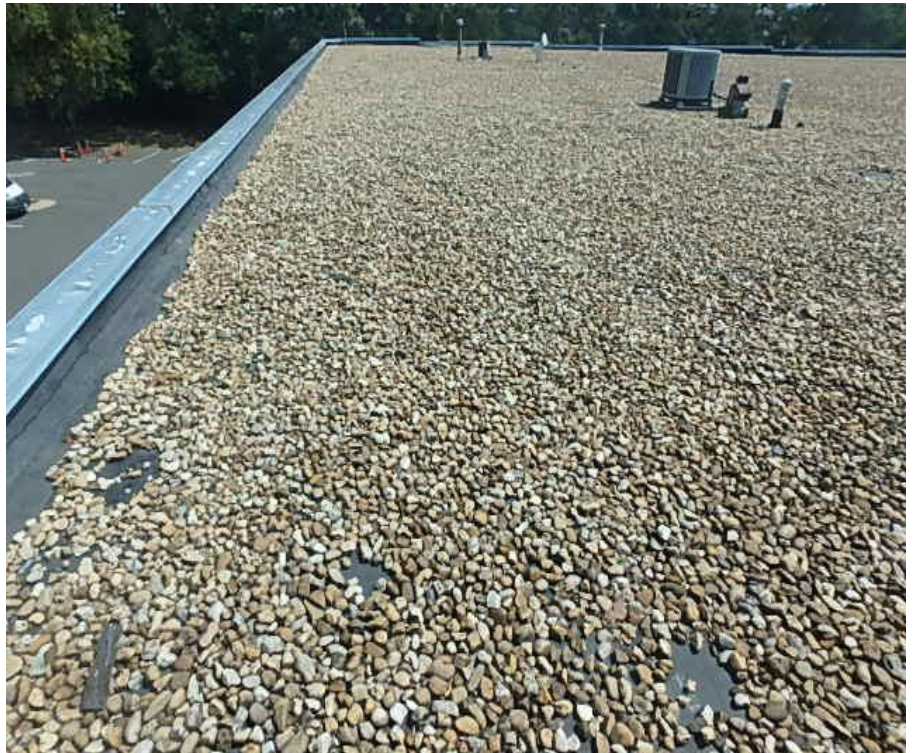
32. Bldg 1 - Area C roof system overview

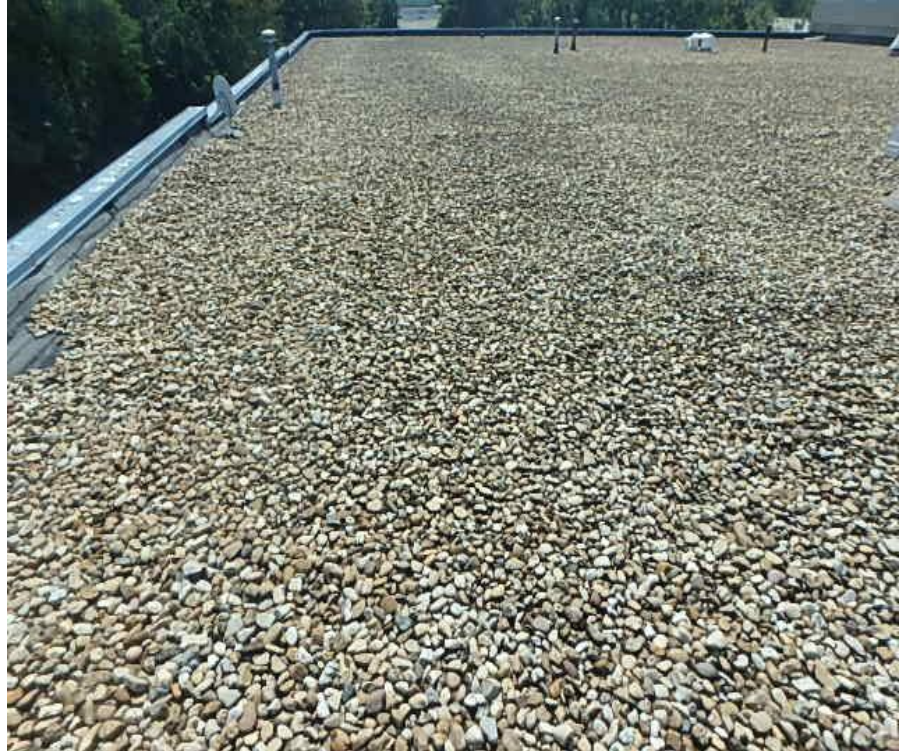
33. Bldg 1 - Area C roof system overview

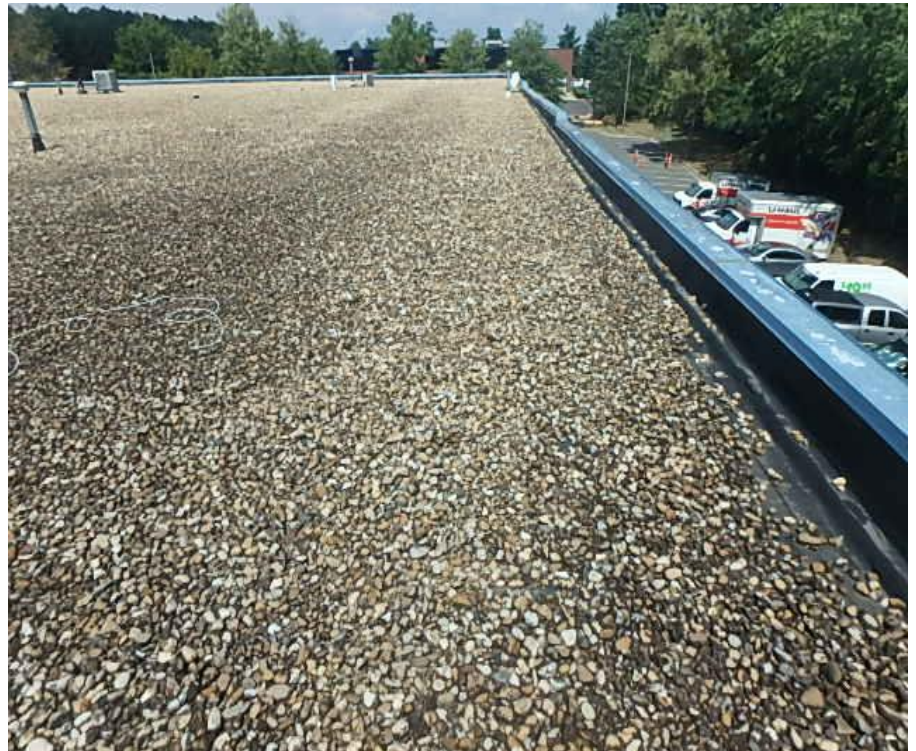
34. Bldg 1 - Area C roof system overview

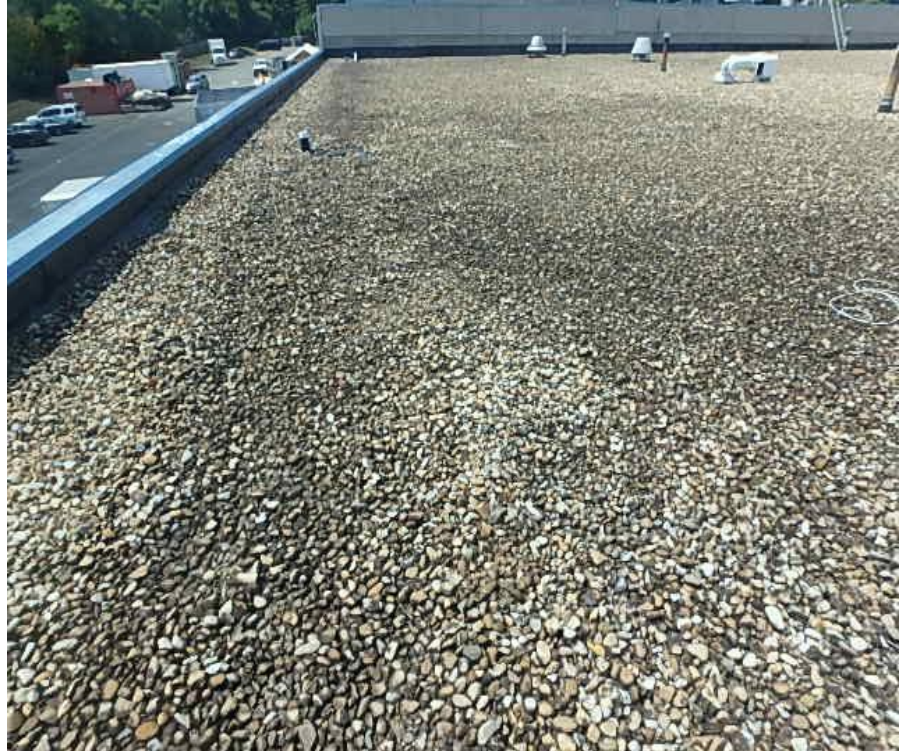
35. Bldg 1 - Area C roof system overview

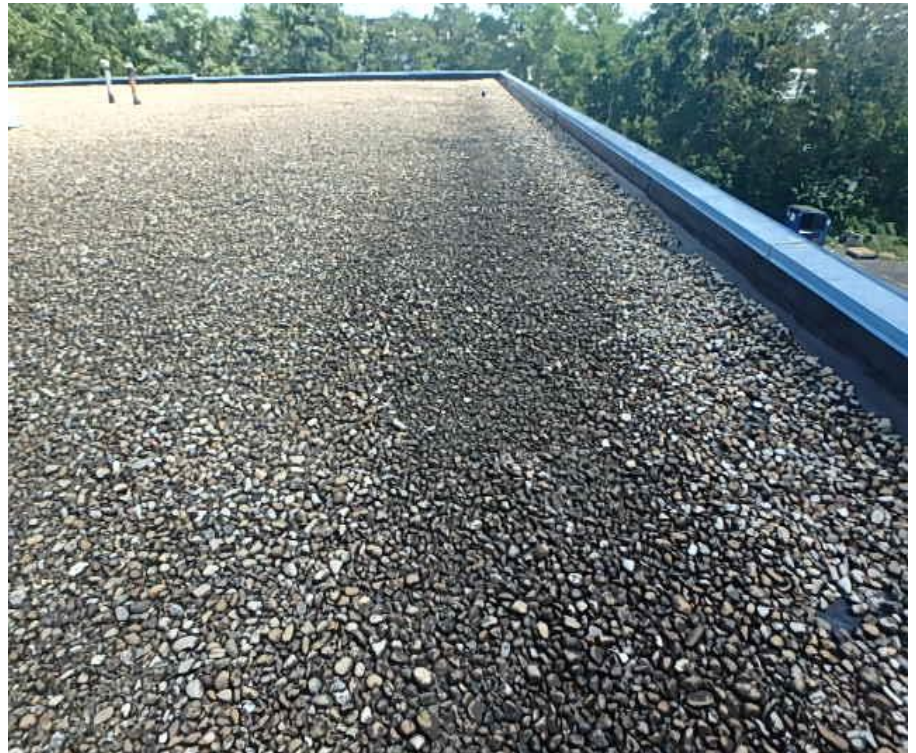
36. Bldg 1 - Area C roof system overview

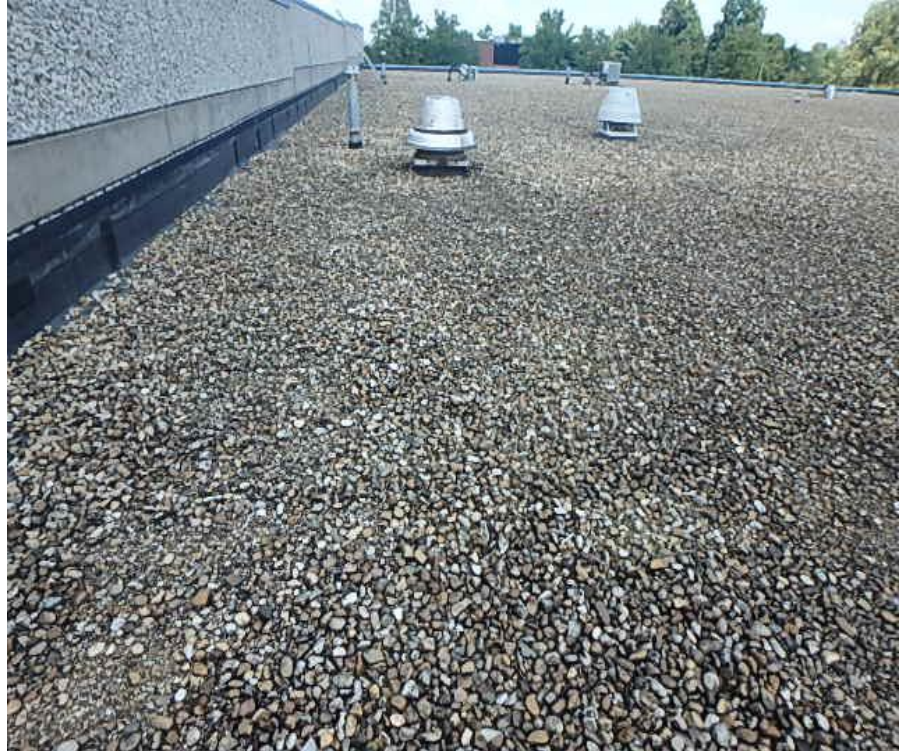
37. Bldg 1 - Area C roof system overview
